Navajo Abandoned Uranium Mine

Site Screen Report

Saytah AUM Site

August 2010

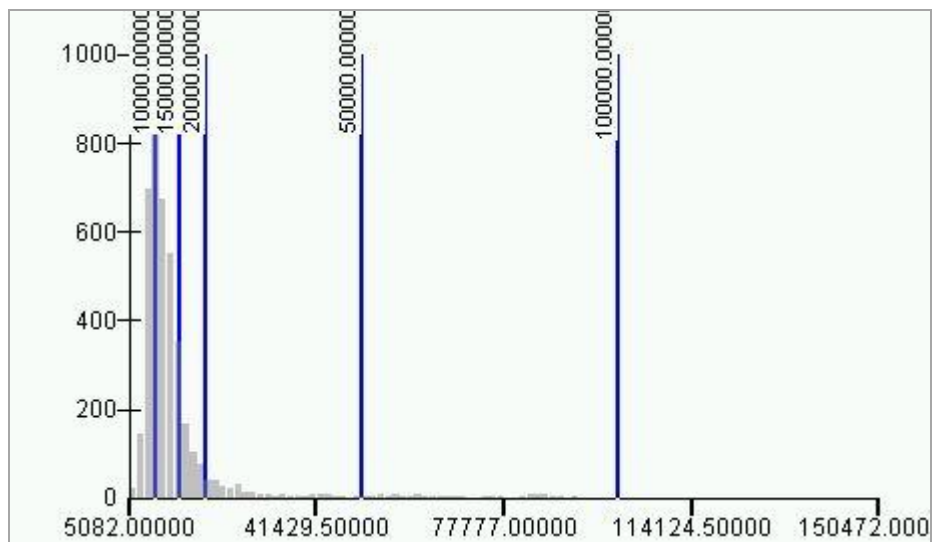
The following chart and statistics were generated by ESRI ArcGIS 9.3.1, and show the general distribution of the site gamma radiation measurements. The horizontal X axis represents the gamma radiation reading levels in cpm (lowest levels to the left). The vertical Y axis represents the frequency of each gamma radiation level.

Count:	4062
Minimum:	5082.00000
Maximum:	150472.00000
Sum:	60845112.00000
Mean:	14979.10192
Median:	11532.50000
Standard Deviation:	13377.50052

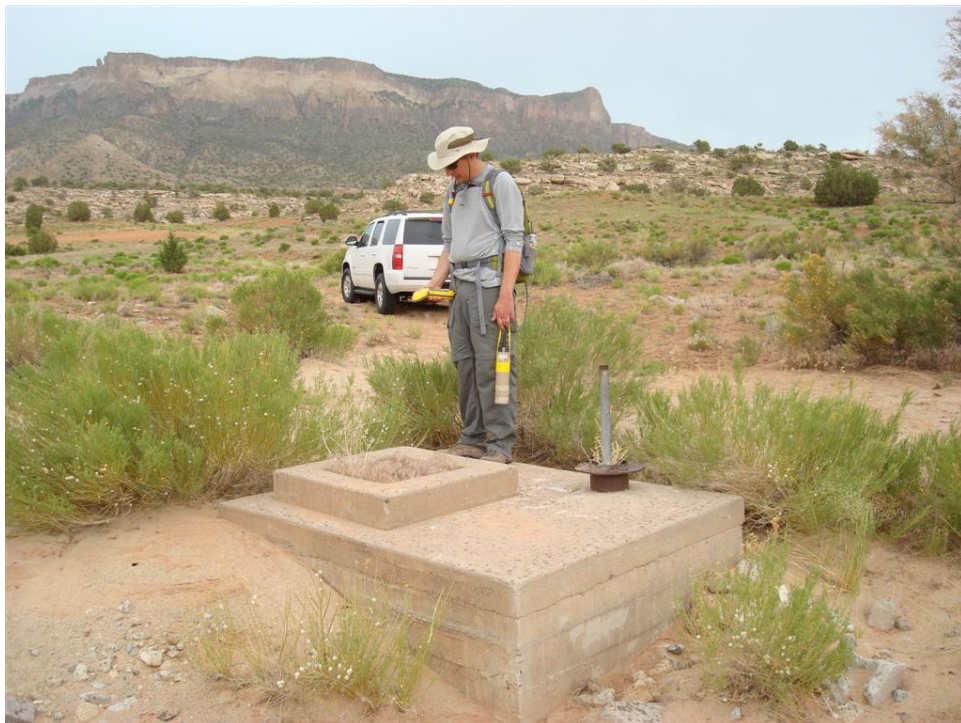
Pond atop mesa and newly built road; concrete pad; rock walls

Photo 4. Saytah site, concrete pad

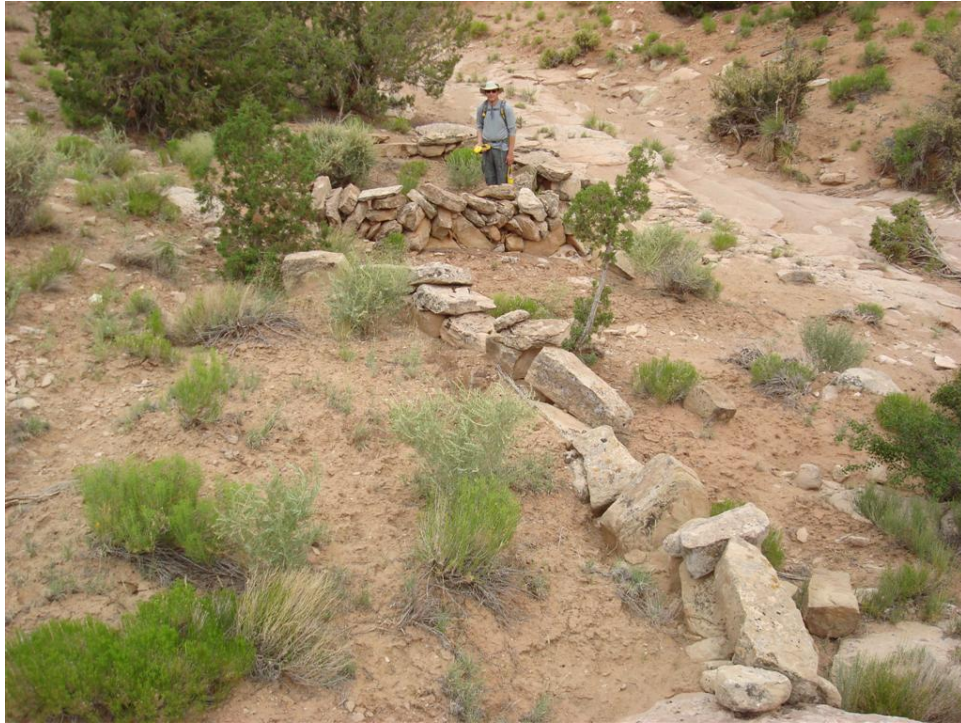
Photo 5. Saytah site, rock wall

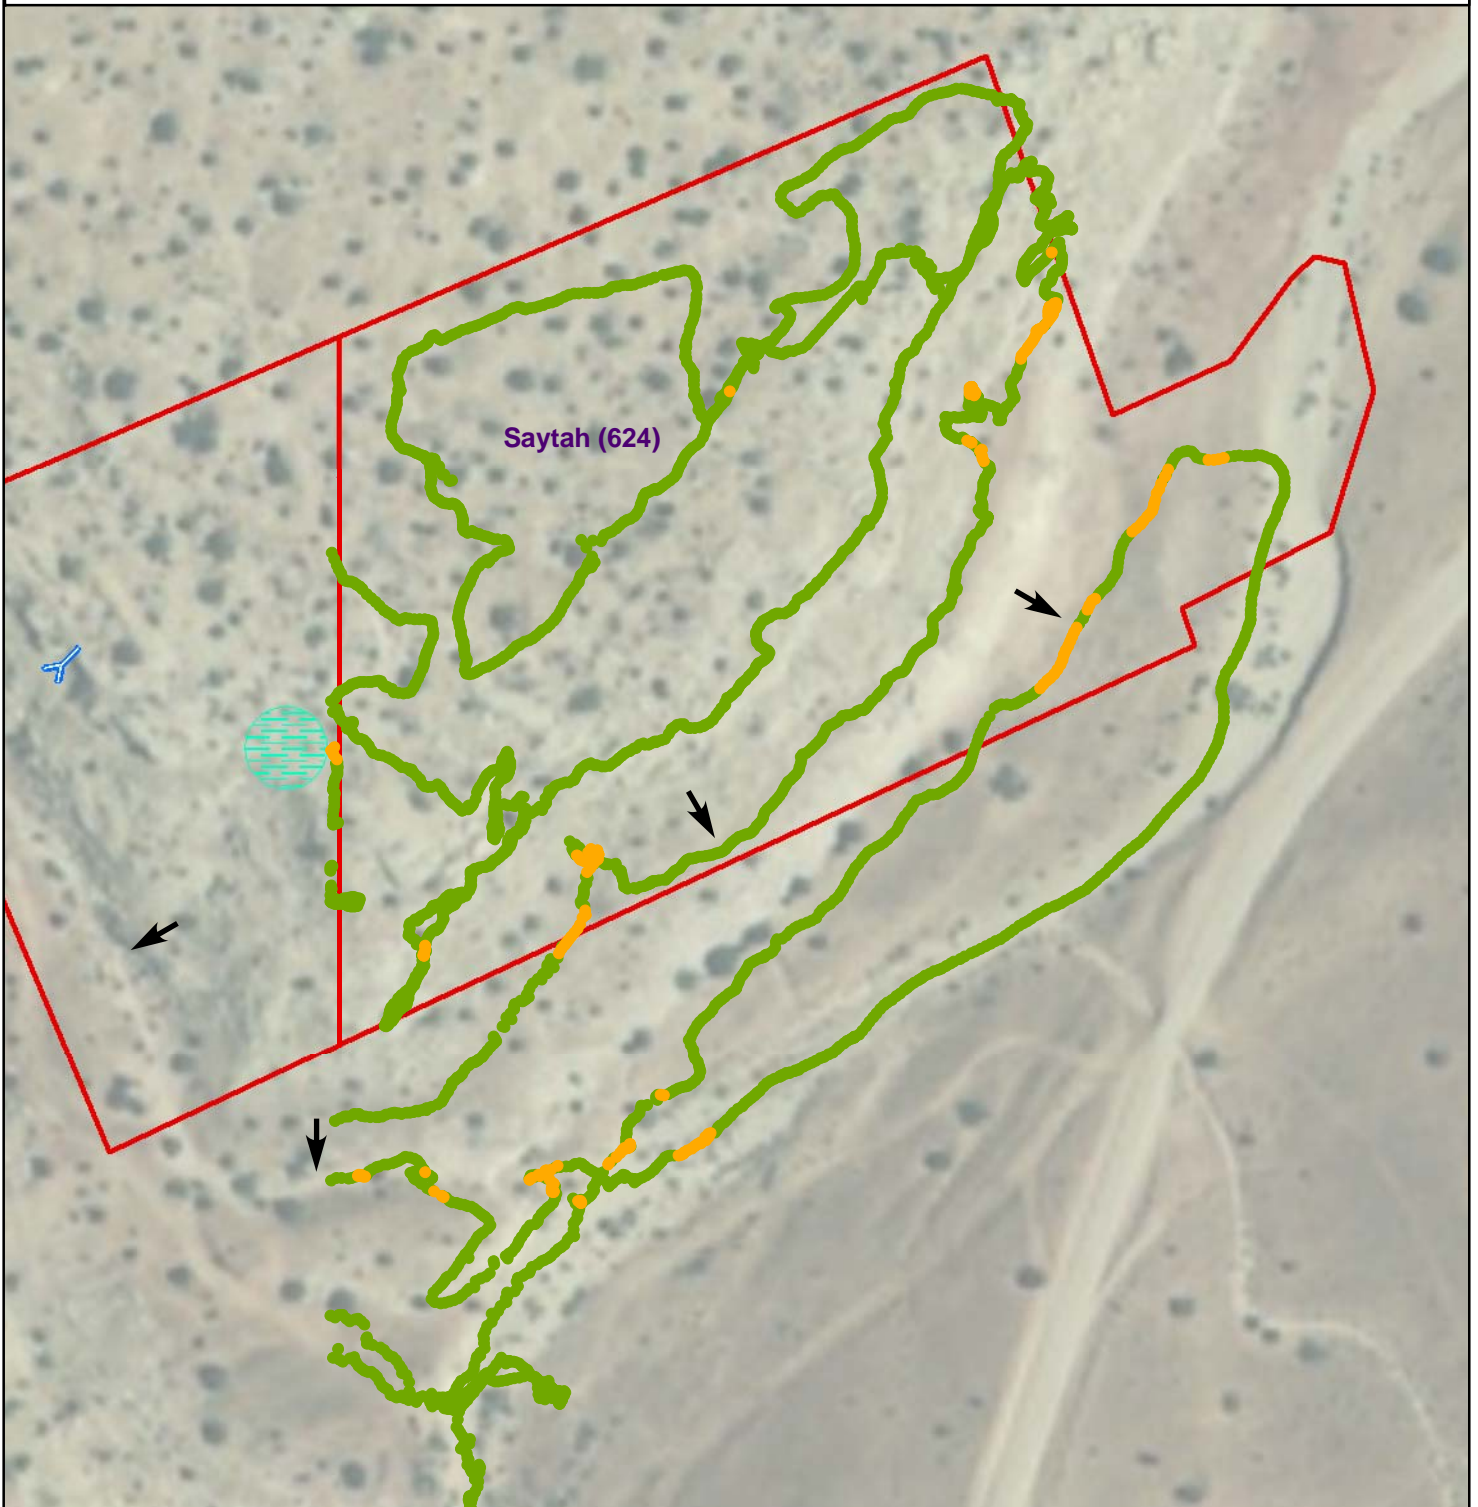
**Figure 1 - Gamma Radiation Measurements, Above Two Times Background
Saytah (624)
Sweetwater / Teec Nos Pos Chapter, Navajo Nation**

A total of 4,062 gamma radiation measurements were collected from the mine site, ranging from 5,082 cpm to 150,472 cpm. The measurements are represented in Figures 1 and 2.

Gamma survey conducted 06/2010
Measured as counts per minute (cpm)

Average background = 9,634 cpm

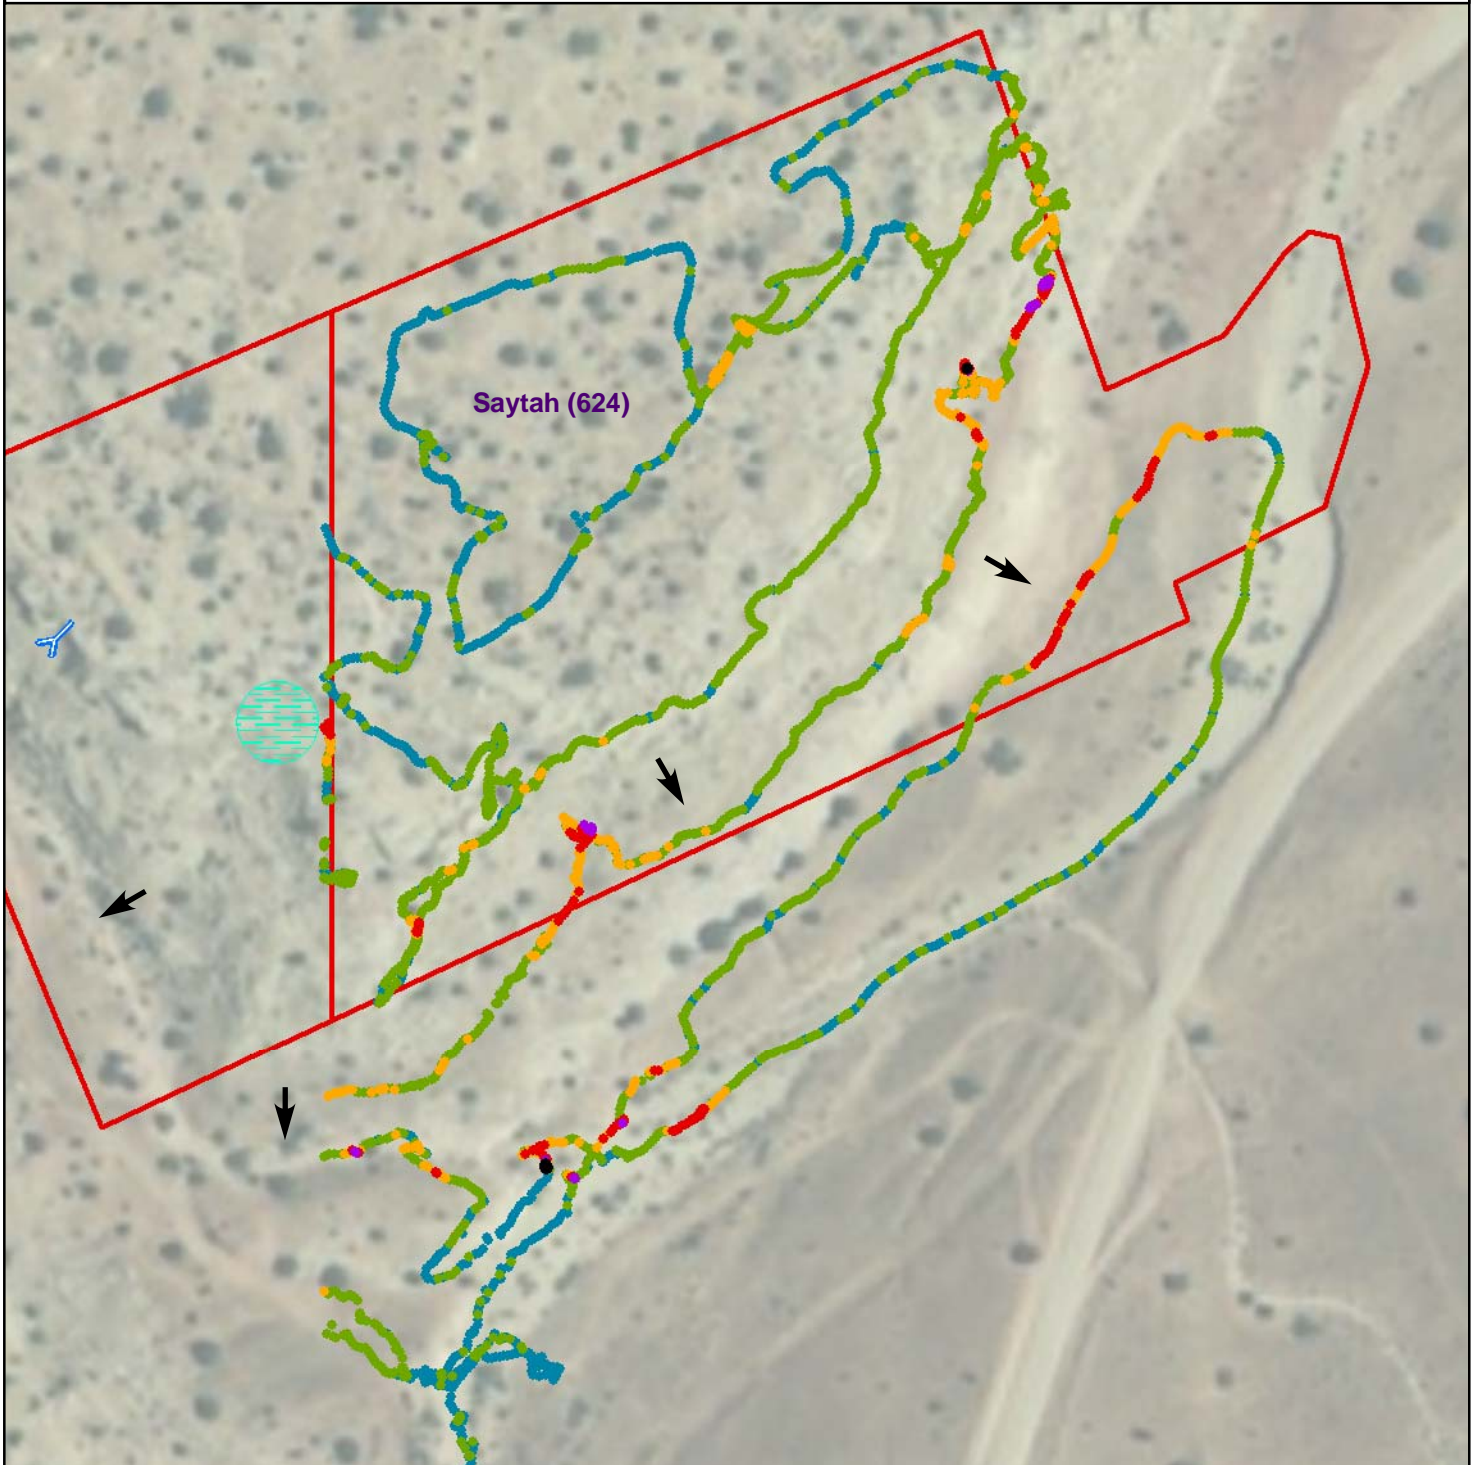
**Figure 2 - Gamma Radiation Measurements
Saytah (624)
Sweetwater / Teec Nos Pos Chapter, Navajo Nation**

**Gamma survey conducted 06/2010
Measured as counts per minute (cpm)**

Average background 9,634 cpm
