Navajo Abandoned Uranium Mine

Site Screen Report

Jimmie Bileen 1 AUM Site

August 2010

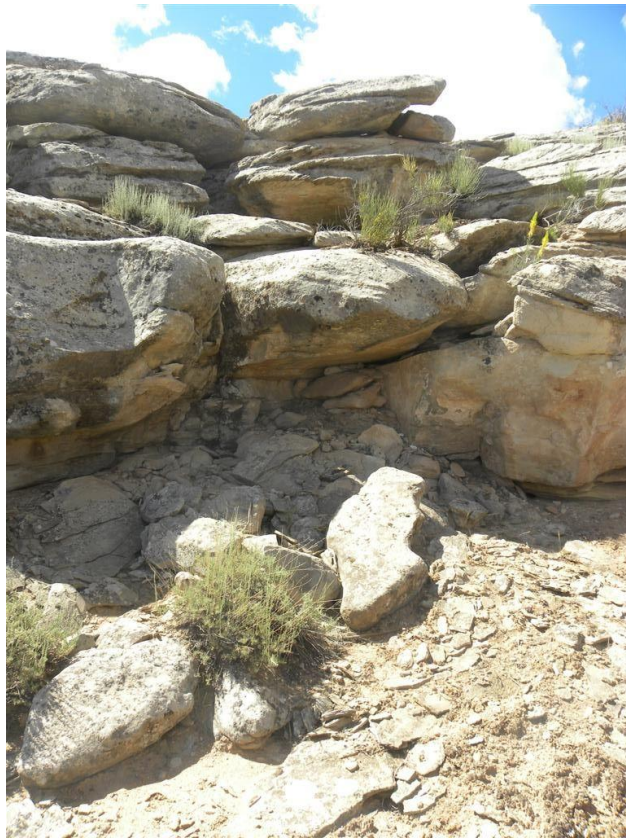
Potential adit leading to drainage below

Photo 2. Jimmie Bileen site, possible adit

Possible adit

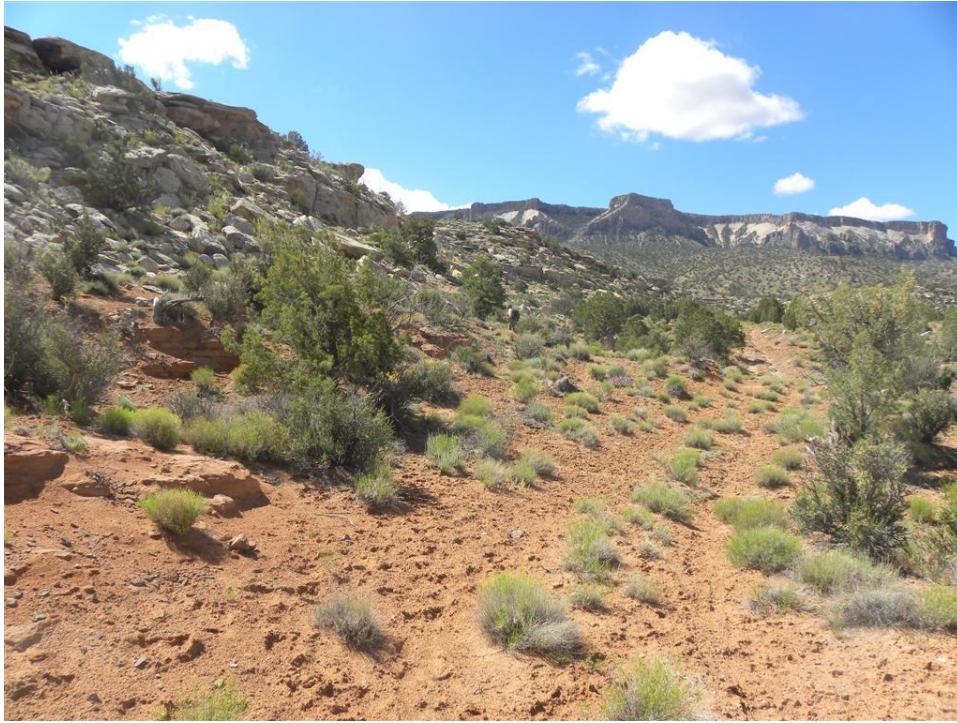
Photo 1. Jimmie Bileen site

Photo 3. Jimmie Bileen site
