Navajo Abandoned Uranium Mine

Site Screen Report

NA-0313 AUM Site

March 2010

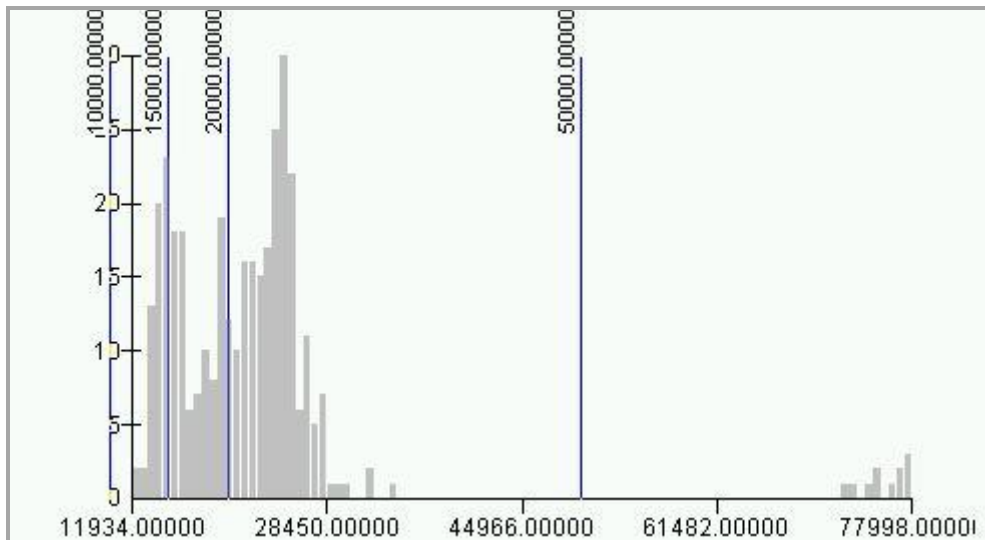
The following chart and statistics were generated by ESRI ArcGIS 9.3.1, and show the general distribution of the site gamma radiation measurements. The horizontal X axis represents the gamma radiation reading levels in cpm (lowest levels to the left). The vertical Y axis represents the frequency of each gamma radiation level.

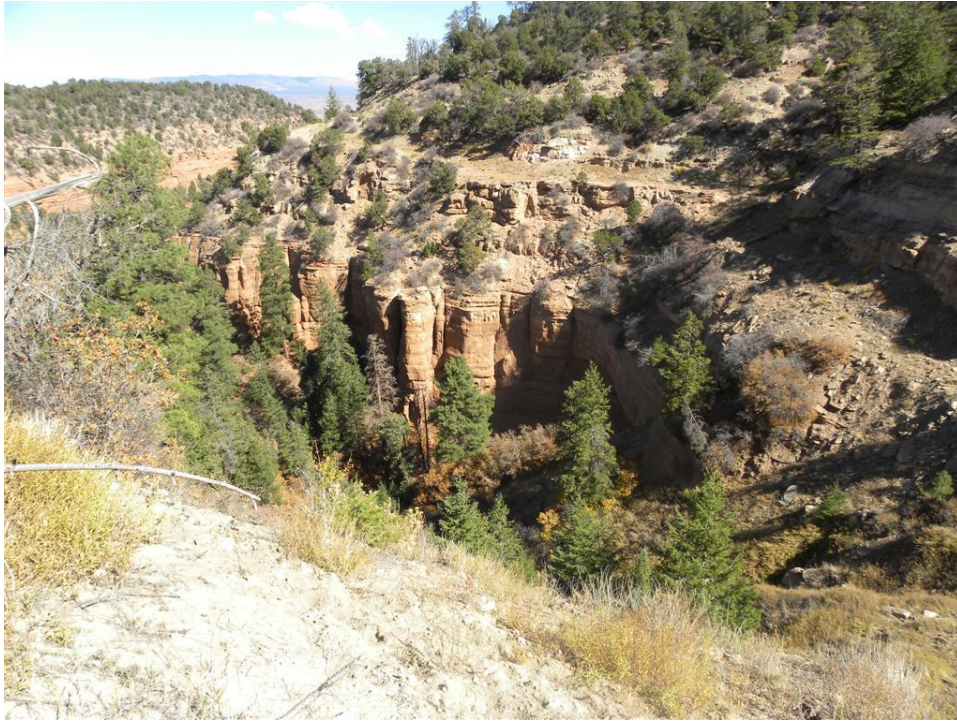
Photo 1. Looking down into mine site

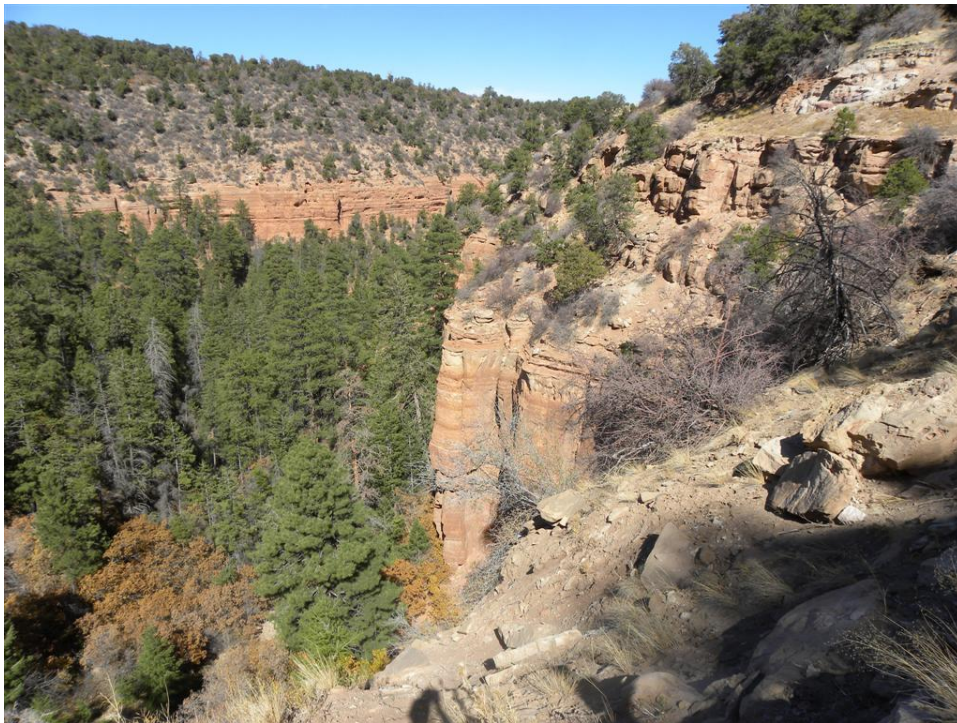
Photo 2. Mine site cliff area

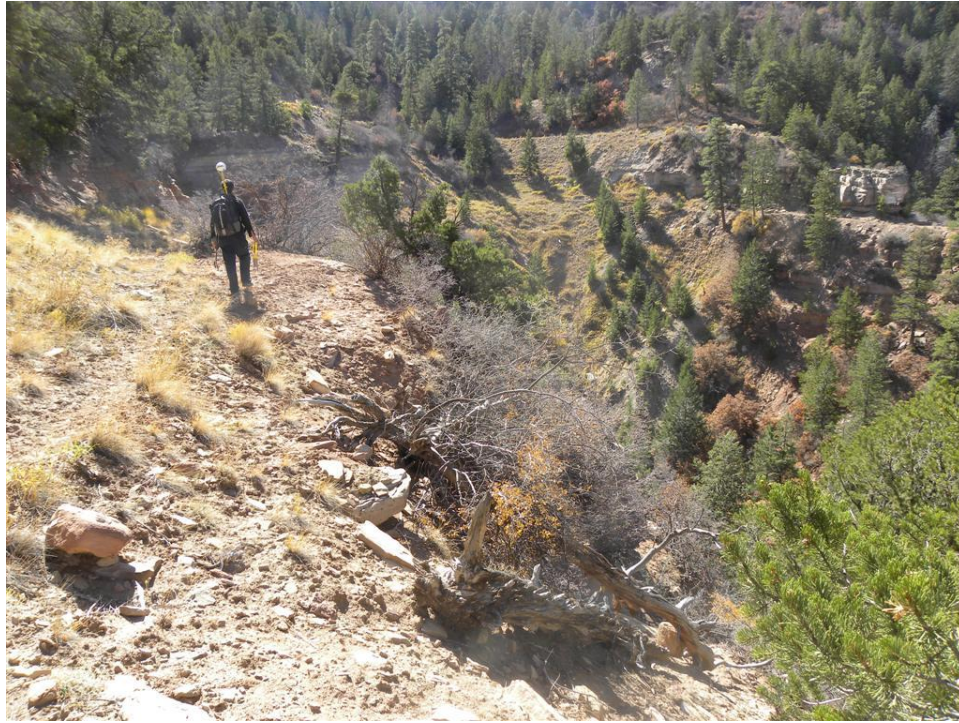
Photo 3. Accessible path on eastern perimeter

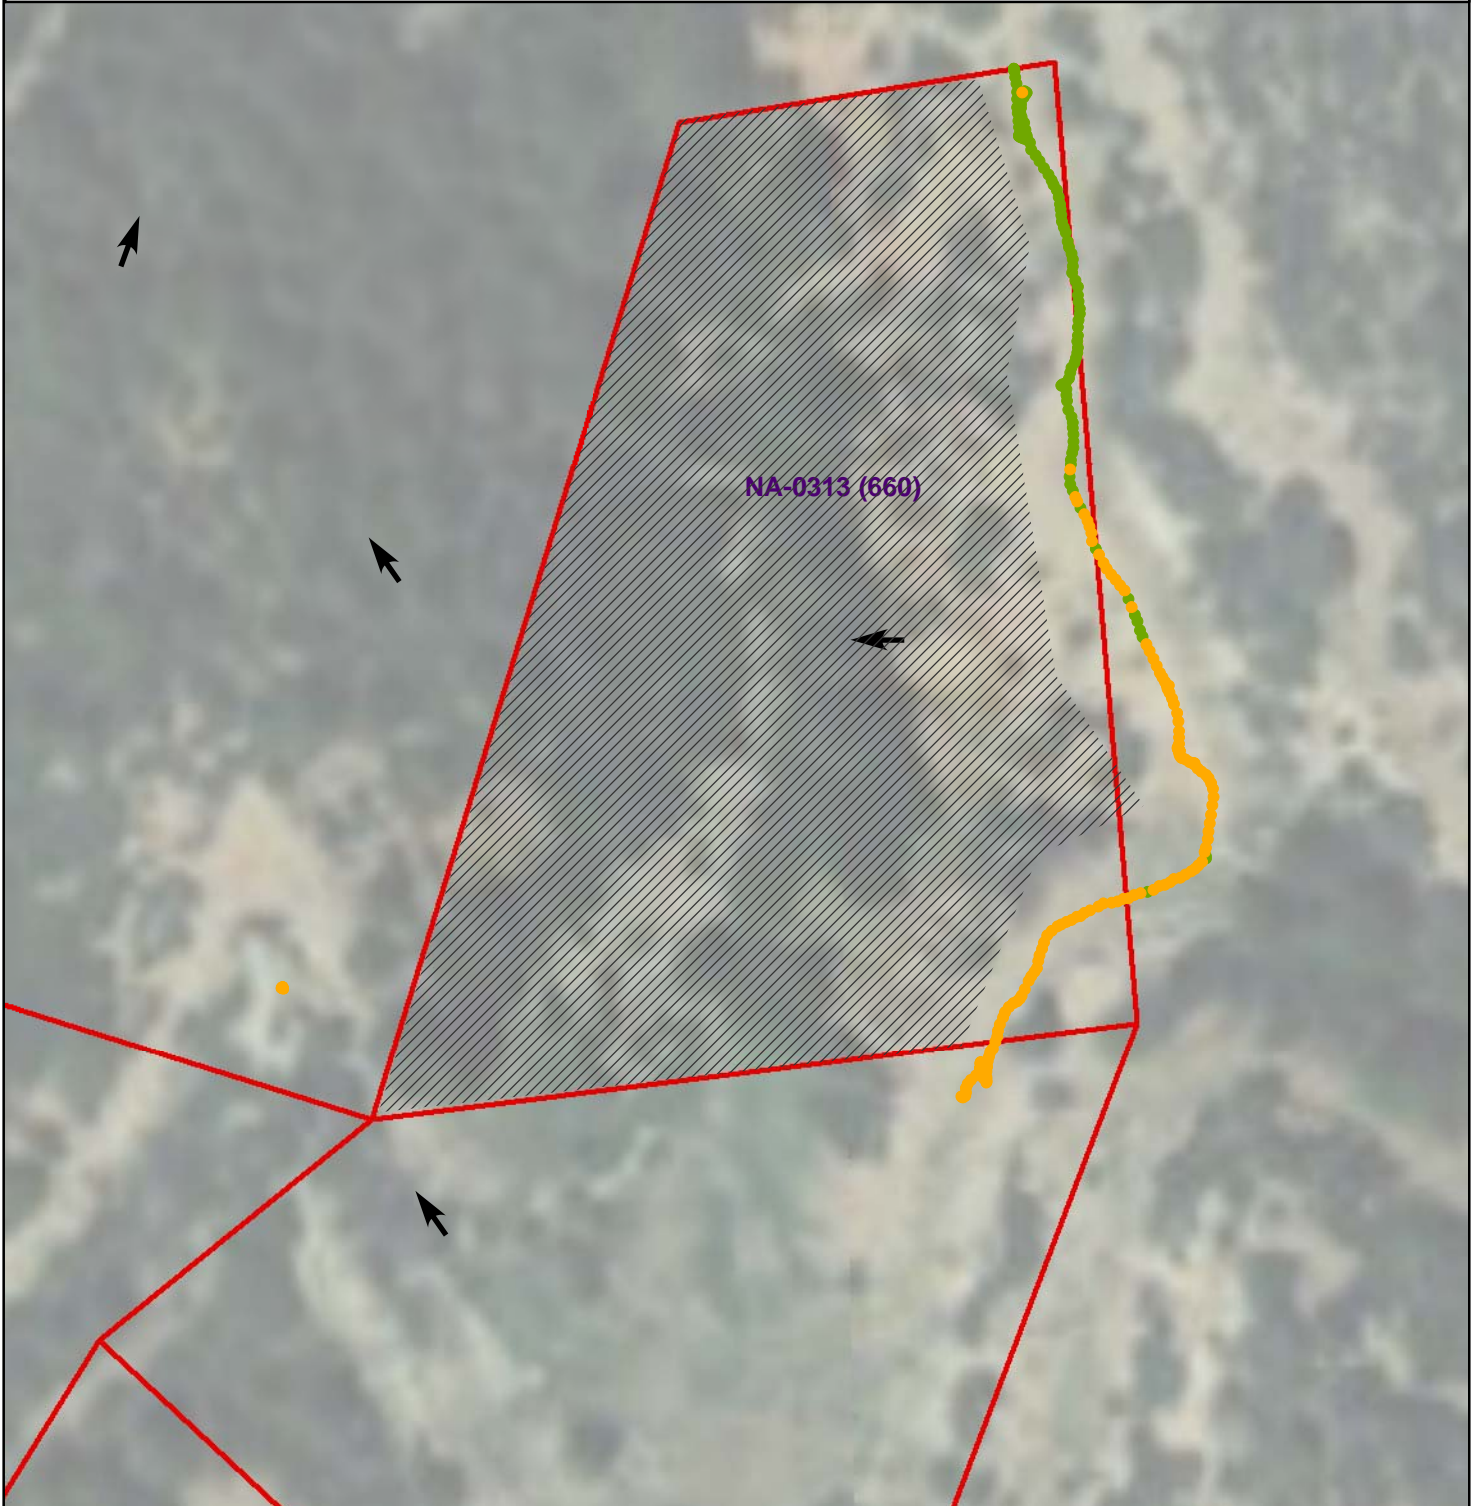
**Figure 1 - Gamma Radiation Measurements, Above Two Times Background
 NA-0313 (660)
 Cove Chapter, Navajo Nation, Arizona**

Gamma survey conducted 10/2009
 Measured as counts per minute (cpm)

Average background = 9,365 cpm

A total of 355 gamma radiation measurements were collected from the mine site, ranging from 11,934 cpm to 77,998 cpm. Measurements were collected from the eastern perimeter, due to steep slopes, but the majority of the site was visible. The measurements are represented in Figures 1 and 2.

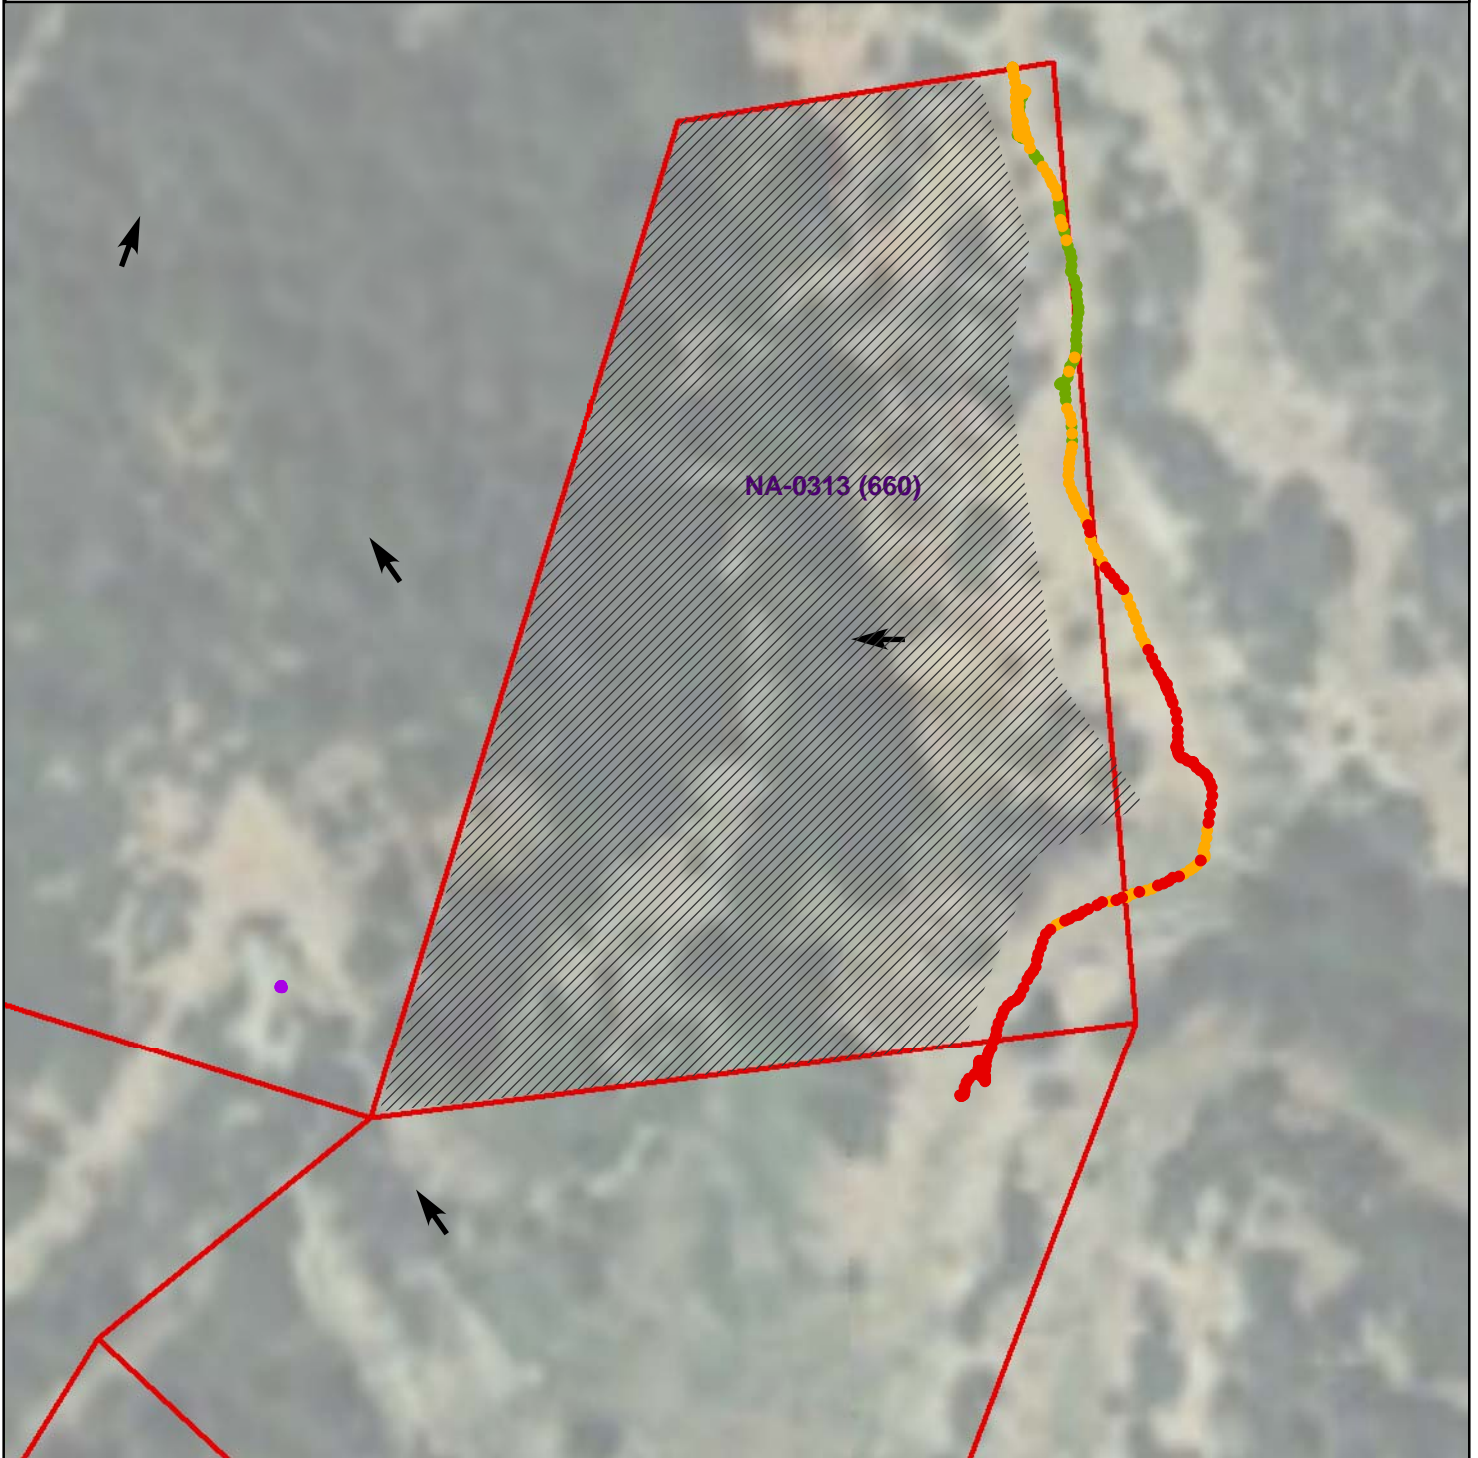
**Figure 2 - Gamma Radiation Measurements
NA-0313 (660)
Cove Chapter, Navajo Nation, Arizona**

Gamma survey conducted 10/2009
Measured as counts per minute (cpm)

Average background = 9,365 cpm
