Navajo Abandoned Uranium Mine

Site Screen Report

AEC Plot 3 AUM Site

Navajo AUM Northern Region

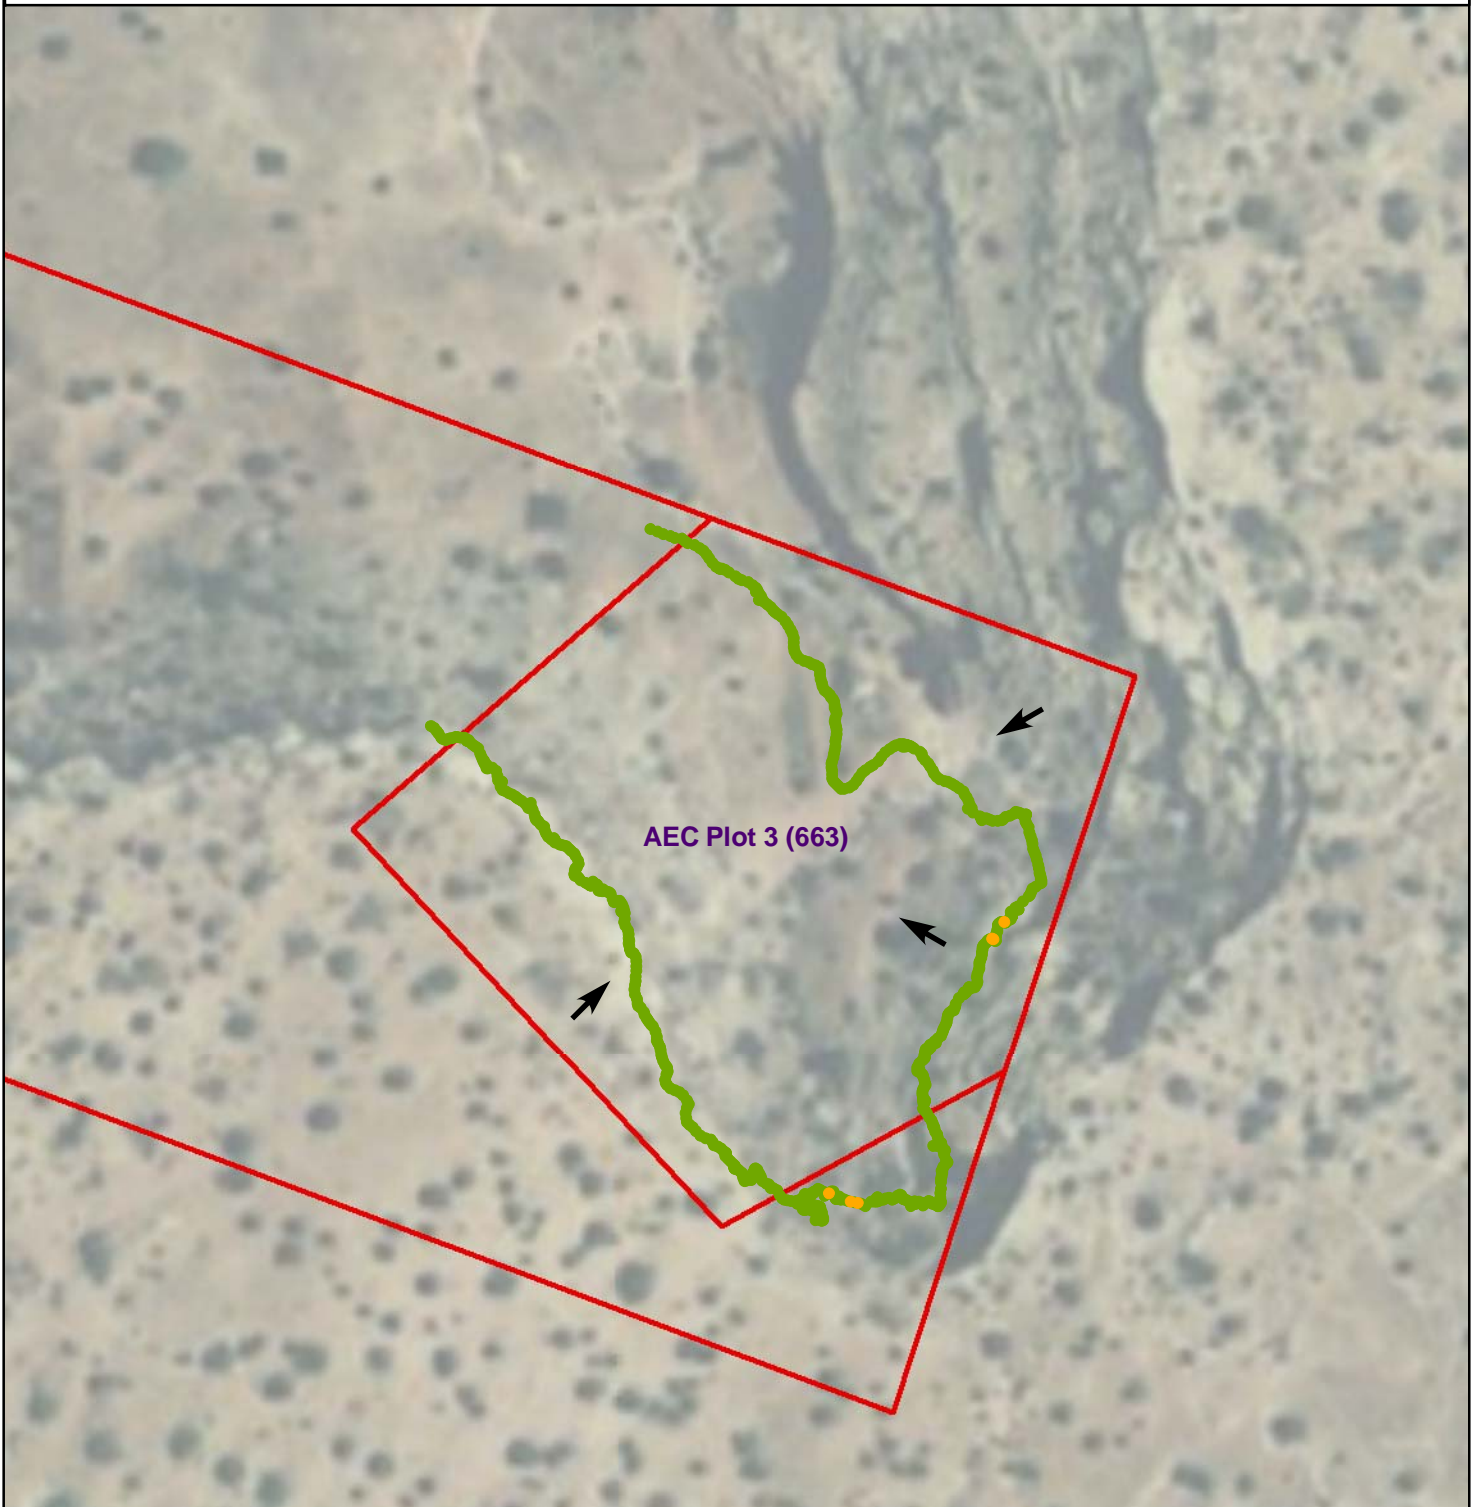
**Figure 1 - Gamma Radiation Measurements, Above Two Times Background
AEC Plot 3 (663)
Sweetwater Chapter, Navajo Nation**

A total of 823 gamma radiation measurements were collected from the mine site, ranging from 9,103 cpm to 21,331 cpm. The measurements are represented in Figures 1 and 2.

Gamma survey conducted 06/2010
Measured as counts per minute (cpm)

Average background = 9,634 cpm

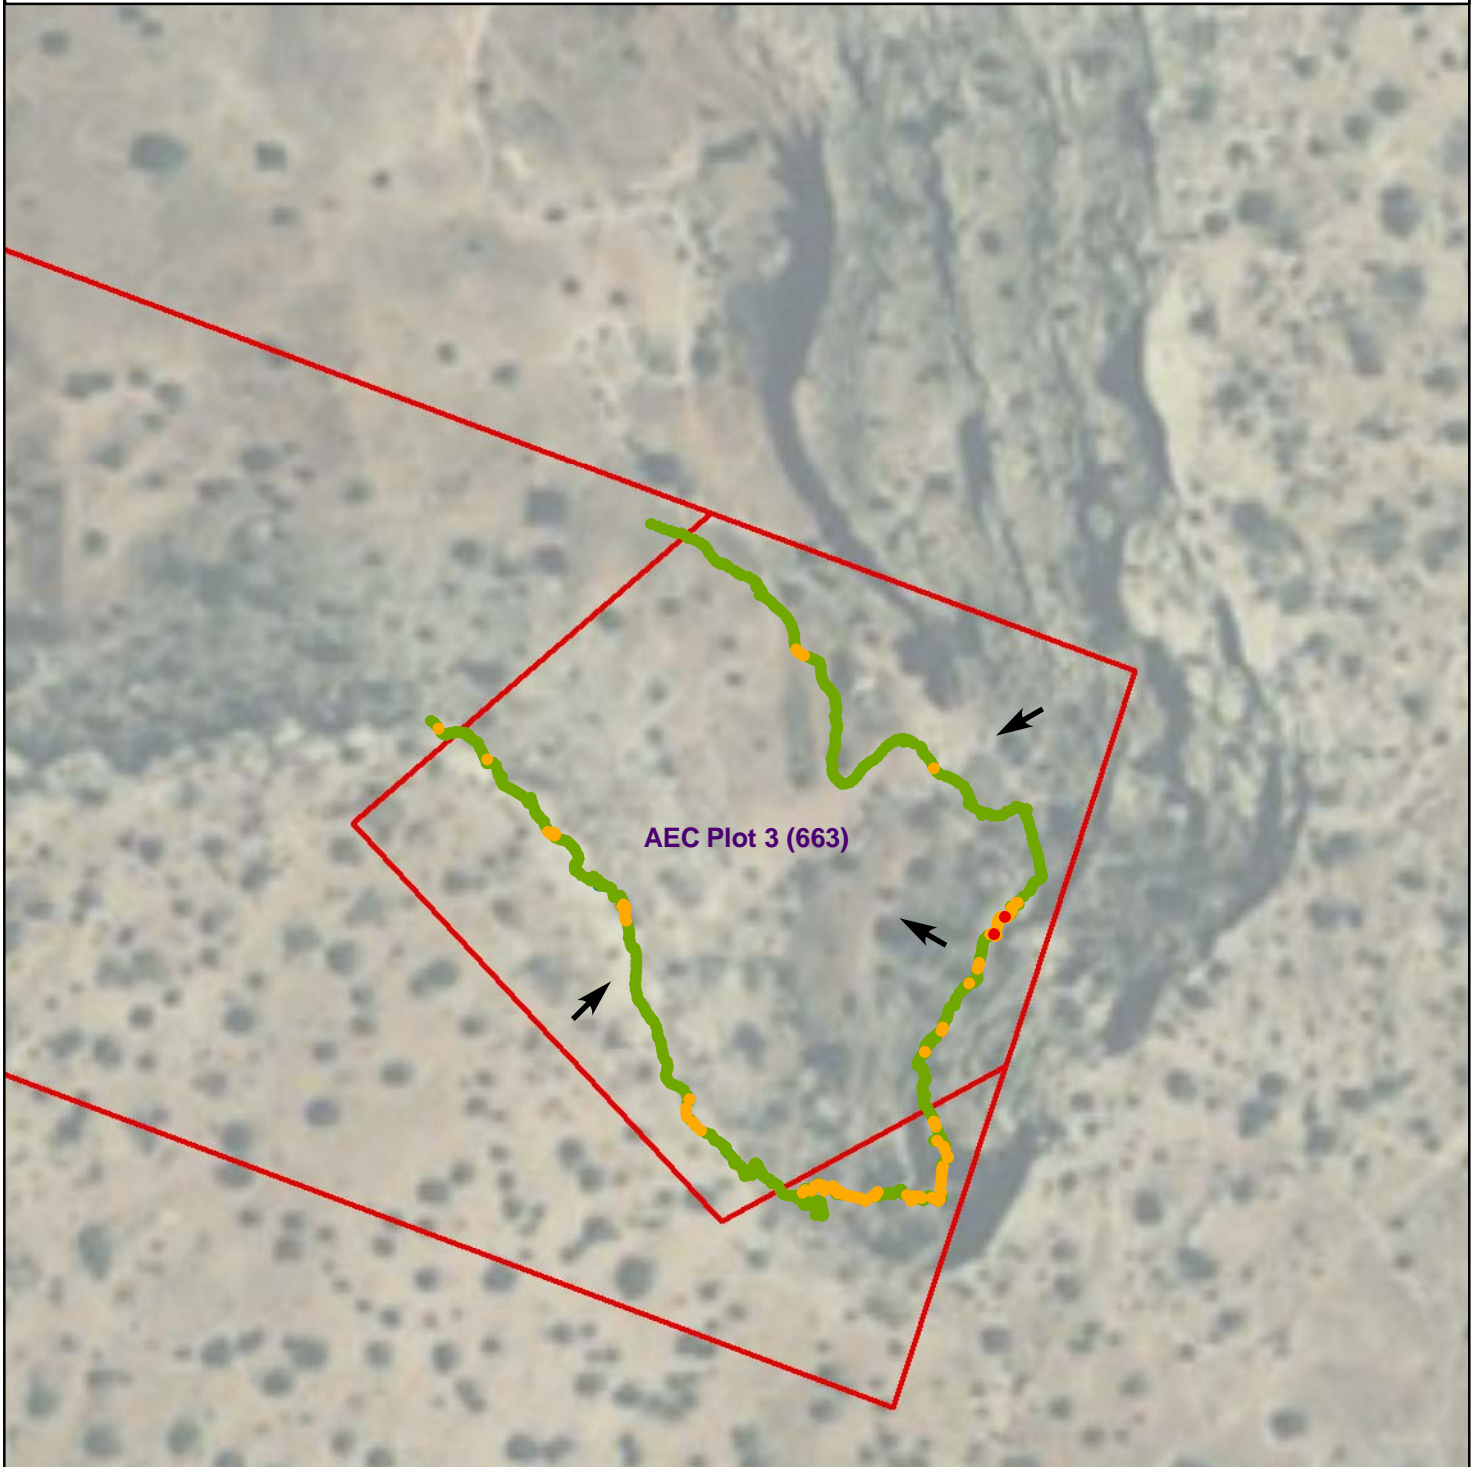
**Figure 2 - Gamma Radiation Measurements
AEC Plot 3 (663)
Sweetwater Chapter, Navajo Nation**

Gamma survey conducted 06/2010
Measured as counts per minute (cpm)

Average background 9,634 cpm
