# Navajo Abandoned Uranium Mine

# Site Screen Report

Mine Name: **Hoskie Tso No. 1**Mine ID: **852**

**April 2012**

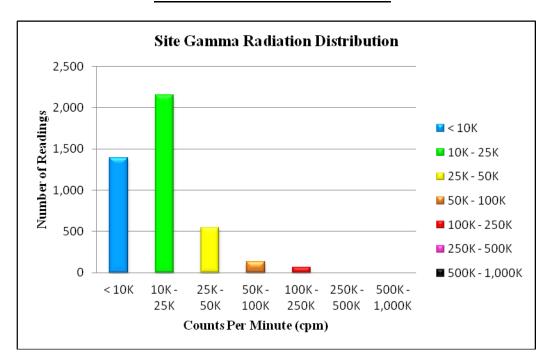
# **Distribution Chart and Statistics:**

<b>Site Gamma Radiation Statistics</b>				
Number of Readings	4,302			
Minimum (cpm)	4,727			
Maximum (cpm)	209,442			
Mean (cpm)	18,448			
Median (cpm)	11,278			
Standard Deviation	20,550

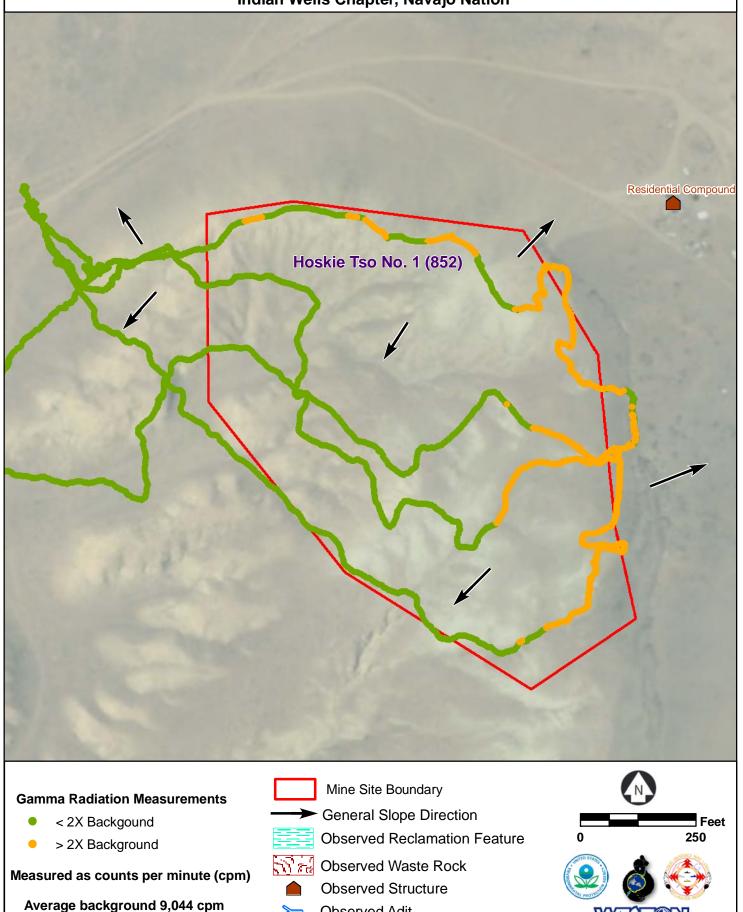
Figure 1 - Gamma Radiation Measurements, Above Two Times Background **Hoskie Tso No. 1 (852) Indian Wells Chapter, Navajo Nation**

A total of 4,302 gamma radiation measurements were collected from the mine site, ranging from 4,727 cpm to 209,442 cpm. The measurements are represented in Figures 1 and 2.

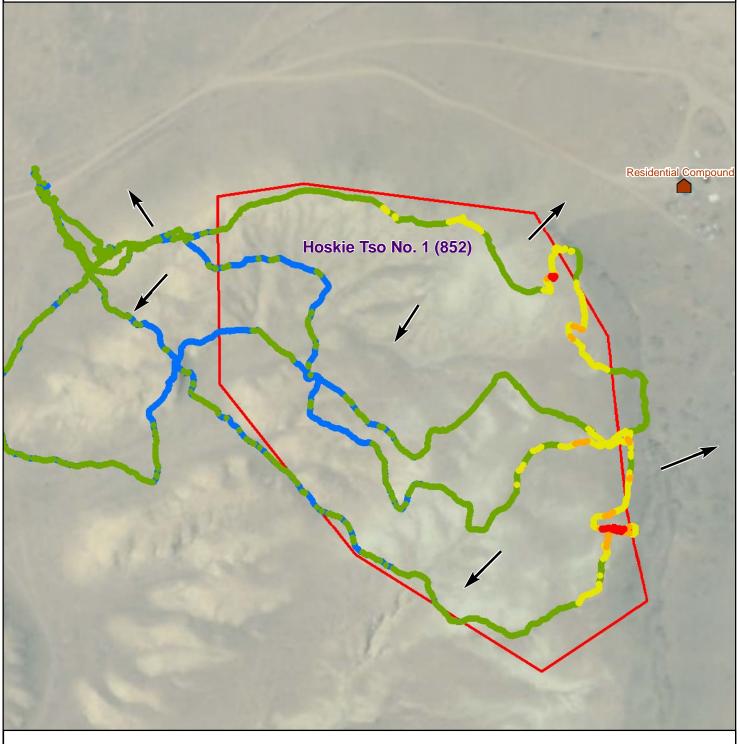
**Figure 2 - Gamma Radiation Measurements** Hoskie Tso No. 1 (852) **Indian Wells Chapter, Navajo Nation**

Measured as counts per minute (cpm)
