# Navajo Abandoned Uranium Mine

## Site Screen Report

**Mine Name: Charles Huskon No. 19**

**August 2011**

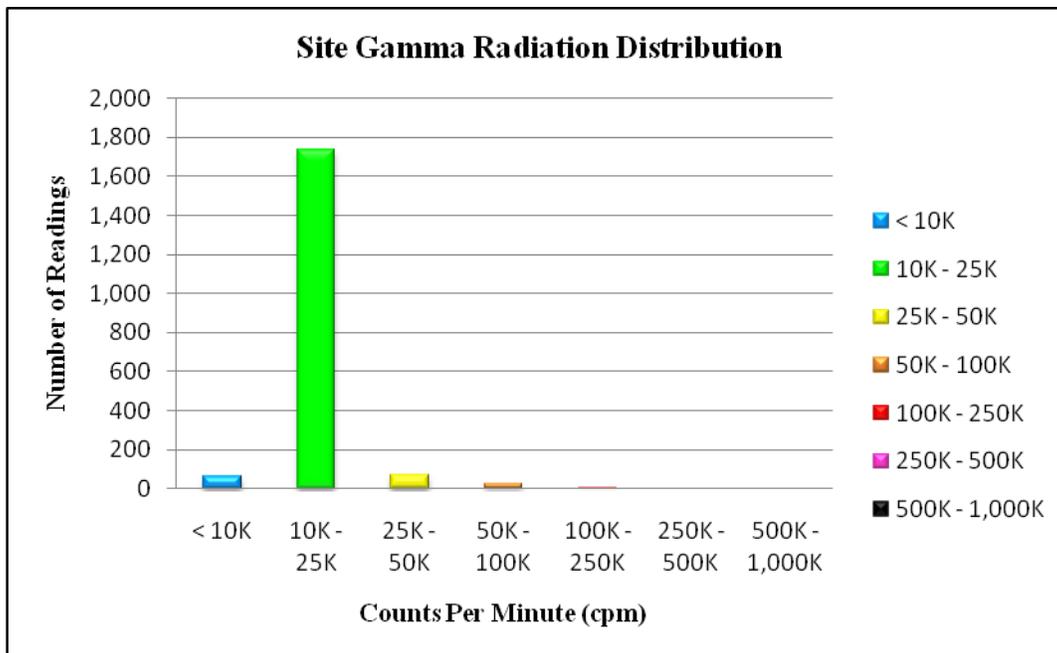
A total of 1,897 gamma radiation measurements were collected from the mine site, ranging from 5,599 cpm to 110,148 cpm. The measurements are represented in Figures 1 and 2.

<b>Site Gamma Radiation Statistics</b>	
Number of Readings	1,897
Minimum (cpm)	5,599
Maximum (cpm)	110,148
Mean (cpm)	14,390
Median (cpm)	12,377
Standard Deviation	8,532

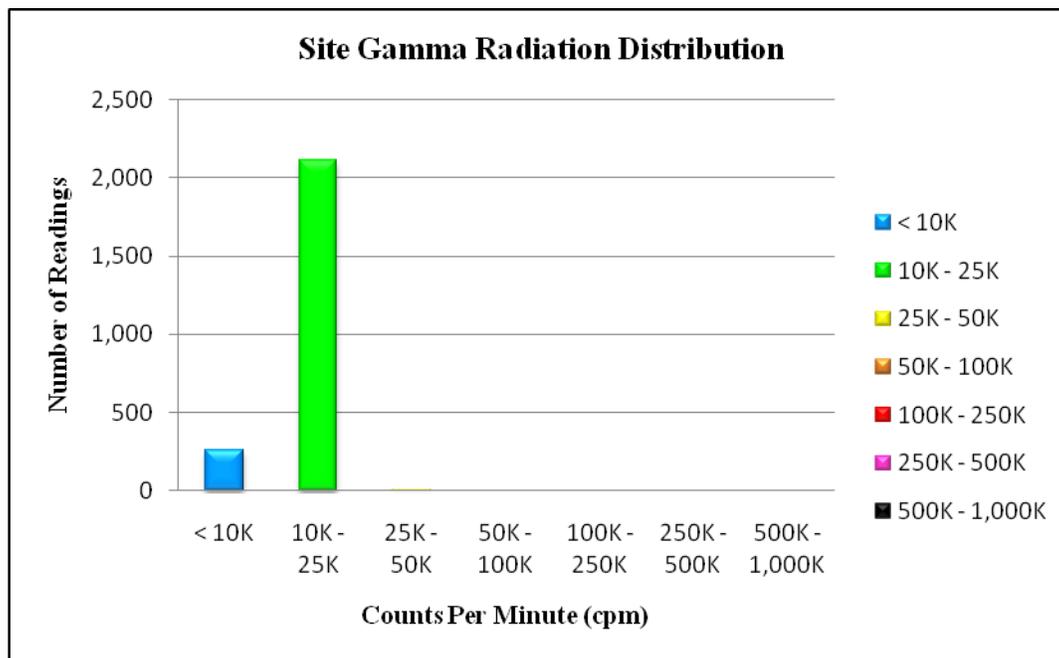
A total of 2,378 gamma radiation measurements were collected from the mine site, ranging from 7,246 cpm to 25,404 cpm. Measurements collected in the vicinity of the reclamation area were found at a maximum level of approximately 20,000 cpm. The measurements are represented in Figures 1 and 2.

<b>Site Gamma Radiation Statistics</b>	
Number of Readings	2,378
Minimum (cpm)	7,246
Maximum (cpm)	25,404
Mean (cpm)	13,511
Median (cpm)	13,981
Standard Deviation	2,157

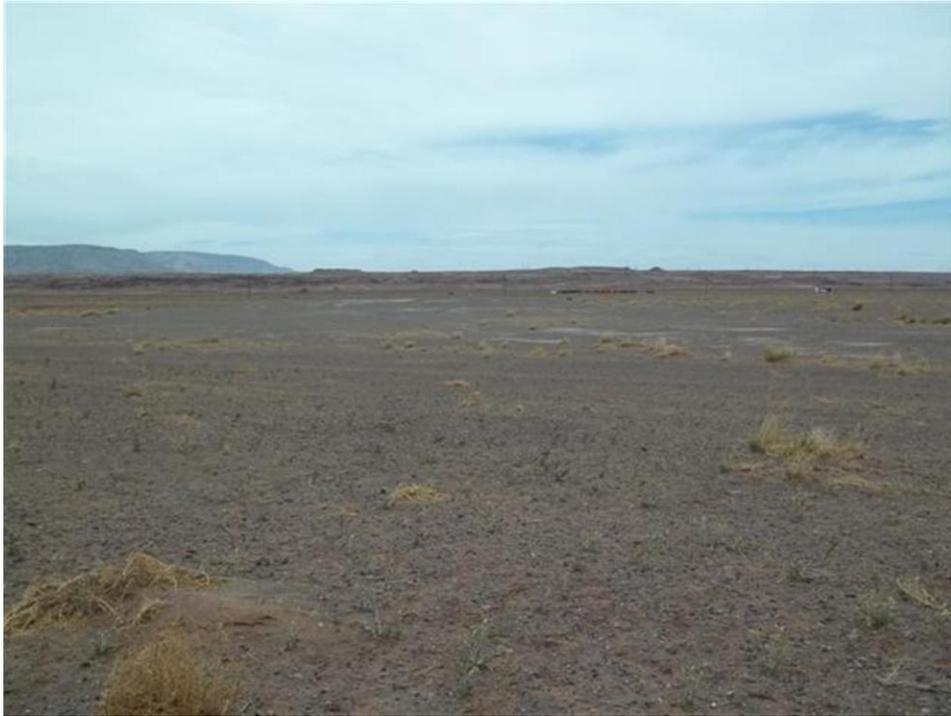
**Photo 1:** Mine Site #120

Excavation area in center of site

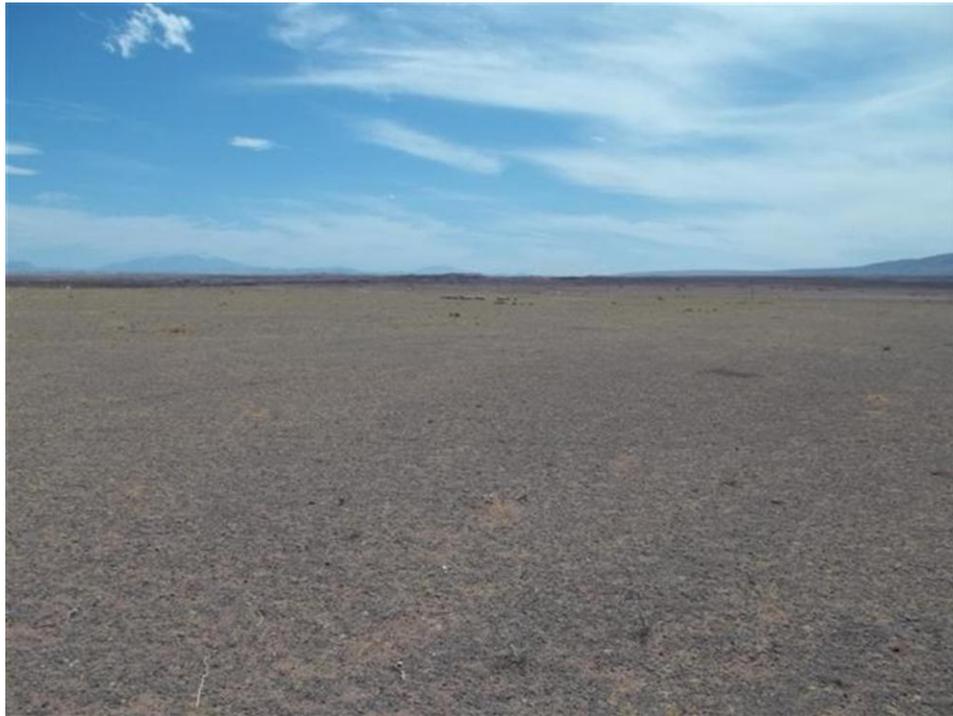
**Photo 8:** Mine Site #229

2 reclamation caps: Cap 1 - 100' x 80' x 2.5', red-brown soil with small gravel and berm along SE corner; Cap 2 - 75'dia x 1.5'h, red-brown soil with small gravel

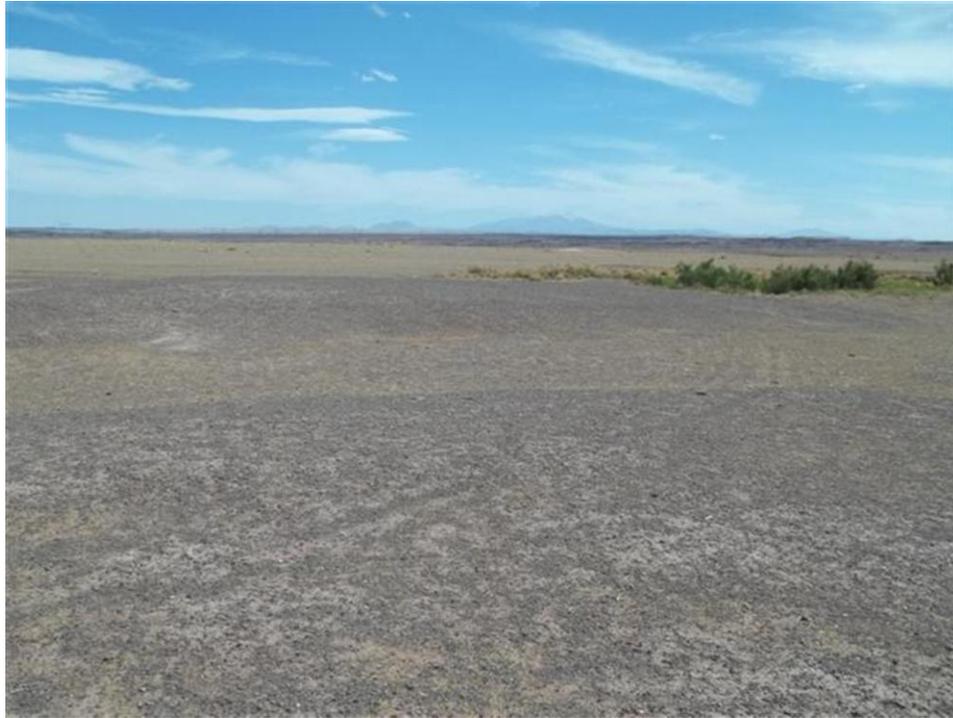
**Photo 9:** Mine Site #229; Reclamation area and spring/pond

**0 to 0.25 miles:** Small livestock pond on site #229
