Navajo Abandoned Uranium Mine

Site Screen Report

Chavez AUM Site

March 2010

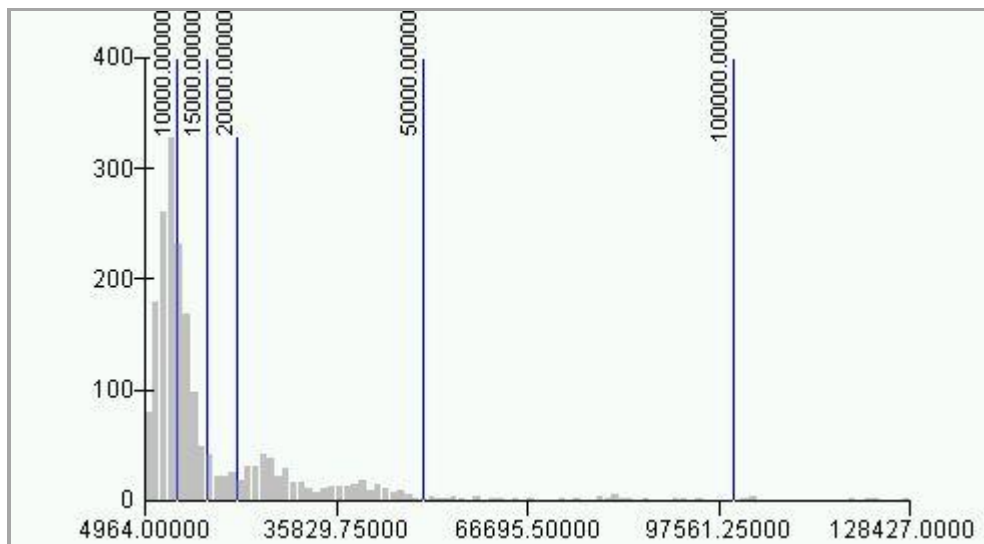
The following chart and statistics were generated by ESRI ArcGIS 9.3.1, and show the general distribution of the site gamma radiation measurements. The horizontal X axis represents the gamma radiation reading levels in cpm (lowest levels to the left). The vertical Y axis represents the frequency of each gamma radiation level.

Count:	1978
Minimum:	4964.00000
Maximum:	128427.00000
Sum:	31311916.00000
Mean:	15830.08898
Median:	10485.50000
Standard Deviation:	13893.77731

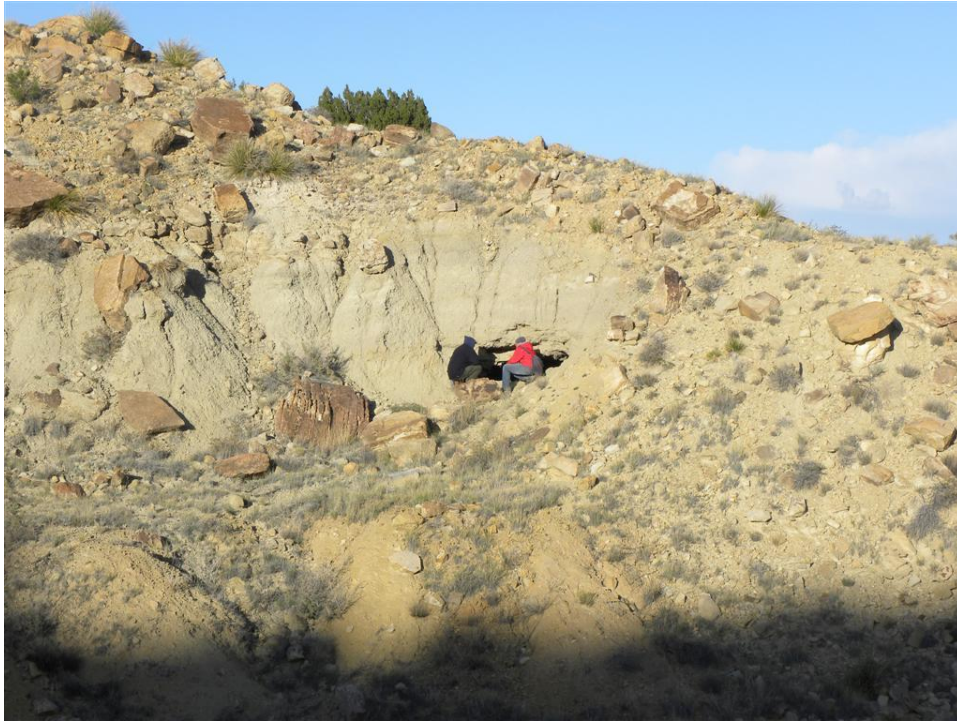
Photo 1. Open adit

1 open adit, 7' wide, with two pathways inside

Open adit with elevated readings

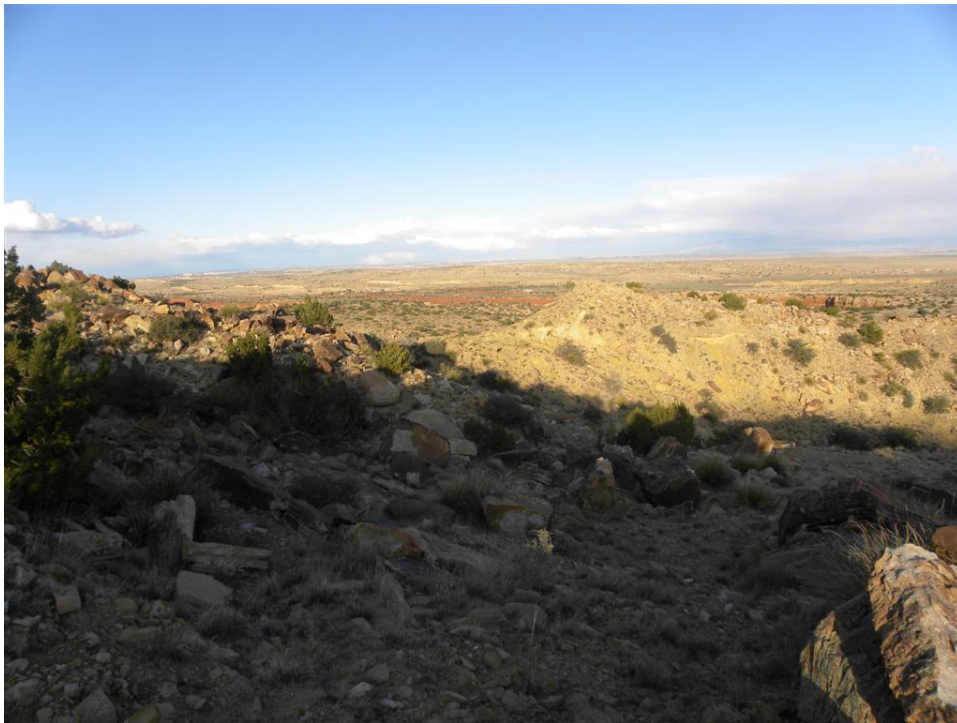
Photo 4. Mine site

Chavez mine consists of an area of 25,006 m². The mine was identified as being operational in 1955. Historical documents showed the operator of the mine as Calmuet and Hecla in 1955. While operational, the mine had a total reported production volume of 192 tons. No other historical information or any additional ownership / lease information was identified in the EPA/AUM database.

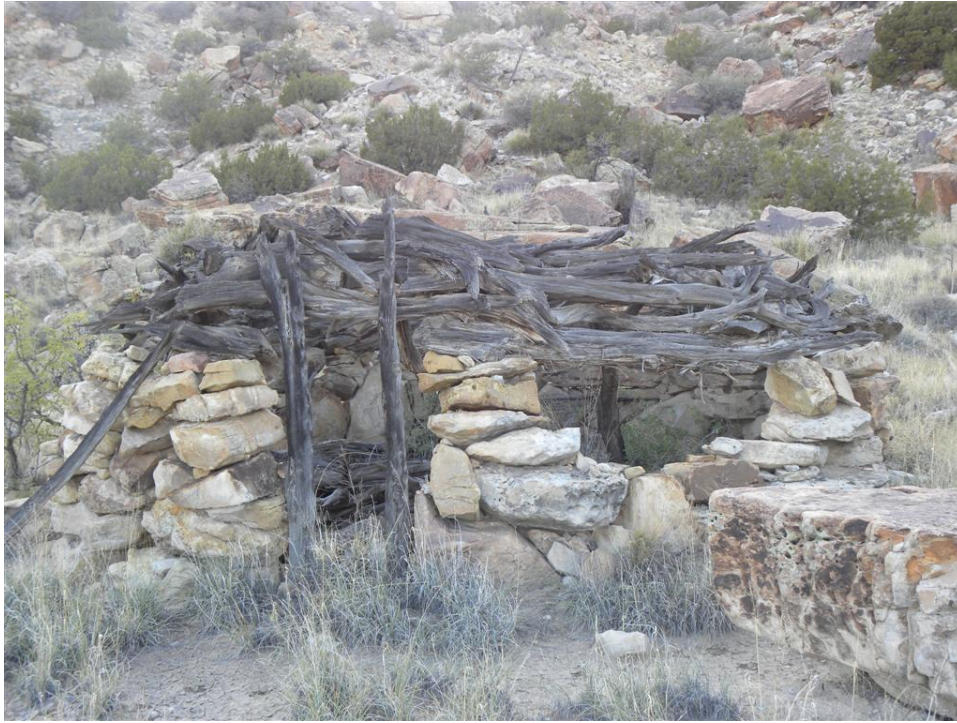
Photo 5. Stone structure southwest of site

Small stone pile/structure approximately 500' southwest of site

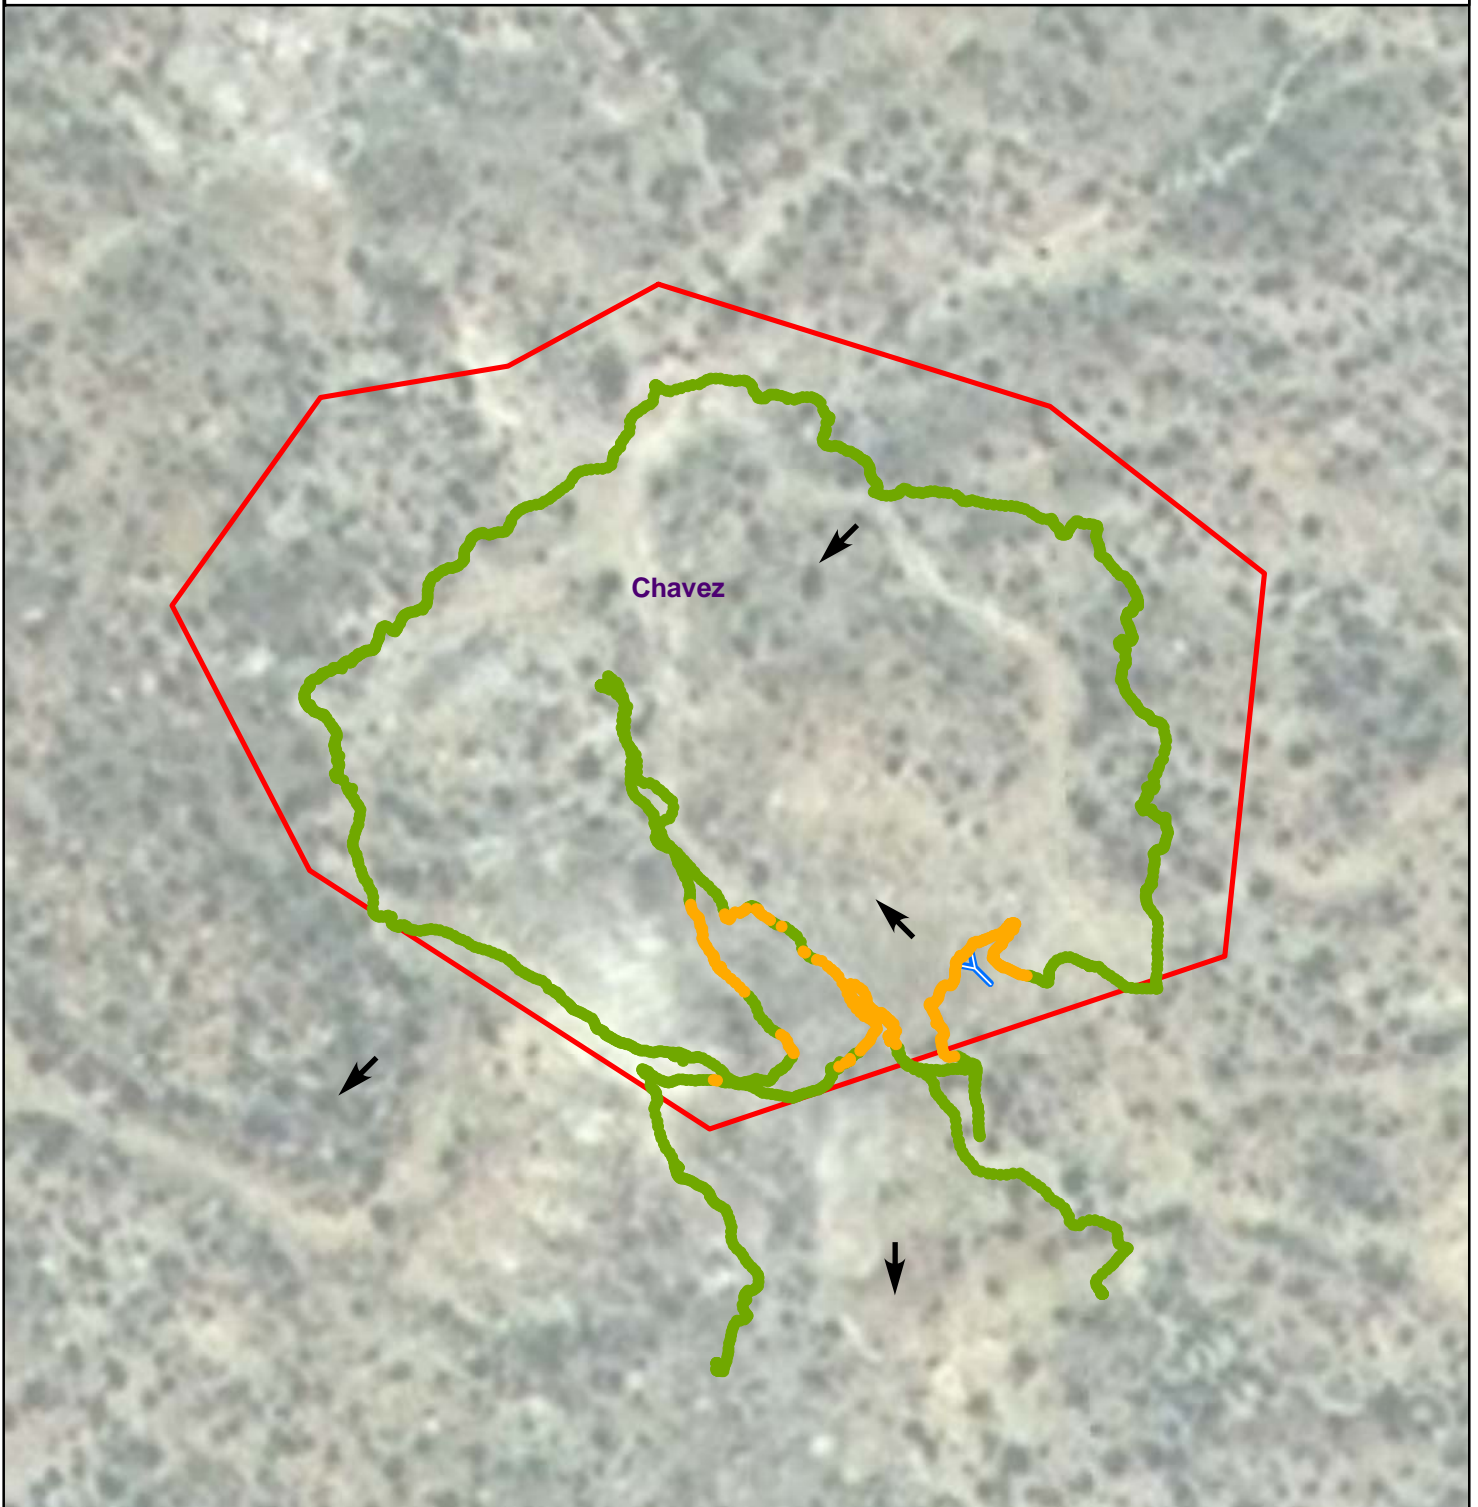
**Figure 1 - Gamma Radiation Measurements, Above Two Times Background
Chavez
Navajo Nation, New Mexico**

A total of 1,978 gamma radiation measurements were collected from the mine site, ranging from 4,964 cpm to 128,427 cpm. Measurements in the vicinity of the adit were found at levels in up to 120,000 cpm, and near the stone structure at levels of approximately 9,000 cpm. The measurements are represented in Figures 1 and 2.

Gamma survey conducted 10/2009
Measured as counts per minute (cpm)

Average background = 10,105 cpm

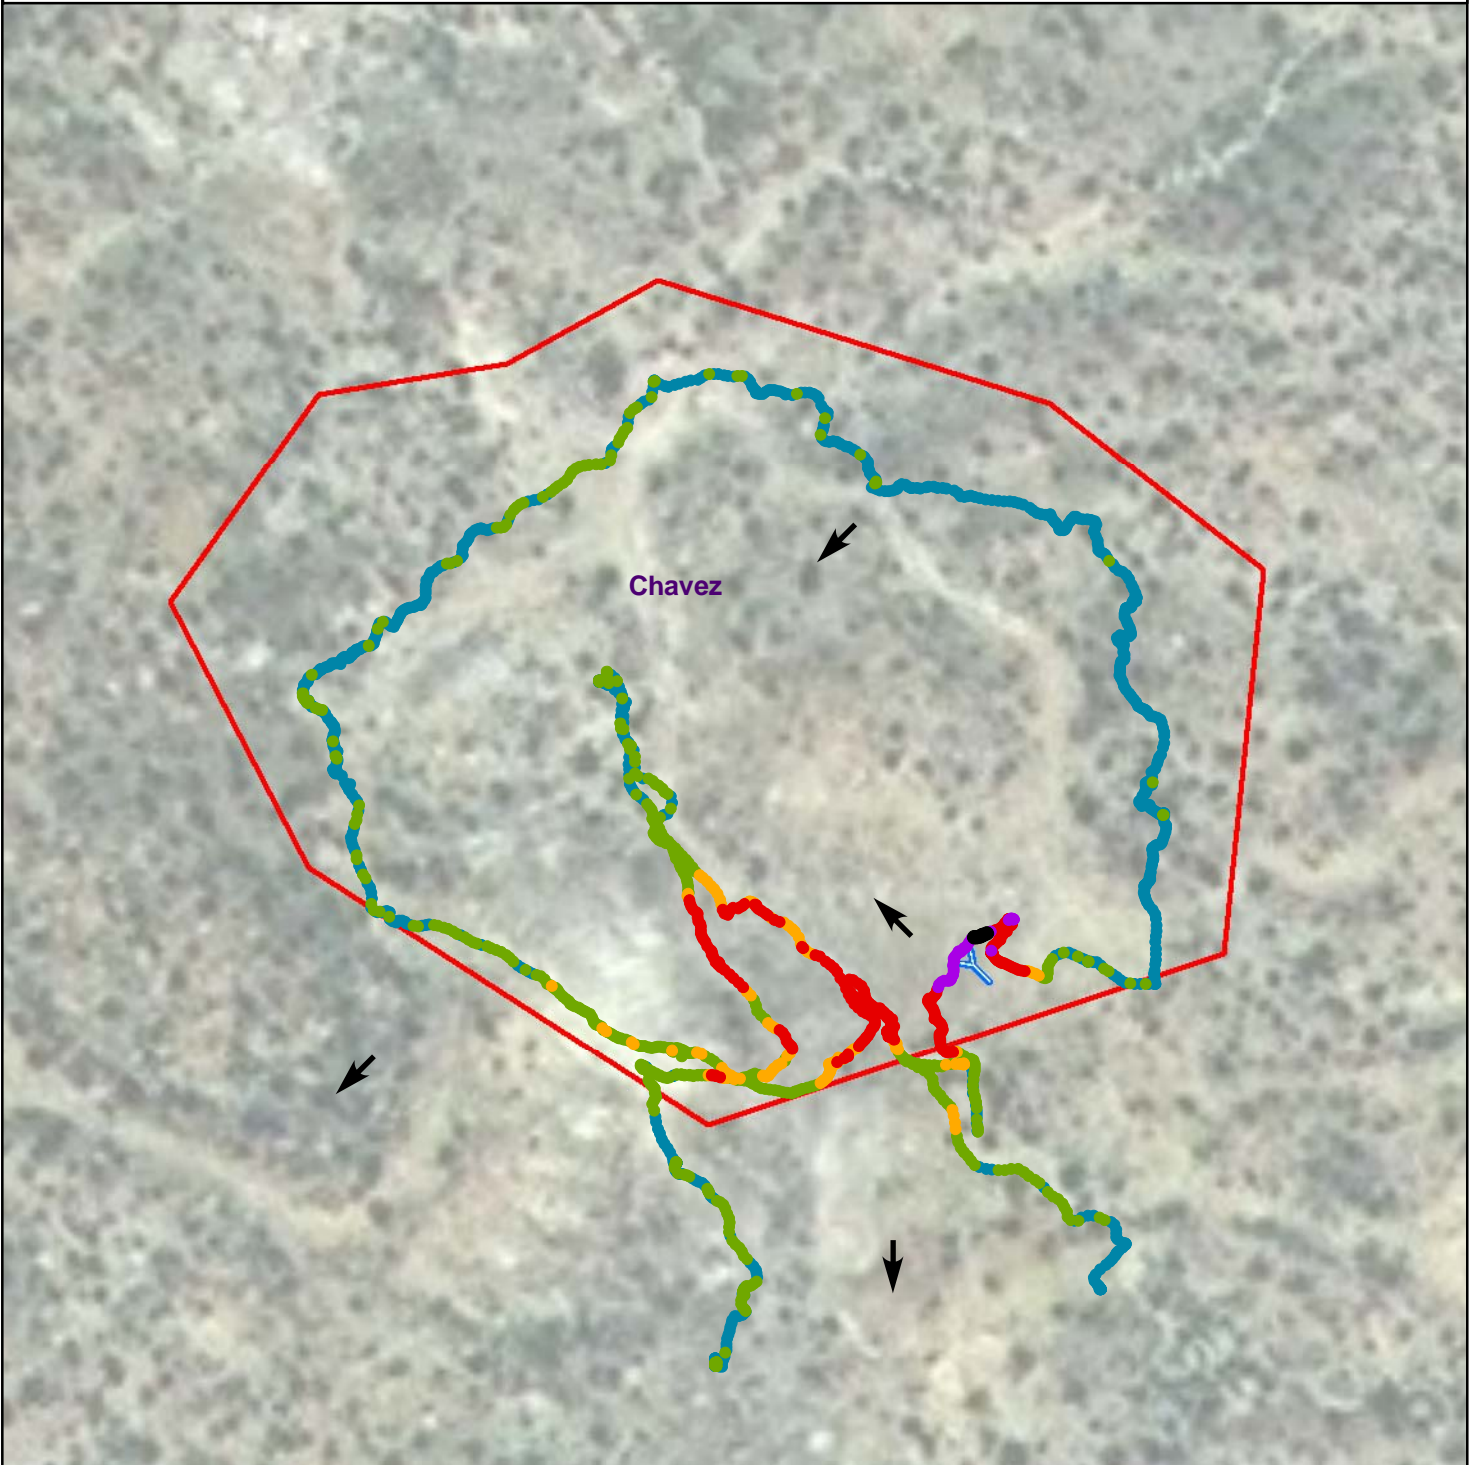
**Figure 2 - Gamma Radiation Measurements
Chavez
Navajo Nation, New Mexico**

Gamma survey conducted 10/2009
Measured as counts per minute (cpm)

Average background 10,105 cpm
