**Subject: Mesa I Mines, Preliminary Assessment Report**  
**EPA ID NO.: NND983466772**

Site Name: Mesa I Mines

*Photographic Documentation  
Mesa I Mines Site  
Apache County, Arizona*

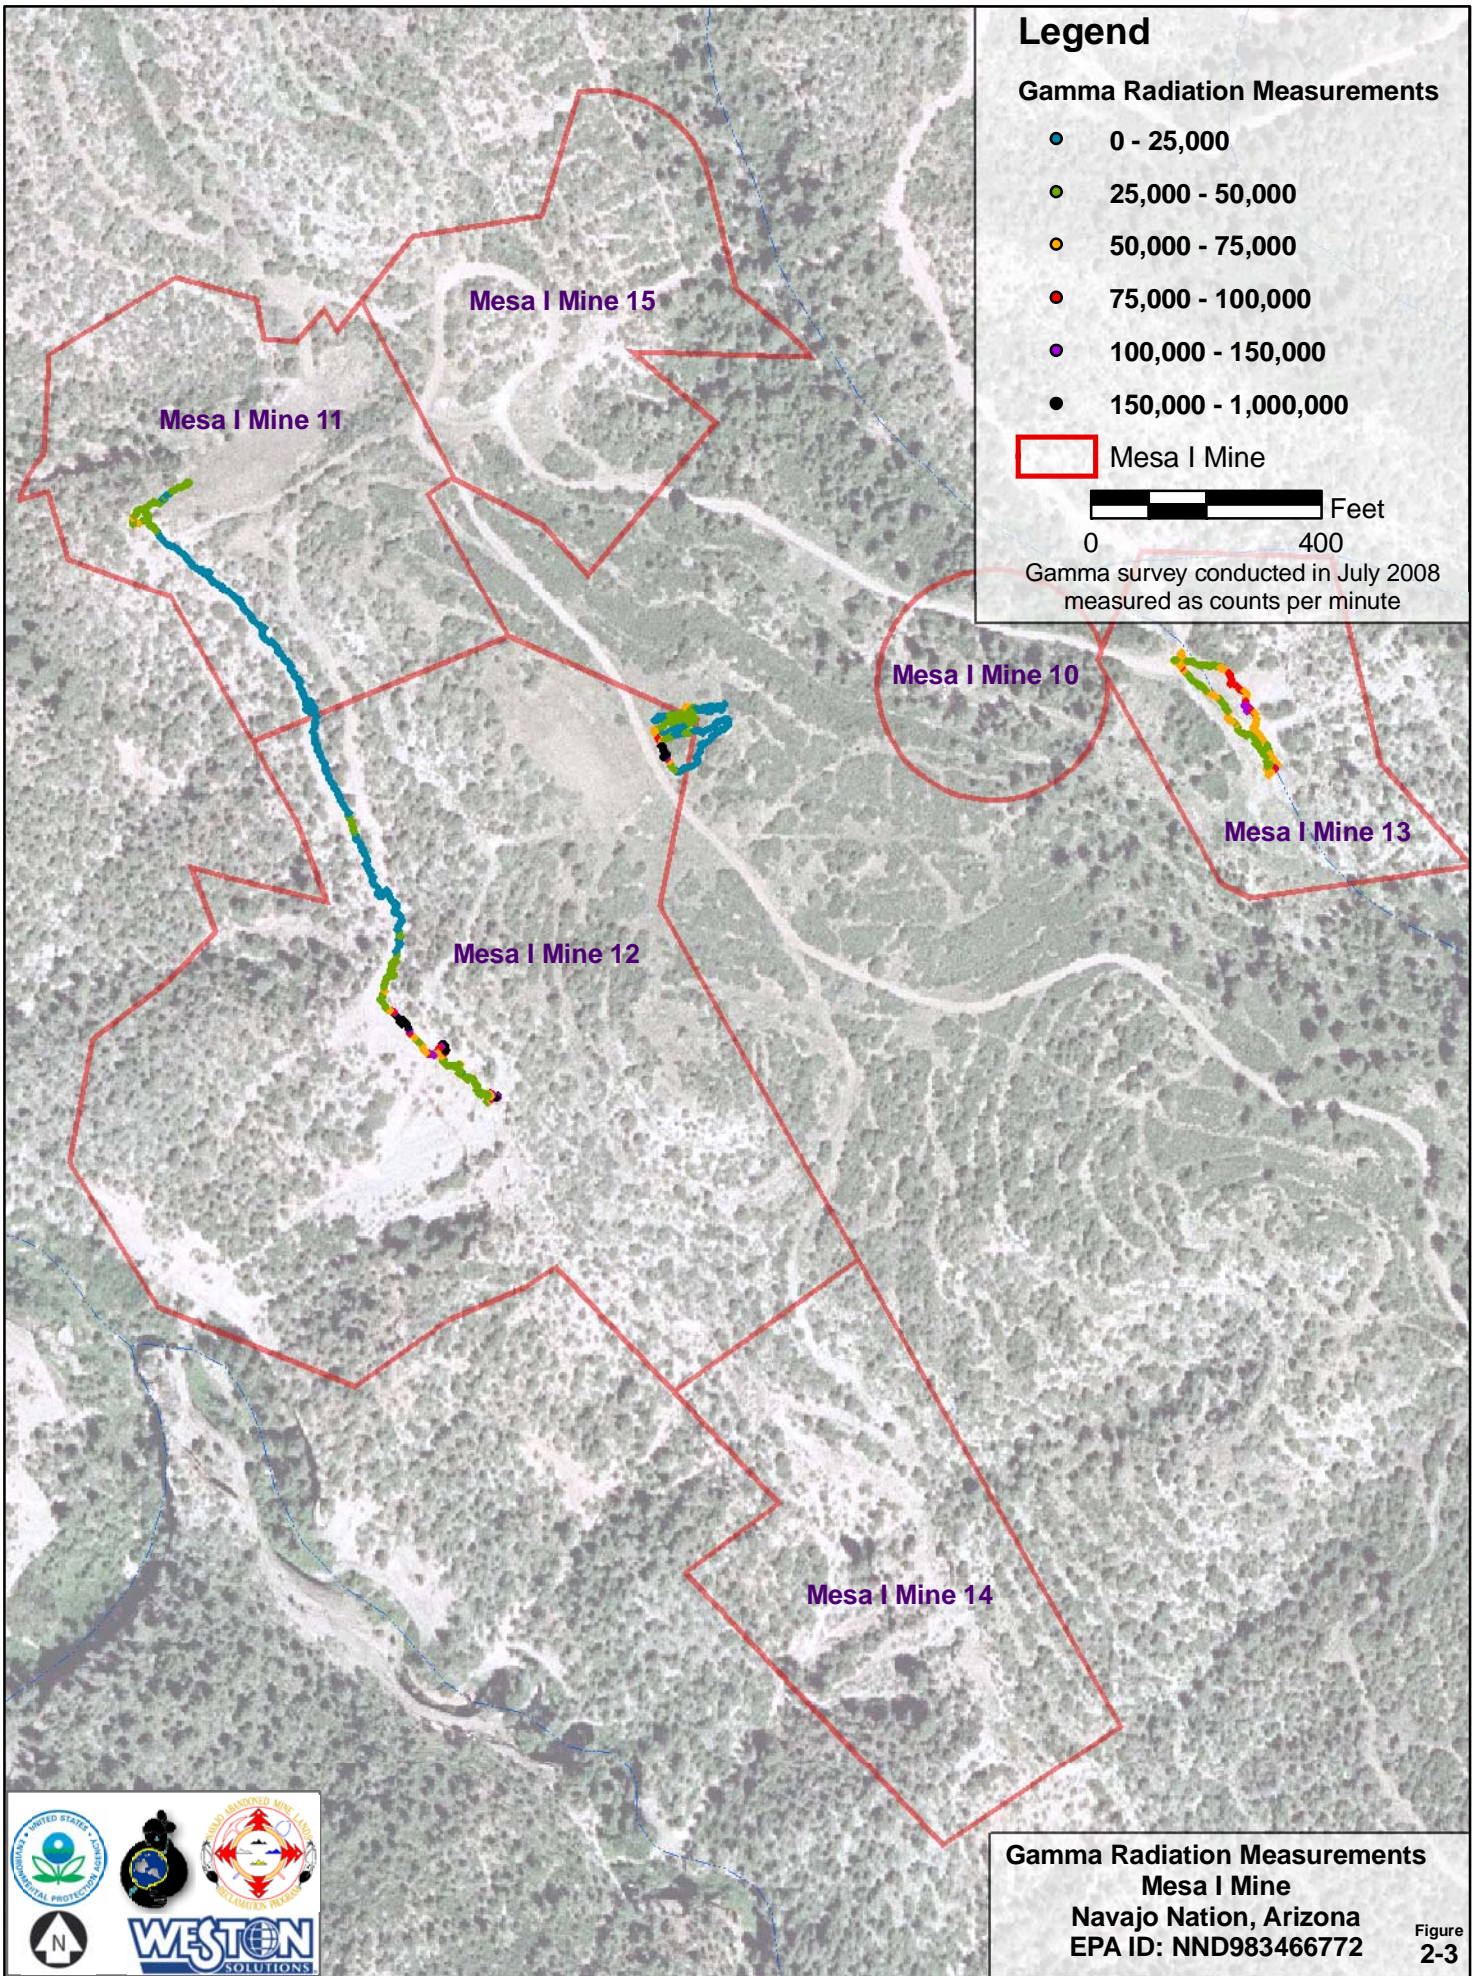
Gamma survey conducted in July 2008  
Background gamma radiation was based on  
an average of 14,970 counts per minute (CPM)

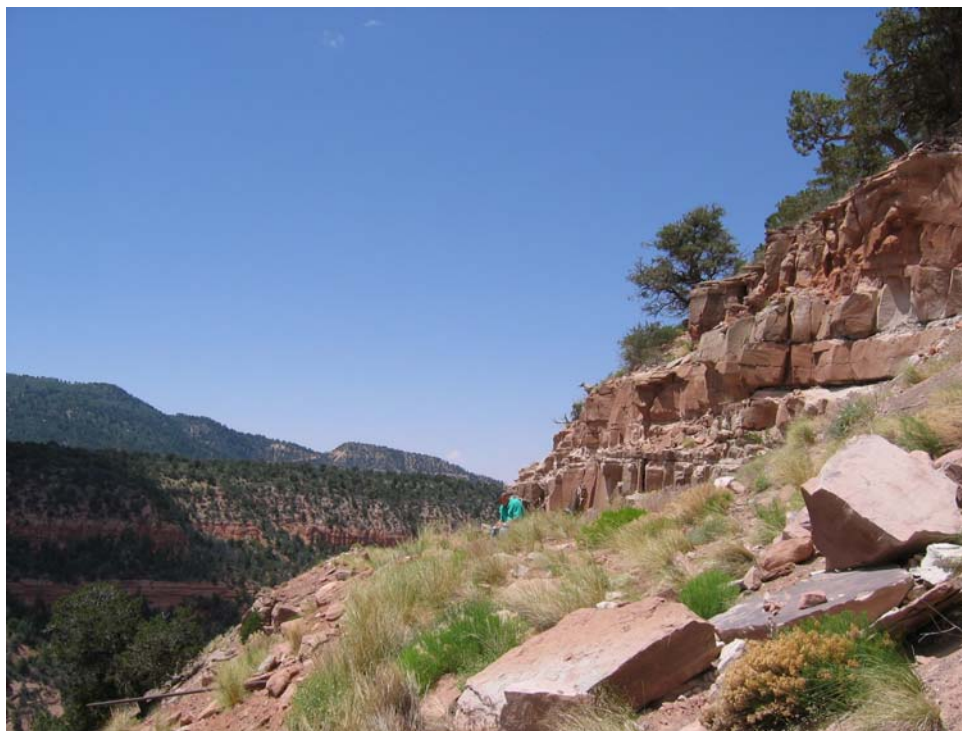
**Photo 3:** Mine tailings at Mine 12 mesa ridge.

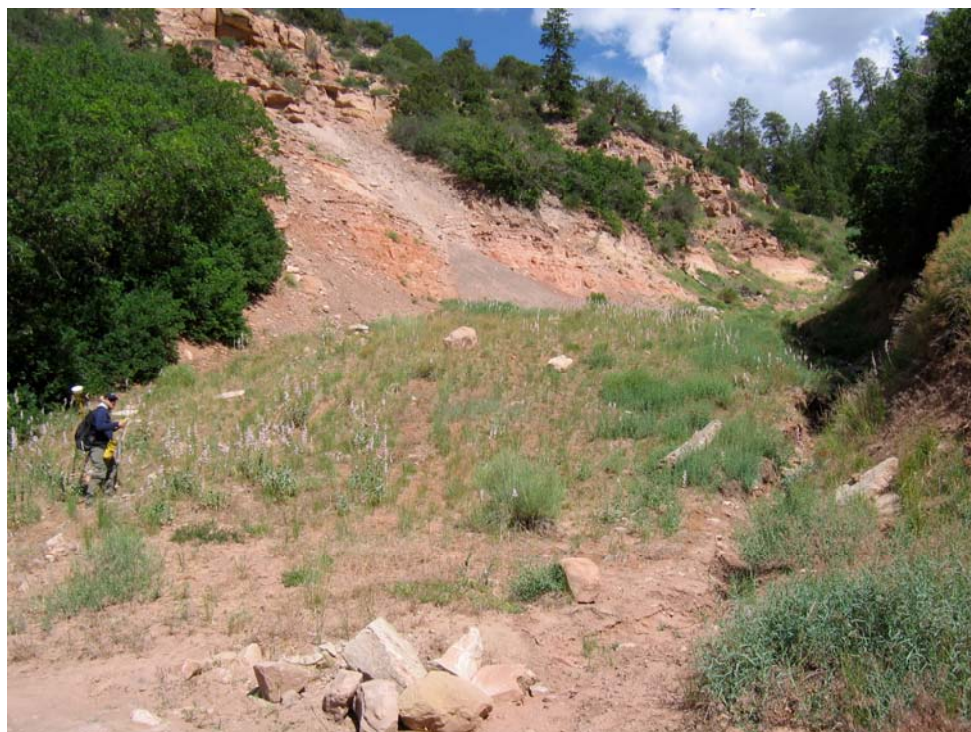
**Photo 4:** Area reclaimed by the Navajo Abandoned Mines Reclamation Program at Mine 13.

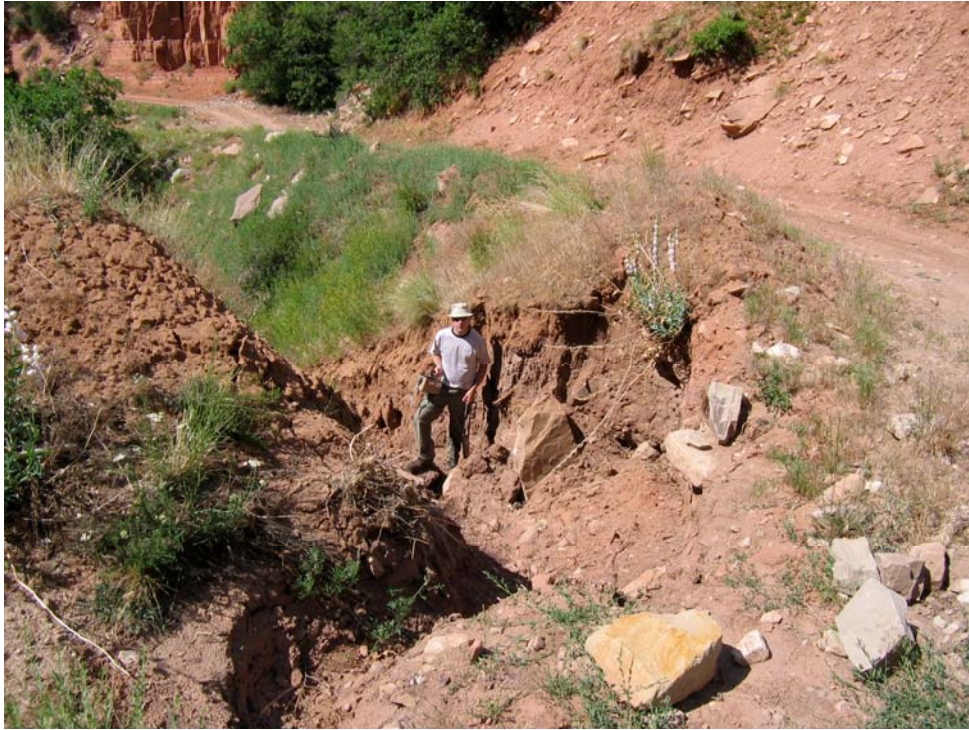
**Photo 5:** A WESTON employee collects gamma radiation readings in the drainage from the reclaimed portion of Mine 13.

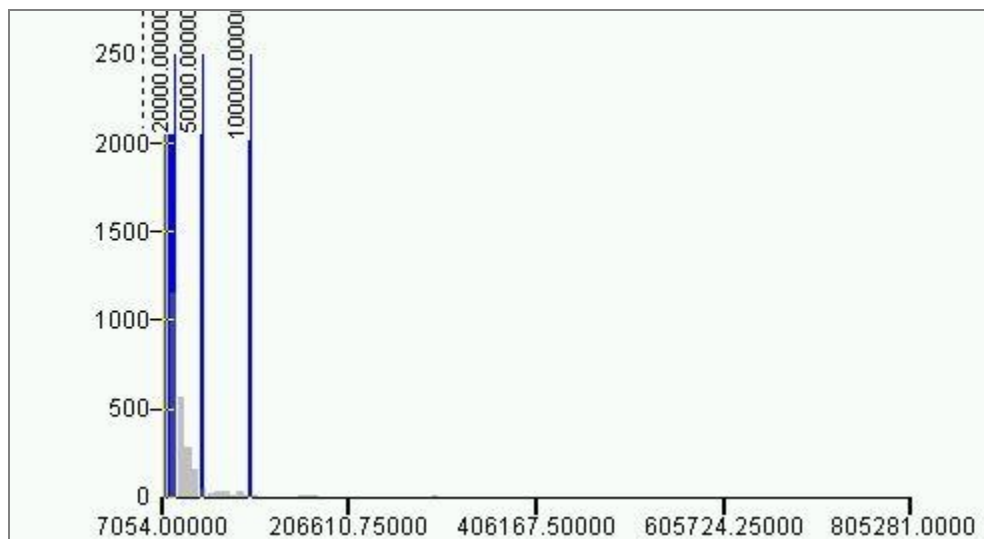
The following chart and statistics were generated by ESRI ArcGIS 9.3.1, and show the general distribution of the site gamma radiation measurements. The horizontal X axis represents the gamma radiation reading levels in cpm (lowest levels to the left). The vertical Y axis represents the frequency of each gamma radiation level.

Count:	4634
Minimum:	7054.00000
Maximum:	805281.00000
Sum:	148520871.00000
Mean:	32050.25270
Median:	15729.50000
Standard Deviation:	72274.65668

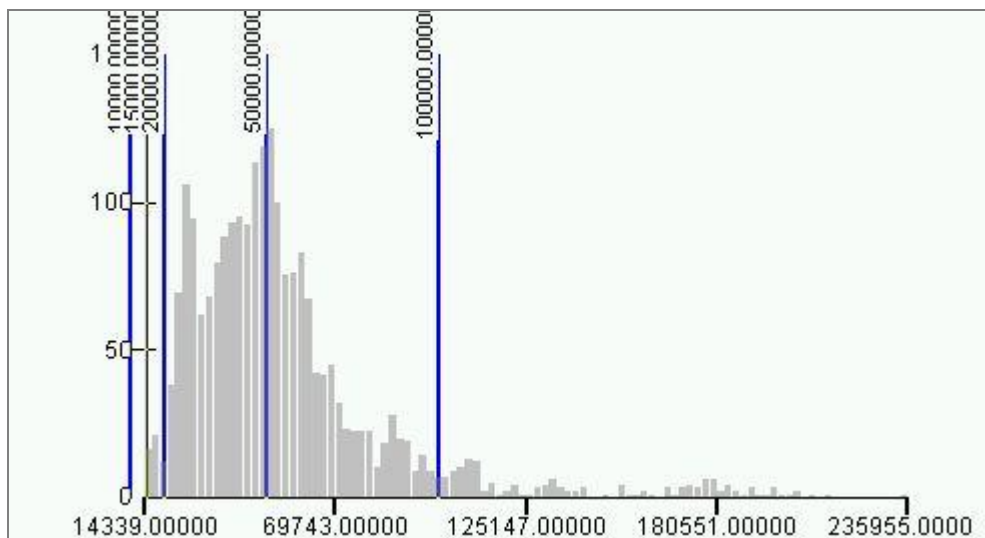
The following chart and statistics were generated by ESRI ArcGIS 9.3.1, and show the general distribution of the site gamma radiation measurements. The horizontal X axis represents the gamma radiation reading levels in cpm (lowest levels to the left). The vertical Y axis represents the frequency of each gamma radiation level.

Count:	2224
Minimum:	14339.00000
Maximum:	235955.00000
Sum:	122129685.00000
Mean:	54914.42671
Median:	48826.50000
Standard Deviation:	30279.81513

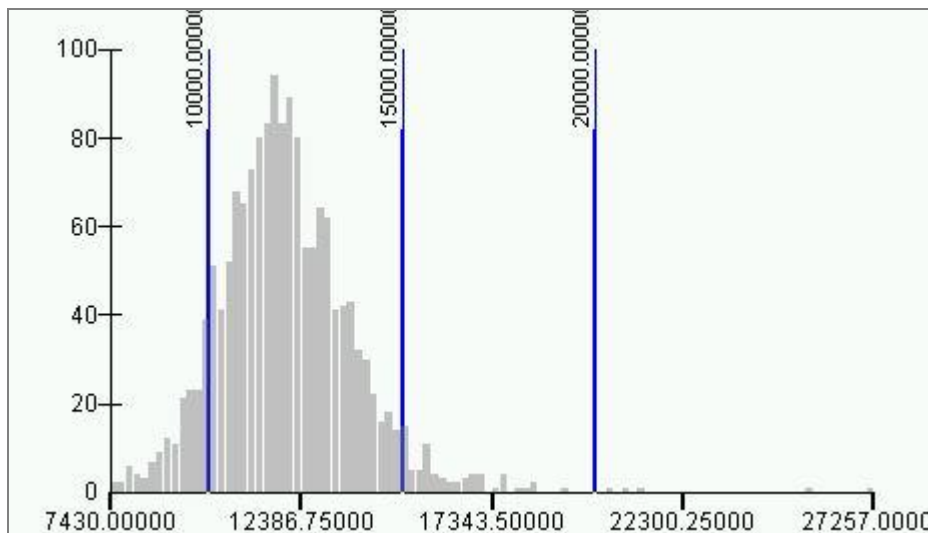
The following chart and statistics were generated by ESRI ArcGIS 9.3.1, and show the general distribution of the site gamma radiation measurements. The horizontal X axis represents the gamma radiation reading levels in cpm (lowest levels to the left). The vertical Y axis represents the frequency of each gamma radiation level.

Count:	1588
Minimum:	7430.00000
Maximum:	27257.00000
Sum:	19051033.00000
Mean:	11996.87217
Median:	11850.00000
Standard Deviation:	1773.03380

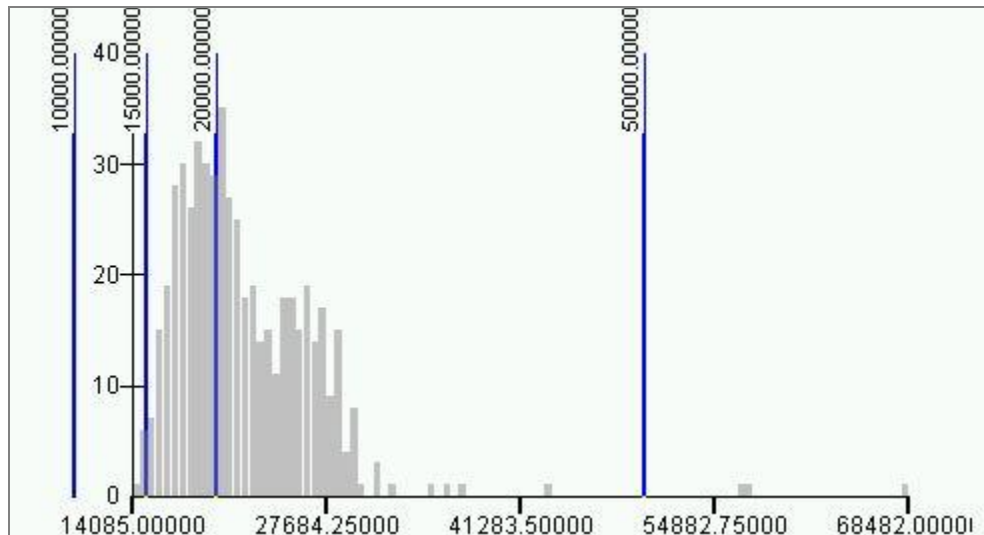
The following chart and statistics were generated by ESRI ArcGIS 9.3.1, and show the general distribution of the site gamma radiation measurements. The horizontal X axis represents the gamma radiation reading levels in cpm (lowest levels to the left). The vertical Y axis represents the frequency of each gamma radiation level.

Count:	536
Minimum:	14085.00000
Maximum:	68482.00000
Sum:	11721989.00000
Mean:	21869.38246
Median:	20777.50000
Standard Deviation:	5084.14379

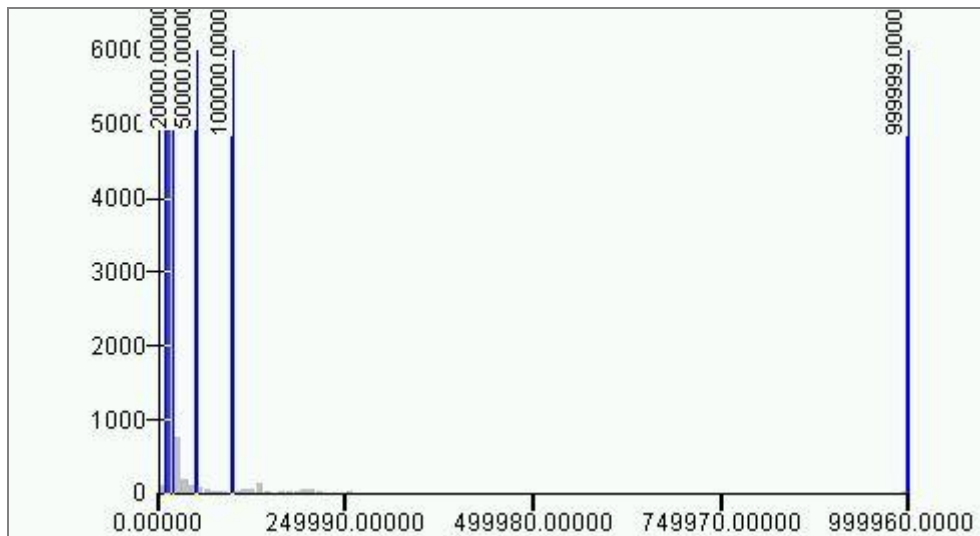
The following chart and statistics were generated by ESRI ArcGIS 9.3.1, and show the general distribution of the site gamma radiation measurements. The horizontal X axis represents the gamma radiation reading levels in cpm (lowest levels to the left). The vertical Y axis represents the frequency of each gamma radiation level.

Count:	7736
Minimum:	0.00000
Maximum:	999960.00000
Sum:	304136087.00000
Mean:	39314.38560
Median:	15526.50000
Standard Deviation:	96164.30029

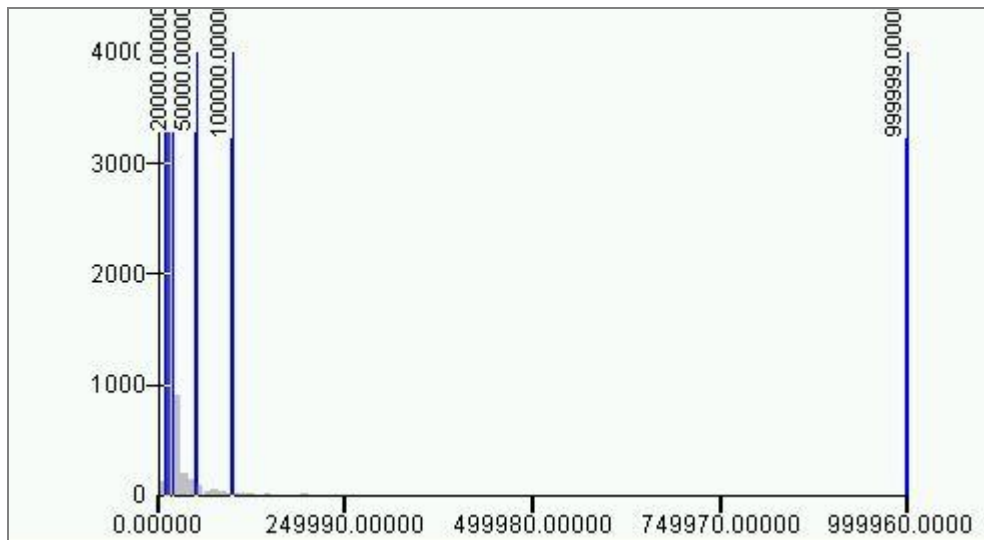
The following chart and statistics were generated by ESRI ArcGIS 9.3.1, and show the general distribution of the site gamma radiation measurements. The horizontal X axis represents the gamma radiation reading levels in cpm (lowest levels to the left). The vertical Y axis represents the frequency of each gamma radiation level.

Count:	5311
Minimum:	0.00000
Maximum:	999960.00000
Sum:	138020056.00000
Mean:	25987.58351
Median:	17161.00000
Standard Deviation:	43411.64480

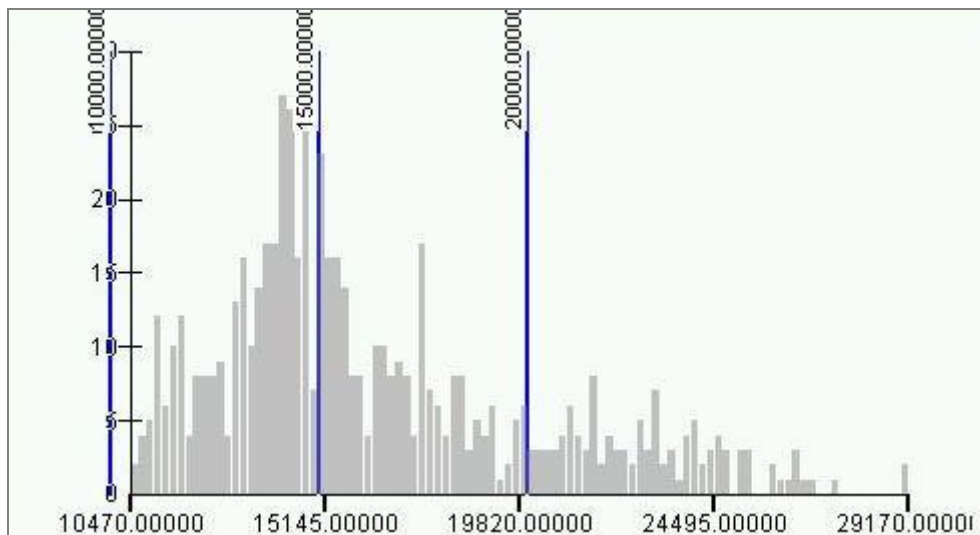
The following chart and statistics were generated by ESRI ArcGIS 9.3.1, and show the general distribution of the site gamma radiation measurements. The horizontal X axis represents the gamma radiation reading levels in cpm (lowest levels to the left). The vertical Y axis represents the frequency of each gamma radiation level.

Count:	611
Minimum:	10470.00000
Maximum:	29170.00000
Sum:	9972044.00000
Mean:	16320.85761
Median:	15196.00000
Standard Deviation:	3826.17518

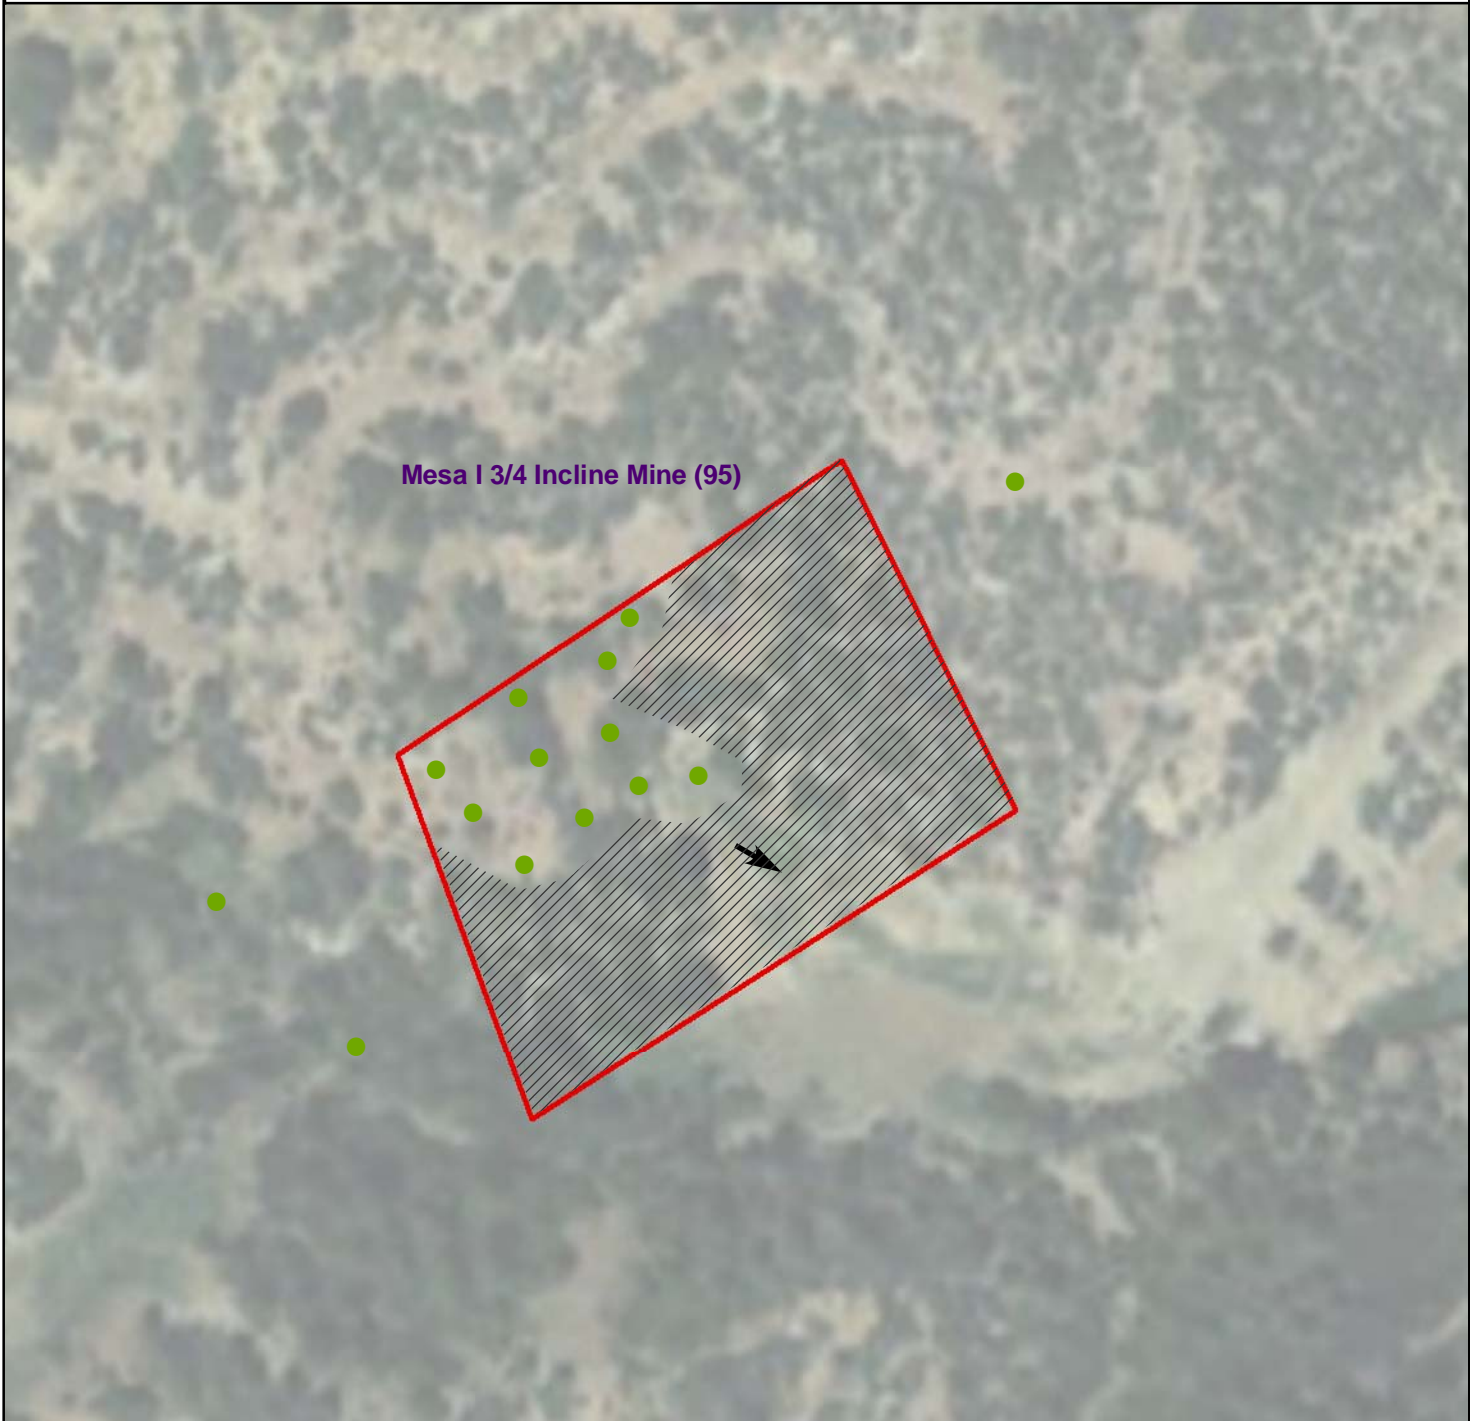
**Figure A-3 - Gamma Radiation Measurements, Above Two Times Background  
Mesa I 3/4 Incline Mine (95)  
Cove Chapter, Navajo Nation**

**Note:** Poor satellite coverage was encountered throughout the general vicinity of the site. Gamma readings were collected manually and marked as individual waypoints.

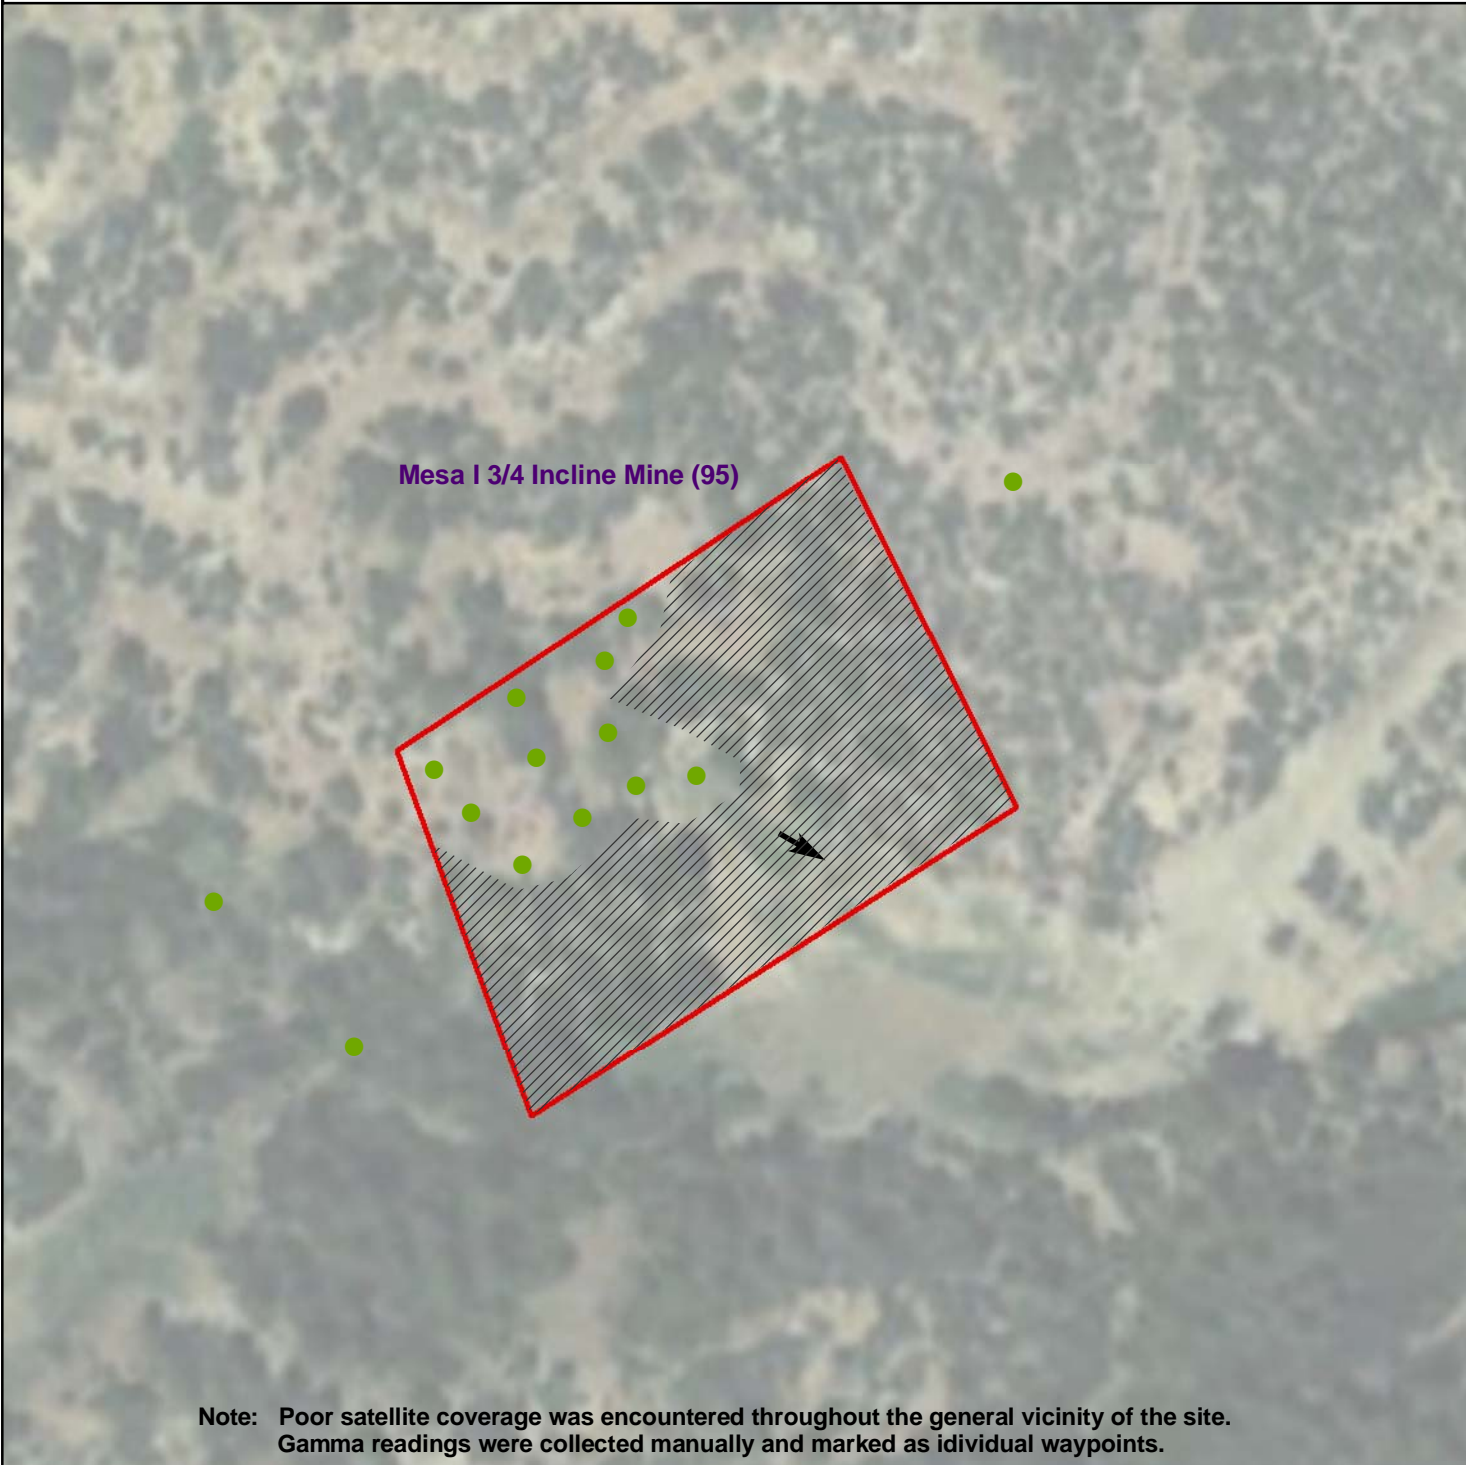
**Figure A-4 - Gamma Radiation Measurements  
Mesa I 3/4 Incline Mine (95)  
Cove Chapter, Navajo Nation**

**Note:** Poor satellite coverage was encountered throughout the general vicinity of the site. Gamma readings were collected manually and marked as individual waypoints.

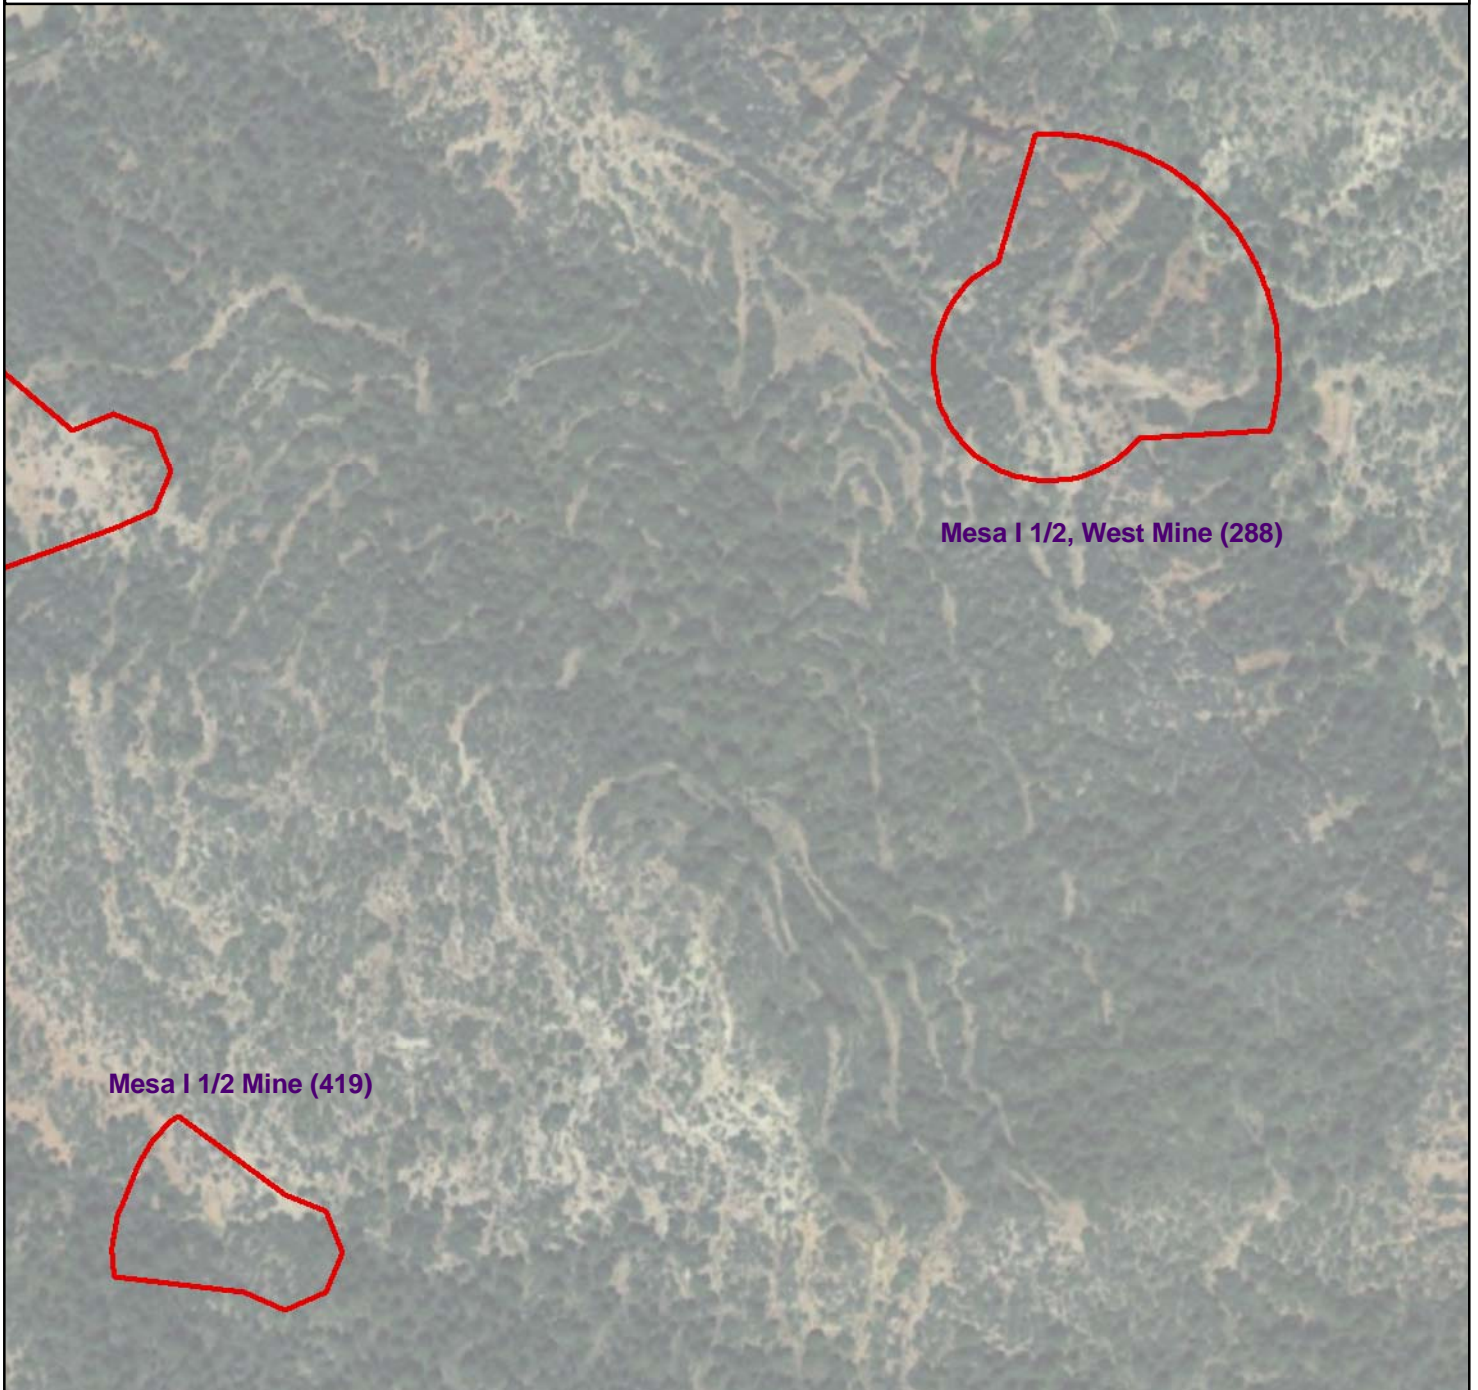
**Figure A-5 - Sites Inaccessible**  
**Mesa I 1/2, West Mine (288), Mesa I 1/2 Mine (419)**  
**Cove Chapter, Navajo Nation**

Weston was unable to access the site during the June 2010 site screenings.  
 All known paths leading towards the site were impassable. See site screen report for documentation.

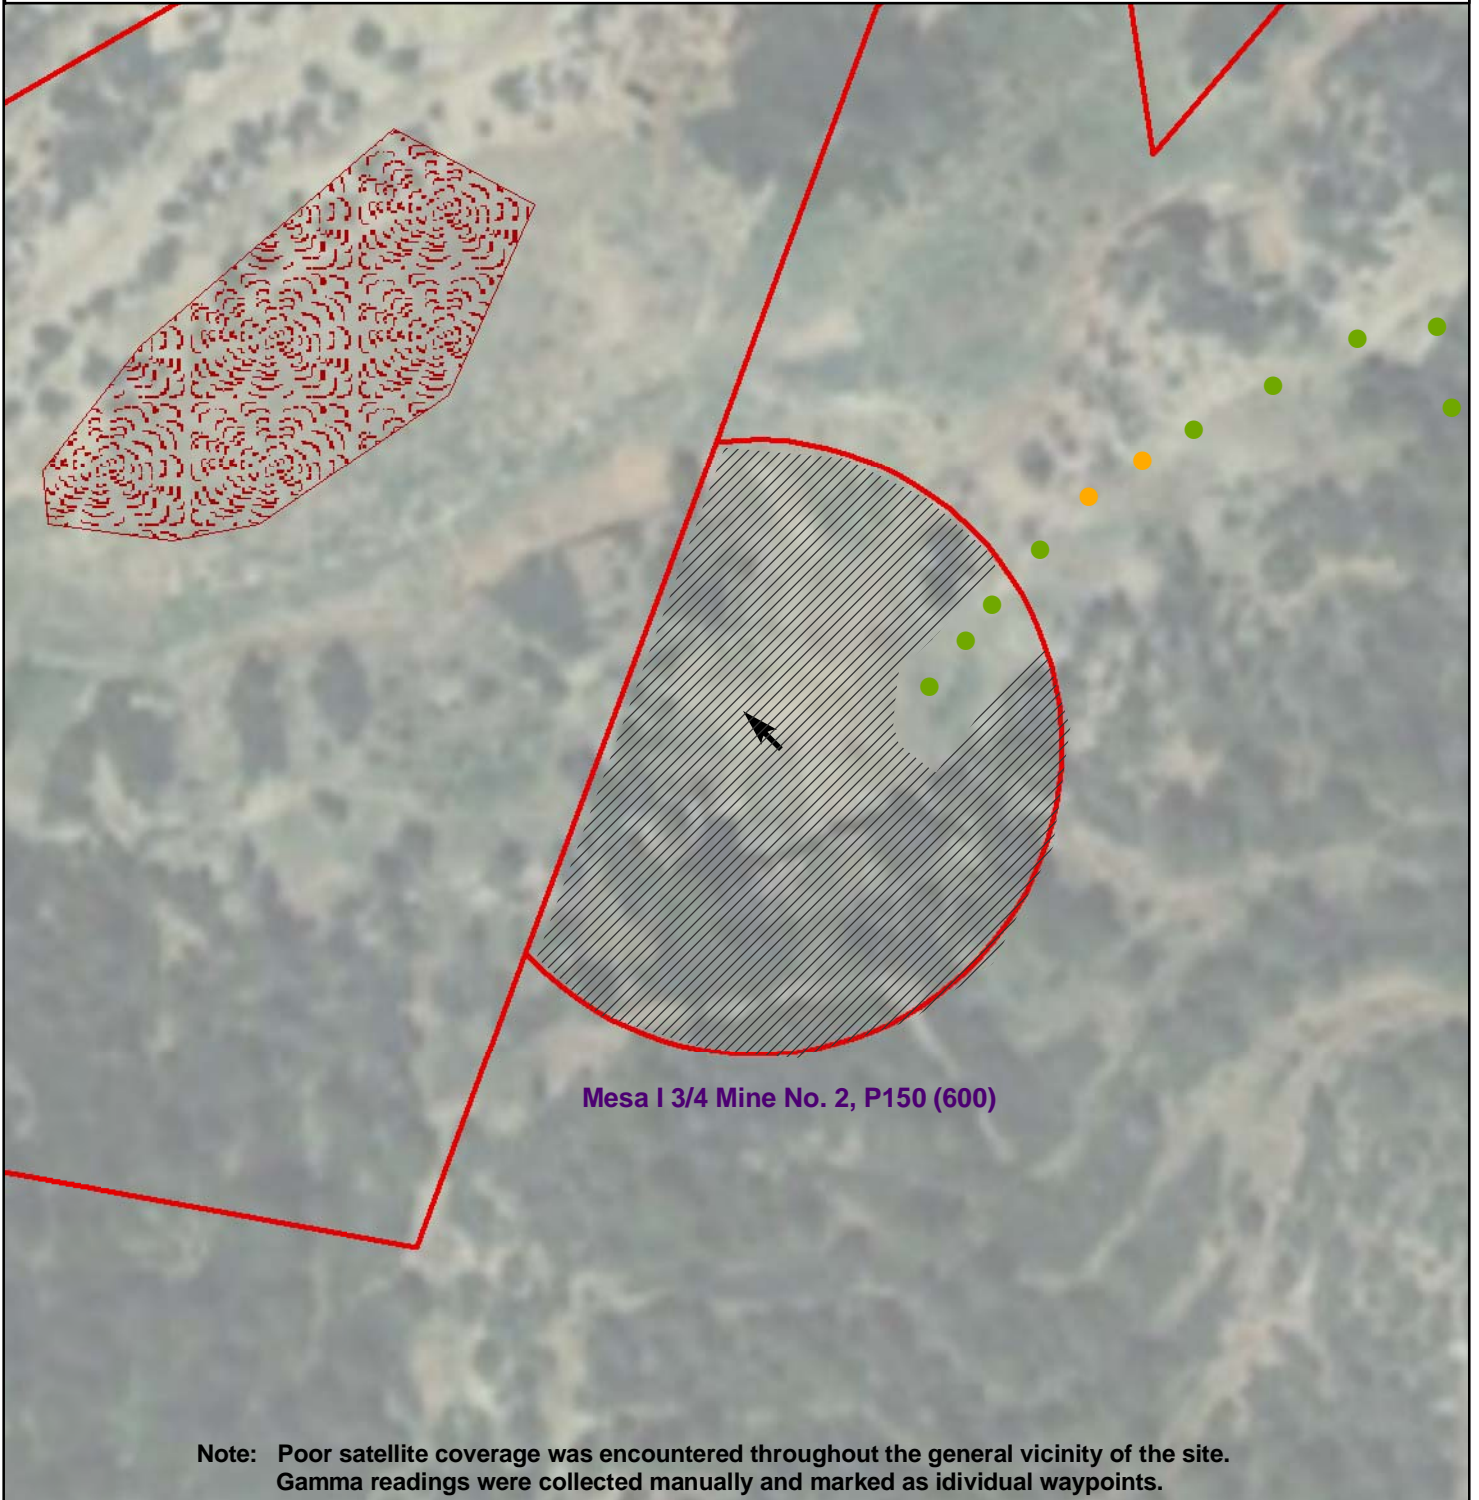
**Figure A-8 - Gamma Radiation Measurements, Above Two Times Background  
Mesa I 3/4 Mine No. 2, P150 (600)  
Cove Chapter, Navajo Nation**

**Note:** Poor satellite coverage was encountered throughout the general vicinity of the site. Gamma readings were collected manually and marked as individual waypoints.
