Success Story Elements

Editorial Formatting Guidance (June 2015)

Graphics and Images Guidance

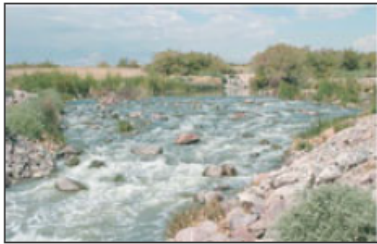
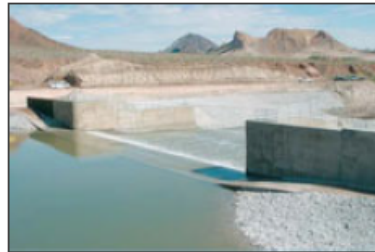
Weirs are low dams designed to reduce streambed erosion by flattening the slope of the channel and slowing flows. Many weirs are constructed of confined rock riprap, providing a somewhat natural look (left). Other structures are built with concrete, resulting in a more engineered look (right). Weirs, wetland restoration, and invasive vegetation removal helped reduce total suspended solids (TSS) concentrations in lower Las Vegas Wash and led to its removal from the Nevada 303(d) list in 2004.
