Final Report: Enbridge Line 5 - East Straits
of Mackinac Hydrostatic Test

Enbridge Energy, Limited Partnership

Hydrostatic Test #: 5-17-153

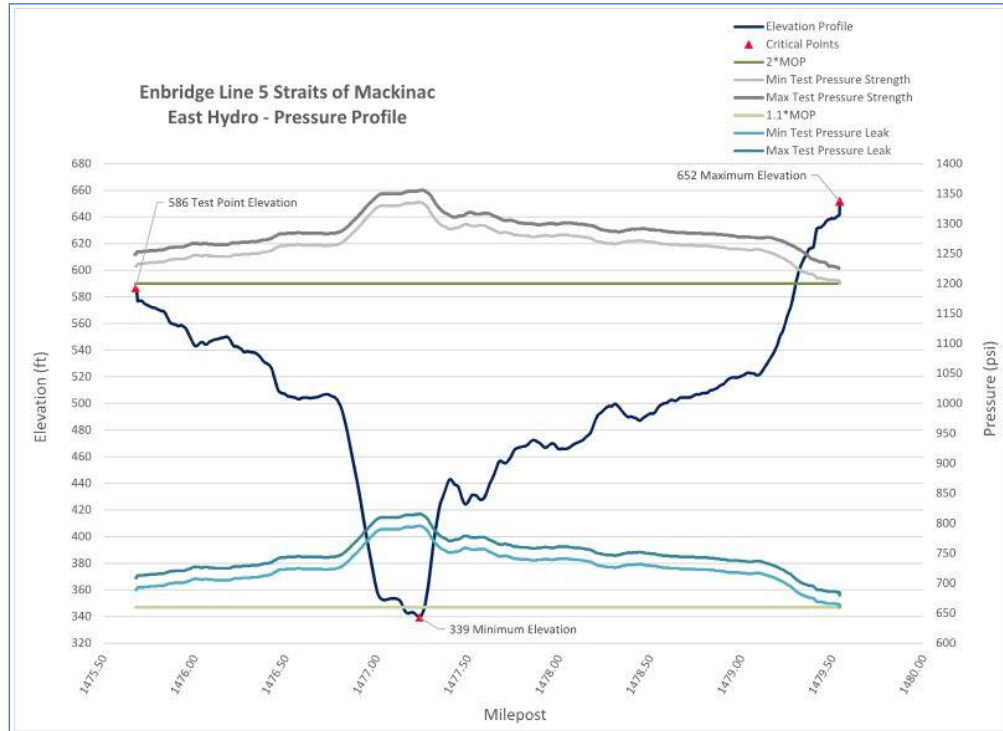
The elevation at the test site was 586.4 feet at the North Straits Pipe Yard. This is the same elevation as the Deadweight in the test trailer. Minimum elevation of the pipeline segment is 339.4 feet and maximum elevation is 651.7 feet.

Figure 1. Test Pressure Profile

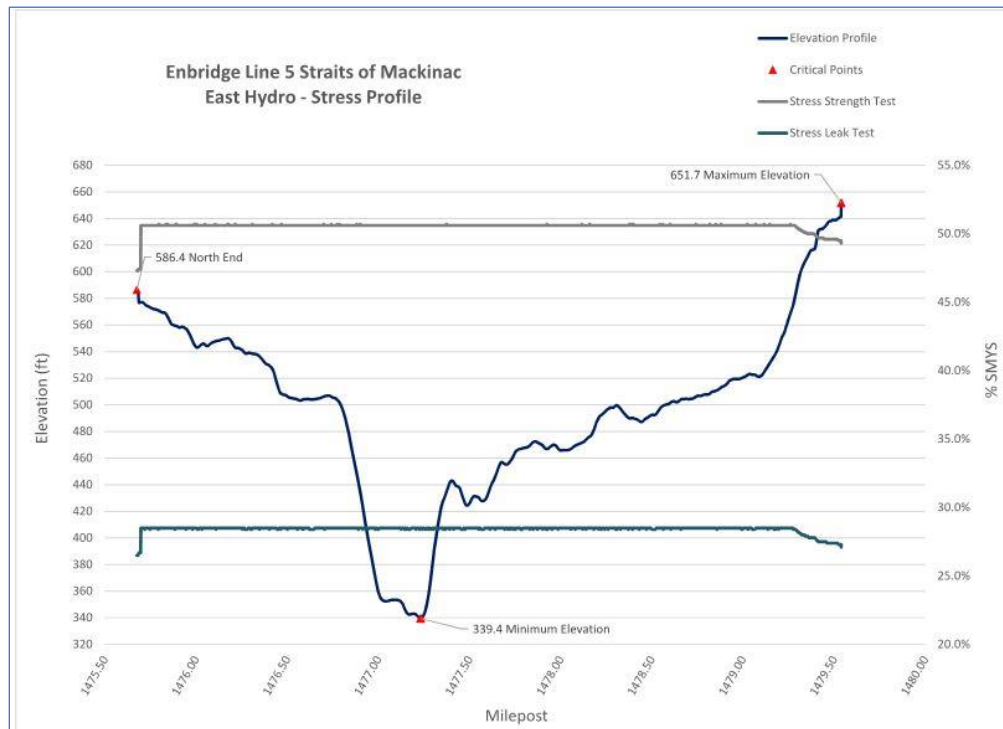
Figure 2. Test Stress Profile

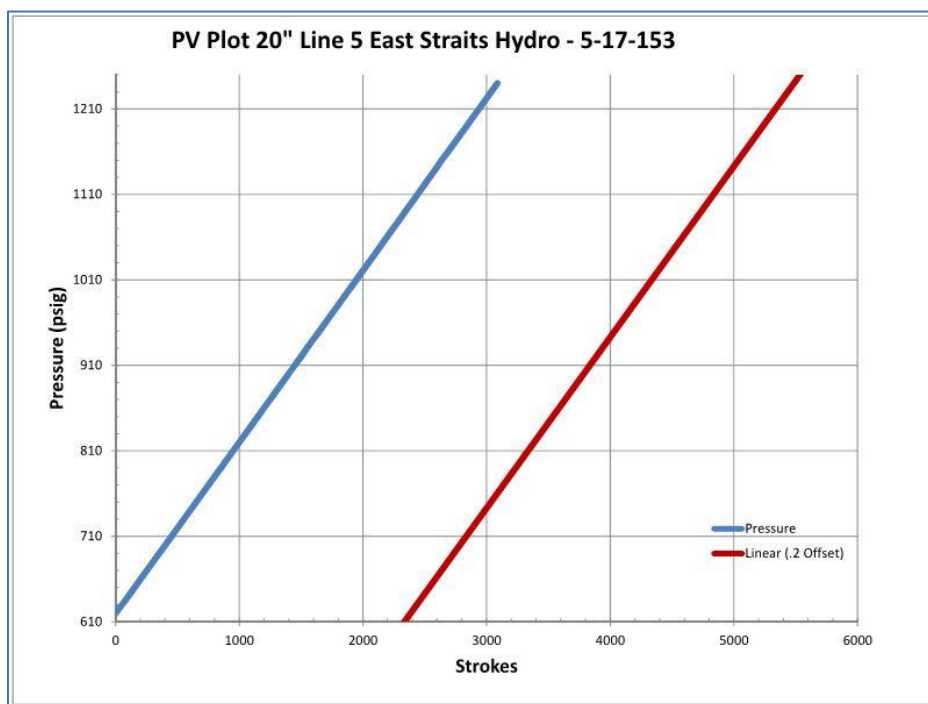
At 5:14 AM, a 50% pressure of 620 psi was reached. A 15-minute hold was commenced at the 50% pressure. At 5:31 AM, pressurization began to 75% with a starting pressure of 621 psi. A PV plot was completed during pressurization from 50% to 75%. This PV plot resulted in an average of 49.9 strokes per 10 psi, using a 0.258 gal/stroke pump, with a maximum of 52 and minimum of 46. Pressurization rate did not exceed the outlined maximum of 10 psi/minute.

At 6:05 AM, a 75% pressure of 930 psi was reached. A 15-minute hold was commenced at the 75% pressure. At 6:31 AM, pressurization began to strength test pressure with a starting pressure of 930 psi. A PV plot was completed during pressurization from 75% to strength test pressure. The PV plot from 75% to strength test pressure resulted in an average of 49.7 strokes per 10 psi with a maximum of 53 and minimum of 46. Pressurization rate did not exceed the outlined maximum of 10 psi/minute.

Figure 3. Pressure vs Volume Plot

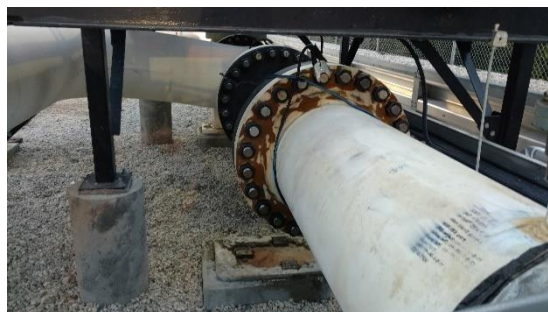
The East Segment of Line 5 across the Straits of Mackinac was isolated on the north end by removing flanged valve 5.1-V-1 and installing blind flanges. It was isolated on the south end by removing flanged check valve 5.1-CV-1 and installing blind flanges. All 2" auxiliary connections on the traps and station piping were removed and isolated with blind flanges or plugs.

Figure 7: North Straits Pipeyard Isolation

Figure 5: North Straits Pipeyard Isolation

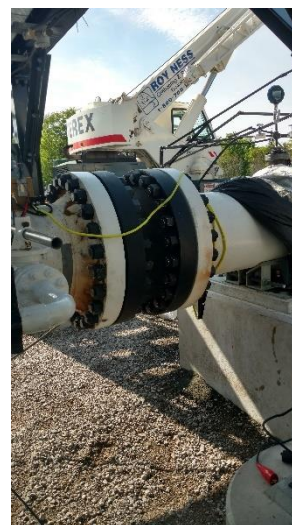
Figure 6: Mackinaw Station Isolation

Figure 4: Mackinaw Station Isolation
