# CALIFORNIA GULCH LAKE COUNTY, COLORADO SUPERFUND CASE STUDY

## A Once Toxic “Moonscape” from Mining and Smelting Is Returned to Fertile Pasture and Native Prairie

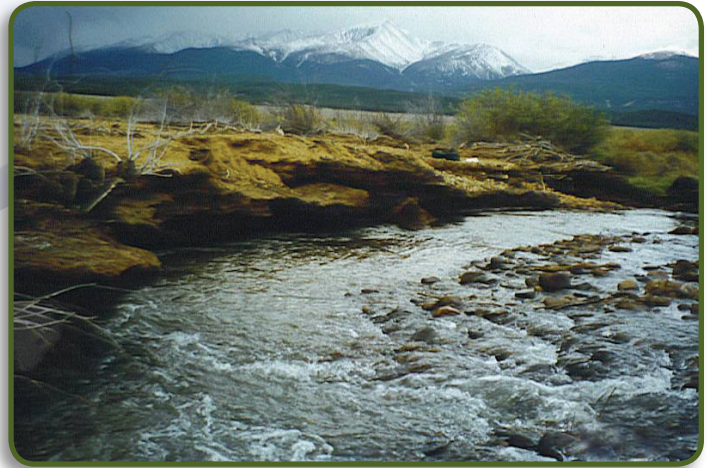
Eroding streambank prior to treatment

The streambanks adjacent to the fluvial deposits were often compromised because of the absence of vegetation caused by metals toxicity or low pH. Tilling amendments

into the tailings would further destabilize the streambanks and leave entire treatment areas open to erosion, so stream bank stabilization measures were needed. Stakeholders expressed concern over armoring banks with riprap or gabion baskets during the demonstration projects; therefore, in a few locations, bendway weirs and root wads were used to protect the bank and enhance fish habitat. The remedial action used soft engineering techniques to create well-vegetated banks that protect the remediated areas in the near term, but will also accommodate natural stream migration in the long term. Streambank stabilization tools included the following:

- Excavation of contaminated soil within 10 feet of the streambank and replacement with clean fill
- Rock roll along the toe of the stream bank
- Coir roll (biolog) along the toe of the stream bank or behind the rock roll
- Sedge (*Carex* spp.) plantings
- Mature willow (*Salix* spp.) transplants
- Tipped willows that extend into the river

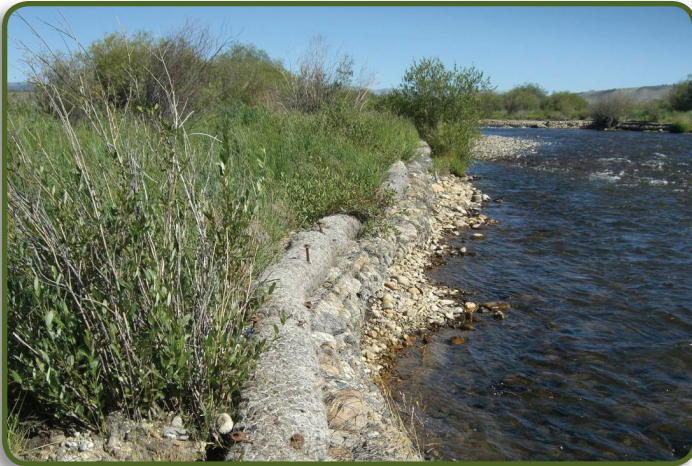
**Streambank after treatment**

The *Carex* plantings and mature willow transplants

were harvested from the adjacent floodplain. These tools were used in various combinations to address the diversity of streambank conditions encountered.

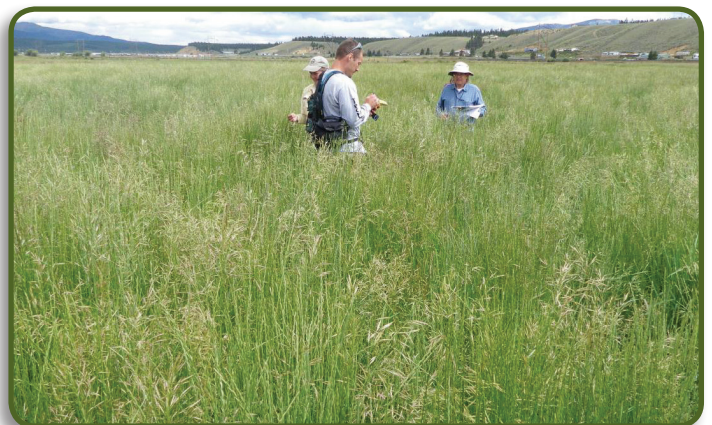
Smith Ranch vegetation assessment, 2010
