**UNITED STATES ENVIRONMENTAL PROTECTION AGENCY
REGION 5
77 WEST JACKSON BOULEVARD
CHICAGO, ILLINOIS 60604**

SUBJECT: CLEAN AIR ACT INSPECTION REPORT
Watco Terminal and Port Services, Chicago, Illinois

Facility Name: Watco Terminal and Port Services

Date of Inspection: September 25, 2018

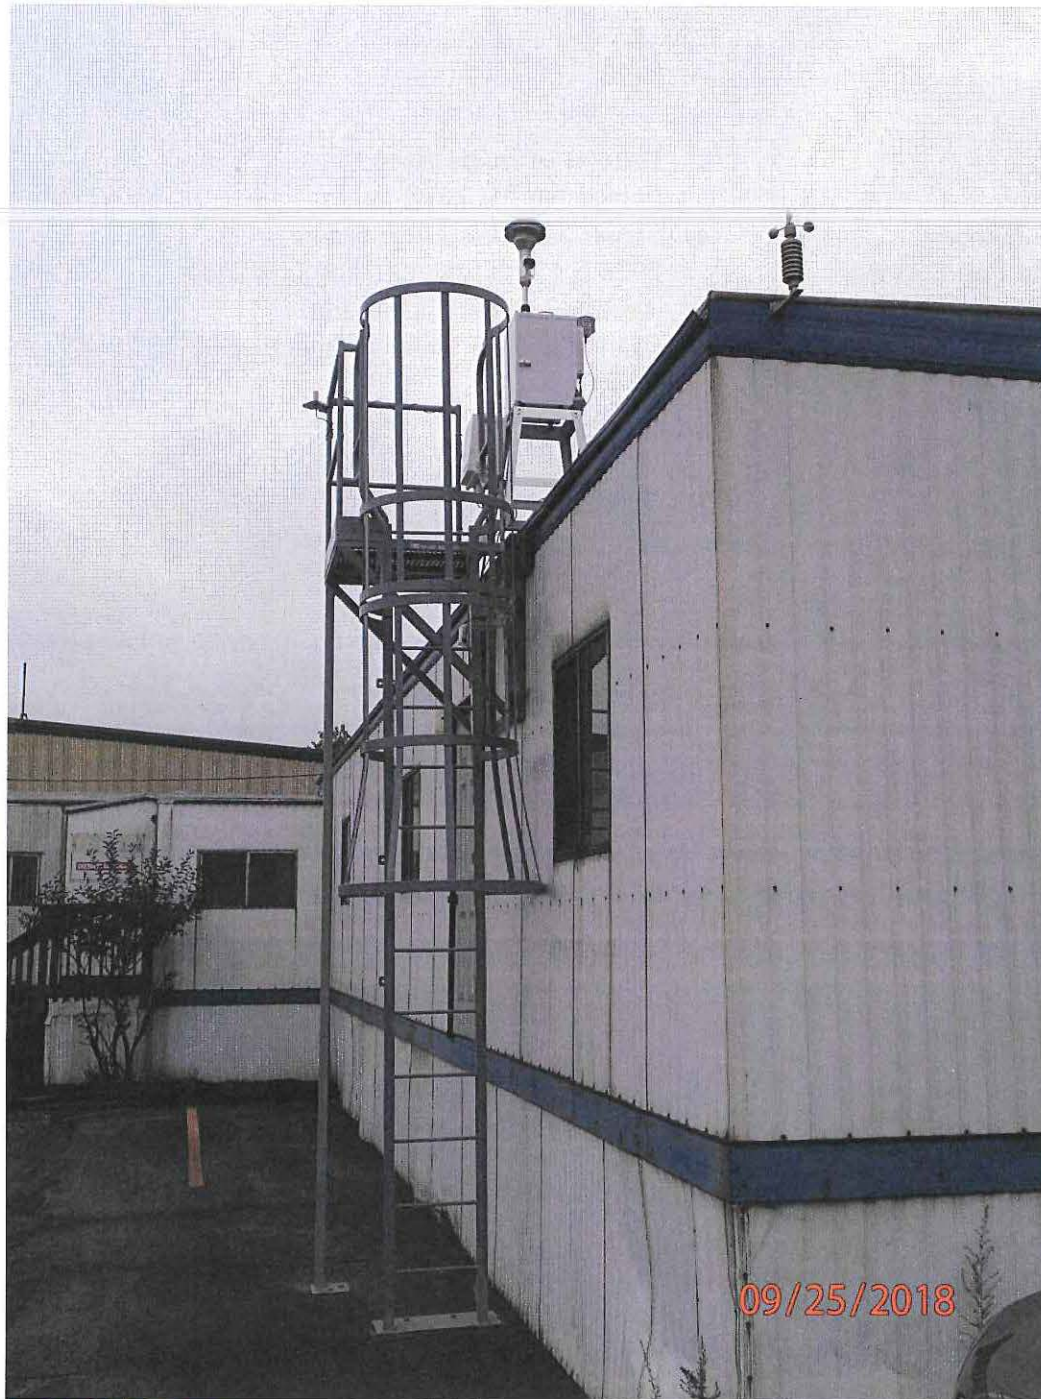
1: P9250001.JPG

Location: Watco Terminal and Port Services
Photographer: Patrick Miller
Date/Time: 9/25/2018 10:50 AM
Camera Direction: North
Description: Roof mounted FRM monitor

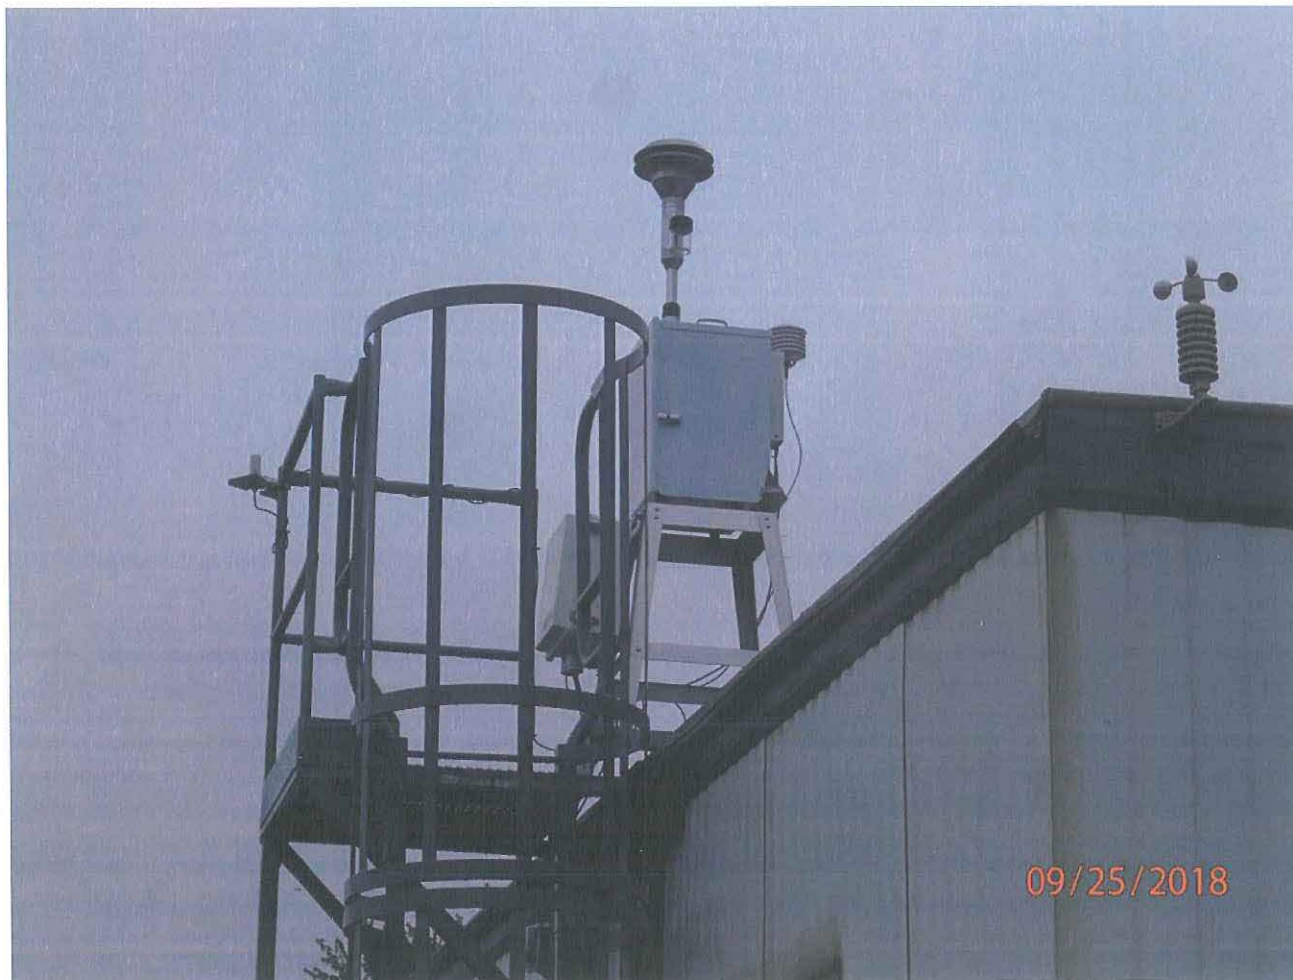
2: P9250002.JPG

Location: Watco Terminal and Port Services
Photographer: Patrick Miller
Date/Time: 9/25/2018 10:50 AM
Camera Direction: North
Description: Roof mounted FRM monitor

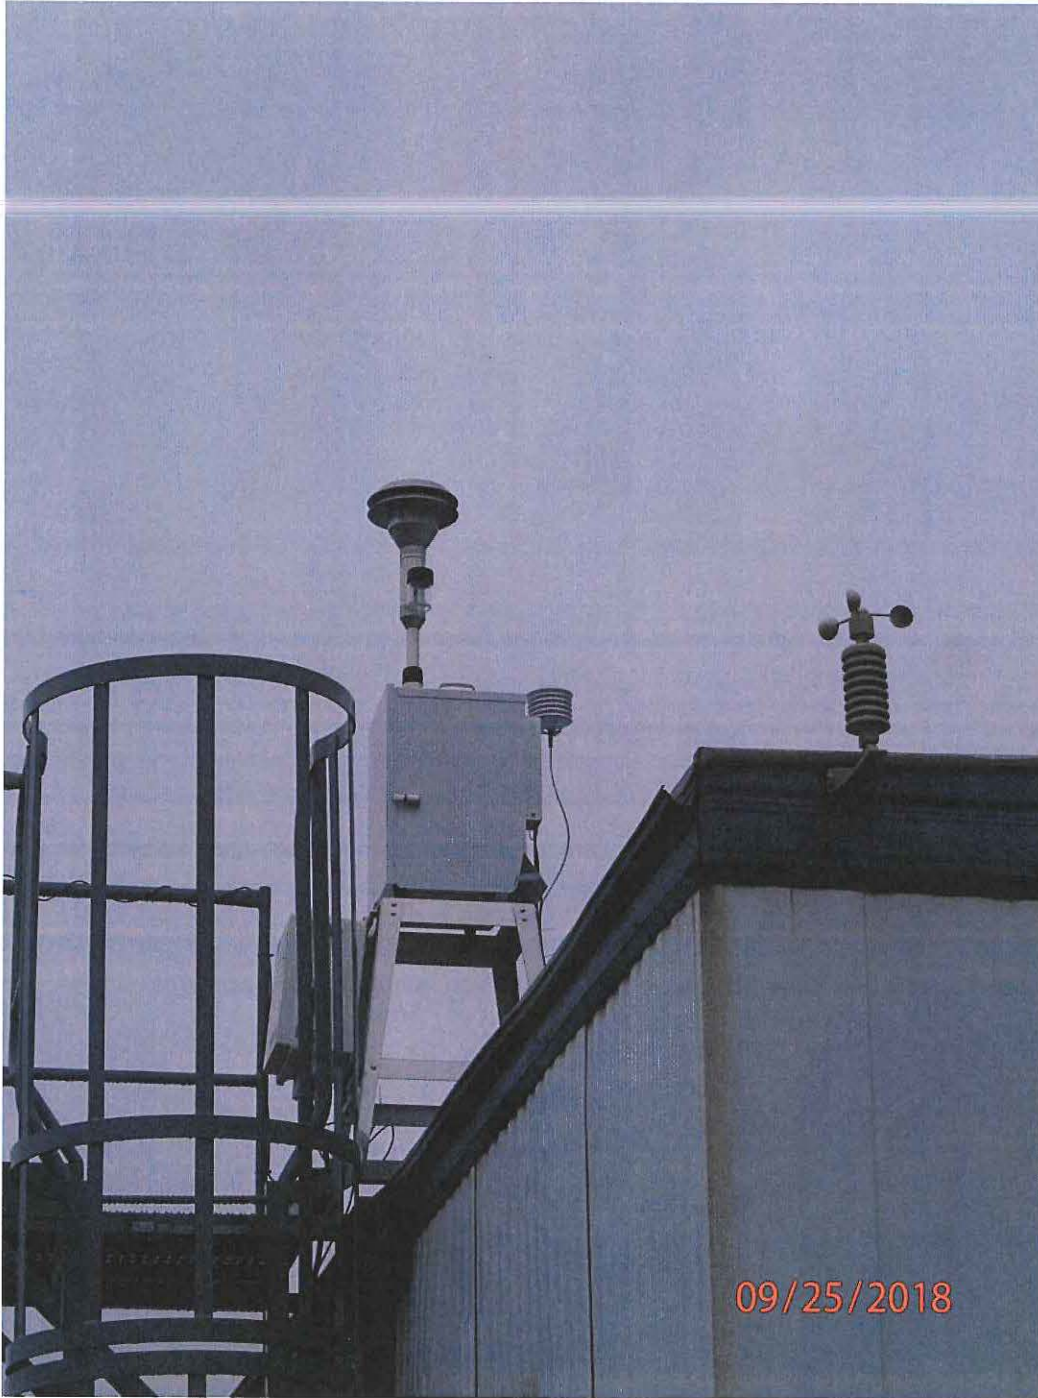
3: P9250003.JPG

EPA observed the FRM monitor installed on the roof of the office pursuant to EPA's May 15, 2018 information request. The monitor began operating on September 14, 2018.

Location: Watco Terminal and Port Services
Photographer: Patrick Miller
Date/Time: 9/25/2018 9:52 AM
Camera Direction: North
Description: Roof mounted FRM monitor

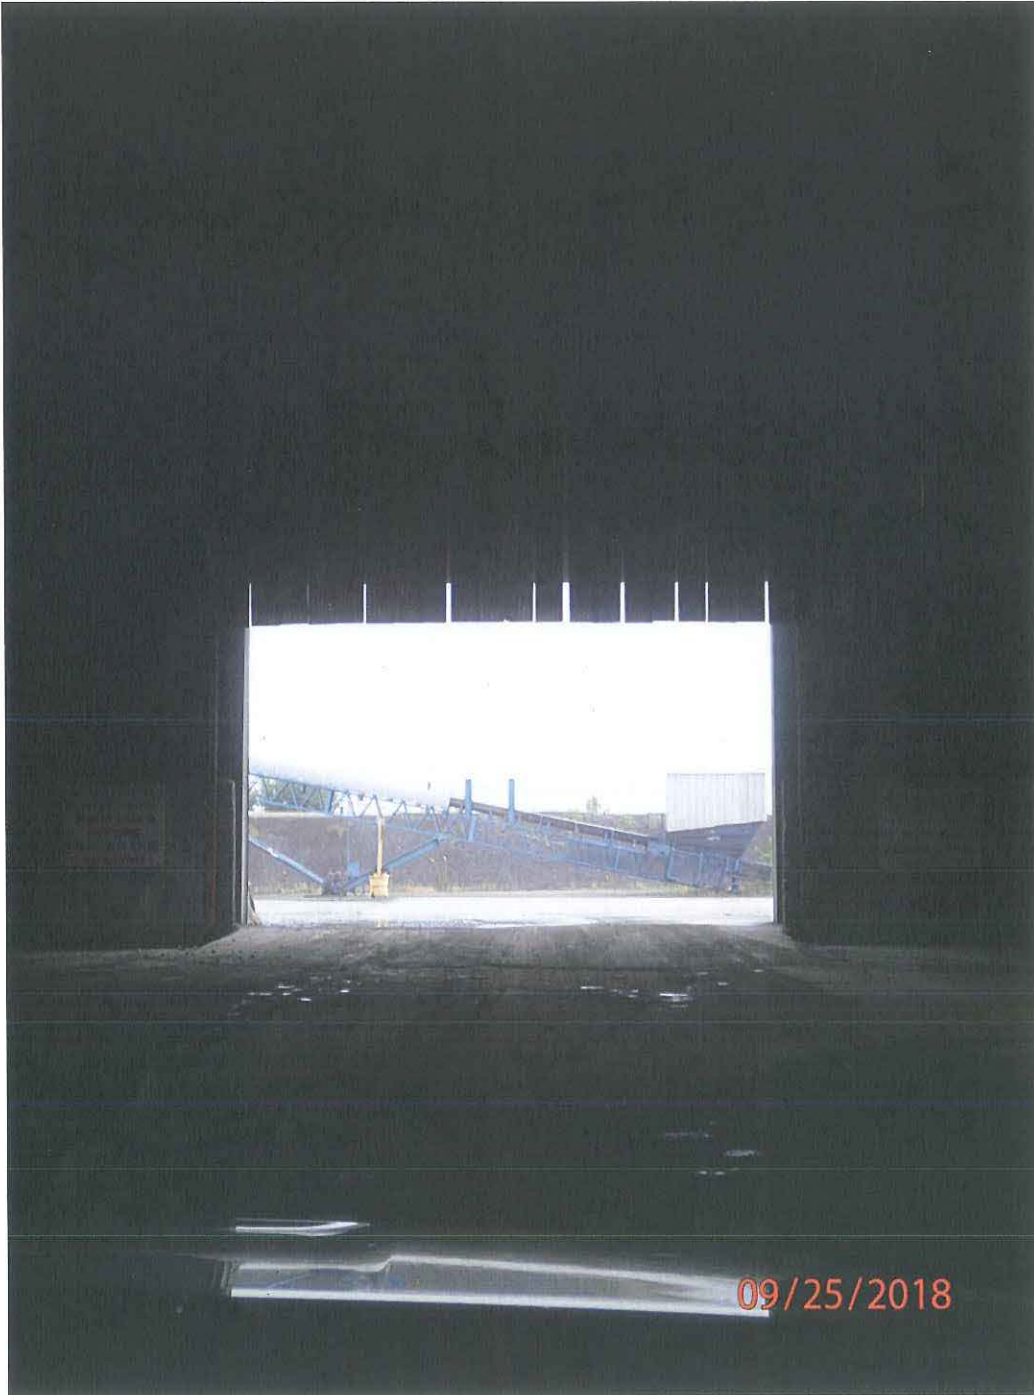
4: P9250004.JPG

New high speed doors were installed on Building F. A truck drives up to the entry and the heavy tarp door opens and closes automatically. The doors remain closed during loading. The truck then drives up to the exit and the door opens and closes automatically. Watco also purchased a fogging system for use during barge unloading when the excavator places material into an in-plant truck. Watco purchased additional nozzles for additional coverage on the front and back of the truck bed.

Location: Watco Terminal and Port Services
Photographer: Patrick Miller
Date/Time: 9/25/2018 10:04 AM
Camera Direction: Indoors (Building F)
Description: Exit for outbound truck loadout at Building F; easy open heavy tarp door

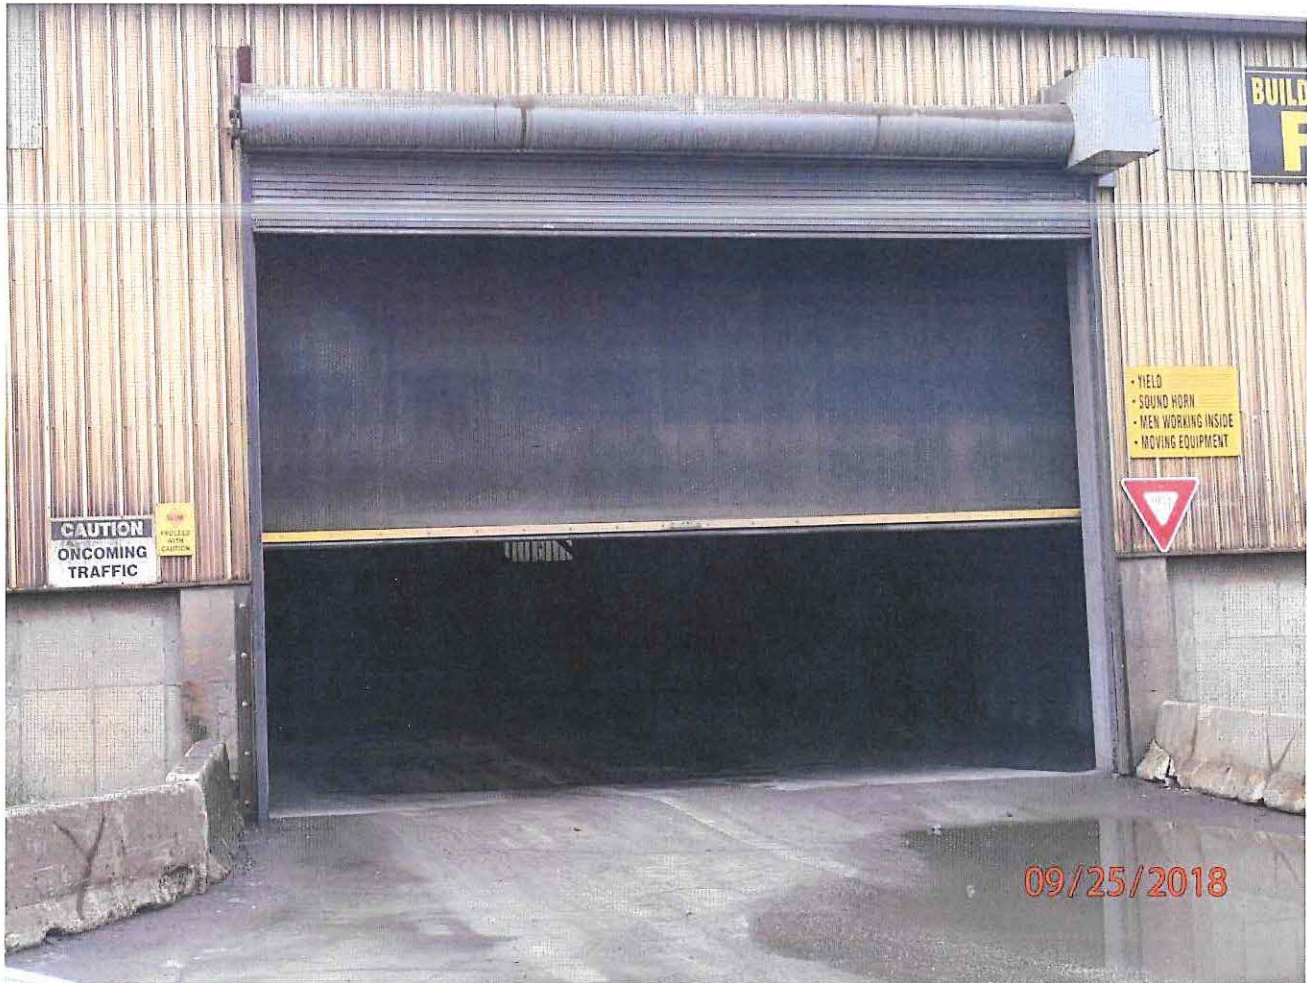
5: P9250005.JPG

Location: Watco Terminal and Port Services
Photographer: Patrick Miller
Date/Time: 9/25/2018 10:07 AM
Camera Direction: Northeast
Description: Entry for outbound truck loadout at Building F; easy open heavy tarp door

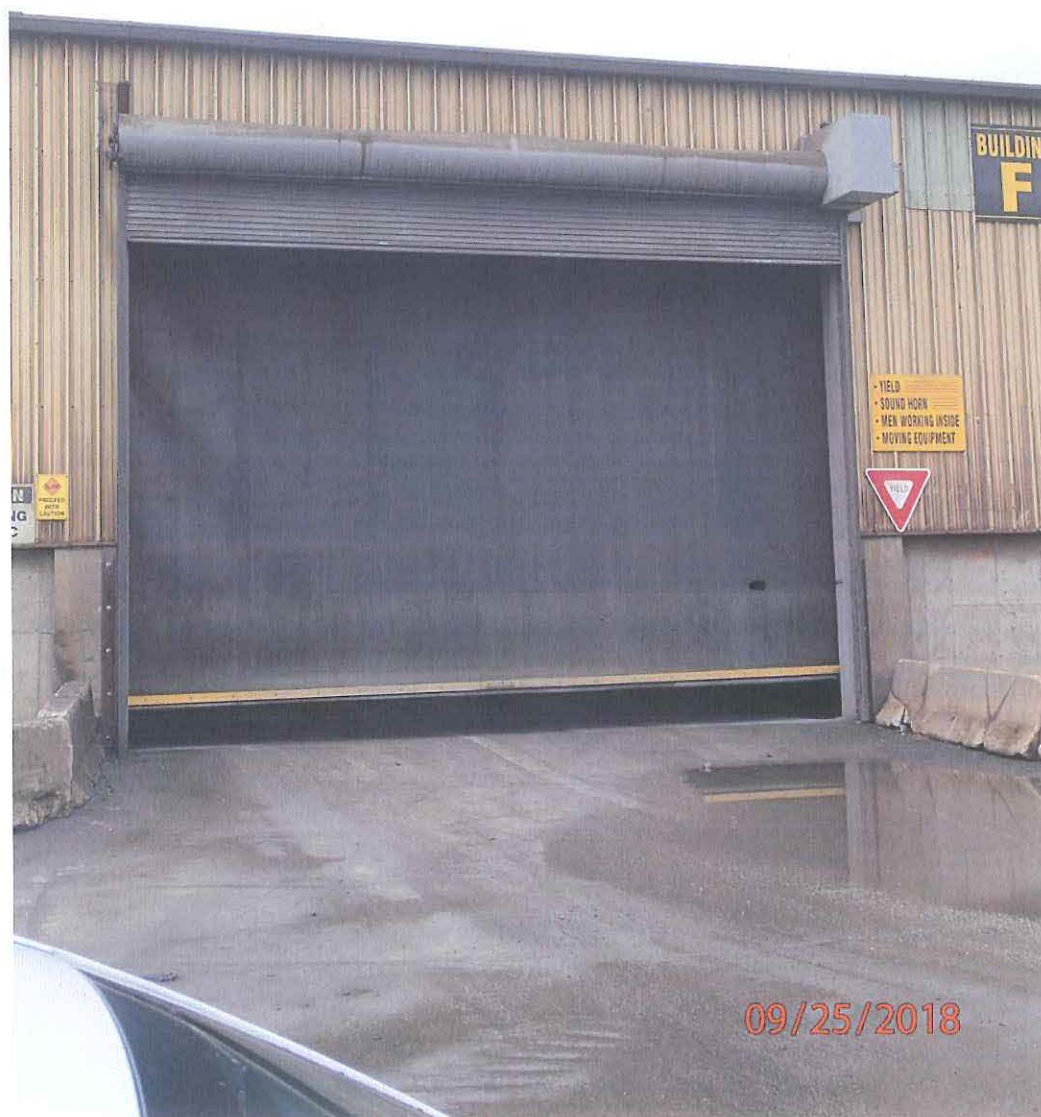
6: P9250006.JPG

Location: Watco Terminal and Port Services
Photographer: Patrick Miller
Date/Time: 9/25/2018 10:07 AM
Camera Direction: Northeast
Description: Entry for outbound truck loadout at Building F; easy open heavy tarp door

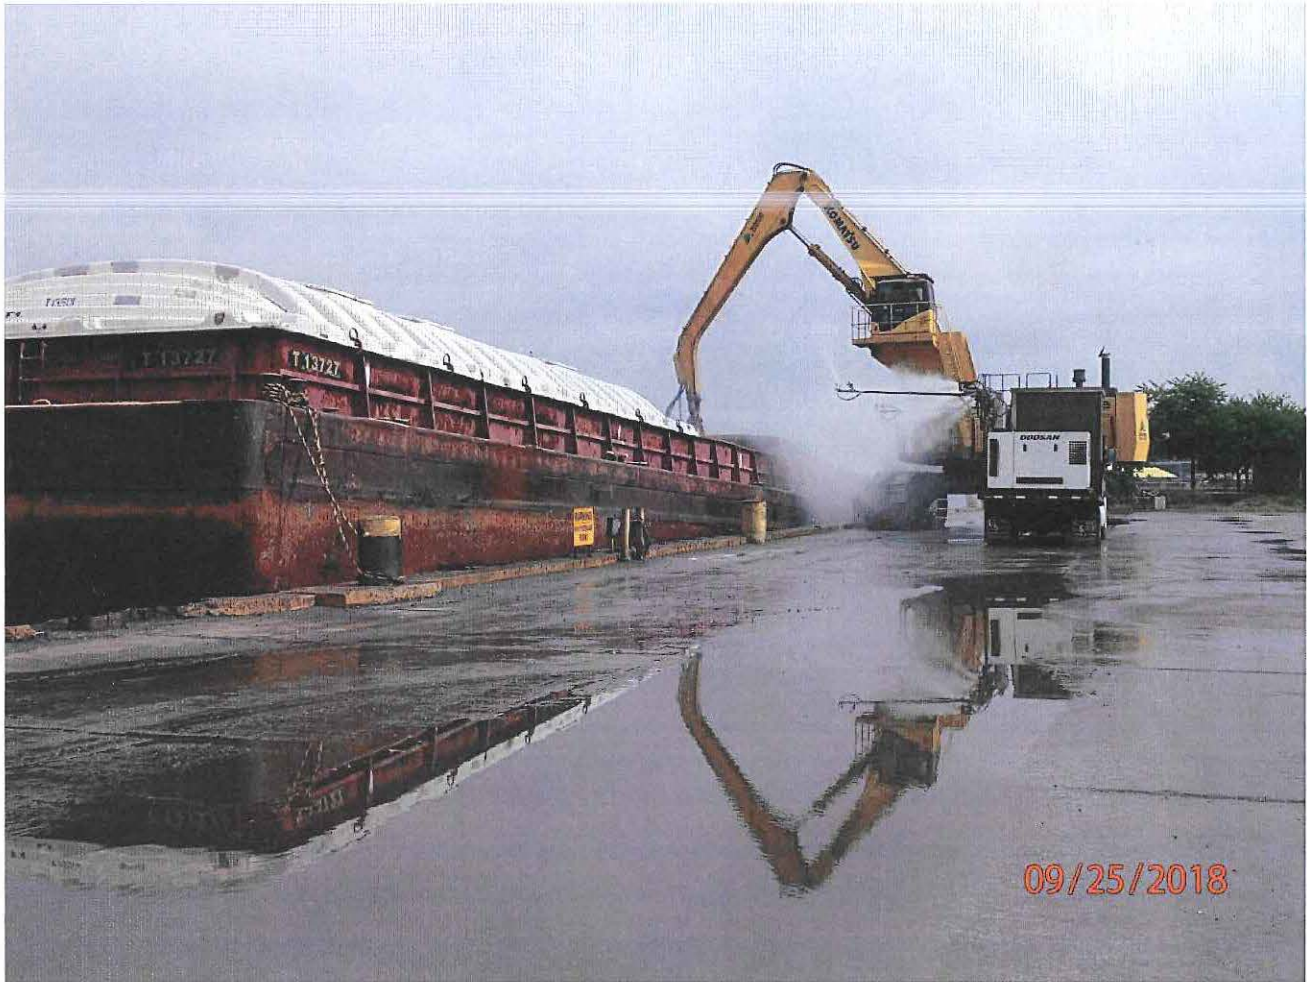
7: P9250007.JPG

Location: Watco Terminal and Port Services
Photographer: Patrick Miller
Date/Time: 9/25/2018 10:09 AM
Camera Direction: Northeast
Description: Excavator for truck transfer from barge to storage location; Fogging system in place around truck

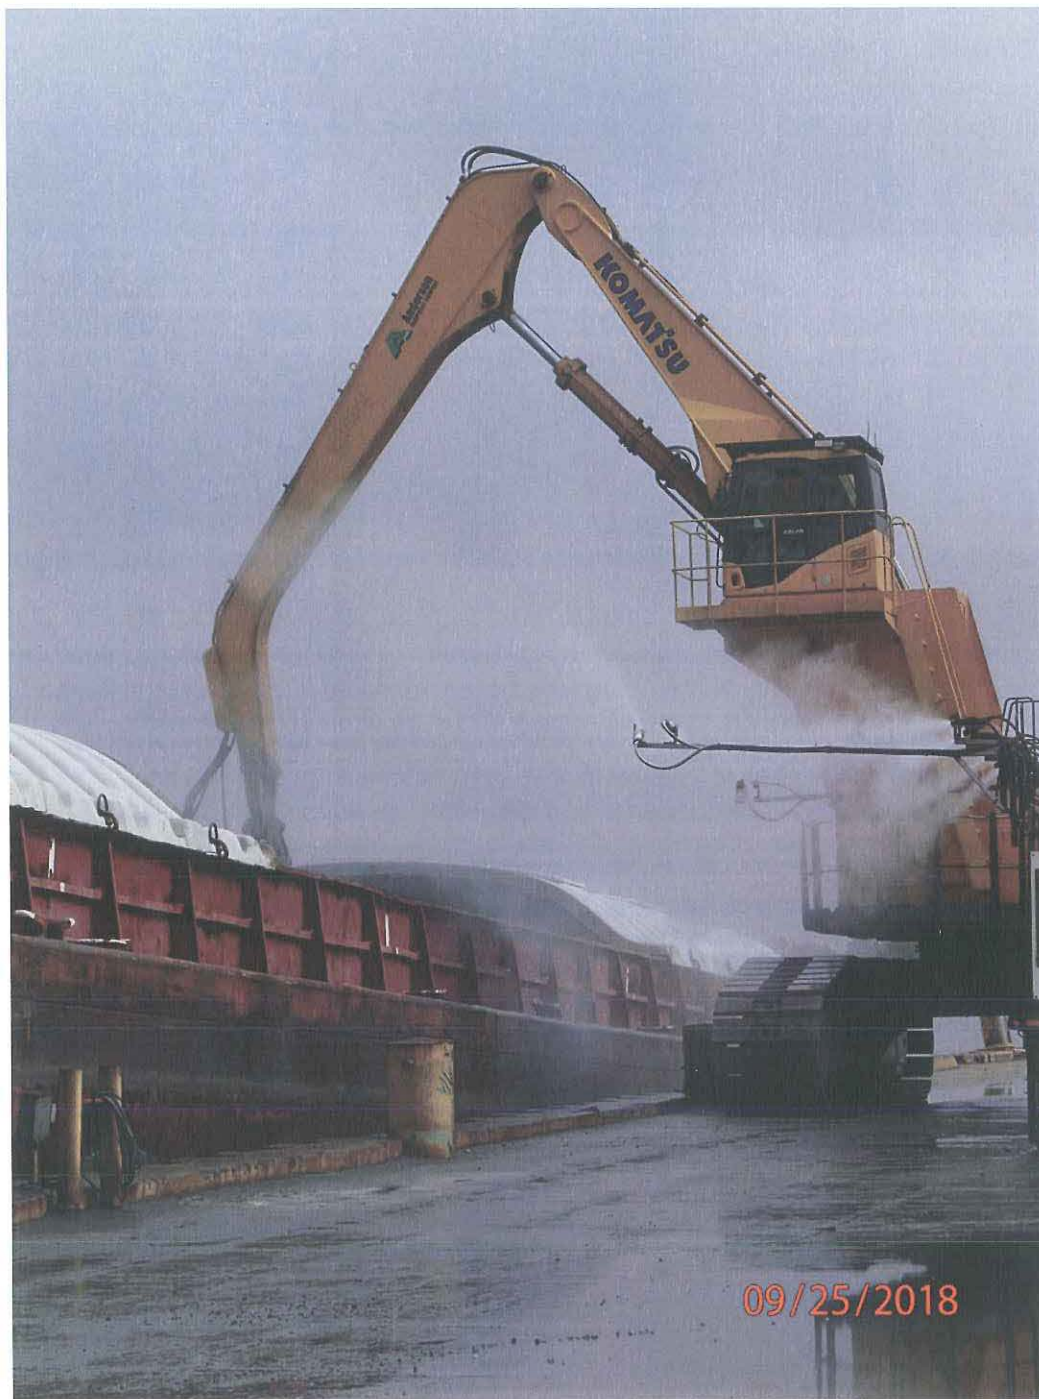
8: P9250008.JPG

Description: Excavator for truck transfer from barge to storage location; Fogging system in place around truck

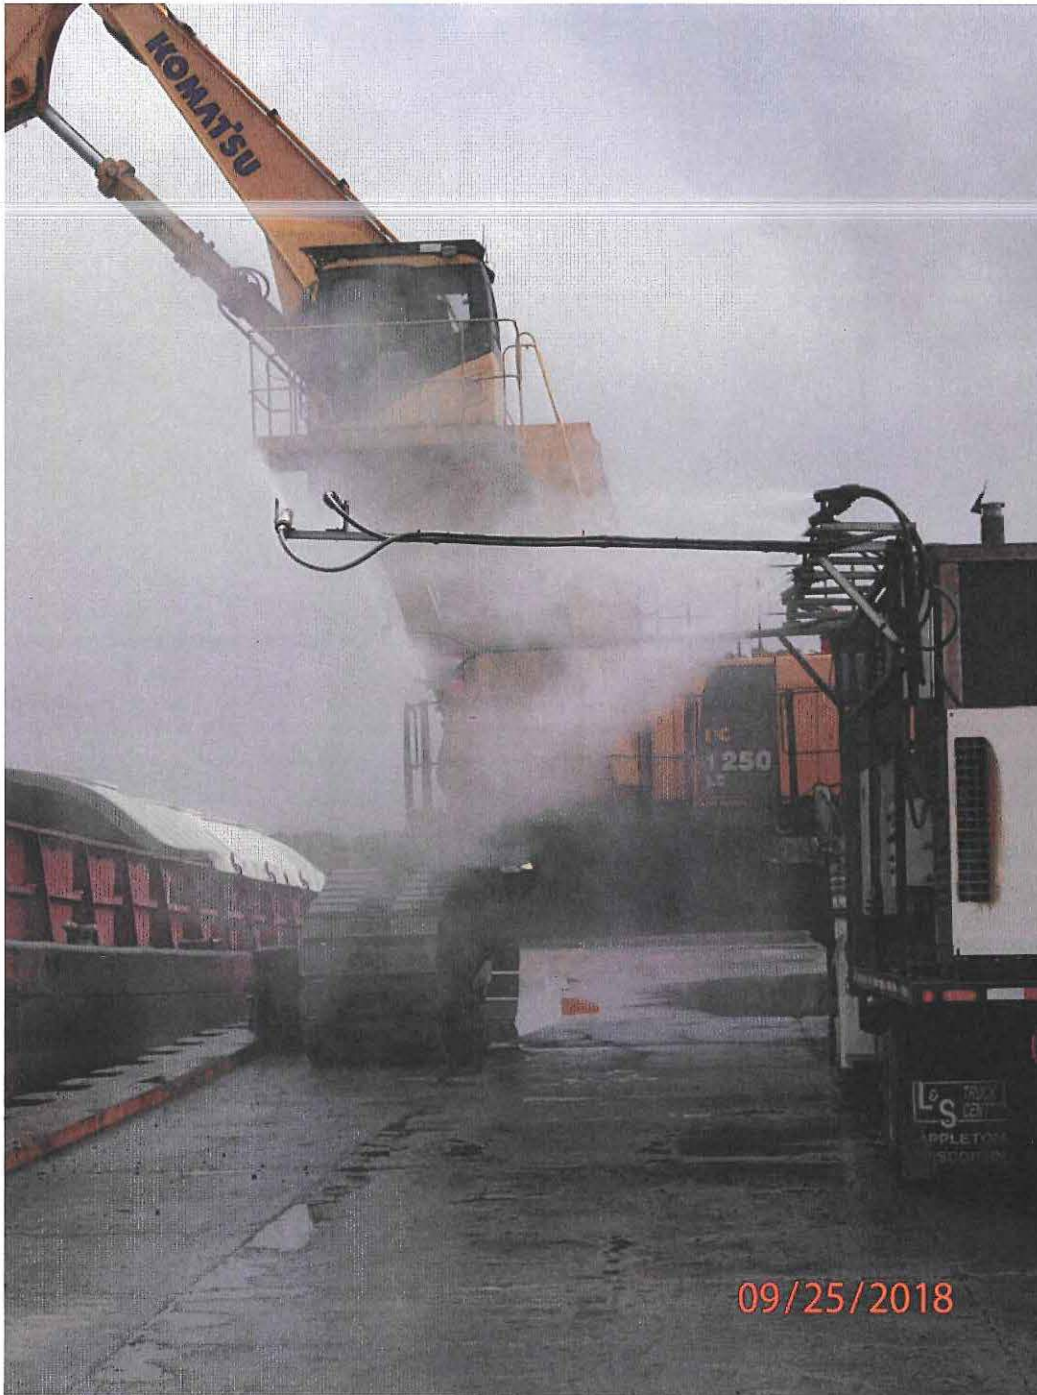
9: P9250009.JPG

Description: Truck transfer from barge to storage location; Fogging system in place around truck

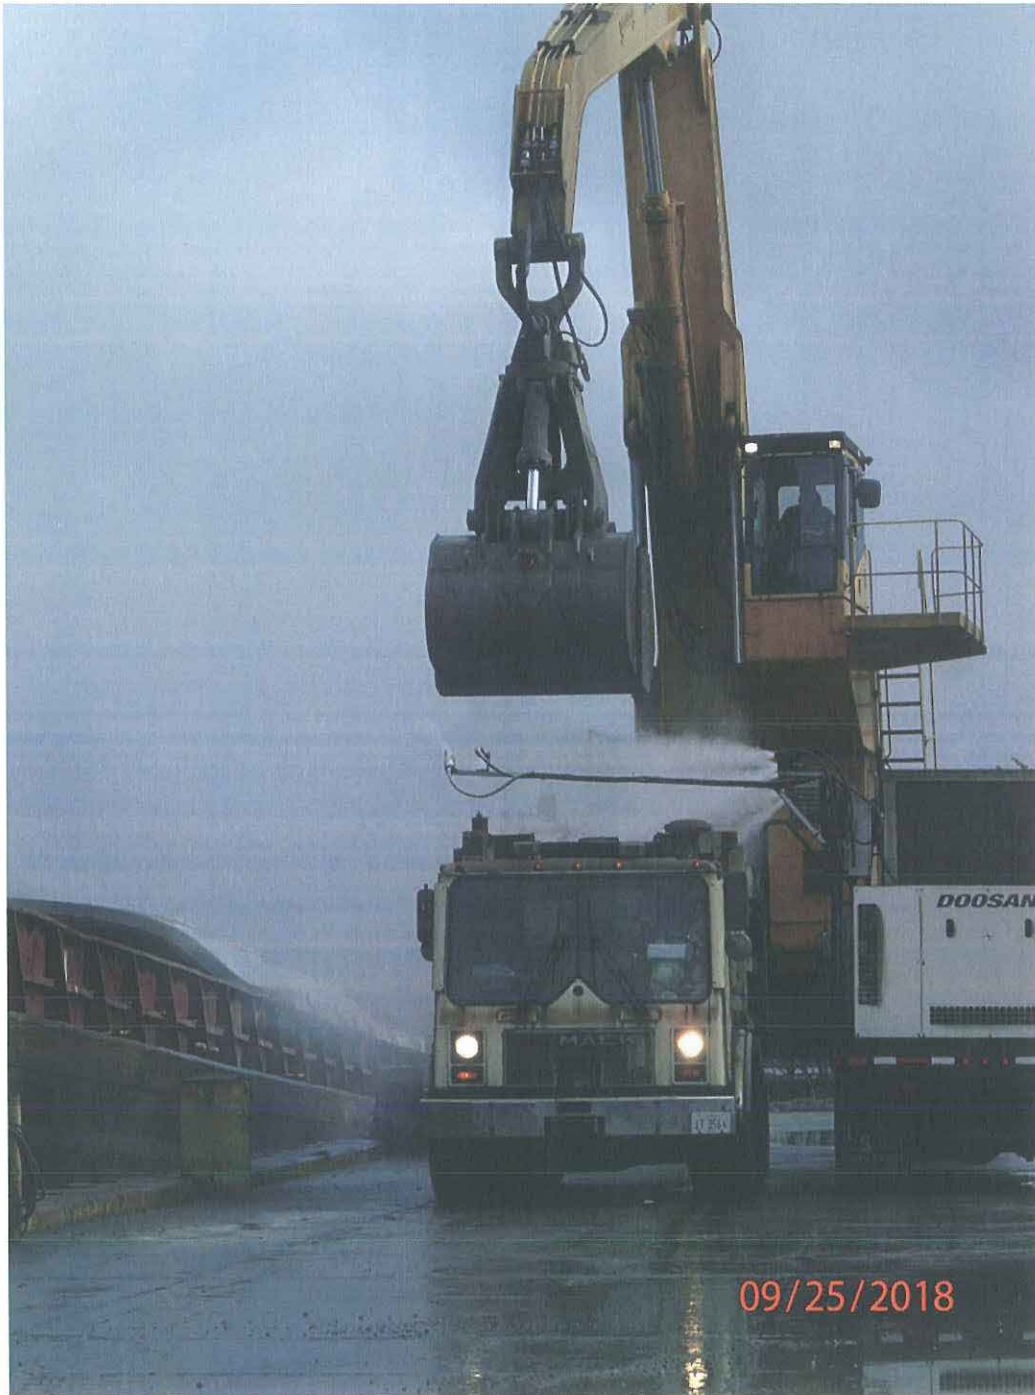
10: P9250010.JPG

Description: Truck transfer from barge to storage location; Fogging system in place around truck

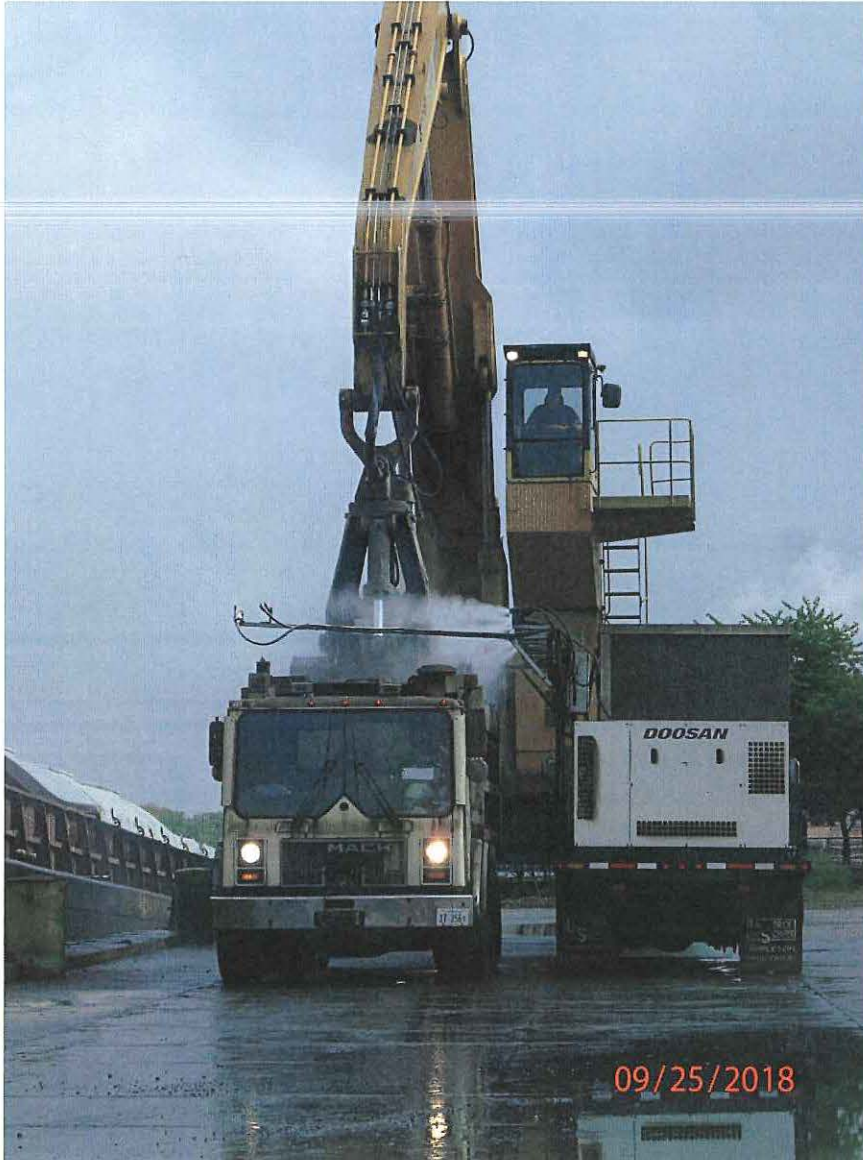
11: P9250011.JPG

Location: Watco Terminal and Port Services
Photographer: Patrick Miller
Date/Time: 9/25/2018 10:11 AM
Camera Direction: Northeast
Description: Truck transfer from barge to storage location; Fogging system in place around truck

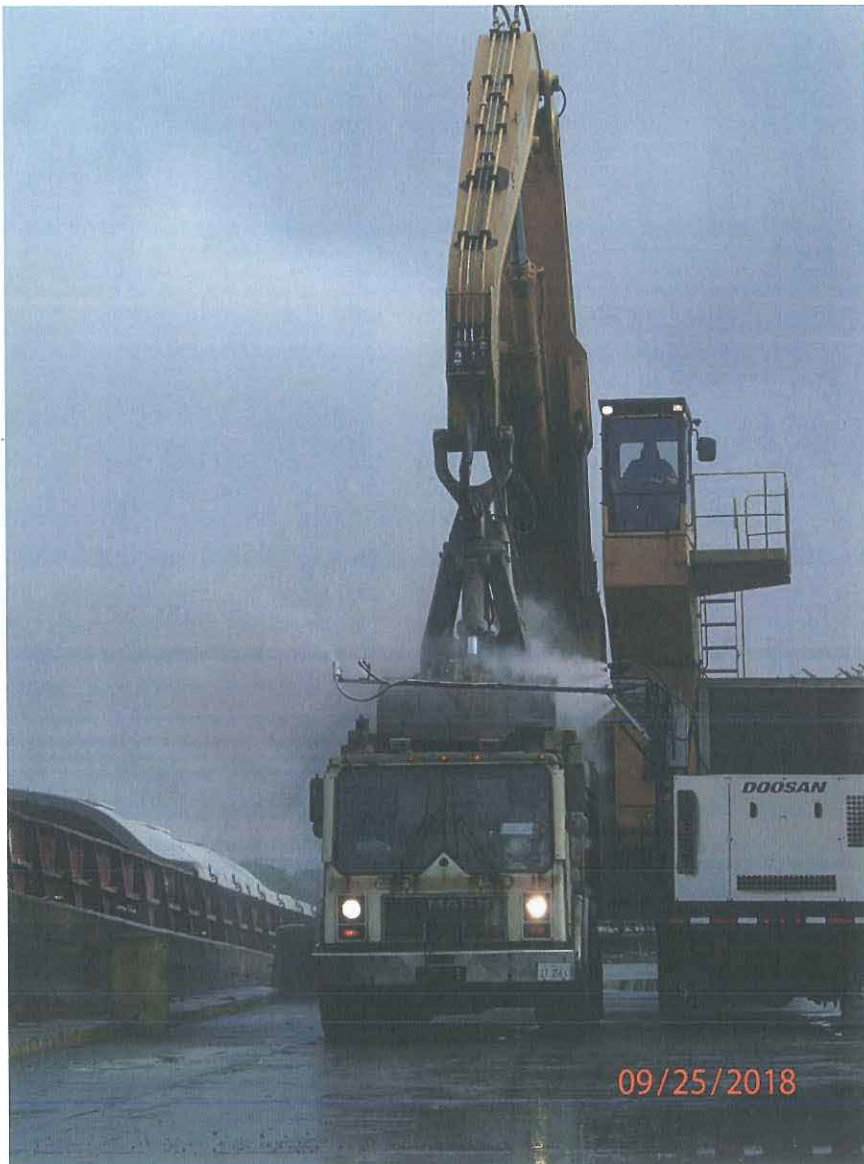
12: P9250012.JPG

Location: Watco Terminal and Port Services
Photographer: Patrick Miller
Date/Time: 9/25/2018 10:11 AM
Camera Direction: Northeast
Description: Truck transfer from barge to storage location; Fogging system in place around truck

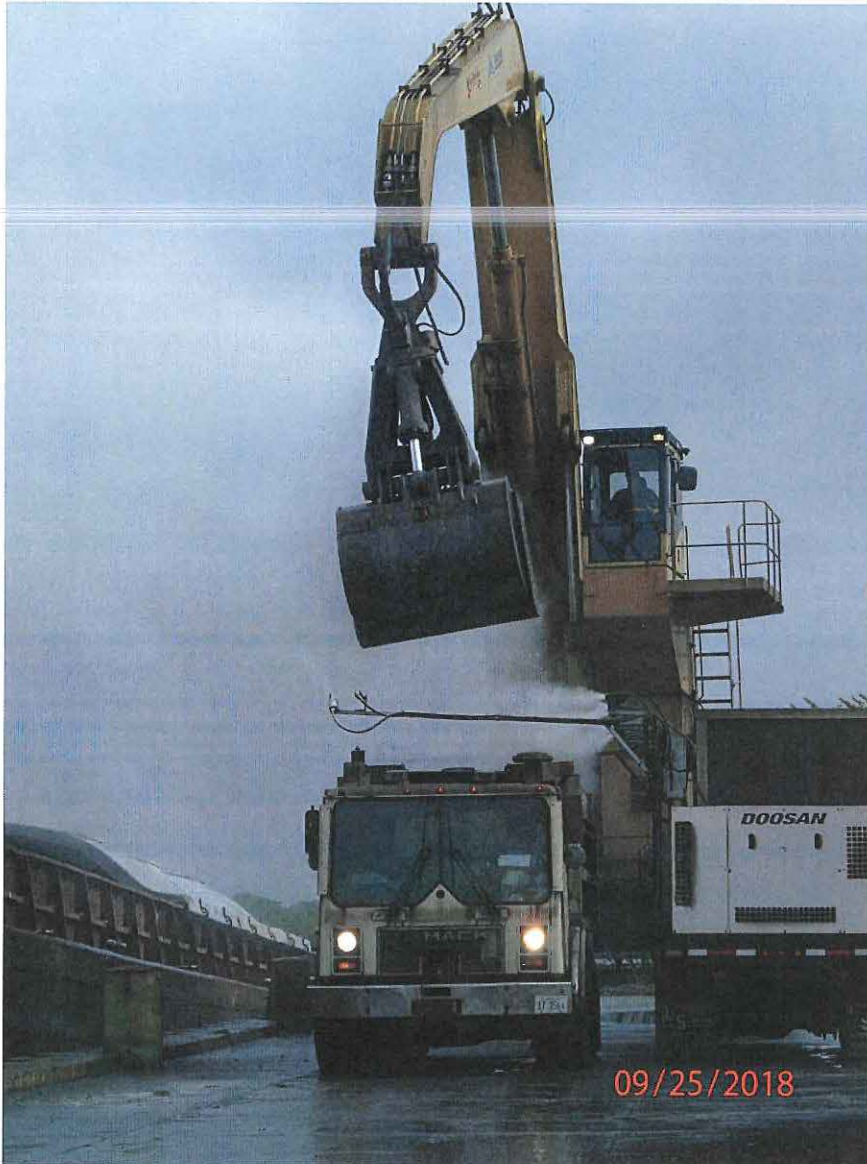
13: P9250013.JPG

Location: Watco Terminal and Port Services
Photographer: Patrick Miller
Date/Time: 9/25/2018 10:11 AM
Camera Direction: Northeast
Description: Truck transfer from barge to storage location; Fogging system in place around truck
