**GOVERNMENT OF THE U.S. VIRGIN ISLANDS
DEPARTMENT OF PLANNING & NATURAL RESOURCES
DIVISION OF ENVIRONMENTAL PROTECTION**

INSPECTION LIST FOR LANDFILL

RE: Anguilla Landfill Inspection Report

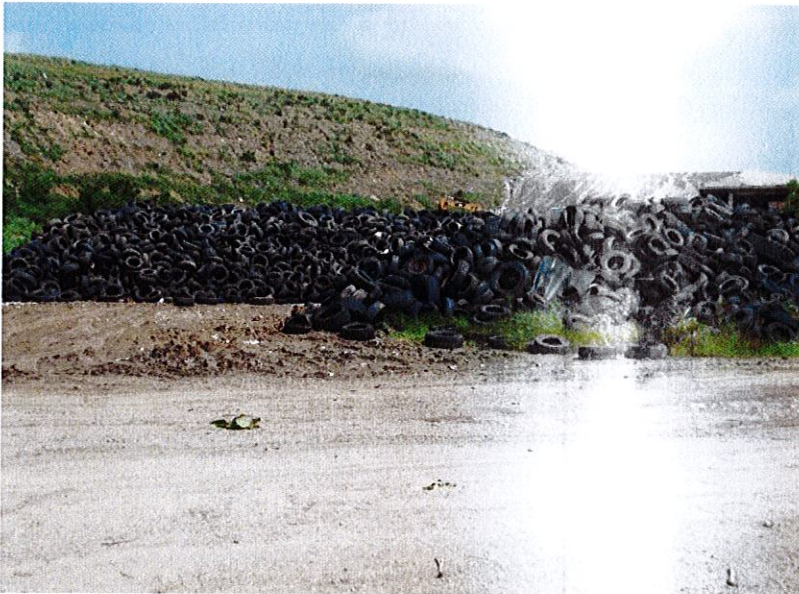
On or about July 7 2010, an inspection was conducted of Anguilla Landfill Tire Storage Area located at Estate Anguilla. The storage site for the tires is located in the section of the landfill that is in close proximity to the Old Abattoir. This storage site is located in a CZM. When it rains water is collected in this area hence, creating swam like conditions.

Site: Anguilla Landfill
Date: July 7, 2010
Photo by: Jason Henry
Description: Stockpile of waste tires.

1. Procure a permit for the storage of waste tires onsite.
2. Store tires in a manner that will not invite the breeding or collection of mosquitoes, flies, fertile animals or rodents, which may prejudice the public health.
3. Provide a tire management plan.

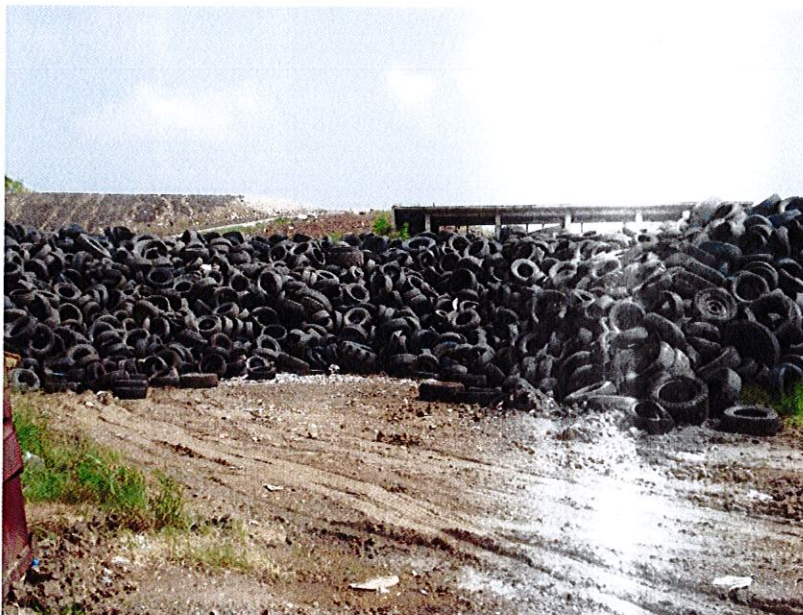
Site: Anguilla Landfill
Date: July 7, 2010
Photo by: Jason Henry
Description: Berm of tires surrounding the old abattoir.

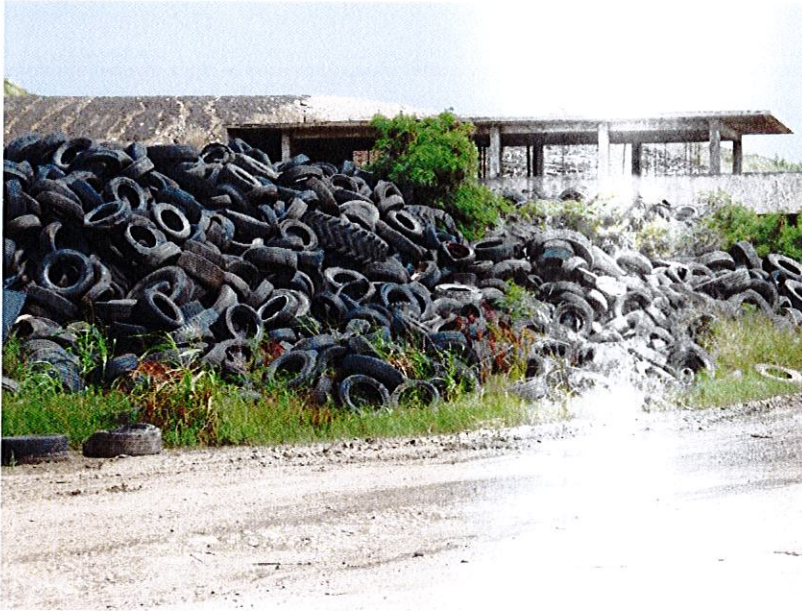
Site: Anguilla Landfill
Date: July 7, 2010
Photo by: Jason Henry
Description: Tires overgrown by vegetation.

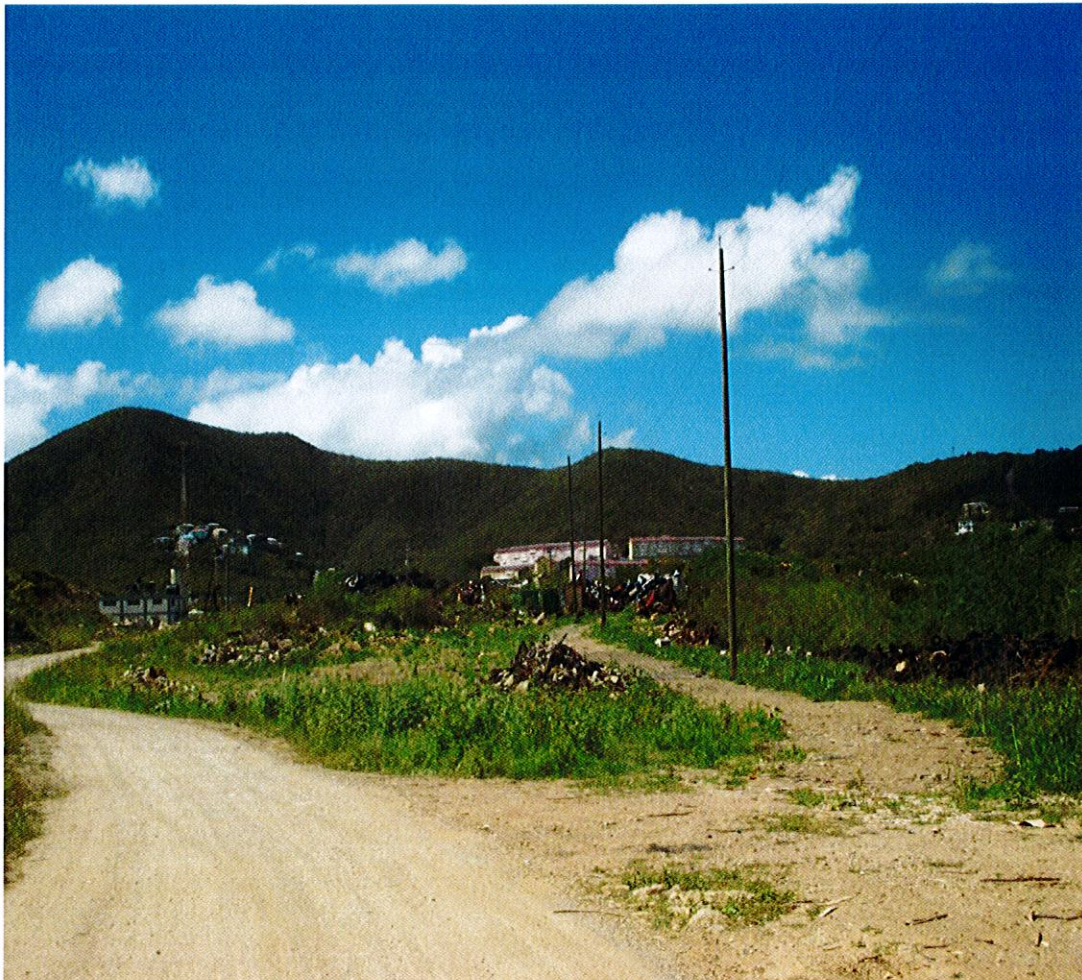
Photograph 2: Additional Air space- Begins 15 ft. in from line of poles toward the left. The new access road will be routed within the 15 feet delineation.

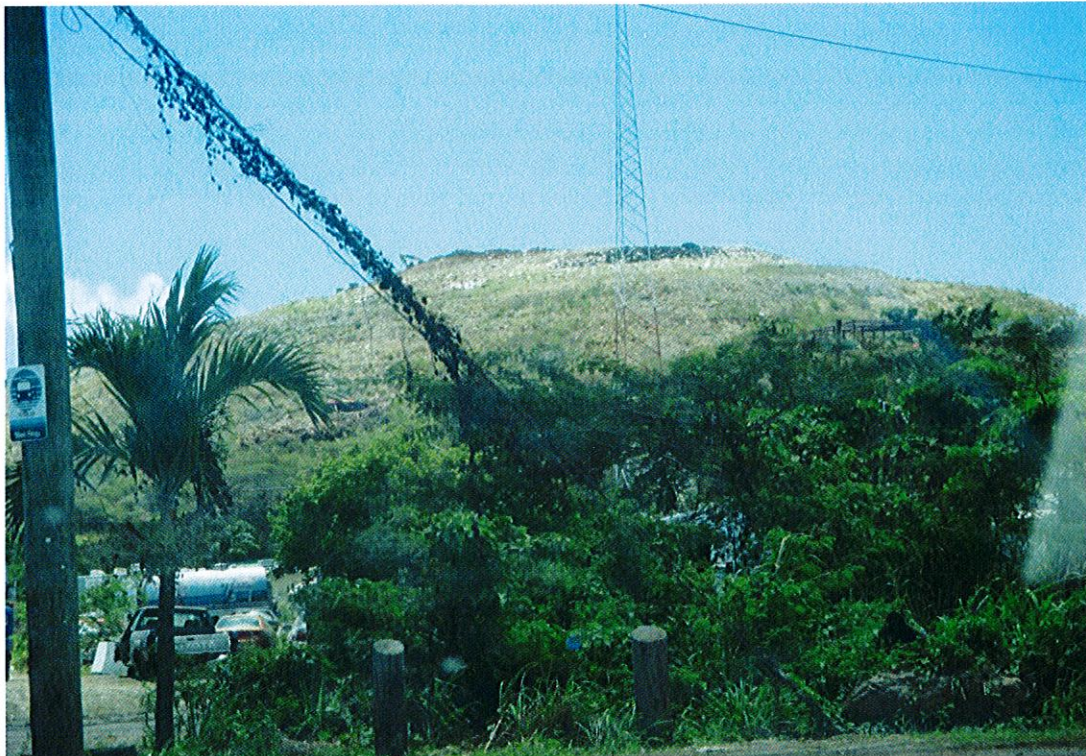
The group proceeded onto the top of the landfill surface. Mr. Ebbesen explained that the current landfill subsurface fire subsided over the years. Since there are no high temperature readings, the fire could have subdued. The elevation of the landfill is now 230 feet above sea level. Mr. Ashby stated that his company is working around the

Photograph 3: The Top of the Landfill Surface – Northern view (elev. 230 ft.)

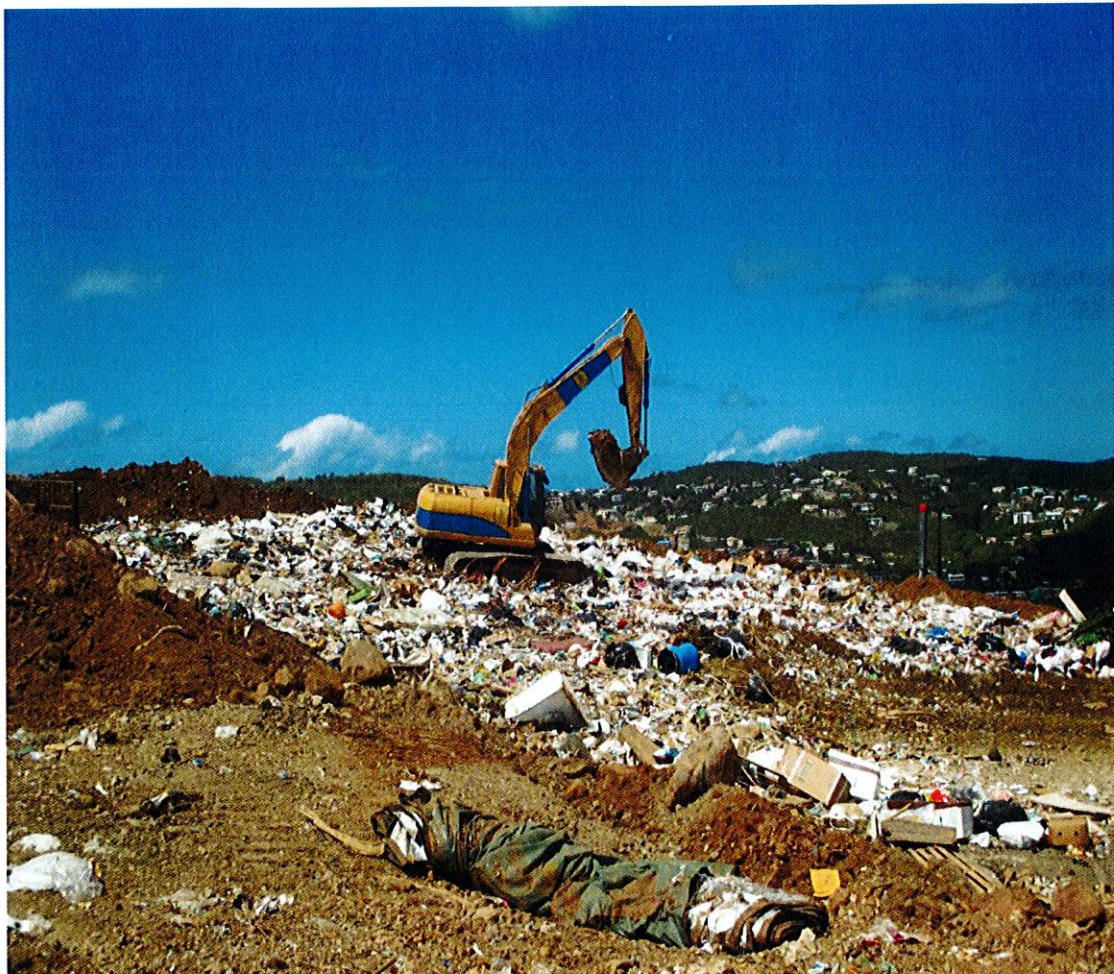
Photograph 6: Top of the landfill surface area

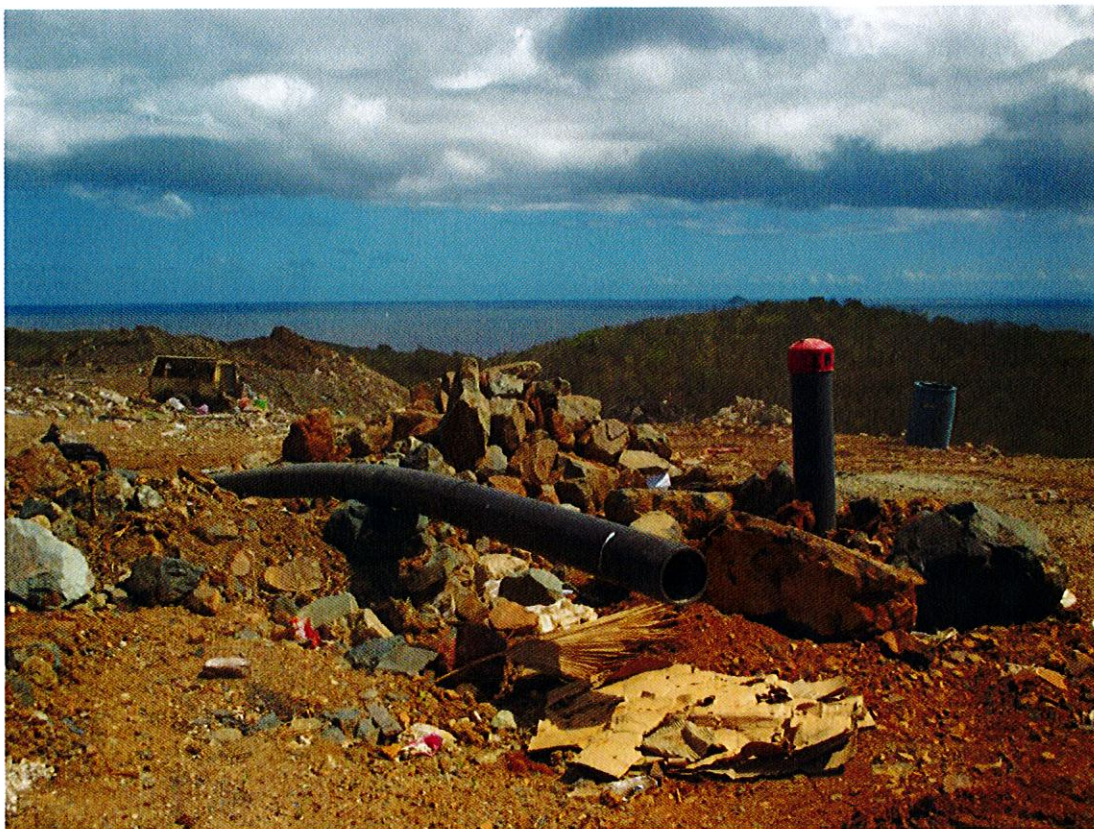
Photograph 7: Monitoring Well that has been capped – Not in use
