# ENVIRONMENTAL COVENANT

**SITE NAME: Reservoir Road (Parcel A2, or Land Unit 5)**

**PROPERTY ADDRESS: 2012-2014 Reservoir Road, Baltimore, Maryland 21219**

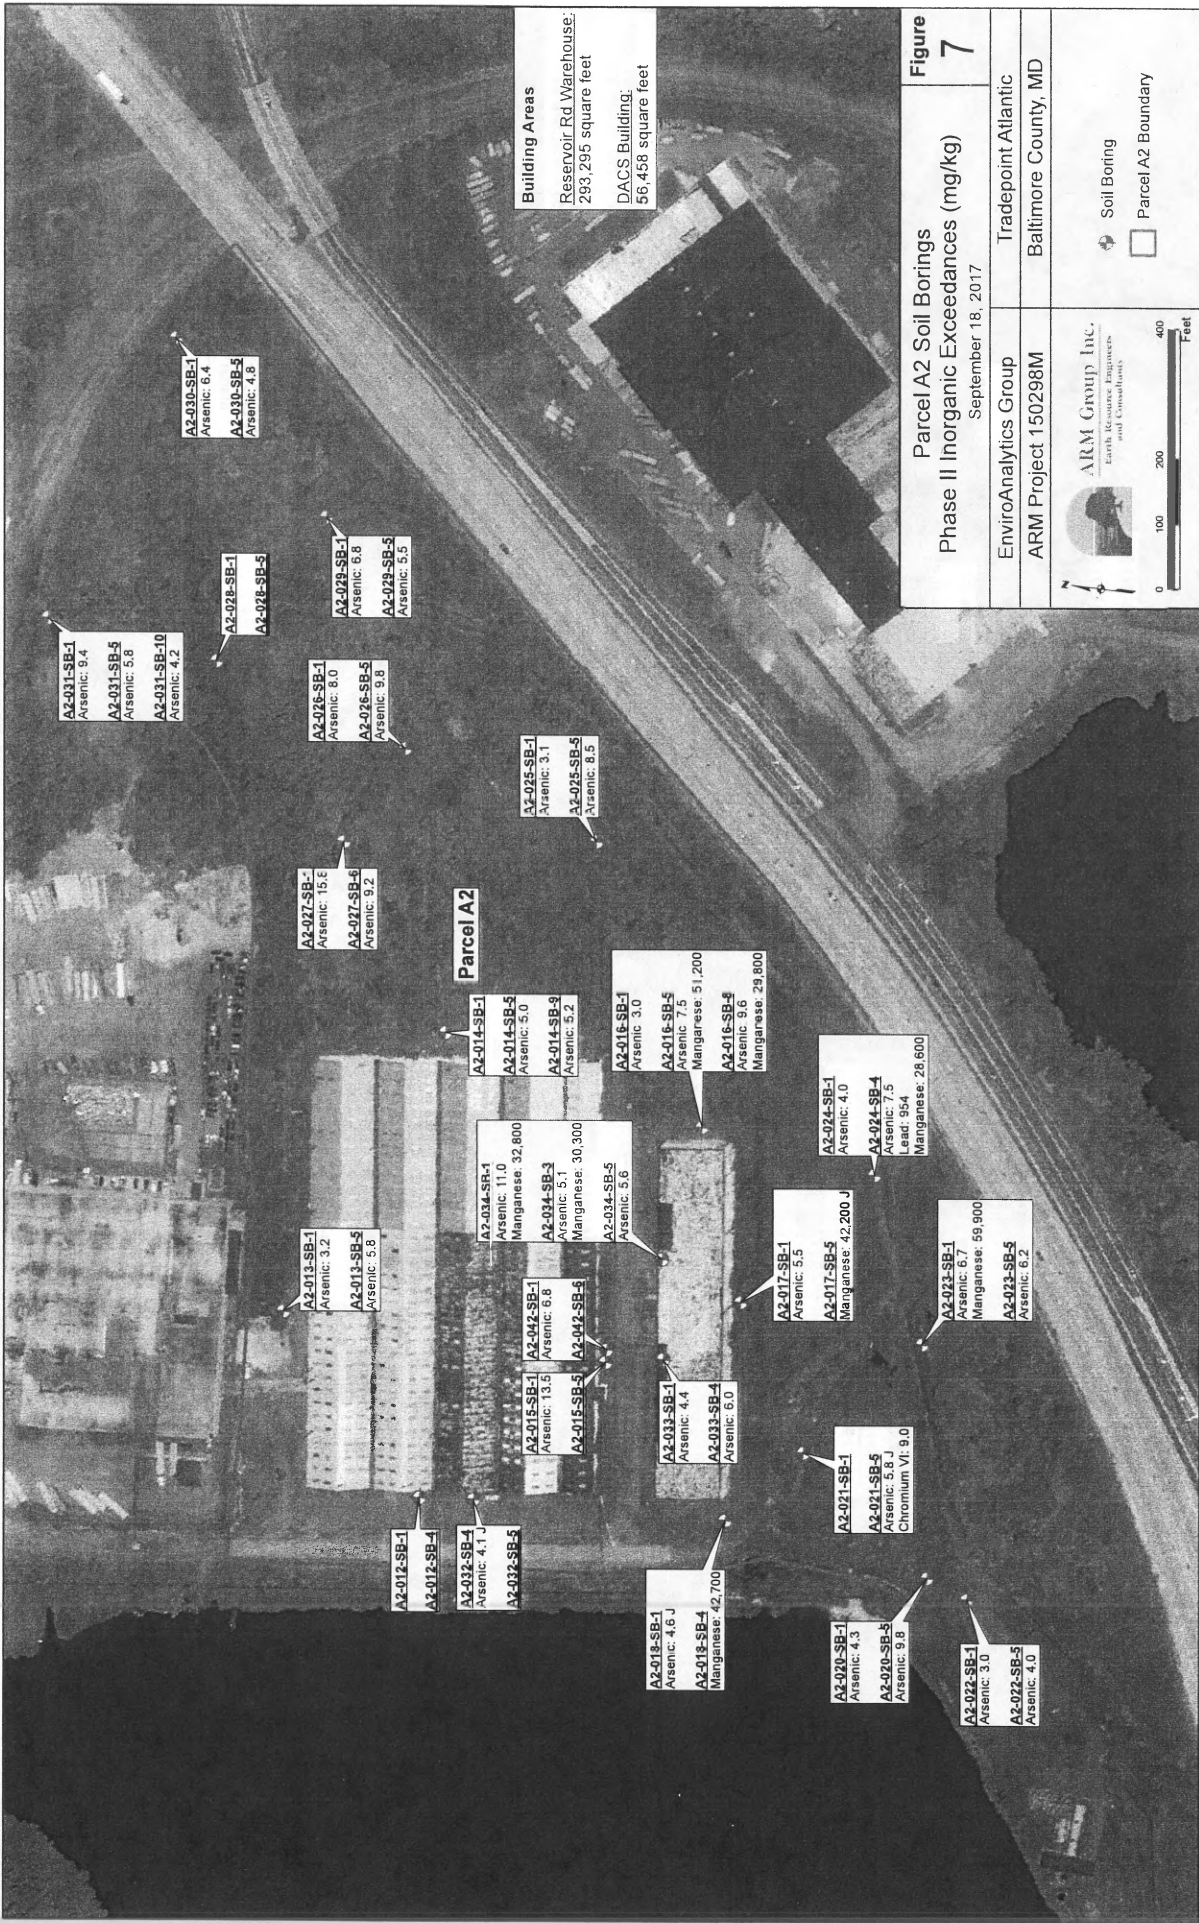
**Figure 7**

A2-020-SB-1  
 Arsenic: 4.3  
 A2-020-SB-5  
 Arsenic: 9.8

A2-022-SB-1  
 Arsenic: 3.0  
 A2-022-SB-5  
 Arsenic: 4.0

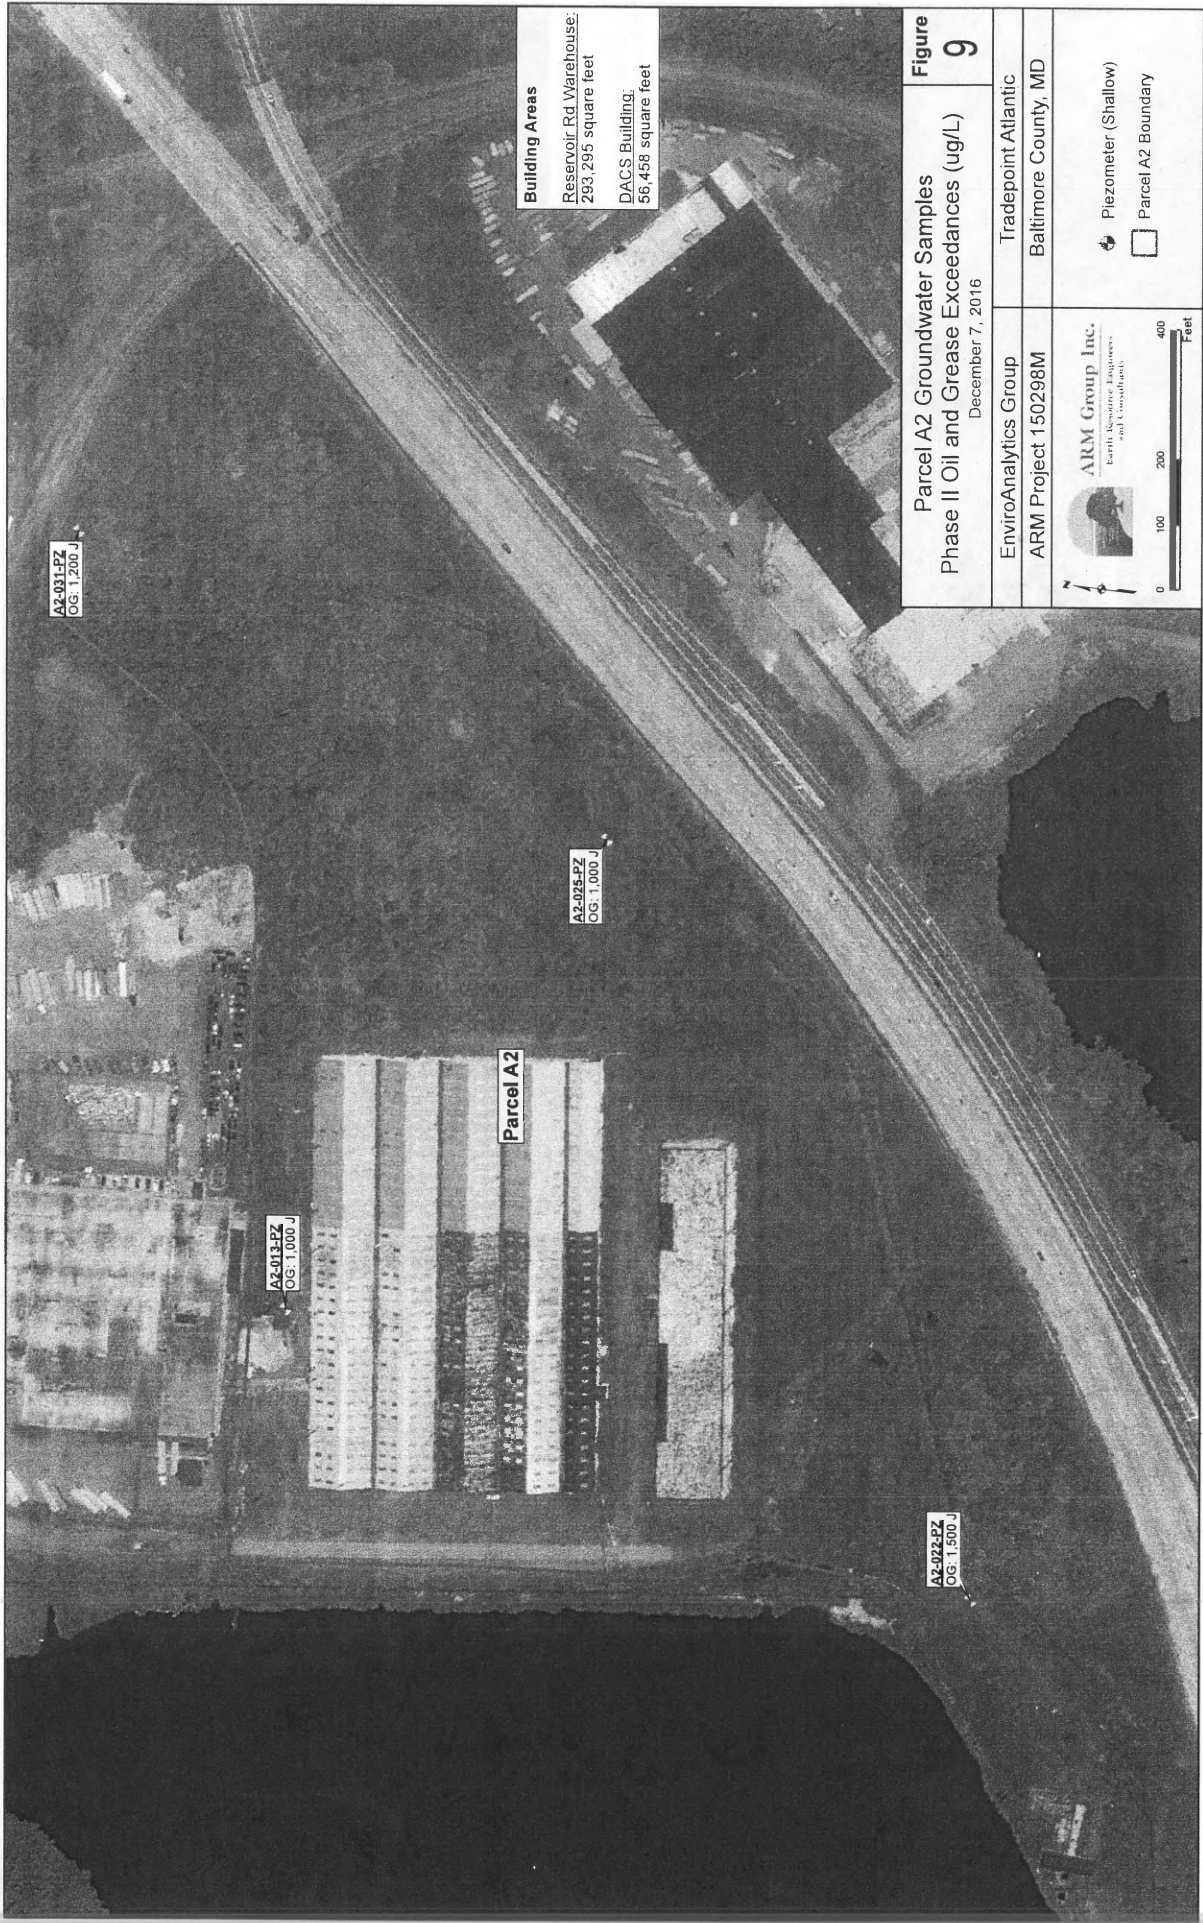
**Figure 9**

A2-013-PZ  
OG: 1,200 J

A2-025-PZ  
OG: 1,000 J
