# GPS Was Here

Tracking Monitoring Events and Path

Optical Gas Imaging Stakeholder Workshop

## Value of GPS in Leak Detection & Repair (LDAR) Programs

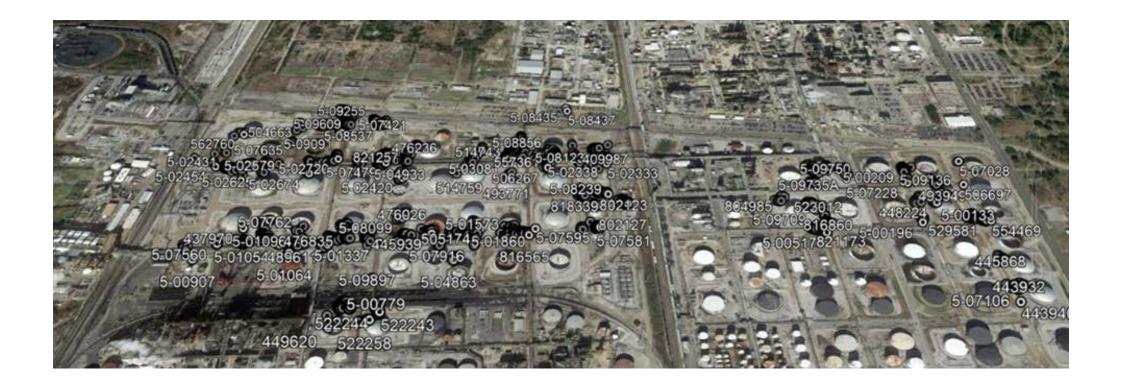
### Exemplar Use of GPS – Plotting Monitoring Events

#### Plotting monitoring event locations for components

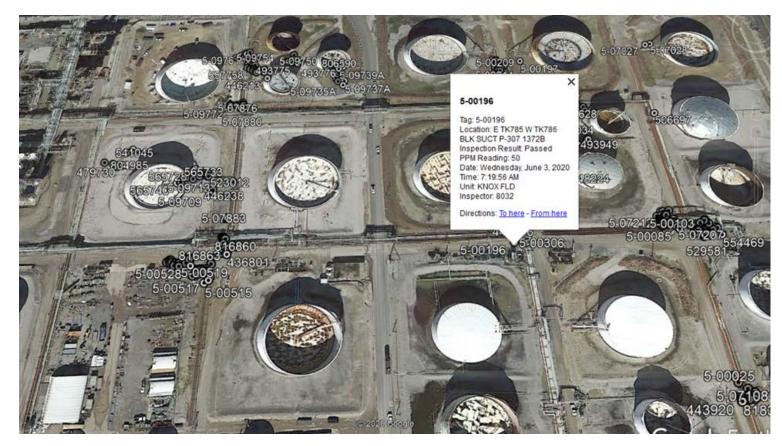
### Exemplar Use of GPS – Detailed Information for Monitoring

Plot at closer resolution – each point has the ability to pull up the regulated components monitoring event data including tag #, location, date/time, and monitoring results from the database system

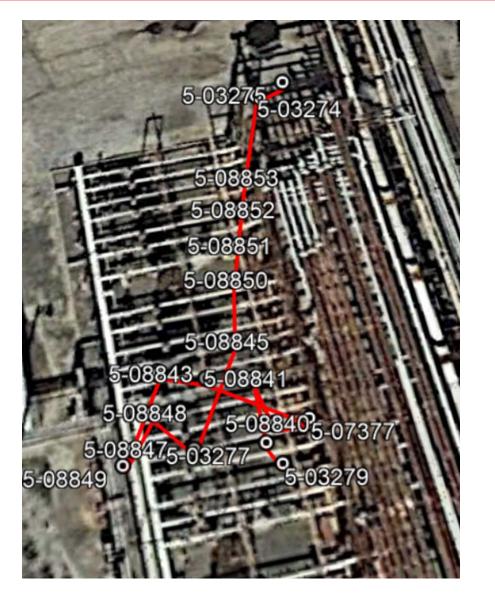
### Exemplar Use of GPS – Plot Monitoring Routes/Movement

Plot of actual route (in time sequence order) of monitoring events
