# EPA Region 8 Drinking Water Unit Tech Tips

## Simple Fixes for Wellheads

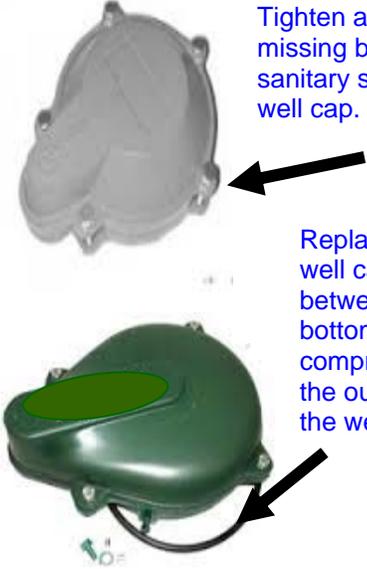
### WELL CAP

Tighten and replace any missing bolts to ensure a proper sanitary seal is created by the well cap.

Replace any damaged well cap gaskets between the top and bottom plate and/or the compression seals on the outside diameter of the well casing.

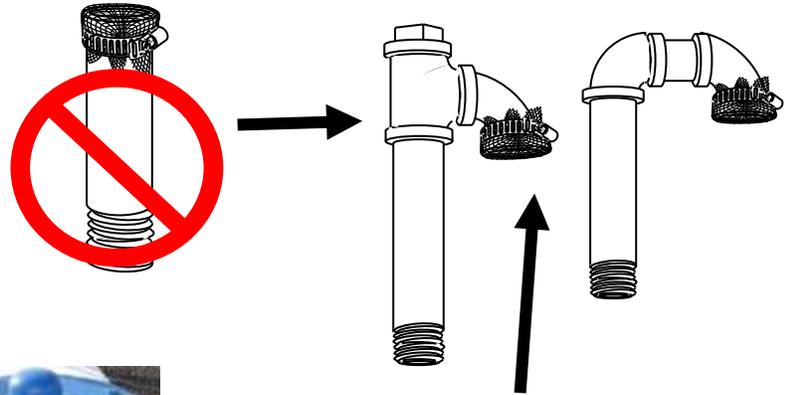
### WELL VENTS

Well vents (if applicable) must be at least as high as the well casing or pitless adapter. Replace straight, open well vents with inverted screened vents such as those below. Use non-corrodible 24-mesh screen on all configurations of well vents to exclude insects, rodents and other small animals.

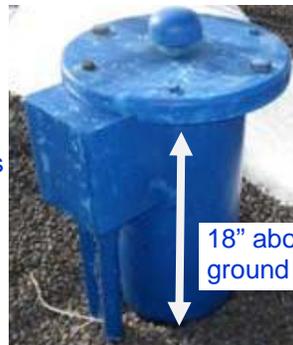
### WELL HEIGHT

Permanent casing for all groundwater wells must project at least:

- 12 inches above the concrete floor; or
- 18 inches above natural ground surface.

18" above natural ground level

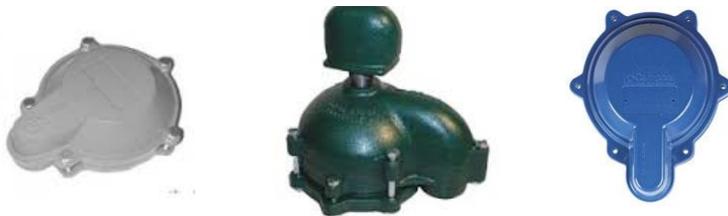
### PROPERLY DESIGNED WELL CAPS & SANITARY SEALS

Replace damaged or non-watertight well caps with vermin-proof, premium watertight wellhead caps. Vented caps must use #24-mesh screen.

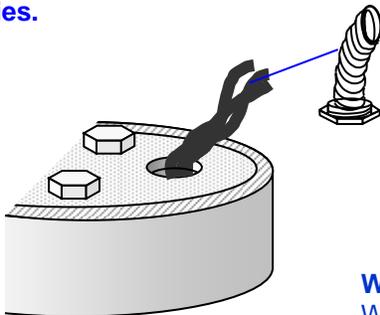
Replace damaged seal and repair well casing. Repairs must be durable and watertight. Silicone is not an acceptable permanent fix for any well opening deficiencies.
