Case Study for Well Integrity over a Full Life Cycle

Lloyd H. Hetrick, PE, CSP
Newfield Exploration Company

Abstract

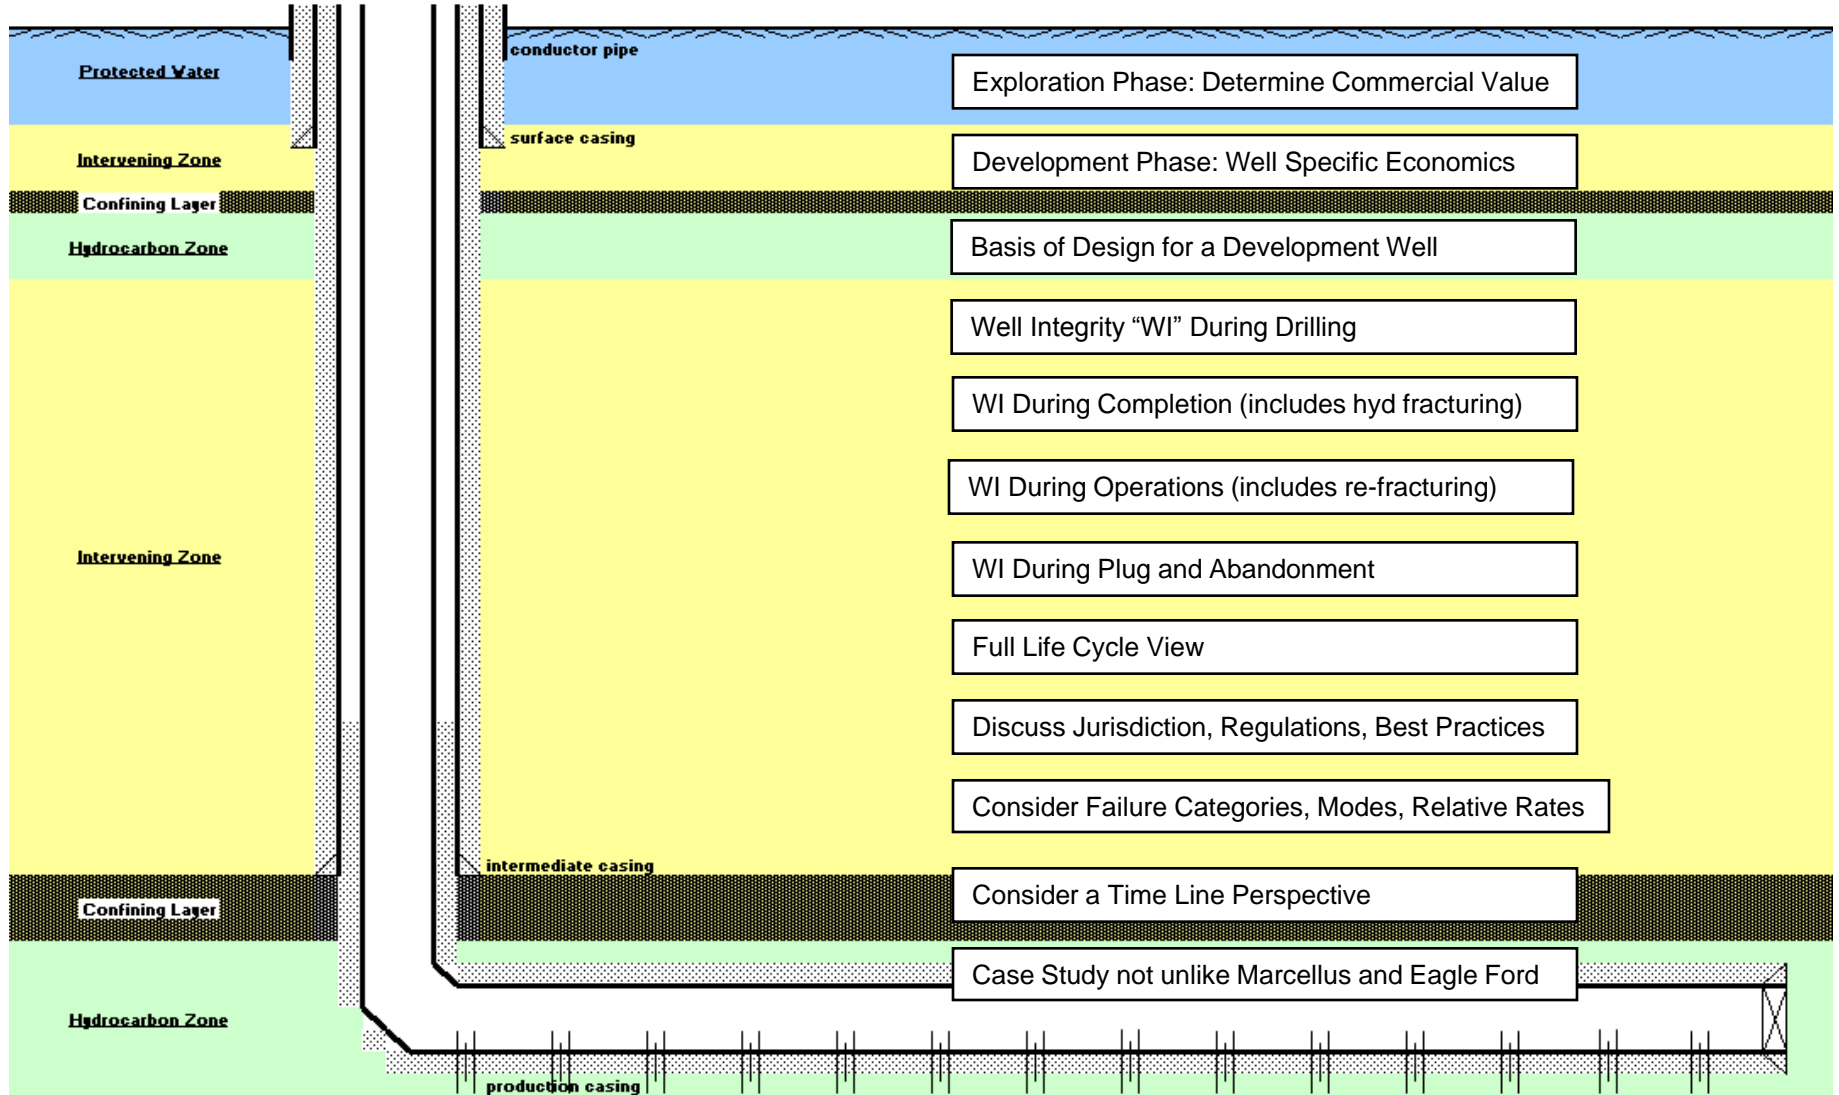
Slide 1 of 22 – Well Integrity Narrowly Defined as the Prevention of Fluids Migration into Protected Water

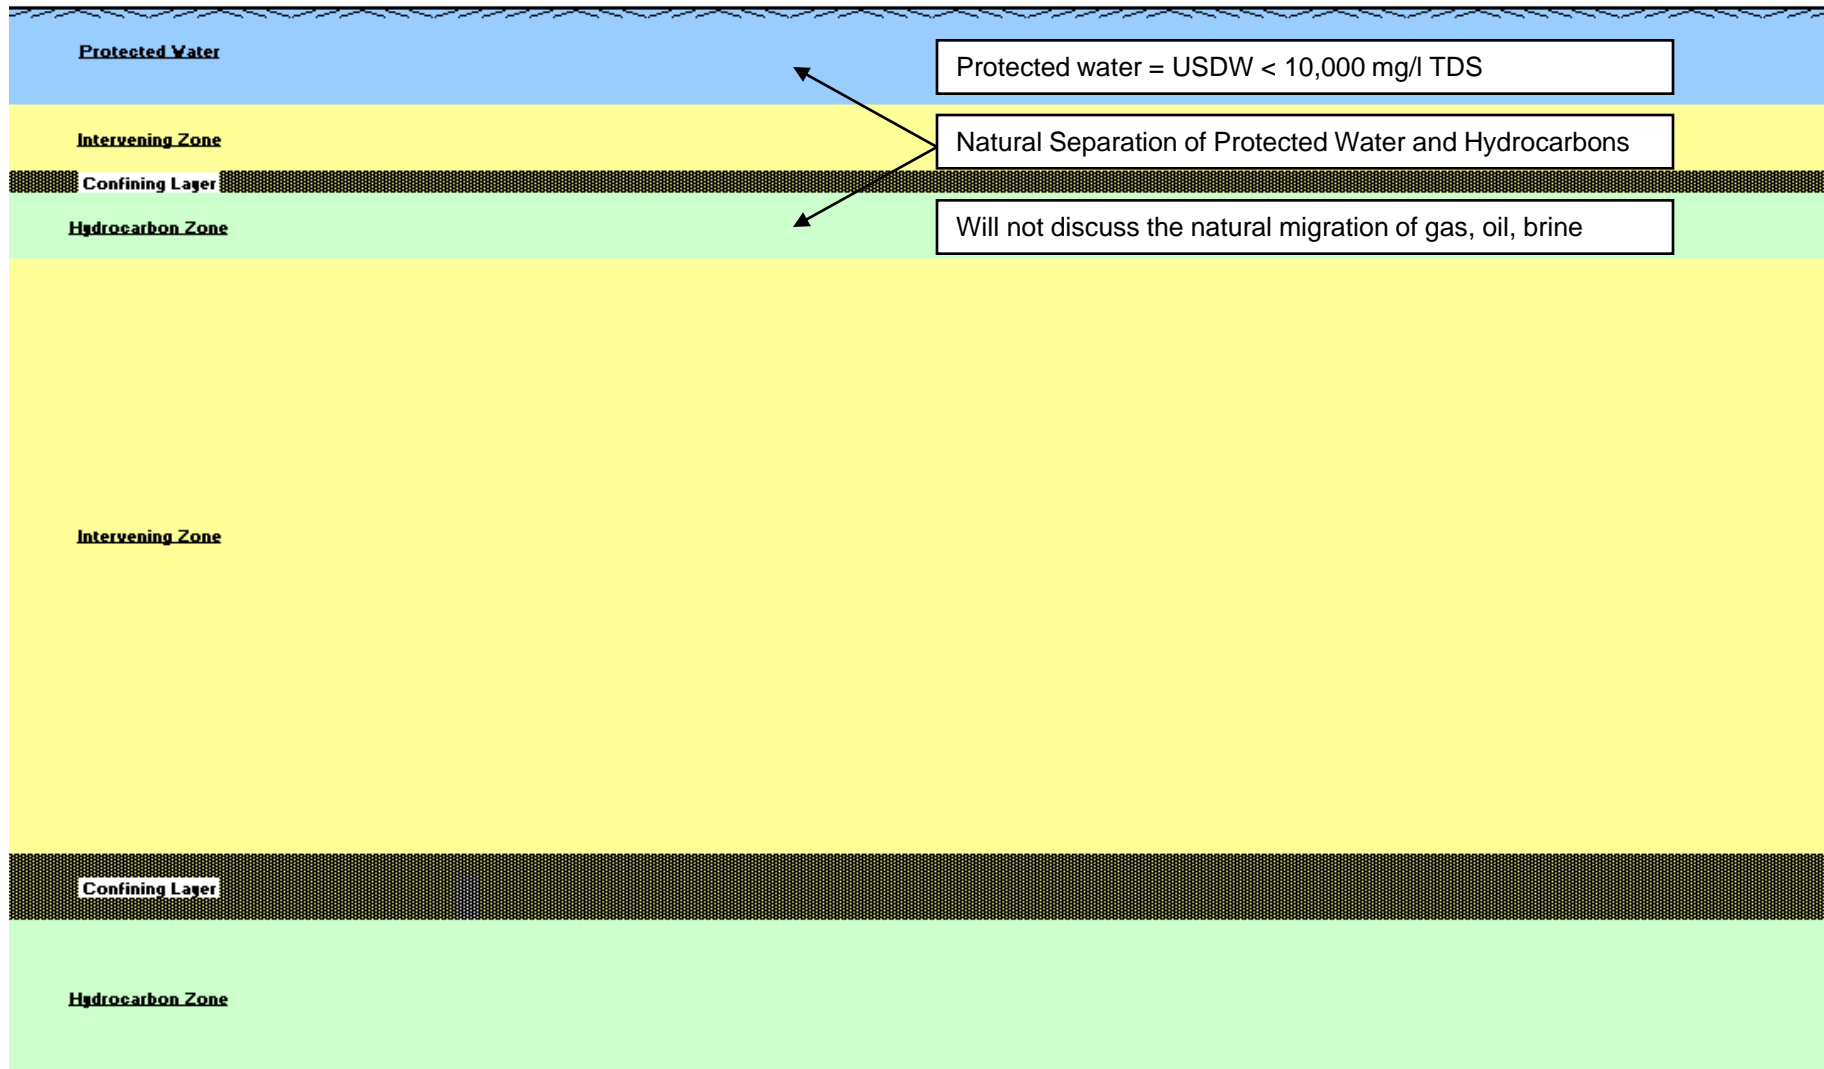
Slide 3 of 22 – Natural Separation of Protected Water and Hydrocarbons, in most cases

Protected water and hydrocarbons have natural separation (5) in most situations. There are however, areas of the country where methane is routinely found to exist naturally in USDWs (6) (7) and has been associated with bubbles in rivers as early as the mid 1800s (8). There are also locations where methane vents to the surface via natural pathways having nothing to do with oil and gas extraction activities (9) (10). It has been estimated from a review of Pennsylvania regulatory records that over 95% of the complaints that oil and gas activities had contaminated private water wells were actually due to preexisting or other land use activities (11). These naturally occurring migrations are not limited to methane, as towns named Oil Springs, KY (12) Oil Springs, Ontario (13) and historical sites such as Seneca Oil Spring, NY (14) and Brine Springs, TX (15) all attest that oil and brine have been observed migrating to the surface dating back to the 1600’s.

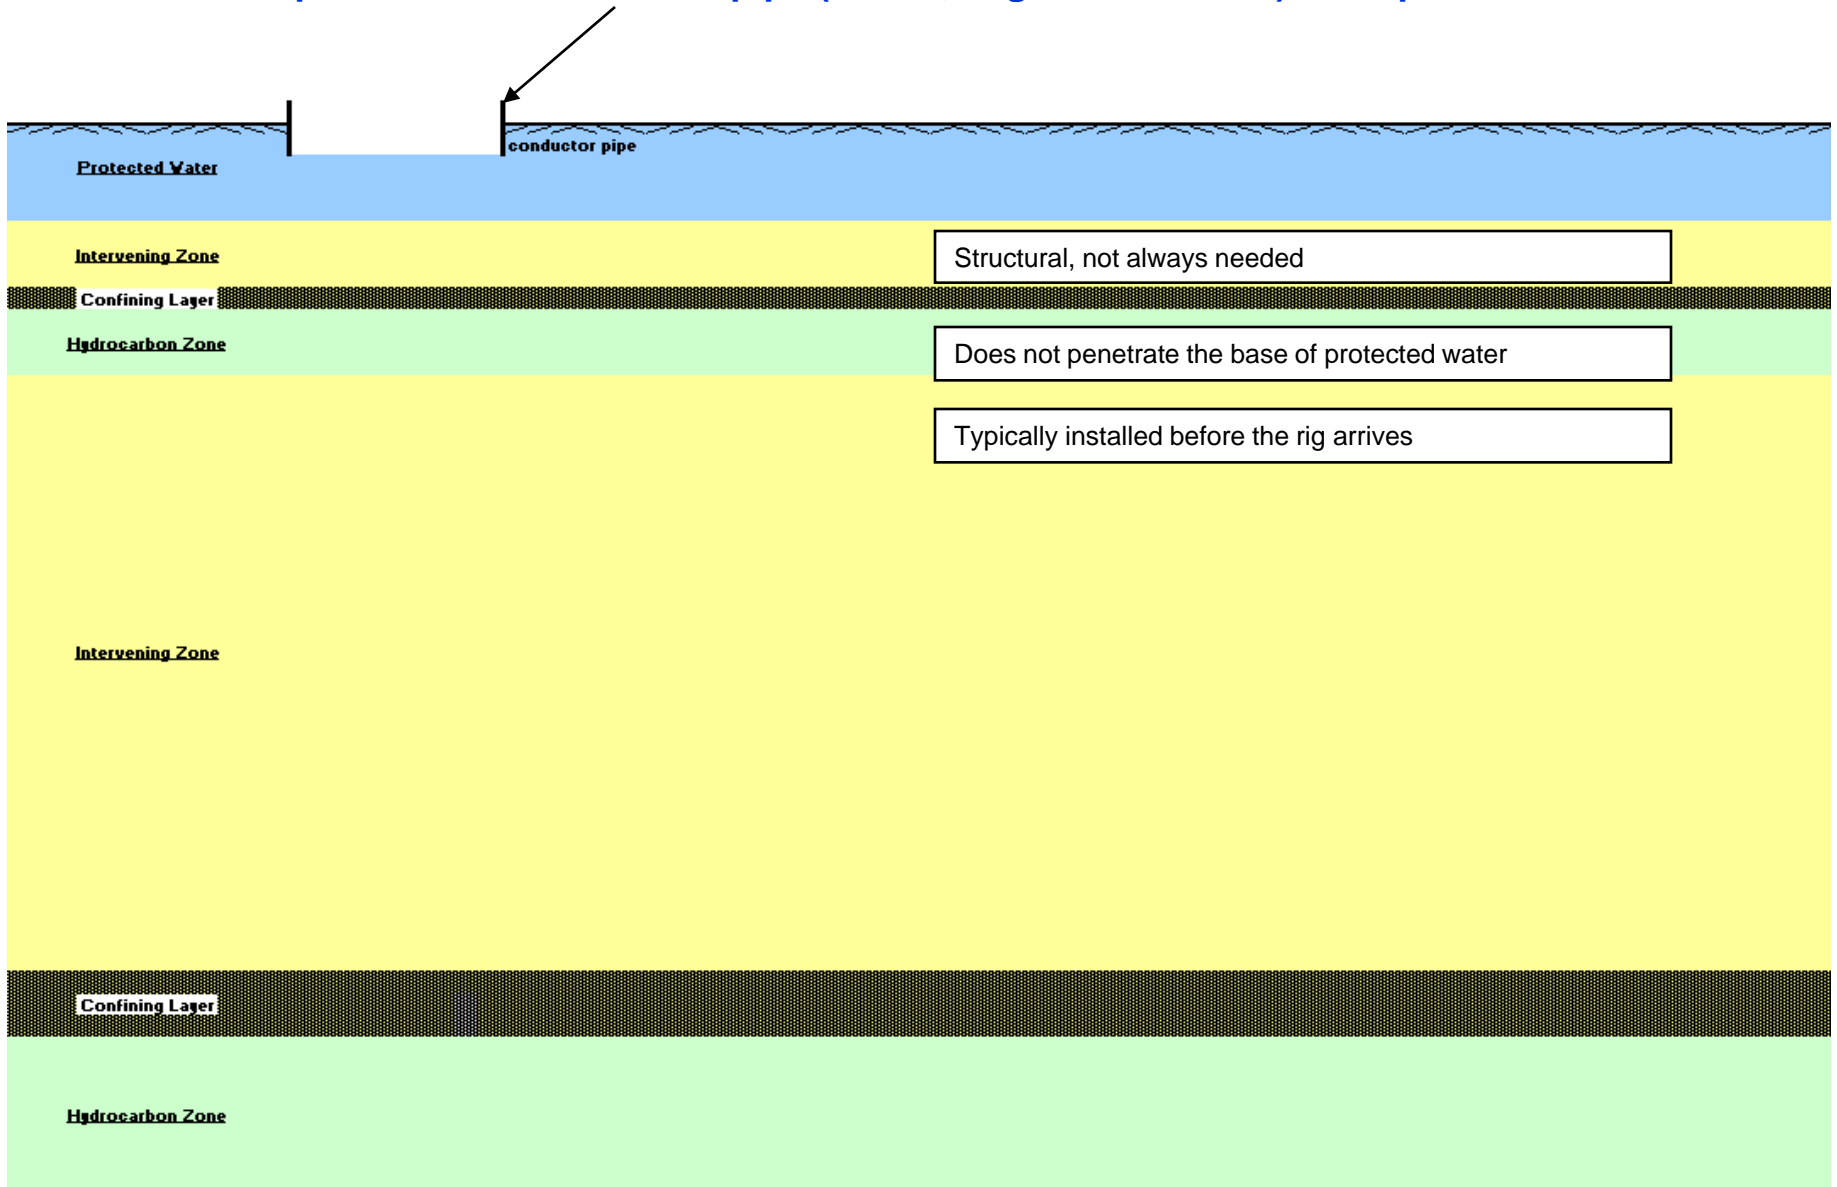
Slide 4 of 22 – Spud well with conductor pipe (driven, augered or drilled) no impact on Protected Water

A typical onshore well is spud with a conductor pipe that is driven, drilled, or augered into the ground by a construction crew or “spud rig” prior to the drilling rig’s arrival. This conductor pipe is a structural component that sometimes is not needed at all. Conductor pipe most often does not reach the top and does not penetrate the base of protected water; therefore it is not involved in protecting USDWs from vertical migration of fluids. Accordingly, failure categories for the conductor pipe will not be discussed.

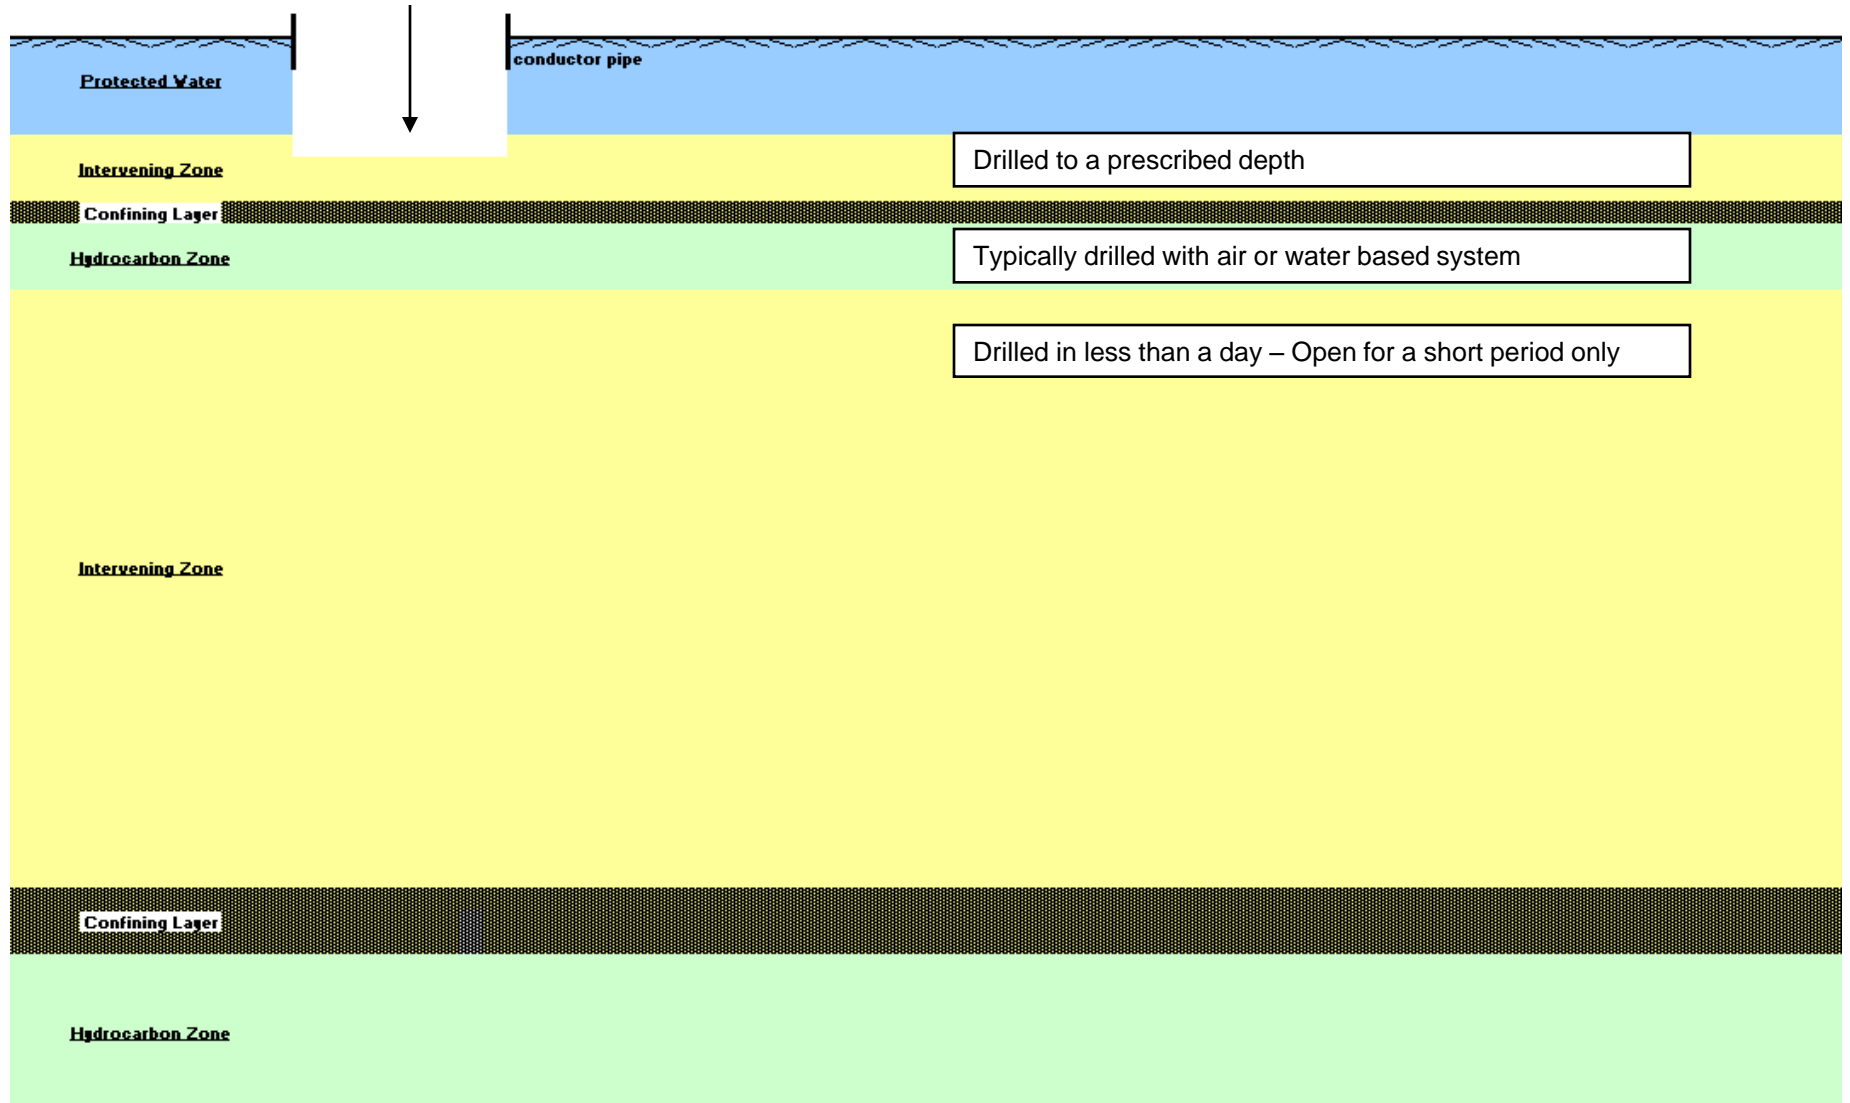
Slide 5 of 22 – Well is drilled to a prescribed depth below Protected Water

The surface hole is drilled to a prescribed depth below the base of protected water. This depth is most often provided by the State Oil and Gas Regulator as in Oklahoma (16), or the State Environmental Protection Regulator as in Texas (17), or not specifically provided other than to protect all USDWs encountered as in Pennsylvania (18). In this latter situation, oil and gas operators typically research a Pennsylvania Groundwater Information System “PaGWIS” database and local water well driller’s records to generate a hydro geological map in order to determine depths of water that need to be protected.

The surface hole is not left open for more than a few hours while being drilled, cased, and then cemented back to surface. Those zones left open during this brief period are all USDWs, so vertical migration of fluids does not present a significant threat during surface hole drilling. The surface hole on our case study well is drilled in a few hours on the first day of the drilling operation.

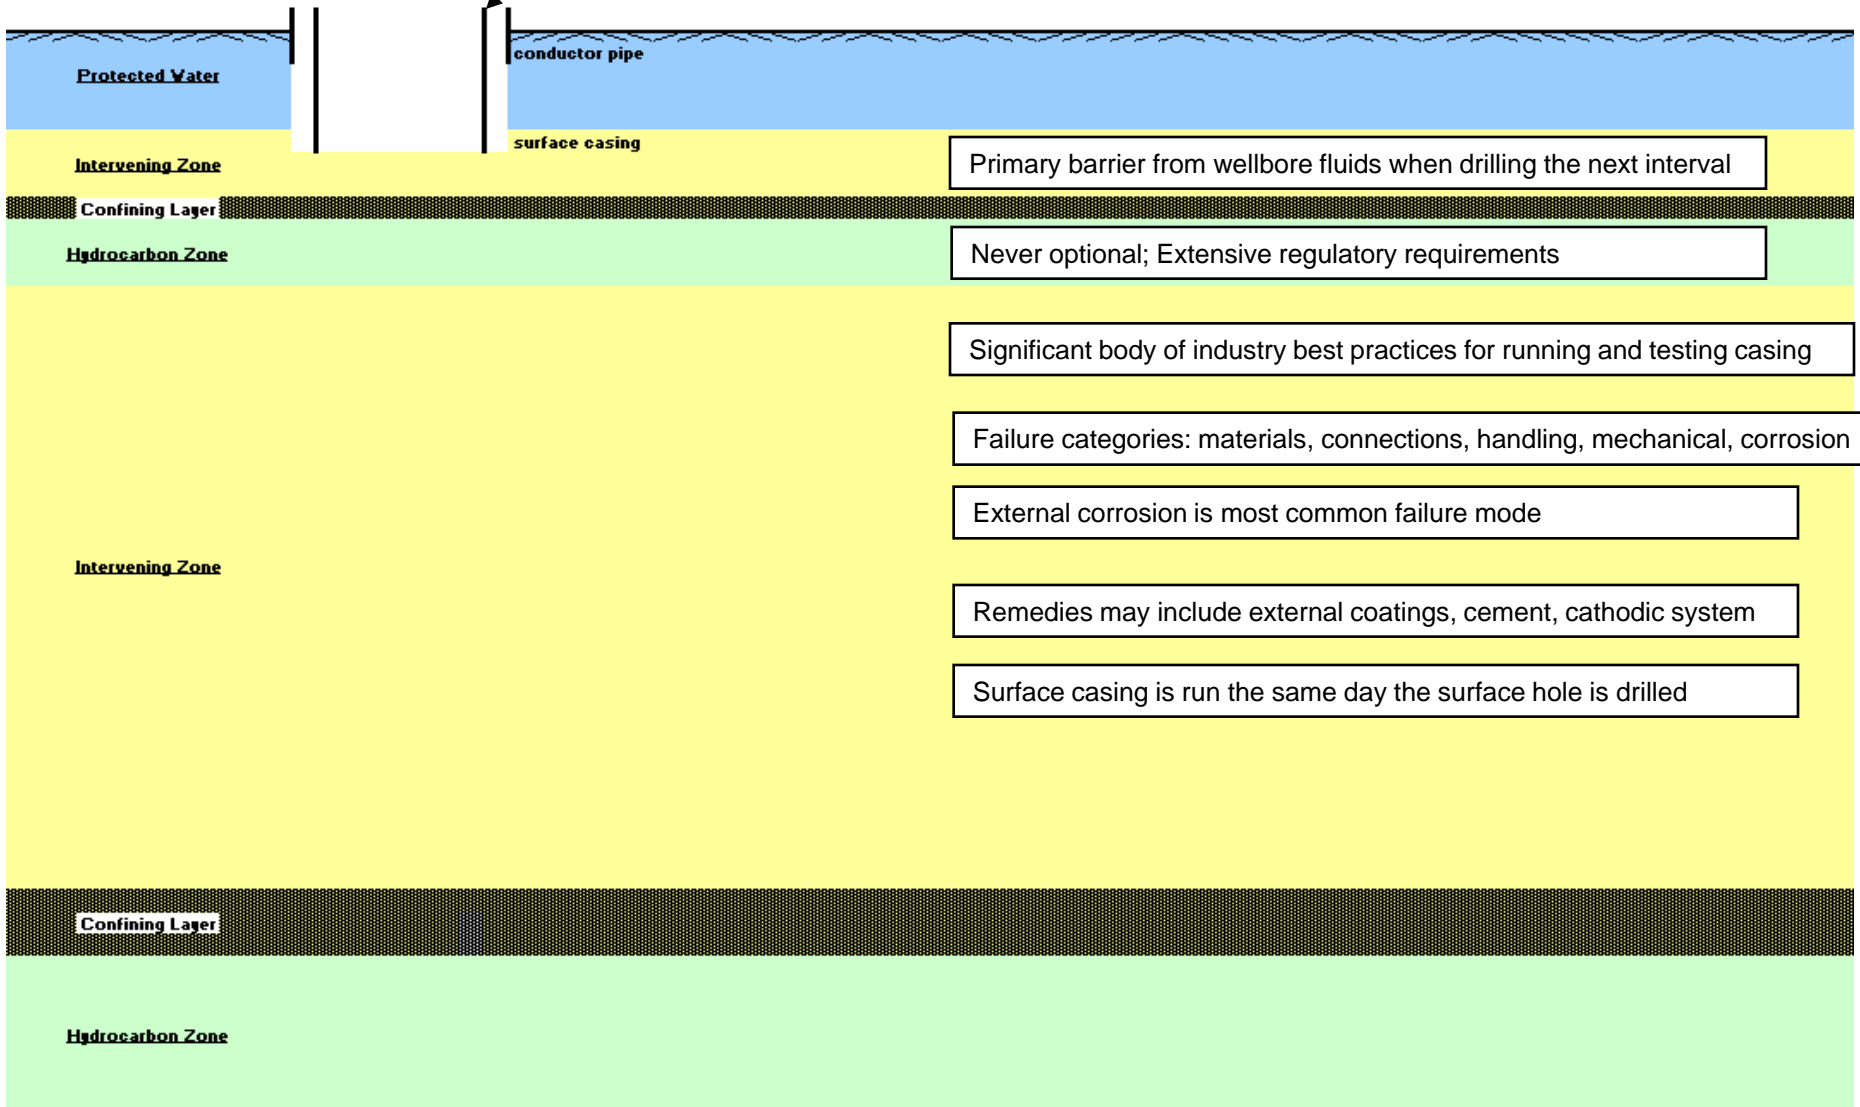
Slide 6 of 22 – Surface casing is run

The surface casing string is the primary barrier to prevent fluids from the wellbore from entering protected water as the well is being drilled to the next casing setting depth. Unlike the conductor pipe, surface casing is always required and is typically specified by regulation to be of “suitable and sufficient” quality (19) or “suitable for all drilling and operating conditions such as tension, burst, collapse” (20). For all casing strings, industry best practices provide extensive guidance on the selection of proper casing size, grade, weight, connections, plus procedures for field handling, inspection, and testing (21) (22) (23) (24) (25) (26) (27). For our case study well, the surface casing is “run” or installed in a few hours during day #1 of the drilling operation.

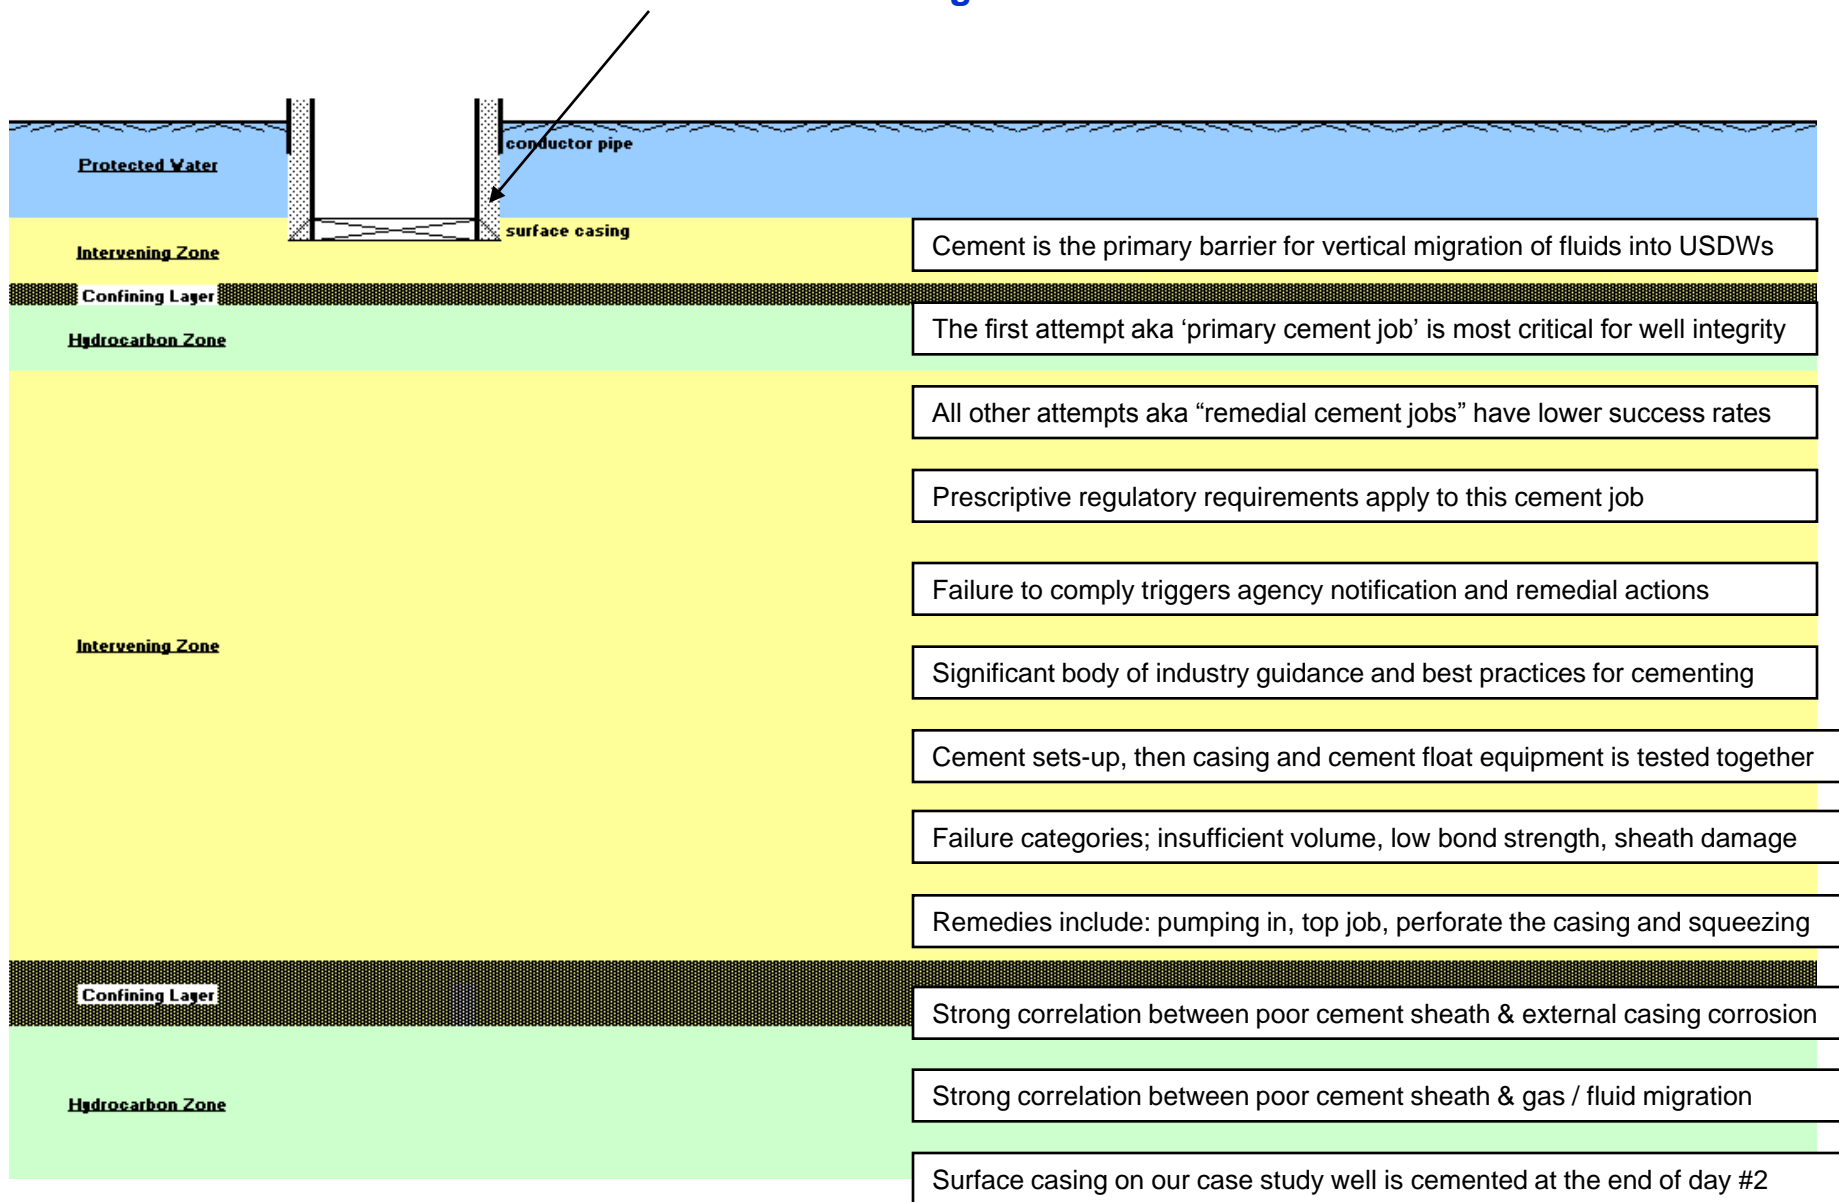
Slide 7 of 22 – Surface casing is cemented and tested

The surface casing string's cement job provides the primary barrier against vertical migration of fluids into protected water for the entire life of the well. In the context of USDW protection, the importance of getting a good primary cement job on the surface casing string cannot be overstated. Remedial cementing options do not provide high success rates for zonal isolation and should be considered only for contingency purposes. Of all regulations for onshore wells, the rules for surface casing cementing contain the most stringent requirements for hole size vs casing size, centralization, cement quality, cement quantity, cement placement techniques, and quality assurance than for any other casing string (29). Failure to properly cement the surface casing string triggers both agency notification and corrective actions (30). The surface casing on our case study well is cemented on day #2 of the drilling operation.

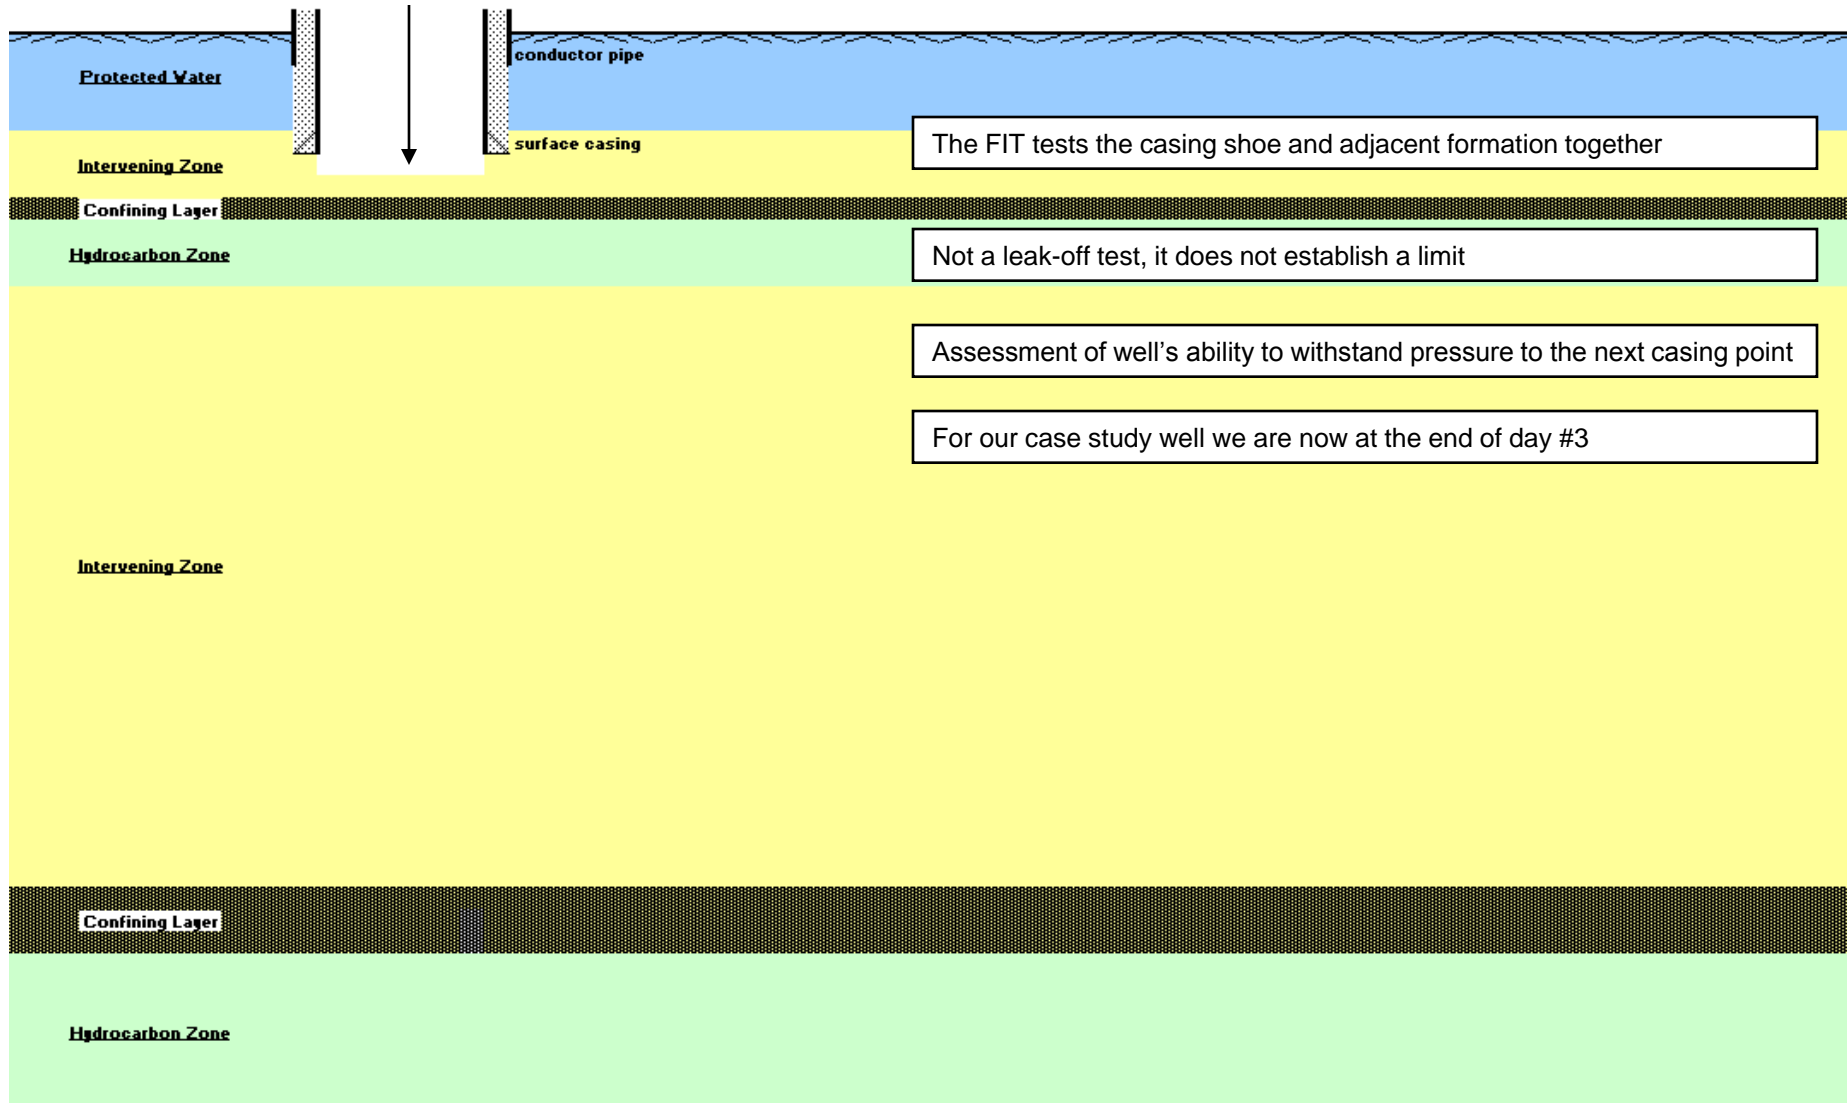
Slide 8 of 22 – Surface casing shoe and formation integrity is tested

After the surface casing has been successfully tested, the float collar, float shoe, and approximately 10' of new formation are drilled. Another integrity test is then performed, a Formation Integrity Test or "FIT" which tests both the casing shoe and new formation together. This is not a leak-off test and does not test the limits of the shoe and formation, rather the FIT provides an assessment of the wellbore's ability to withstand additional pressure in case of an influx of fluids and allows for safer drilling to the next casing point (38).

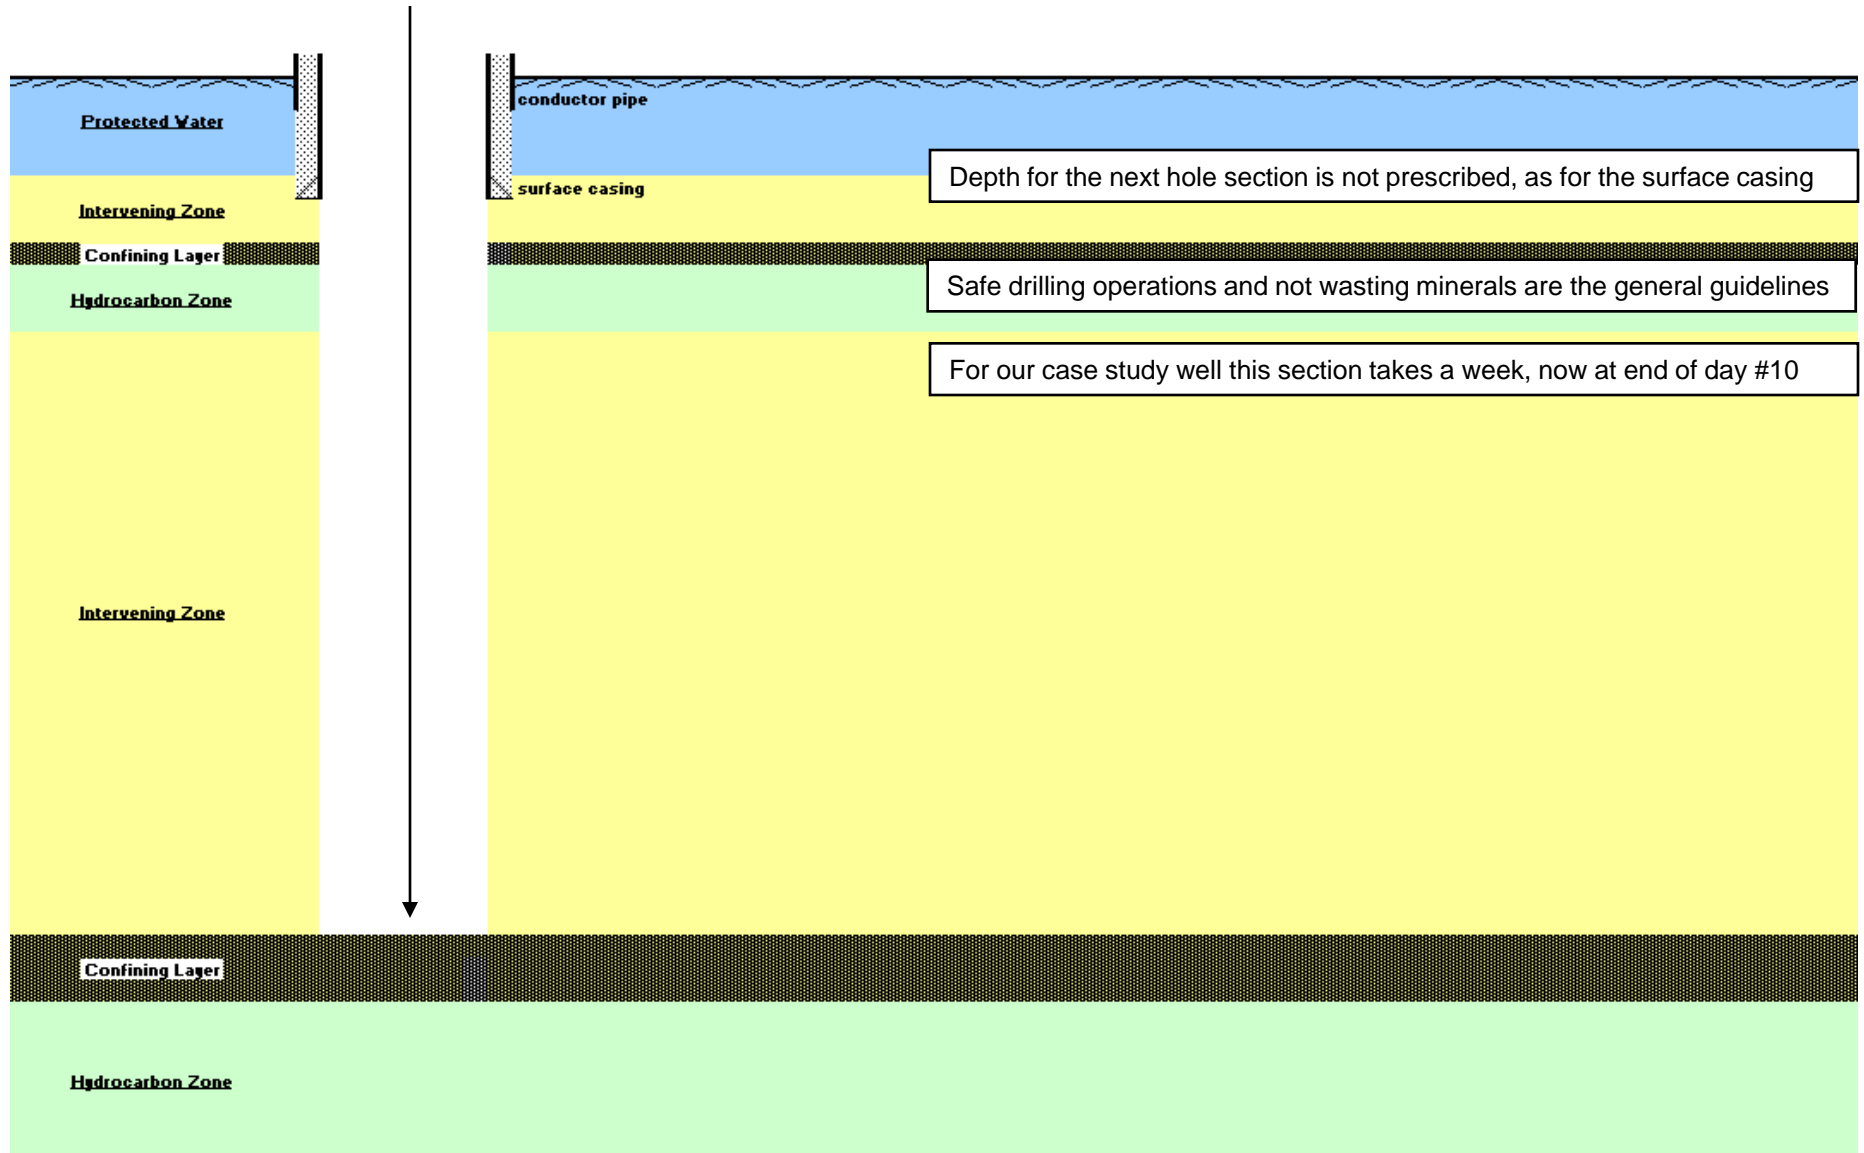
Slide 9 of 22 – Next section of hole is drilled

The next sections of well, which for this case study includes an intermediate and production casing section, are essentially a repeat of the surface casing section described above except that:

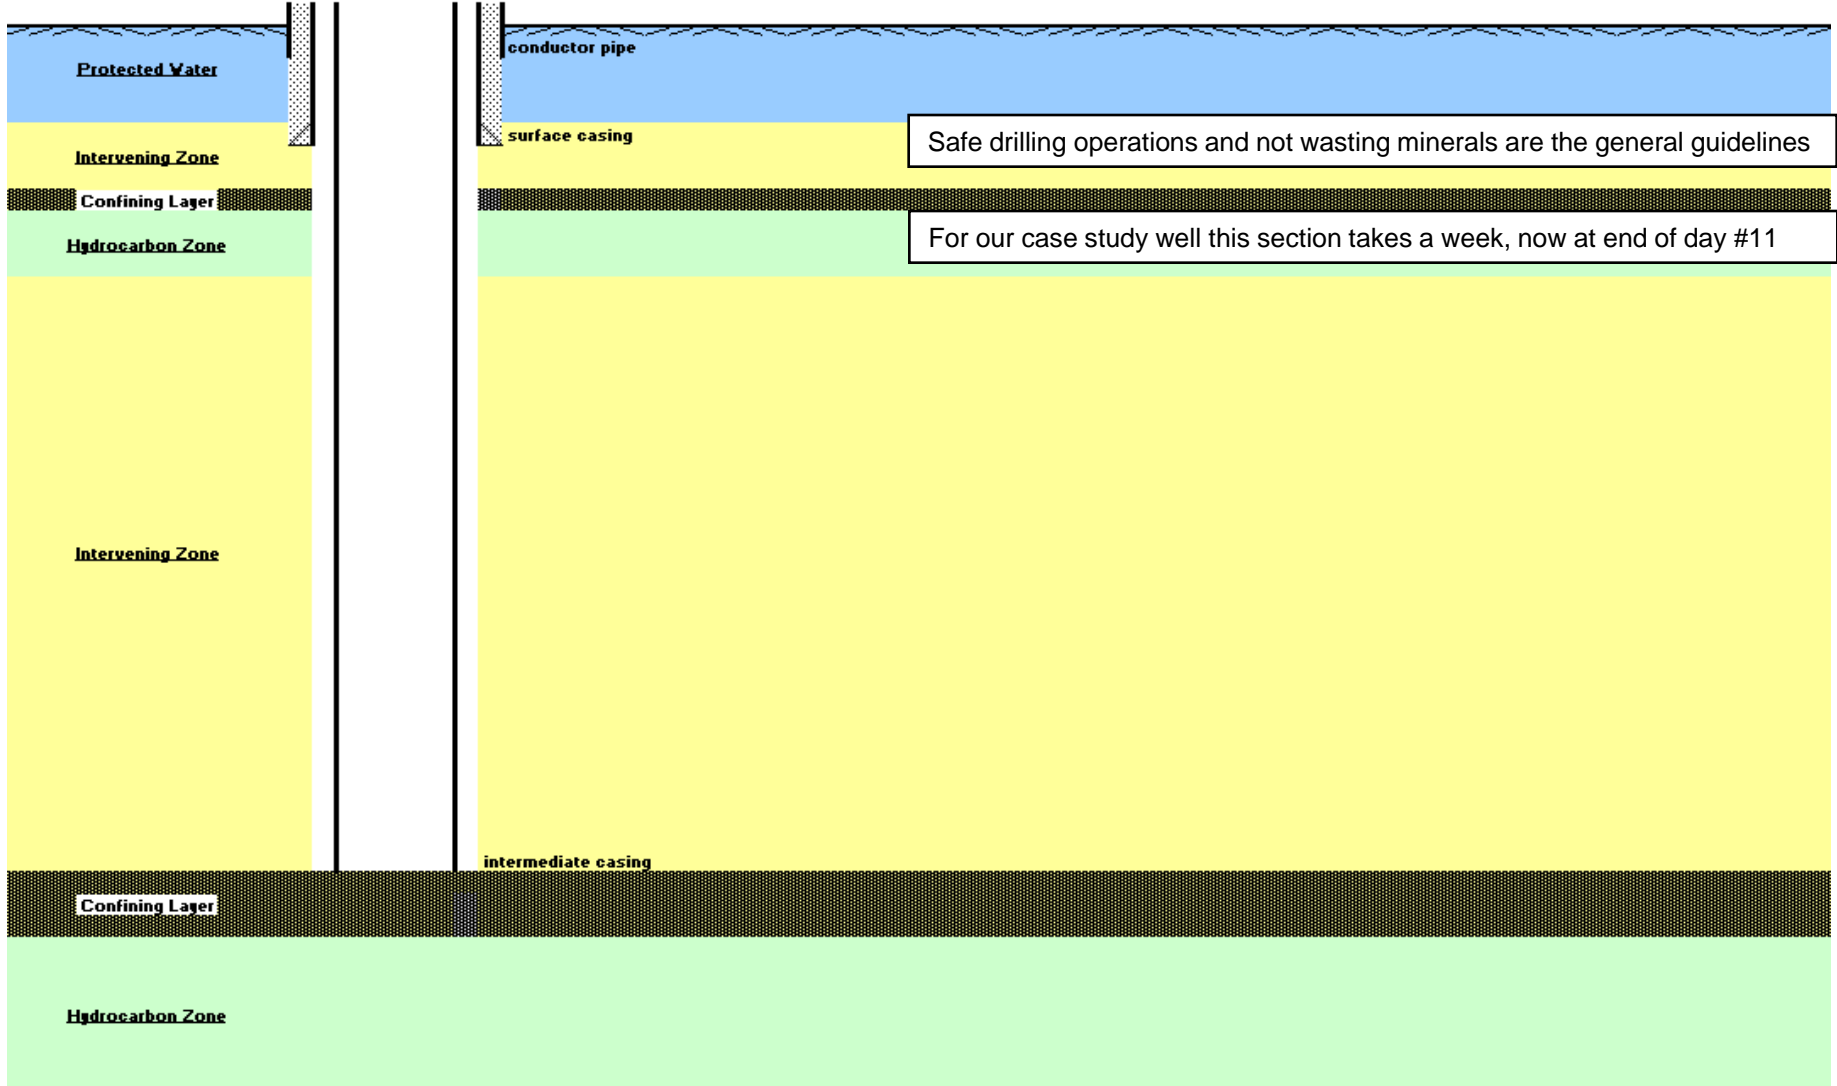
Slide 10 of 22 – Intermediate string of casing is run

Safe drilling operations and not wasting minerals are the general guidelines

For our case study well this section takes a week, now at end of day #11

- The design depth for intermediate and production casing strings are not as comprehensively regulated (as for the surface casing depth) other than to provide safe drilling operations and to prevent the waste of minerals.
- The regulations concerning hole size vs casing size, centralization, cement quality, cement quantity, cement placement techniques, and quality assurance for intermediate and production casing strings are not as specific (as for the surface casing) other than to provide safe drilling operations and prevent the waste of minerals.

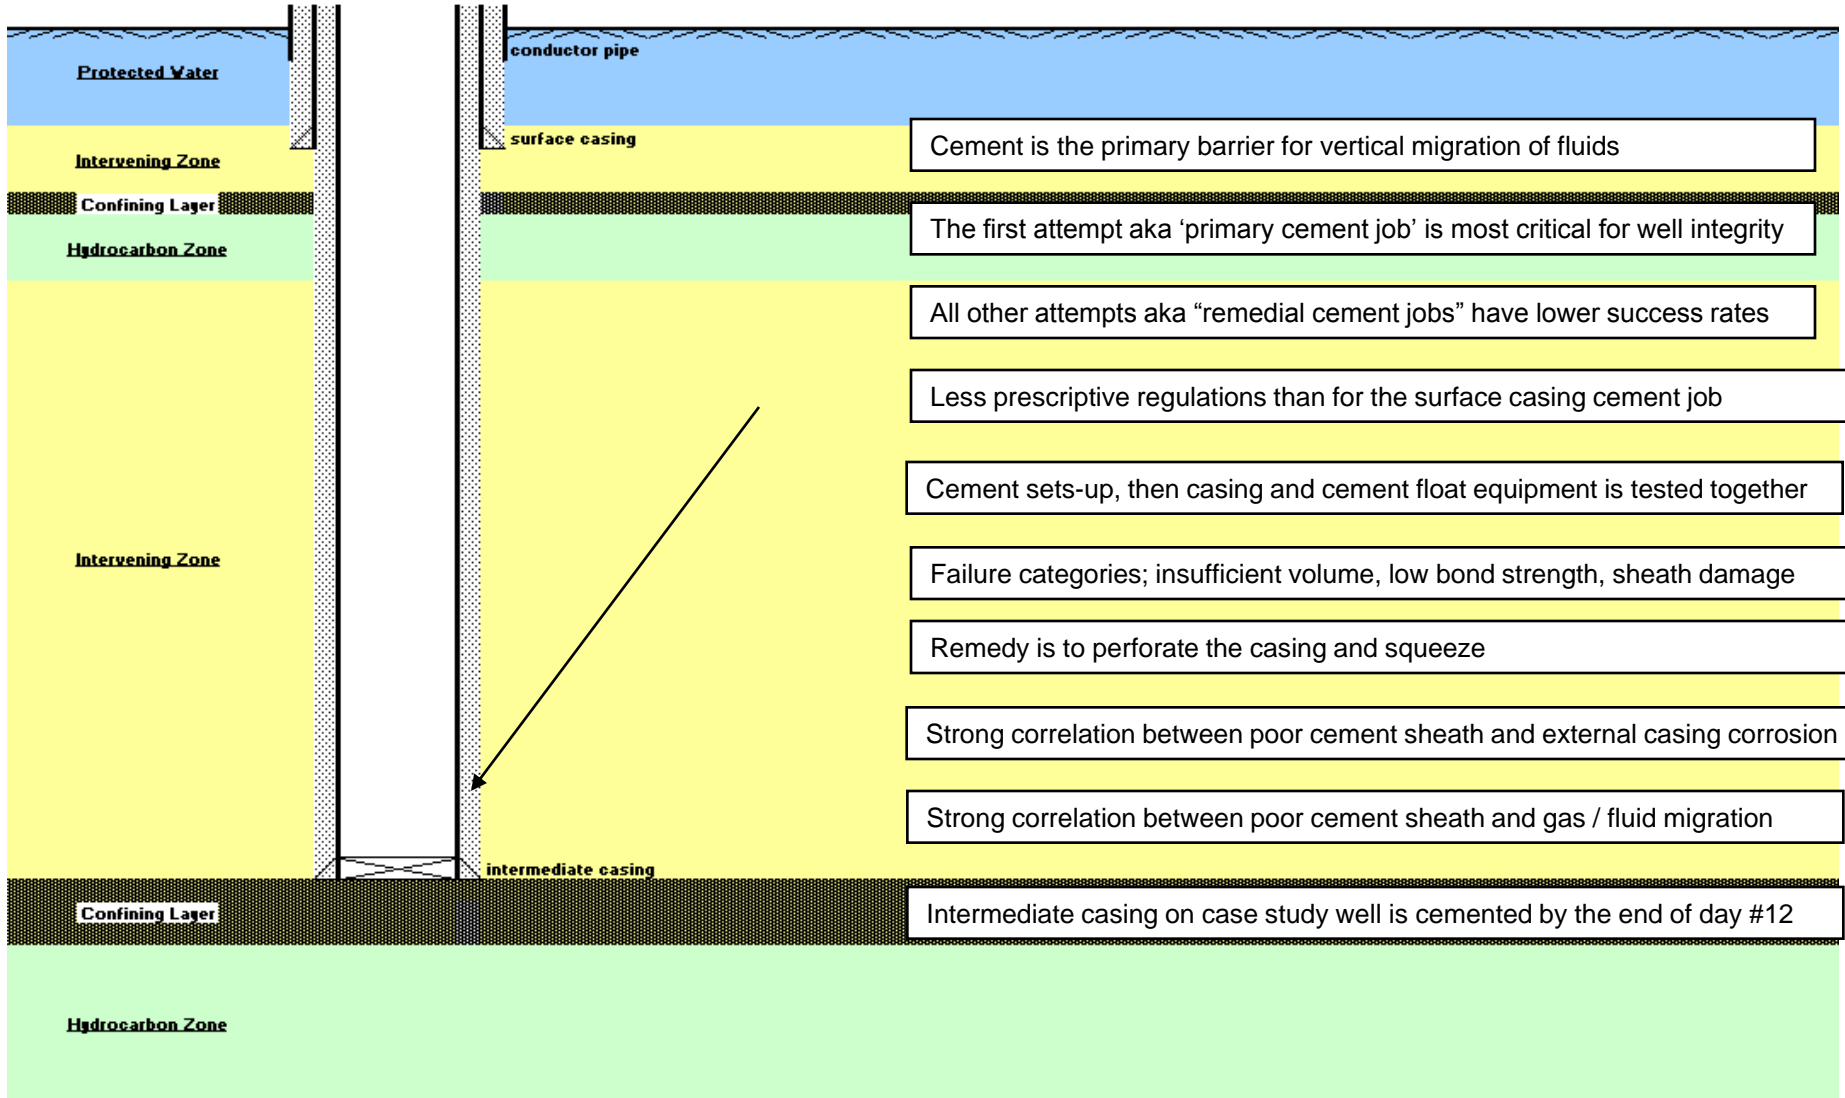
Slide 11 of 22 – Intermediate casing is cemented and tested
