Case Study for Well Integrity over a Full Life Cycle

Lloyd H. Hetrick, PE, CSP
Newfield Exploration Company

Abstract

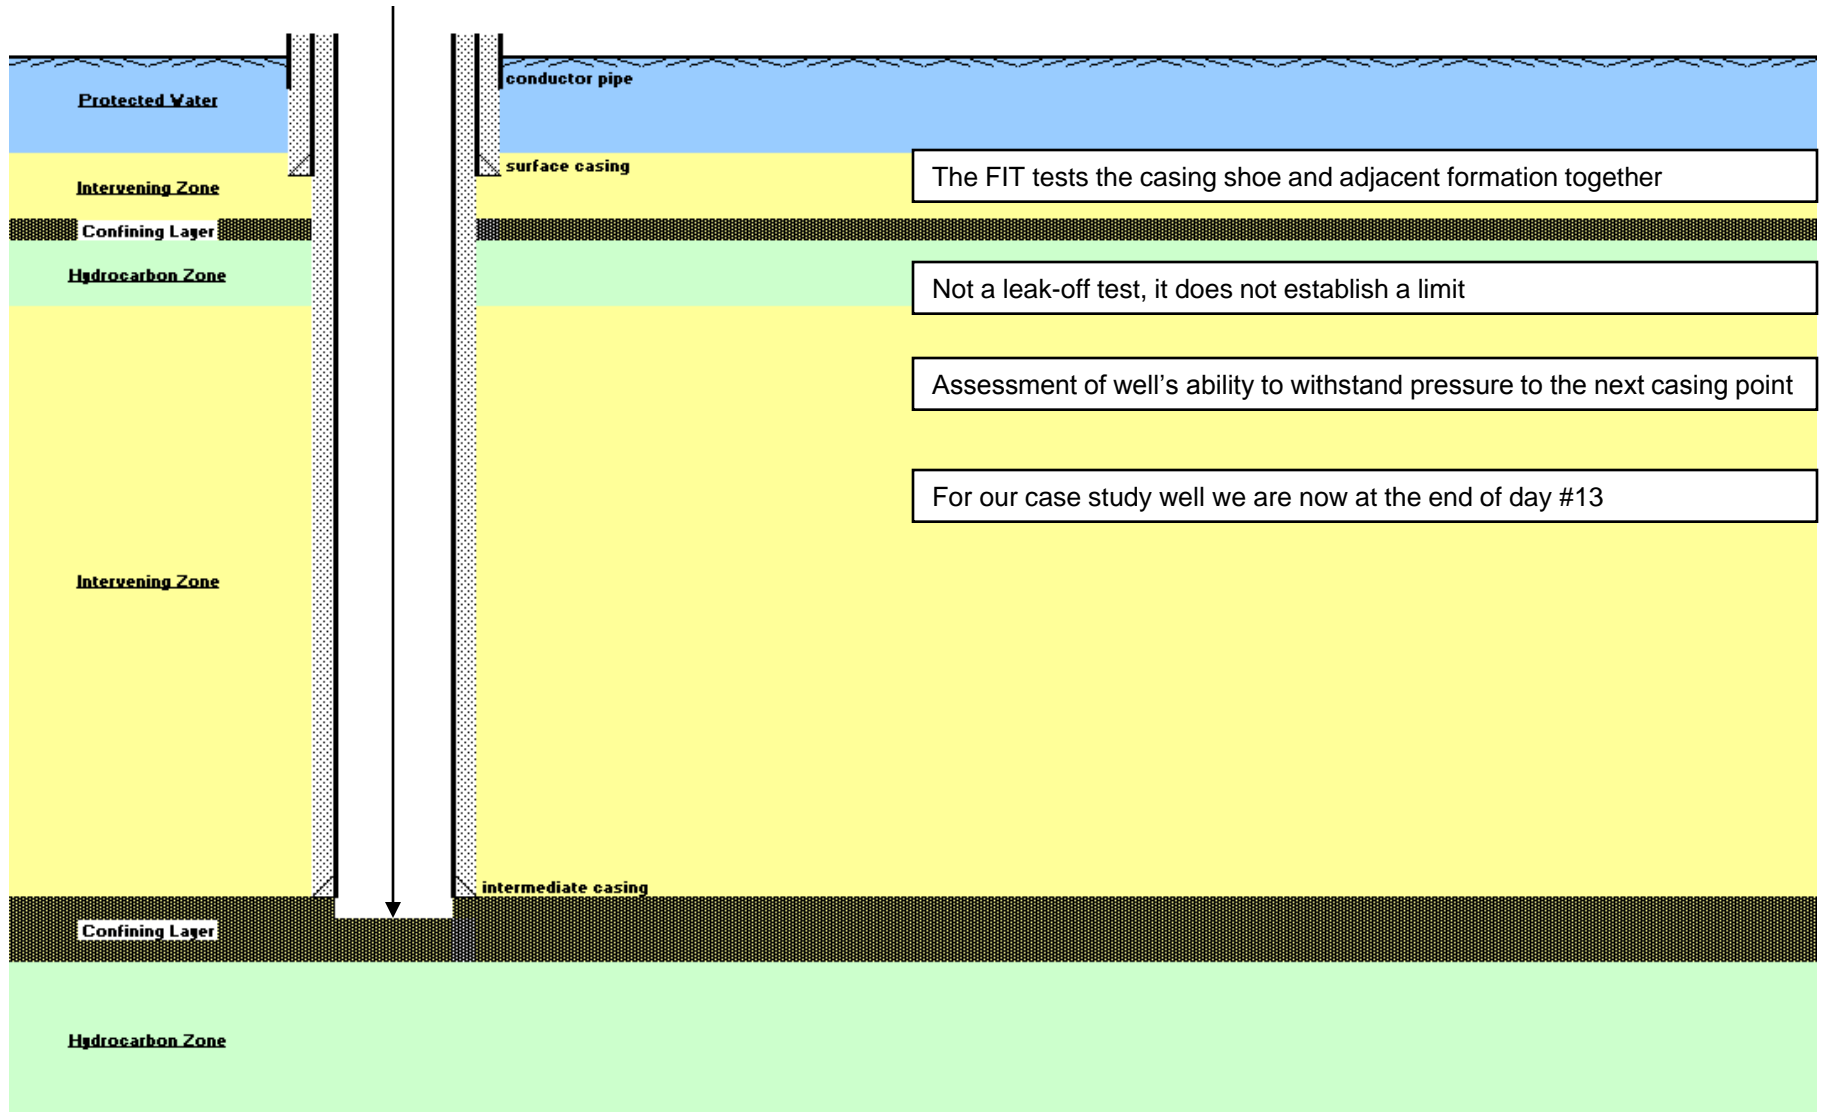
Slide 12 of 22 – Intermediate casing shoe and formation integrity are tested

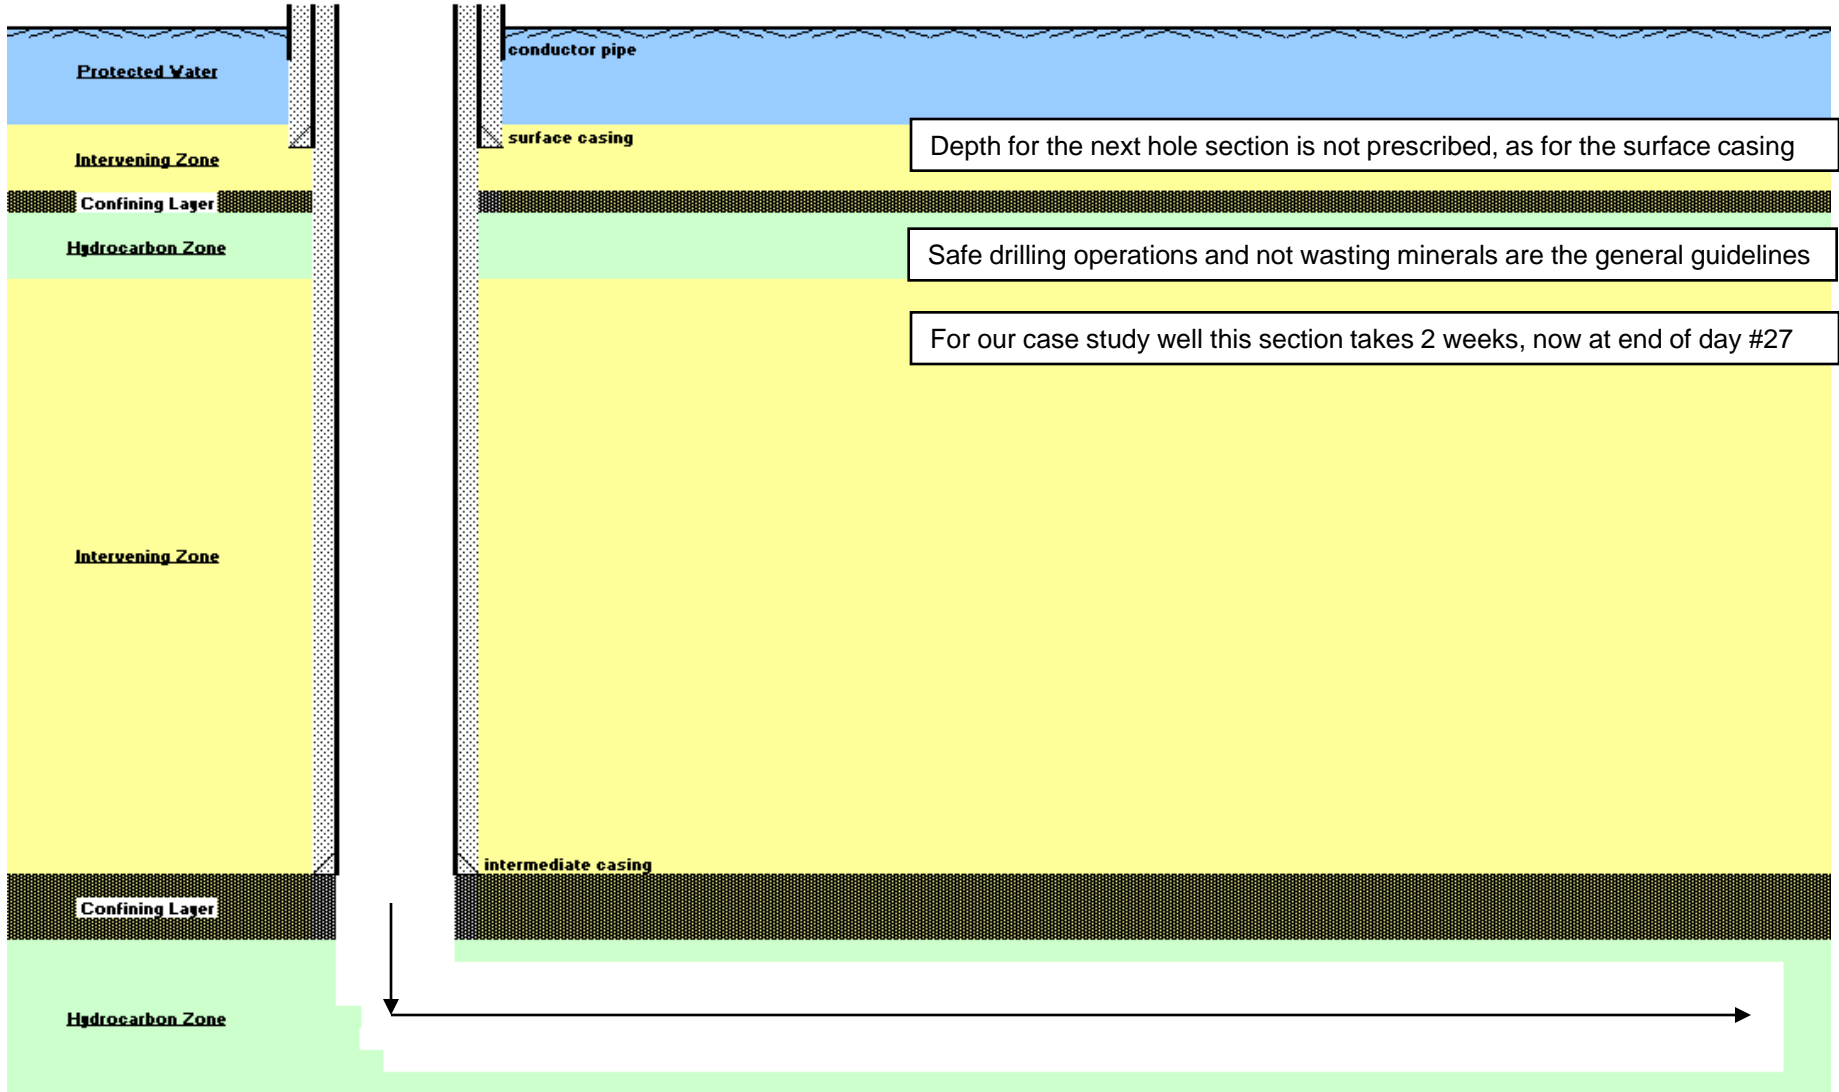
Slide 13 of 22 – Next section of hole is drilled

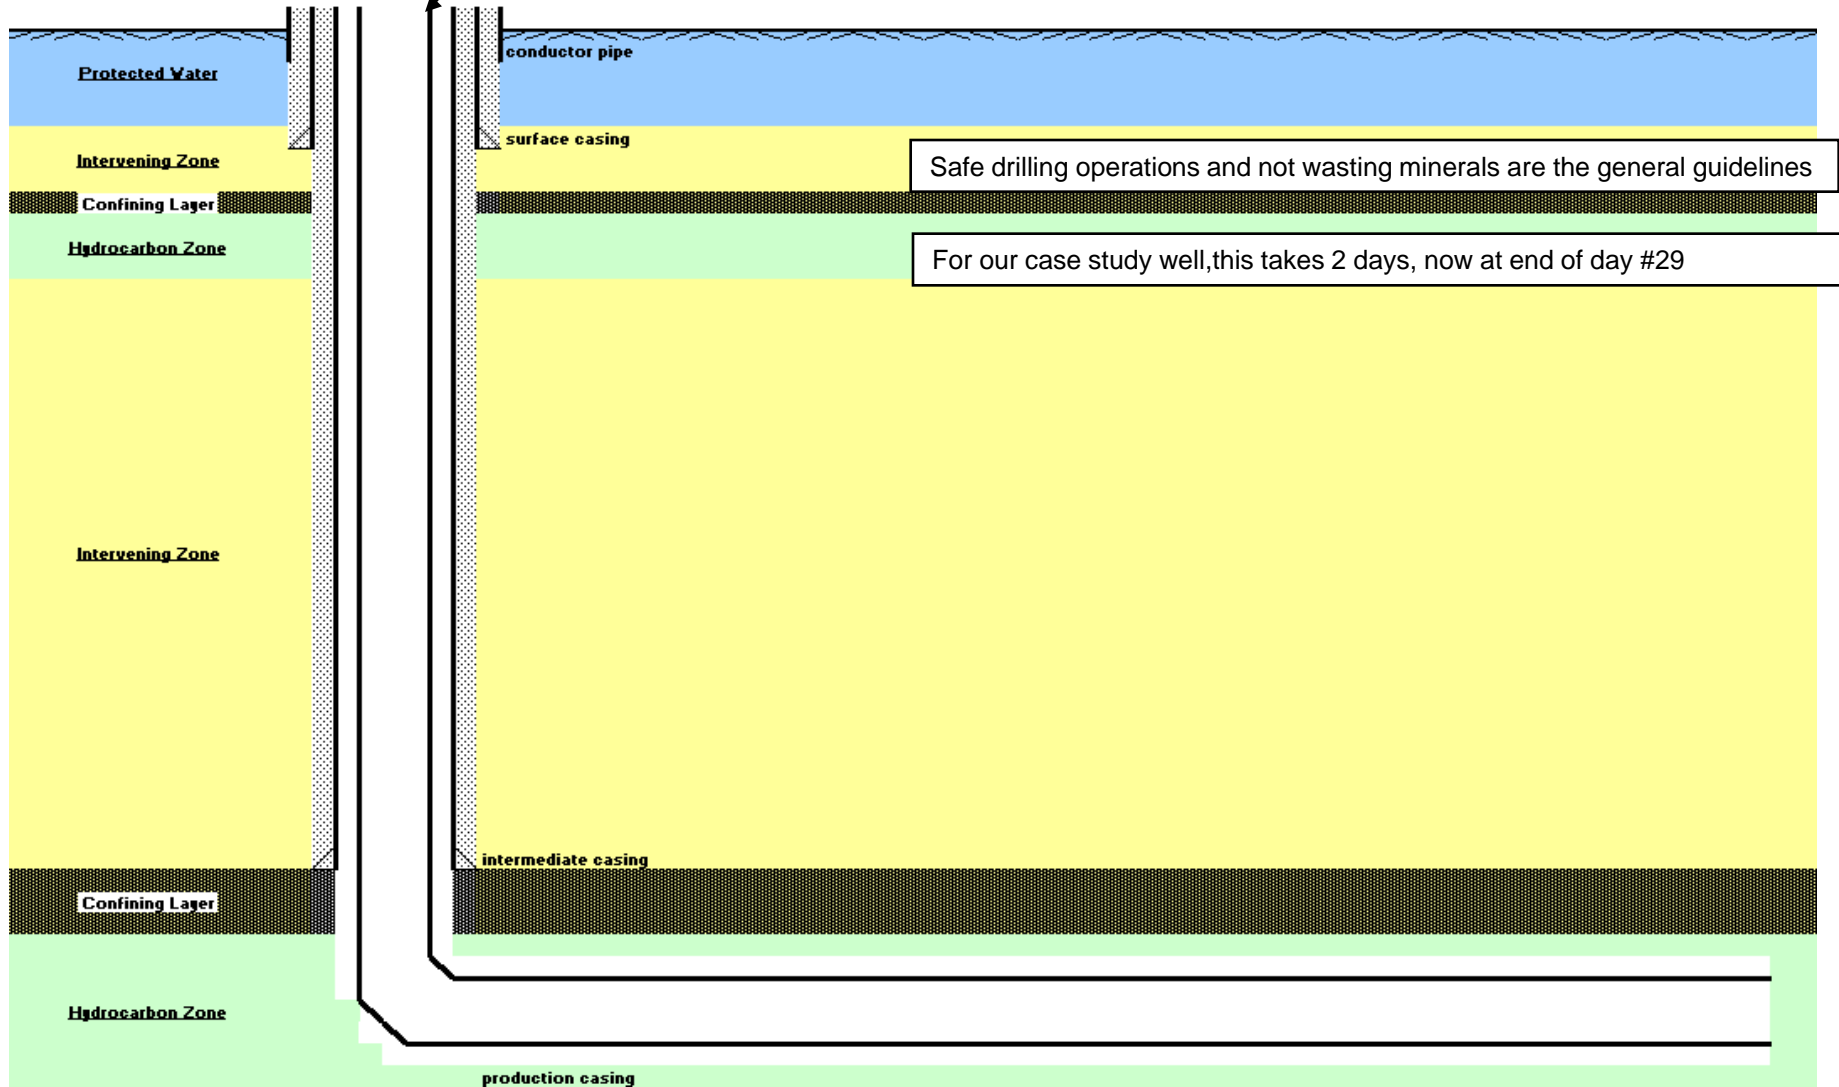
Slide 14 of 22 – Production casing is run

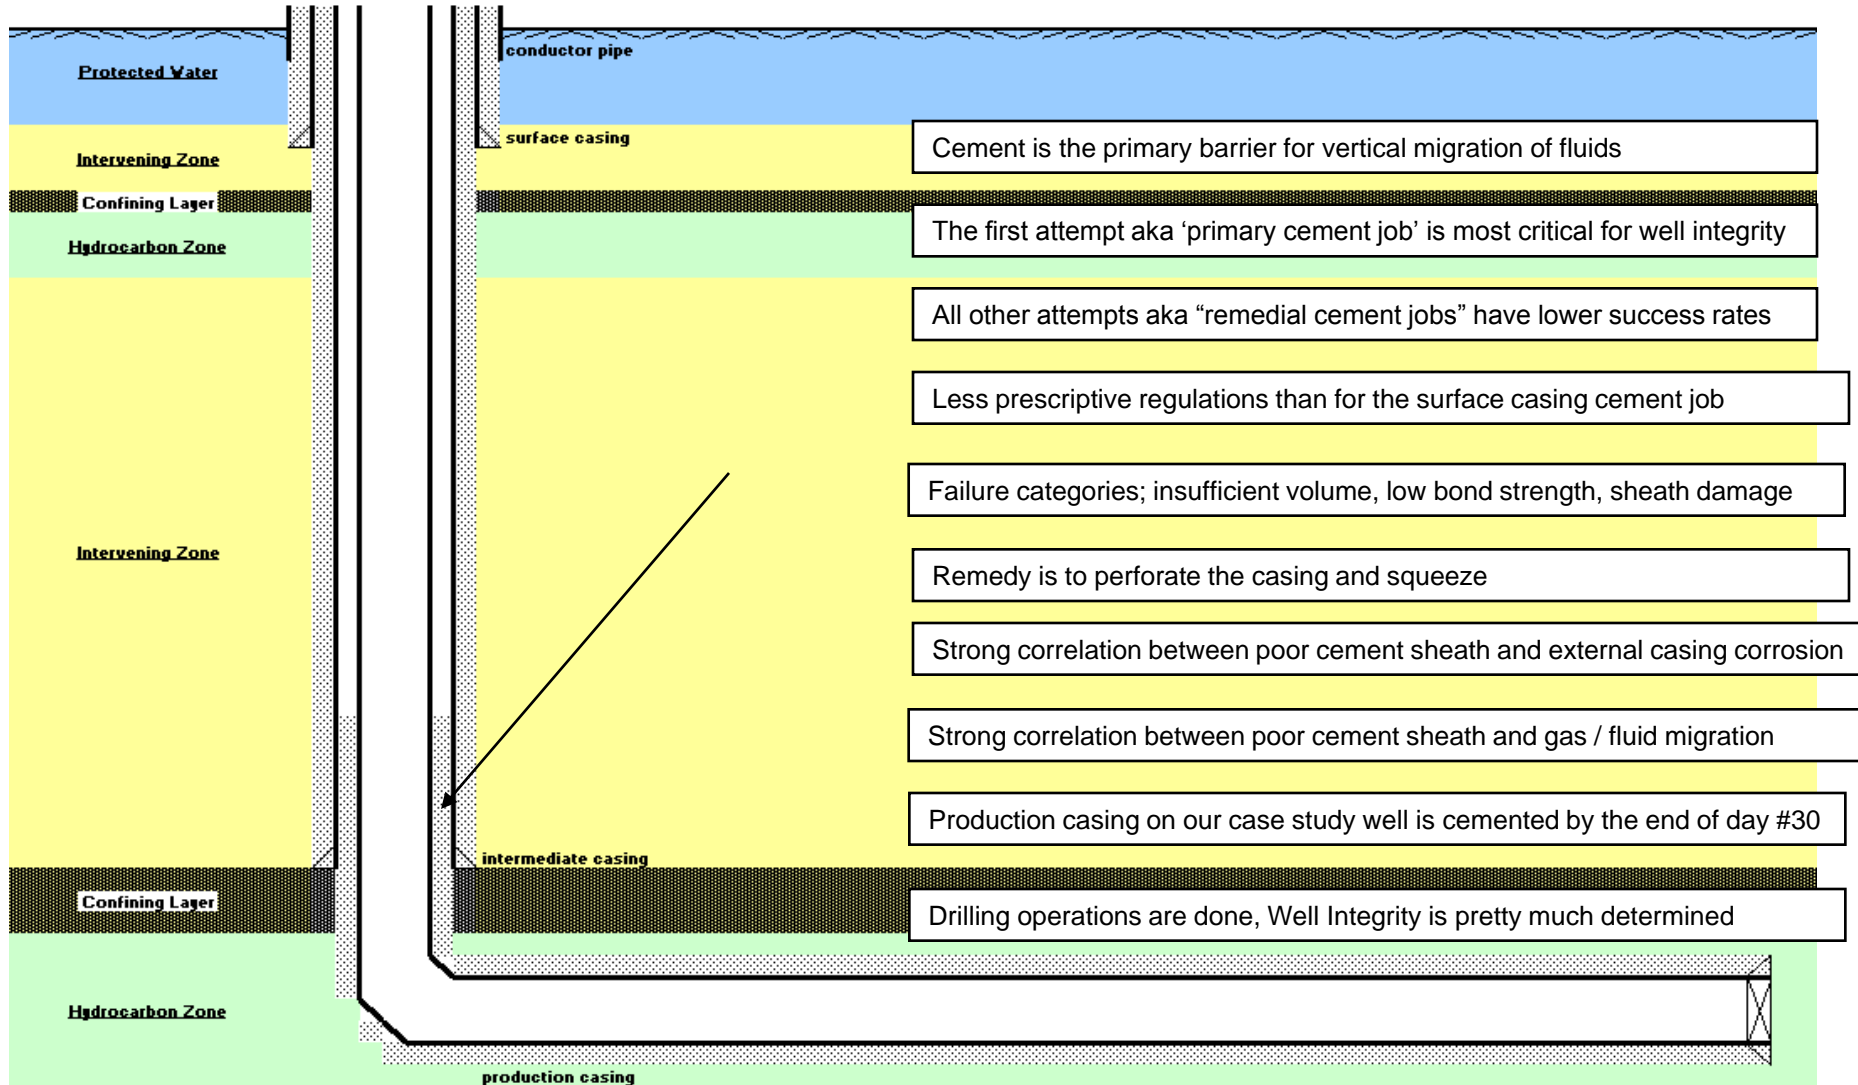
Slide 15 of 22 – Production casing is cemented, Drilling phase is done

Although this case study well has been drilled, cased, and cemented over a 30 day period, the first two days are the most critical for zonal isolation of USDWs where the foundation for well integrity is determined.

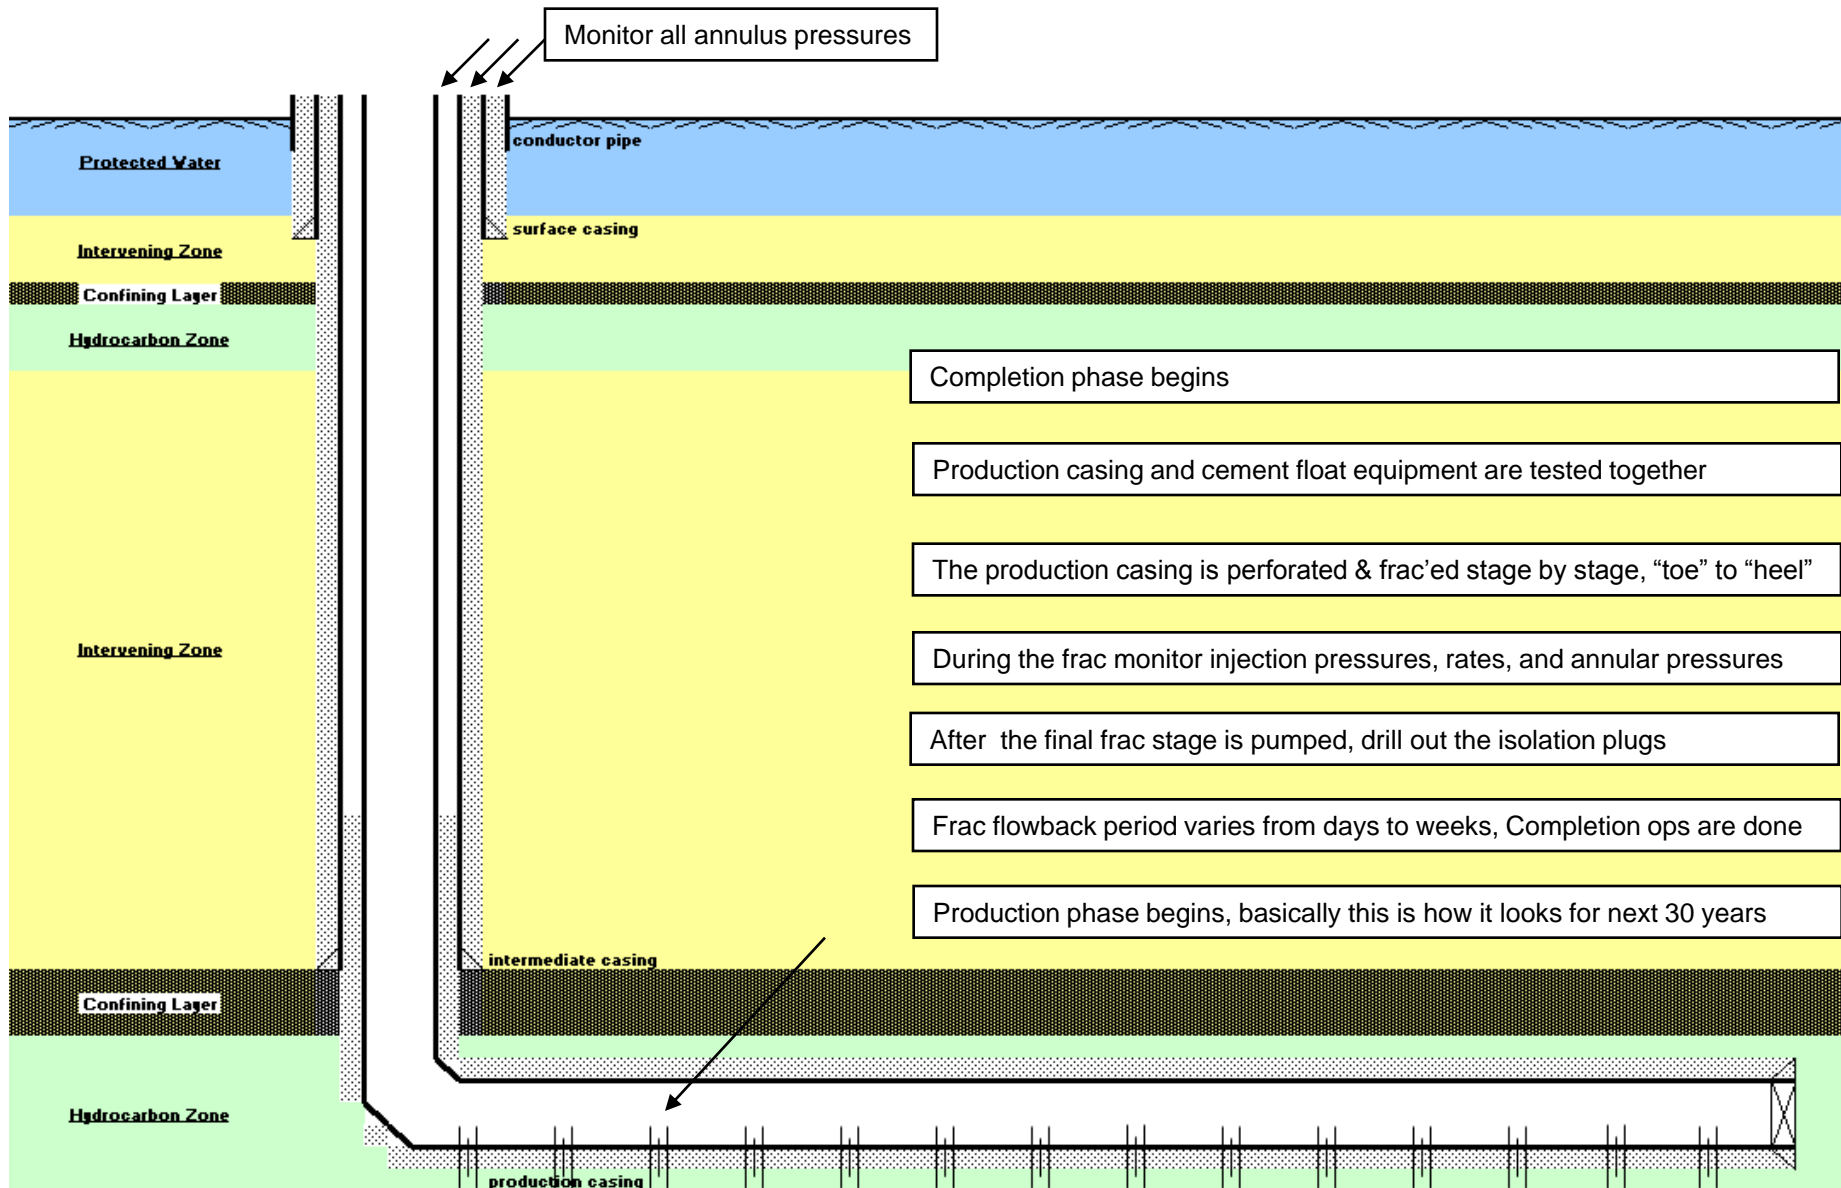
Slide 16 of 22 – Completion phase: perforate, hydraulically frac, flowback, production begins

Well completion is the where the production casing is perforated, the formation is hydraulically fractured, frac fluids are unloaded from the formation, and production operations commence. This is basically the well's configuration for the rest of its life as it relates to protecting USDWs.

Prior to performing the hydraulic frac, the production casing is tested to anticipated frac pressure plus a safety factor, as is the frac tree and all the surface pumping equipment and lines. During the frac, all casing annuli are monitored, as is the injection rate, injection pressure, and slurry properties. If during the frac job, significant pressure is found on the intermediate casing annulus, or there is any indication of communication with the surface casing annulus, the frac job is shut down and not resumed until corrective actions are made that only the intended zone is subject to frac pressures.

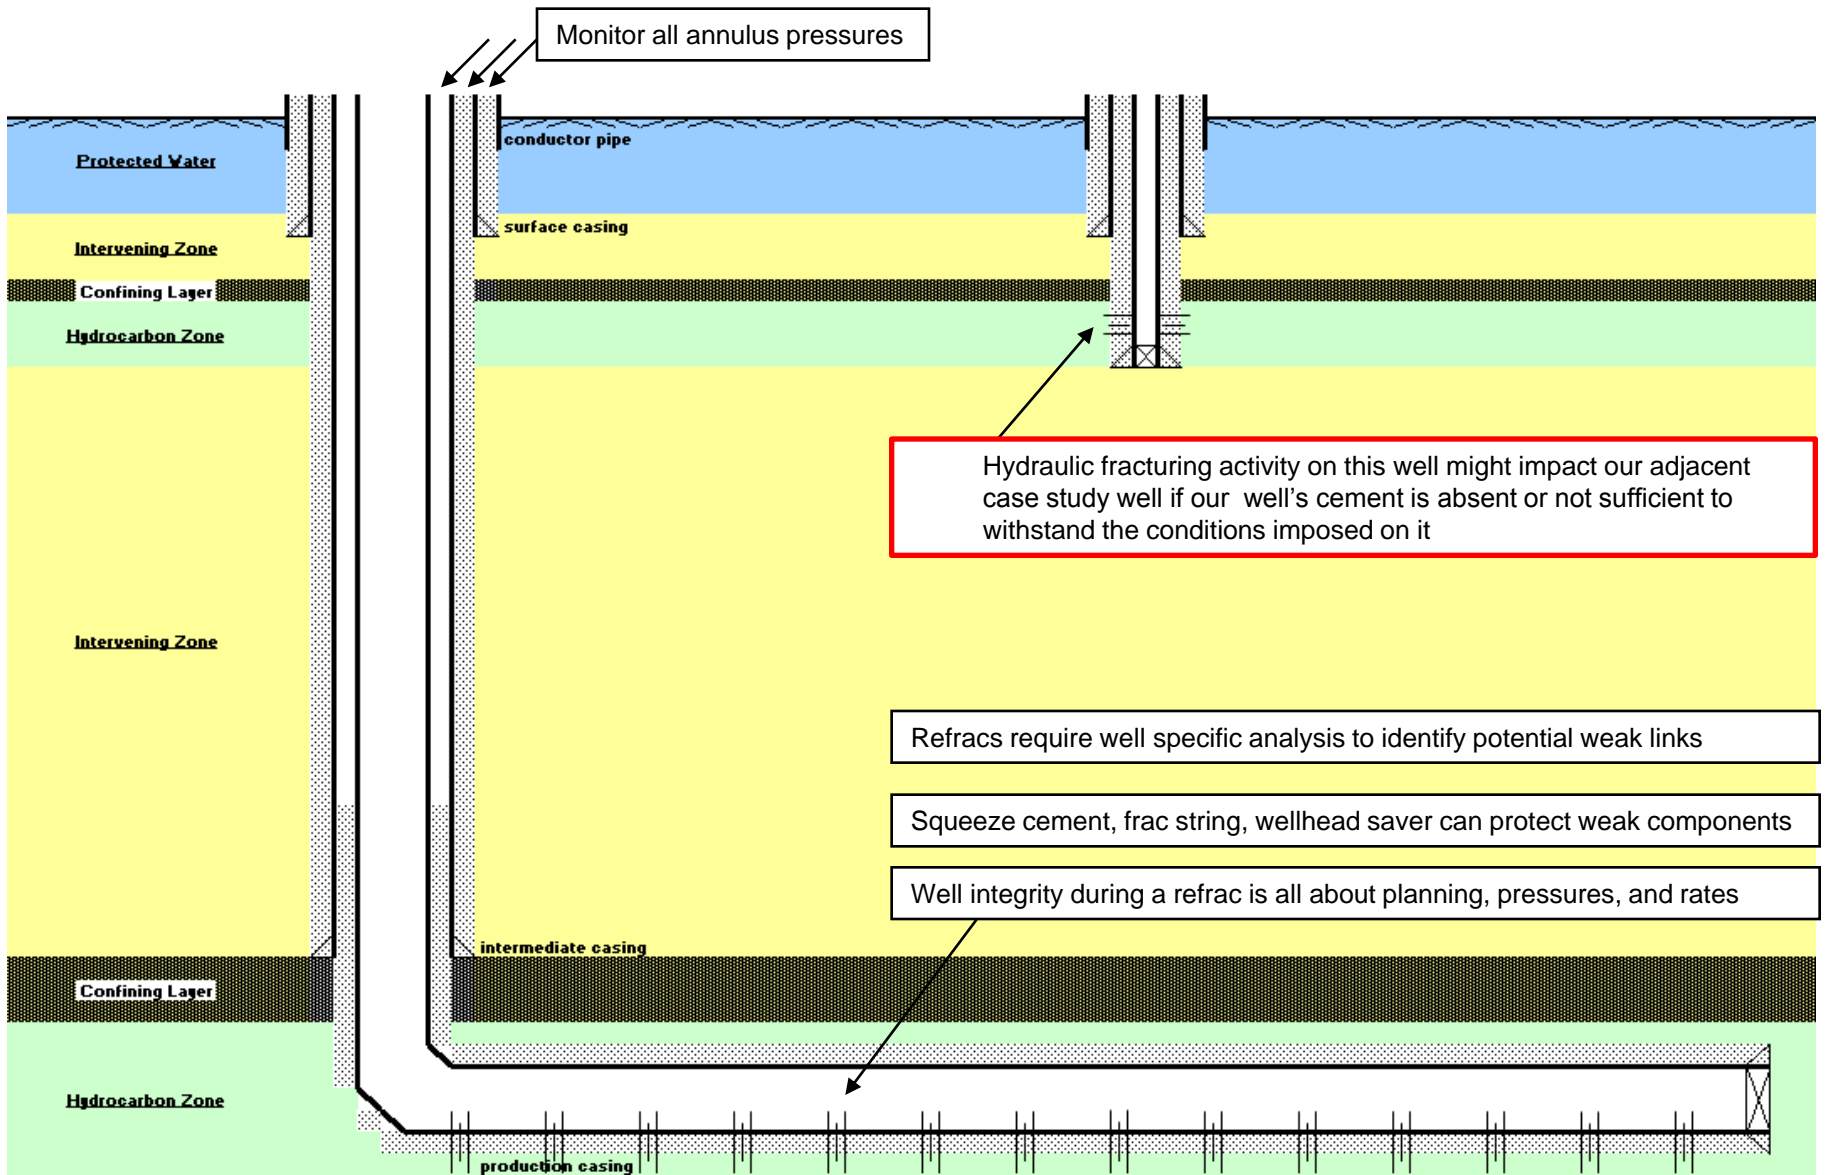
Slide 17 of 22 – Refrac and Adjacent Well Frac Scenarios

Refracs are similar to original fracs as discussed above with the exception that a frac string or wellhead saver might be used to protect older production casing strings and wellheads from frac pressures. This is a case by case situation that requires additional testing and engineering analysis in order to protect both the well and USDWs during refrac operations.

Adjacent well operations may have an impact on mechanical integrity of our case study well. Hydraulic fracturing of a well near our case study well into a zone that is not protected, or not adequately protected for the conditions imposed can lead to unwanted well to well communication. This is currently a void where regulations and industry practices have not fully recognized that well integrity can become a neighborhood issue.

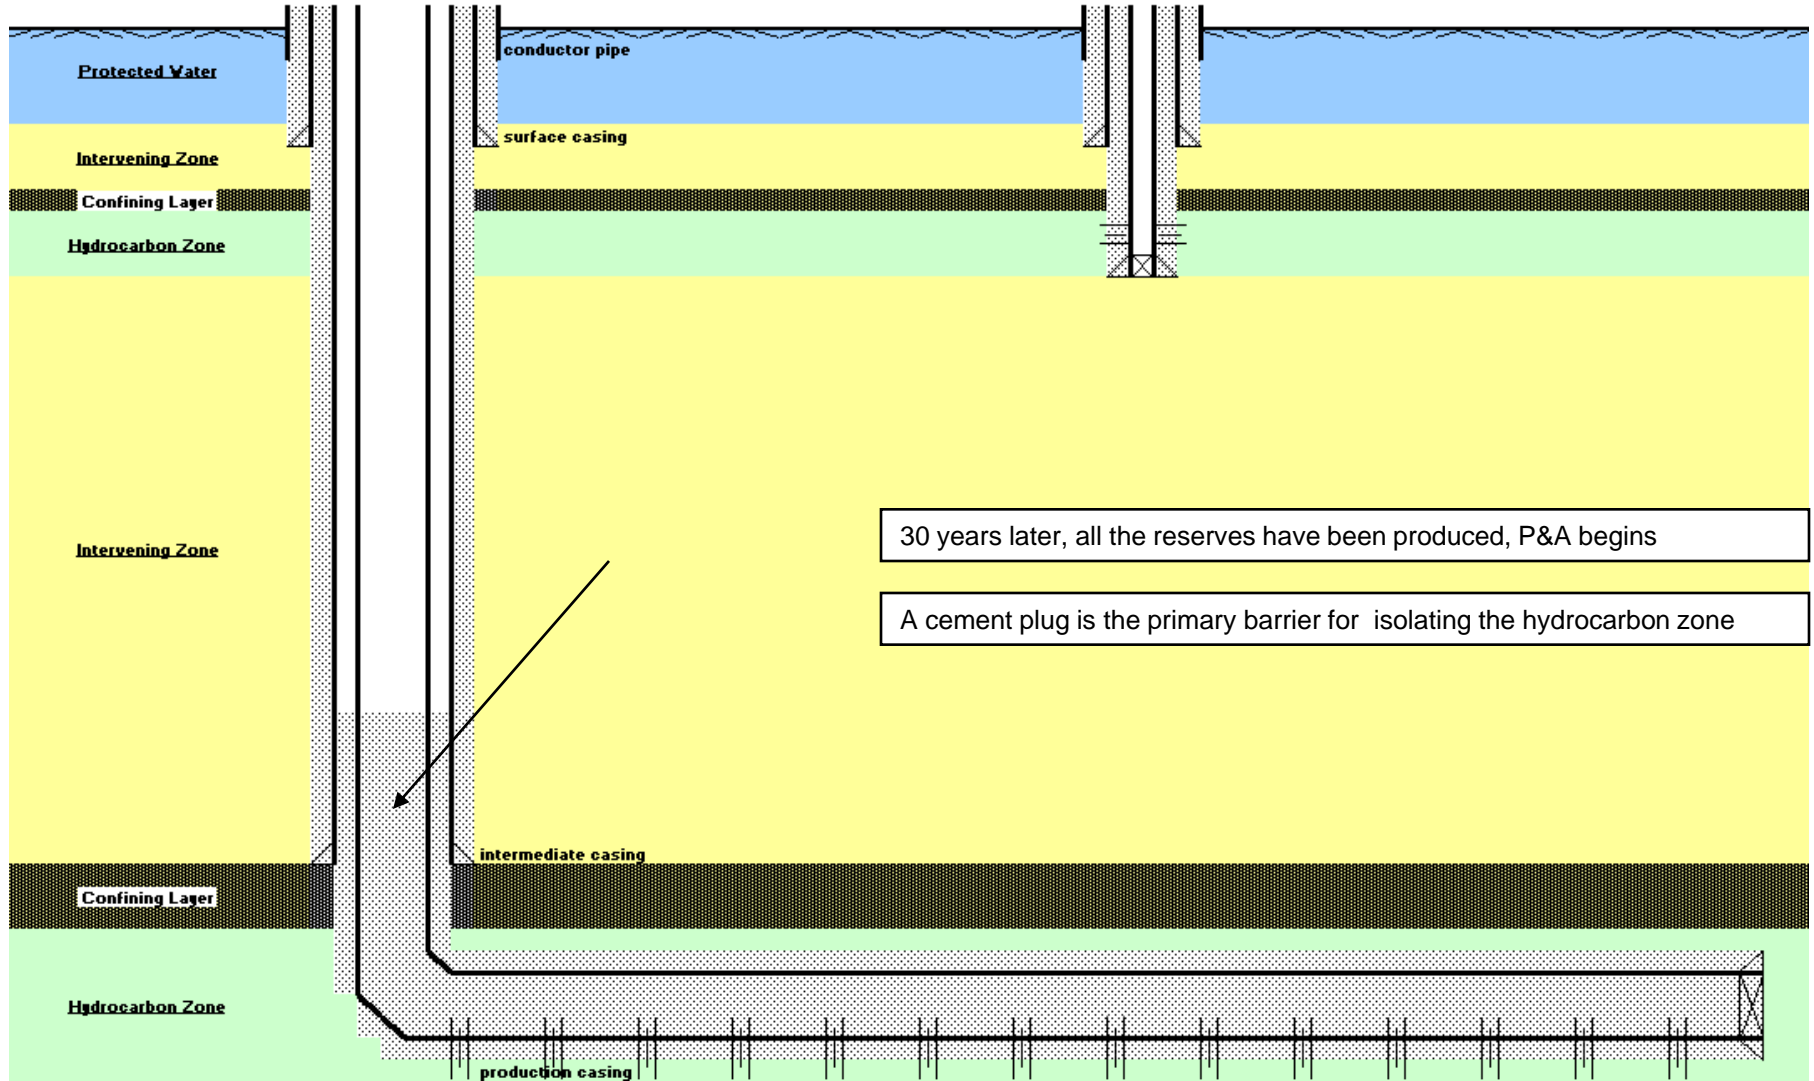
Slide 18 of 22 – Plug and Abandonment begins, producing zone is plugged and tested

Similar to well construction regulations and industry practices, well P&A also has comprehensive guidance to prevent vertical migration of fluids into USDWs. There is clear guidance for plug location, cement quantity, quality, placement techniques, testing, and reporting (43) (44) (45). Regulations may also specify that only approved cementing contractors perform plugging, require independent onsite supervision, and require post cement job certifications by both the operator and the cementing company.

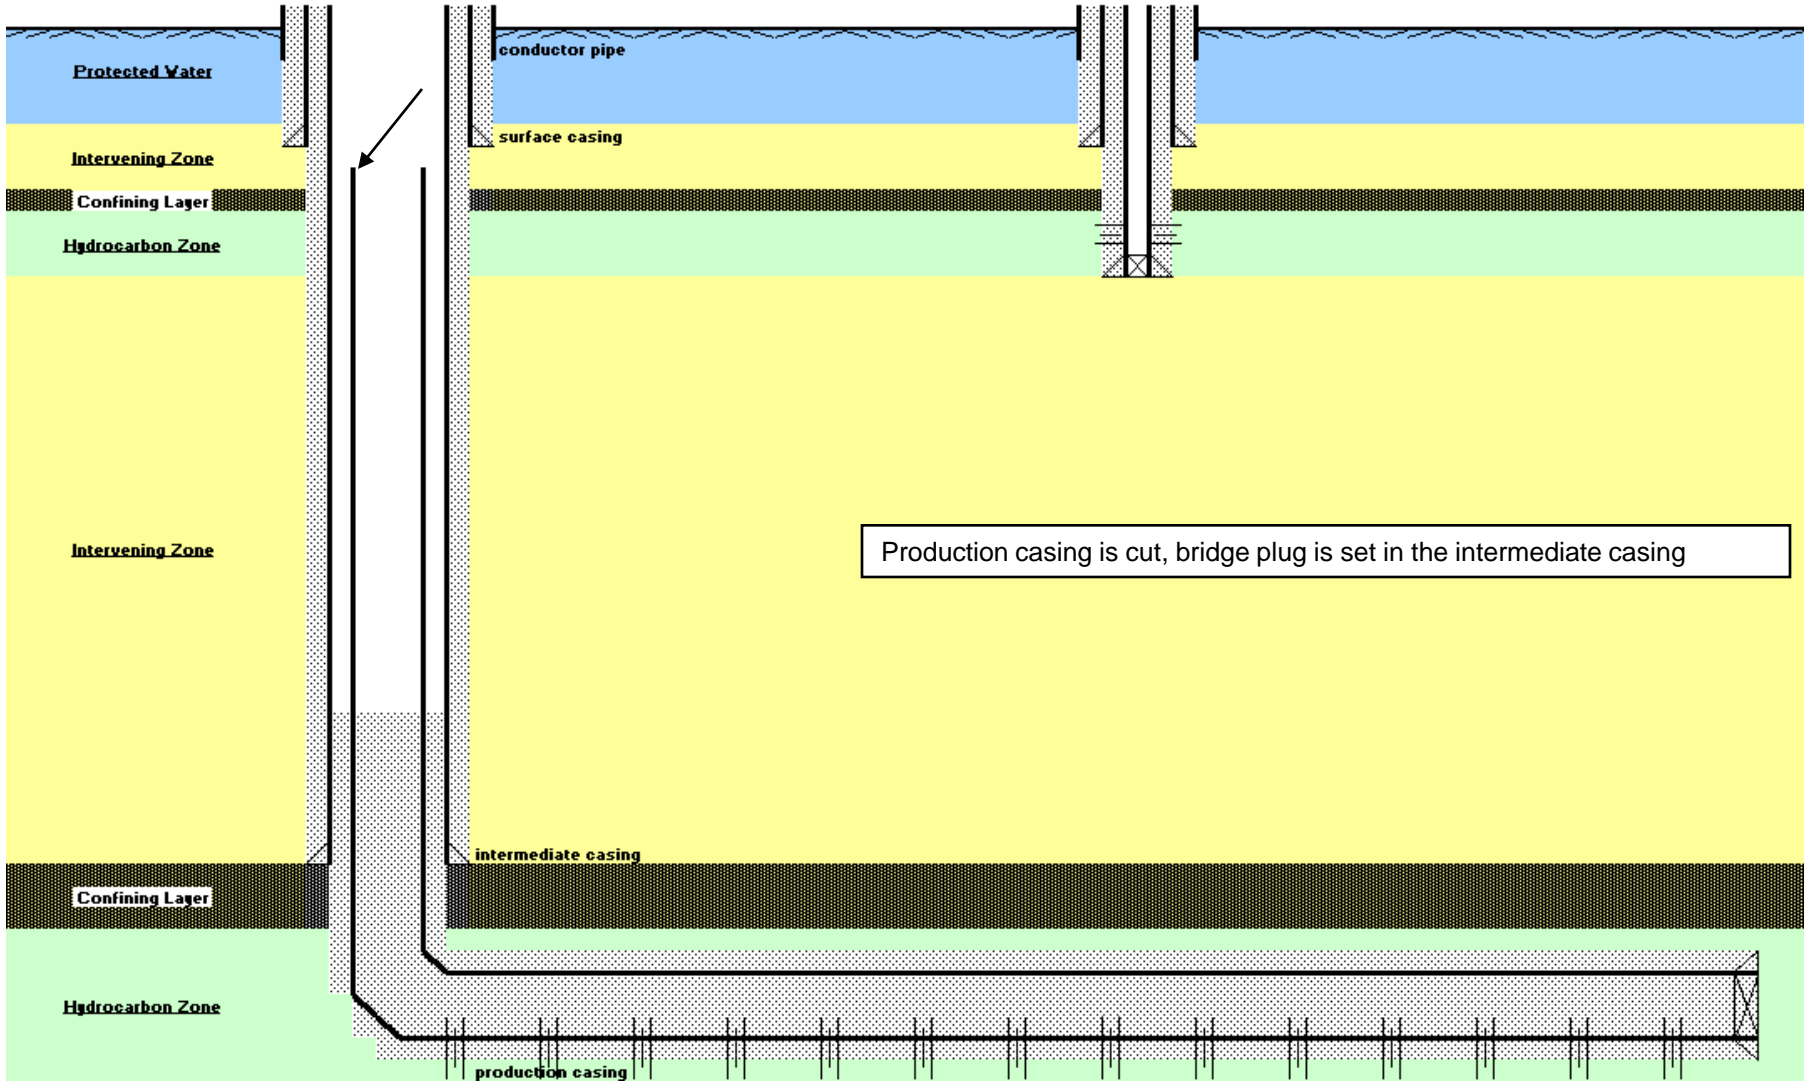
EPA Hydraulic Fracturing Study Technical Workshop #2 March 10-11, 2011
Well Integrity Case Study by Lloyd H. Hetrick
Slide 19 of 22 – Casing is cut or perforated near the surface casing shoe

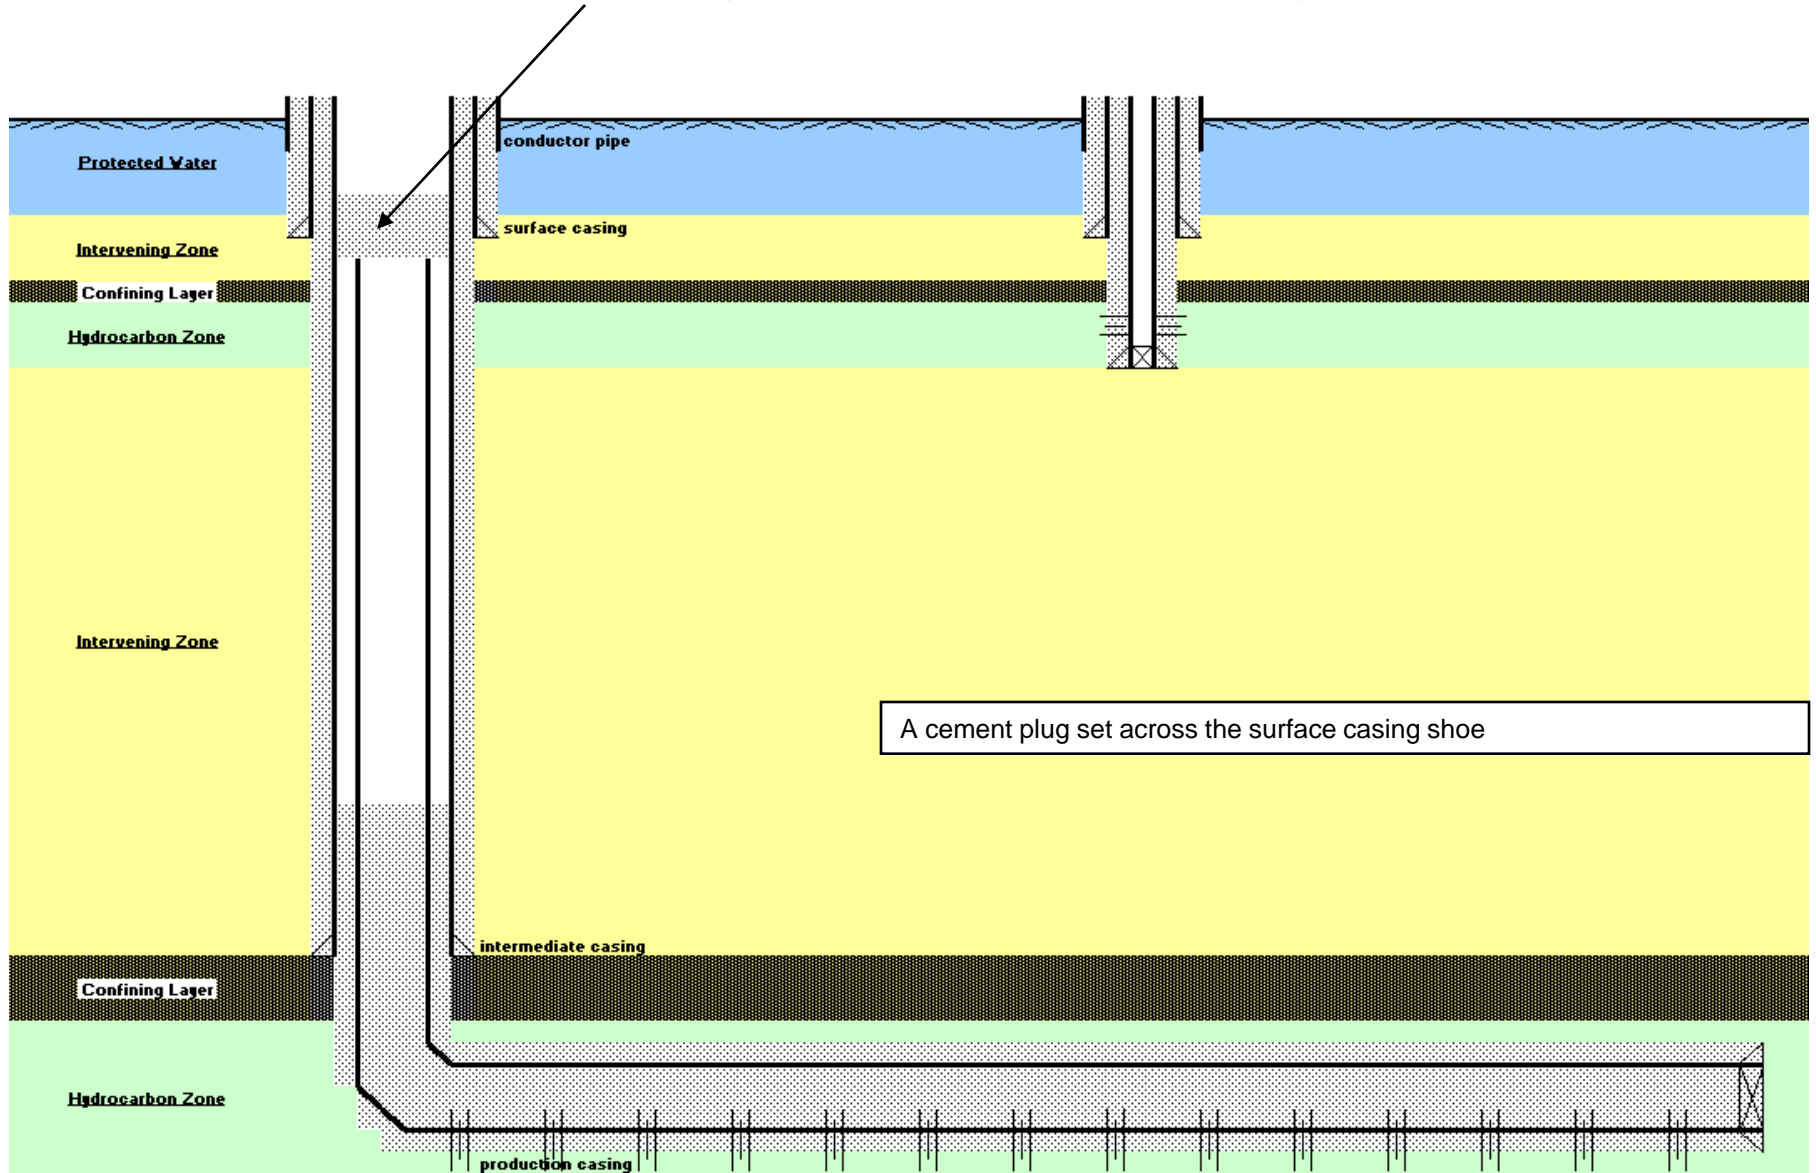
Slide 20 of 22 – Cement plug is set across the surface casing shoe and tested

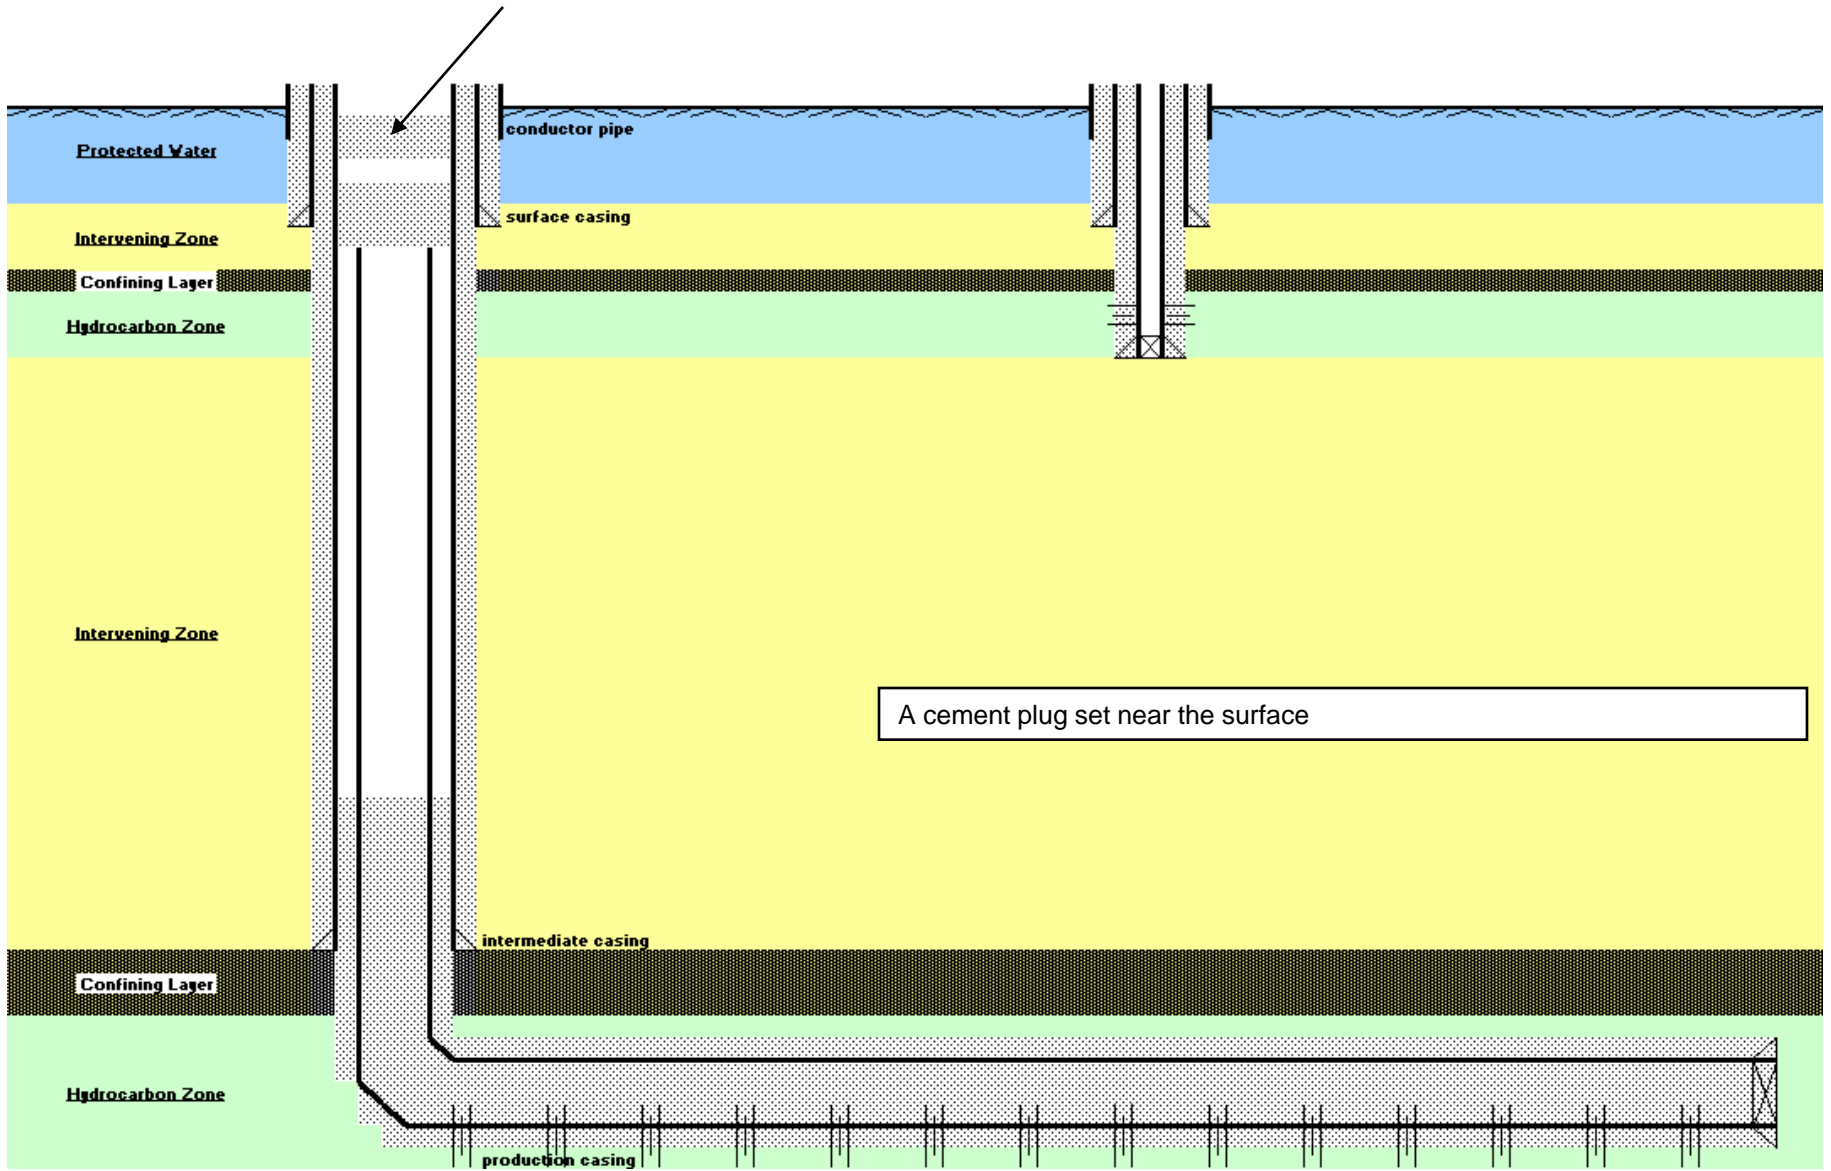
Slide 21 of 22 – Shallow surface plug is set and tested
