Case Study for Well Integrity over a Full Life Cycle

Lloyd H. Hetrick, PE, CSP
Newfield Exploration Company

Abstract

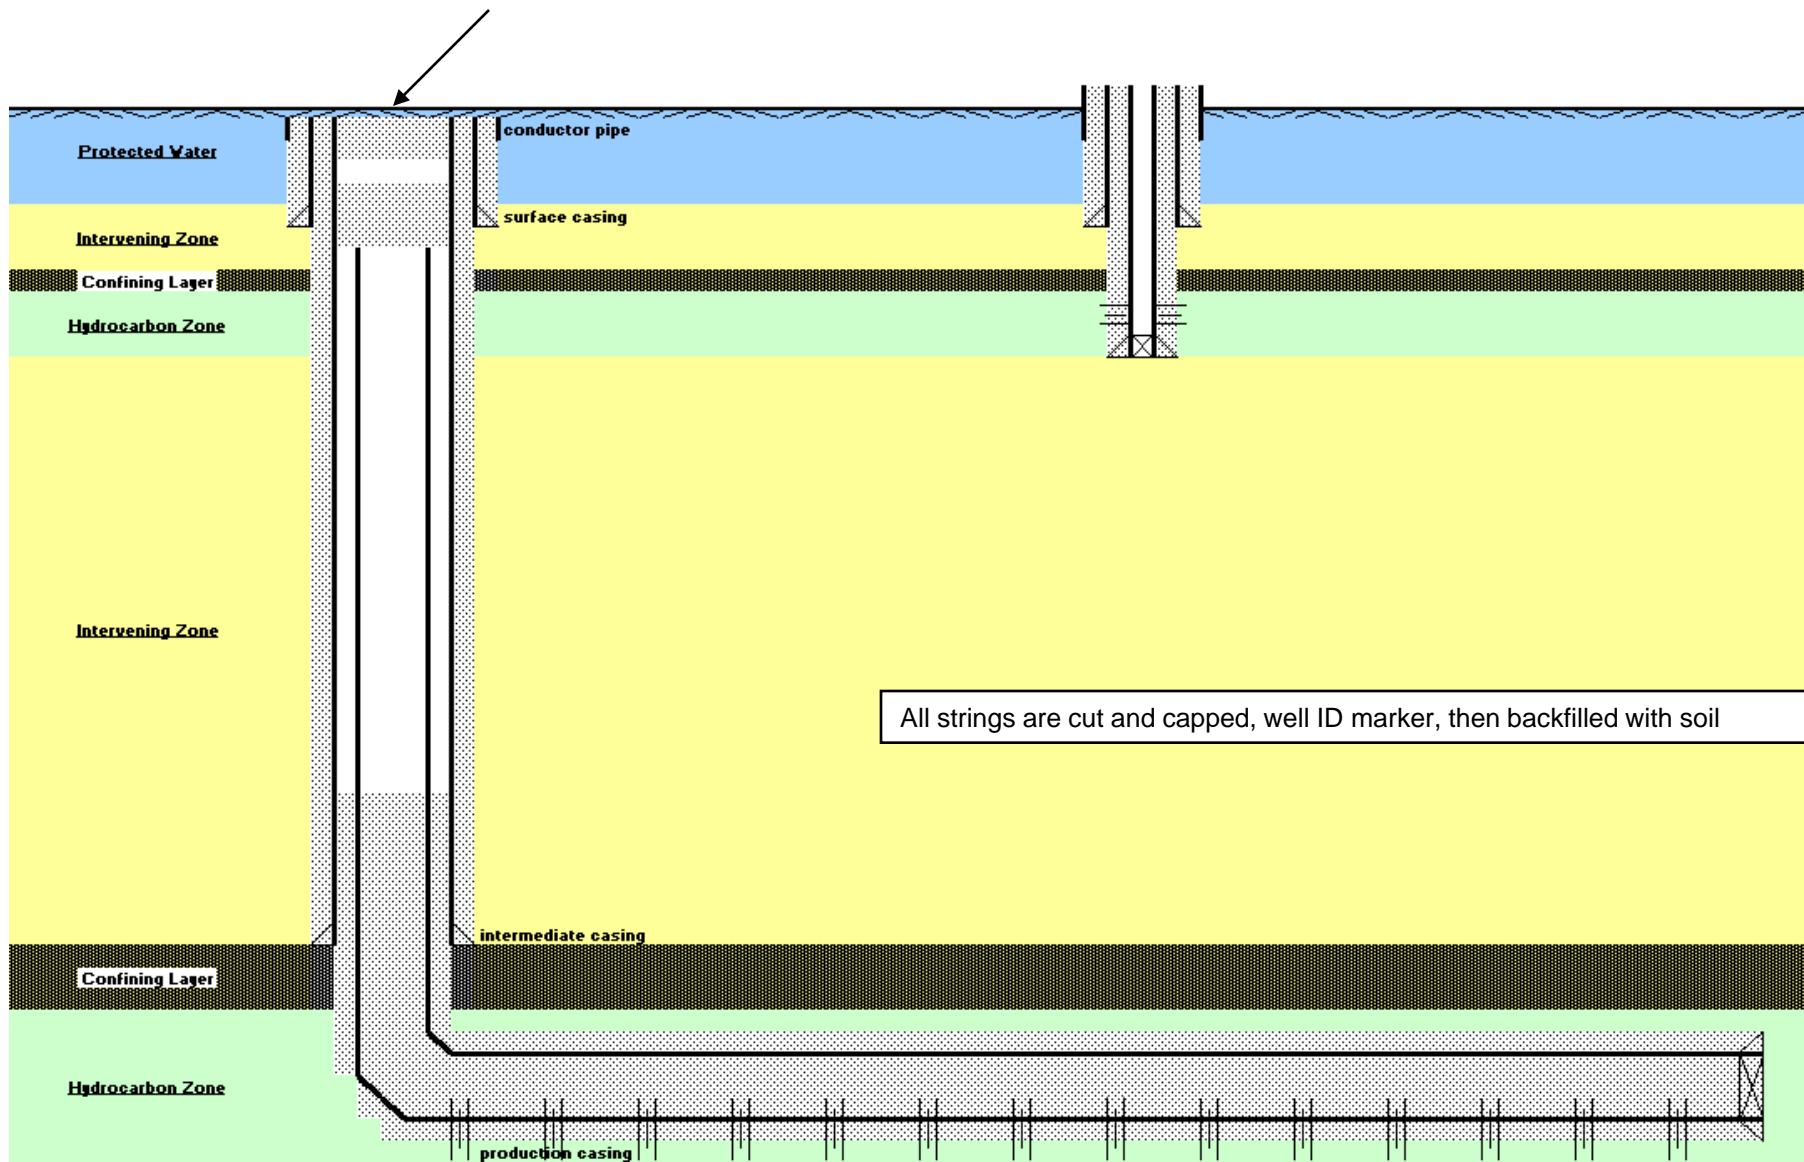
Slide 22 of 22 – Pipe cut-off, cap welded, well ID marker, backfill

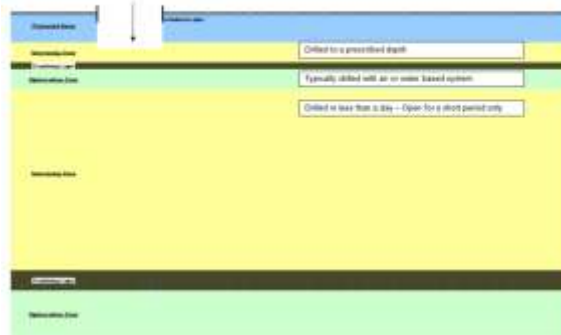
EPA Hydraulic Fracturing Study Technical Workshop #2 March 10-11, 2011
Well Integrity Case Study by Lloyd H. Hetrick
Slide 5 of 22 – Well is drilled to a prescribed depth below Protected Water

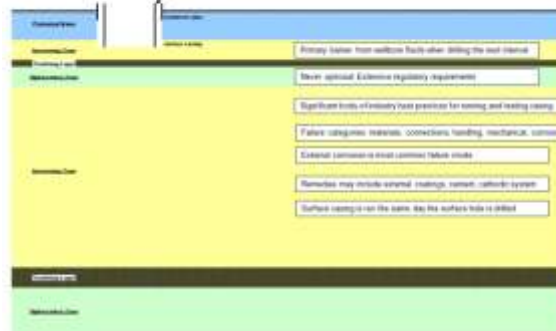
EPA Hydraulic Fracturing Study Technical Workshop #2 March 10-11, 2011
Well Integrity Case Study by Lloyd H. Hetrick
Slide 6 of 22 – Surface casing is run

The surface casing string is the primary barrier to prevent fluids from the wellbore from entering protected water as the well is being drilled to the next casing setting depth. Unlike the conductor pipe, surface casing is always required and is typically specified by regulation to be of “suitable and sufficient” quality (19) or “suitable for all drilling and operating conditions such as tension, burst, collapse” (20). For all casing strings, industry best practices provide extensive guidance on the selection of proper casing size, grade, weight, connections, plus procedures for field handling, inspection, and testing (21) (22) (23) (24) (25) (26) (27). For our case study well, the surface casing is “run” or installed in a few hours during day #1 of the drilling operation.

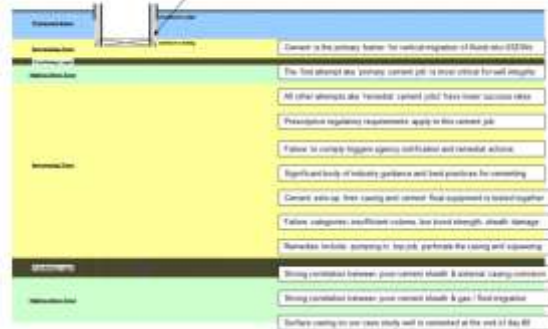
EPA Hydraulic Fracturing Study Technical Workshop #2 March 10-11, 2011
Well Integrity Case Study by Lloyd H. Hetrick
Slide 7 of 22 – Surface casing is cemented and tested

There is a significant body of information published on cement selection and cementing best practices (31) (32) (33) (34). There is also a significant body of information available on cementing failure rates (35) (36). This Well Integrity Case Study will focus on those conditions which directly relate to zonal isolation for the protection of USDWs, briefly discussing three failure categories, with their respective modes and relative failure rates, and remedial options:

- Insufficient cement volume – underestimated annular volume, lost circulation
- Low bond strength – poor slurry design, poor management of hydrostatic head pressure
- Micro annulus, cracking, plastic deformation – thermal and pressure effects, cyclic loads

Cement failure rates are directly proportional to the ability to evaluate the top of and quality of the cement sheath. Cement tops can be identified by a temperature log, relative cement bond quality can be identified by a Cement Bond Log or CBL, while absolute cement bond quality requires a combination of logging, testing, and engineering analysis (37).

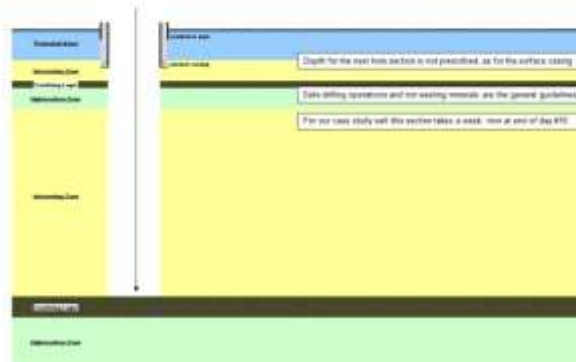
EPA Hydraulic Fracturing Study Technical Workshop #2 March 10-11, 2011
Well Integrity Case Study by Lloyd H. Hetrick
Slide 9 of 22 – Next section of hole is drilled

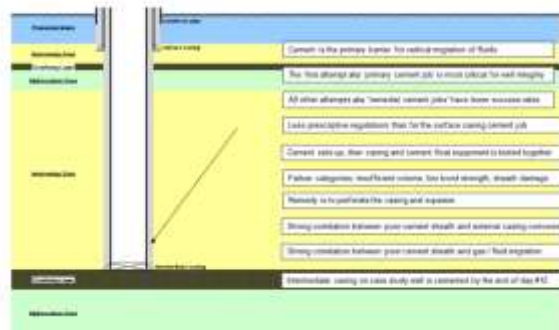
EPA Hydraulic Fracturing Study Technical Workshop #2 March 10-11, 2011
Well Integrity Case Study by Lloyd H. Hetrick
Slide 11 of 22 – Intermediate casing is cemented and tested

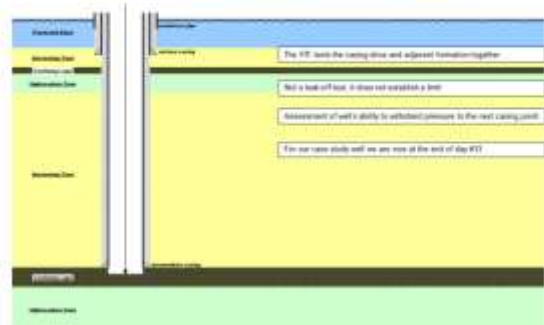
EPA Hydraulic Fracturing Study Technical Workshop #2 March 10-11, 2011
Well Integrity Case Study by Lloyd H. Hetrick
Slide 12 of 22 – Intermediate casing shoe and formation integrity are tested

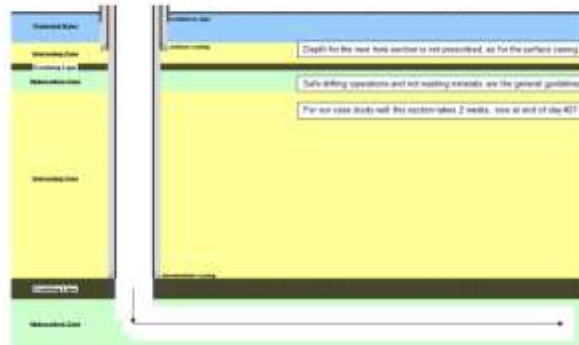
EPA Hydraulic Fracturing Study Technical Workshop #2 March 10-11, 2011
Well Integrity Case Study by Lloyd H. Helwick
Slide 13 of 22 – Next section of hole is drilled

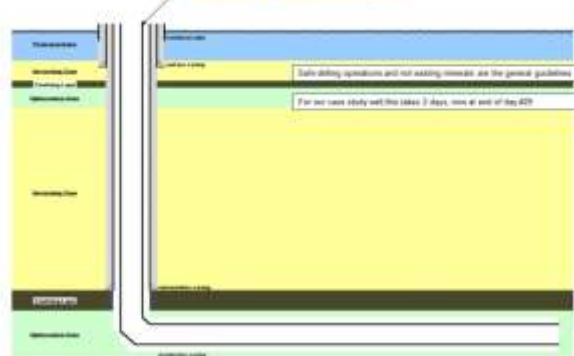
EPA Hydraulic Fracturing Study Technical Workshop #2 March 10-11, 2011
Well Integrity Case Study by Lloyd H. Helwick
Slide 14 of 22 – Production casing is run

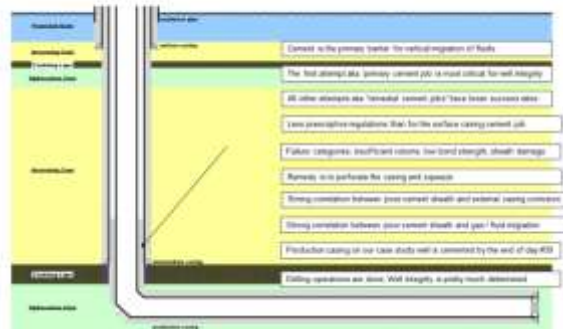
EPA Hydraulic Fracturing Study Technical Workshop #2 March 10-11, 2011
Well Integrity Case Study by Lloyd H. Helwick
Slide 15 of 22 – Production casing is cemented, Drilling phase is done

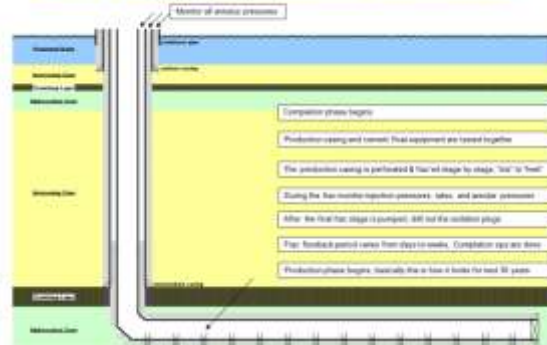
EPA Hydraulic Fracturing Study Technical Workshop #2 March 10-11, 2011
Well Integrity Case Study by Lloyd H. Helwick
Slide 16 of 22 – Completion phase: perforate, hydraulically frac, flowback, production begins

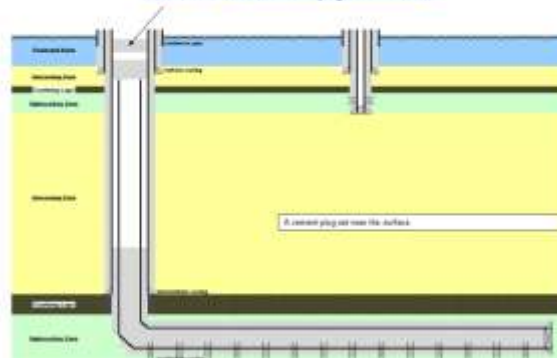
EPA Hydraulic Fracturing Study Technical Workshop #2 March 10-11, 2011
Well Integrity Case Study by Lloyd H. Helwick
Slide 21 of 22 – Shallow surface plug is set and tested

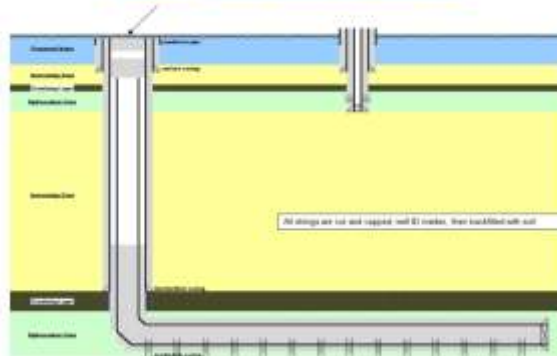
EPA Hydraulic Fracturing Study Technical Workshop #2 March 10-11, 2011
Well Integrity Case Study by Lloyd H. Helwick
Slide 22 of 22 – Pipe cut-off, cap welded, well ID marker, backfill
