# River Restoration Activities in the Rio Grande Canalization Flood Control Project in the Lower Rio Grande, NM

Elizabeth Verdecchia  
International Boundary and Water  
Commission, U.S. Section  
New Mexico Water Conference  
November 22, 2013

# Rio Grande Canalization Flood Control Project

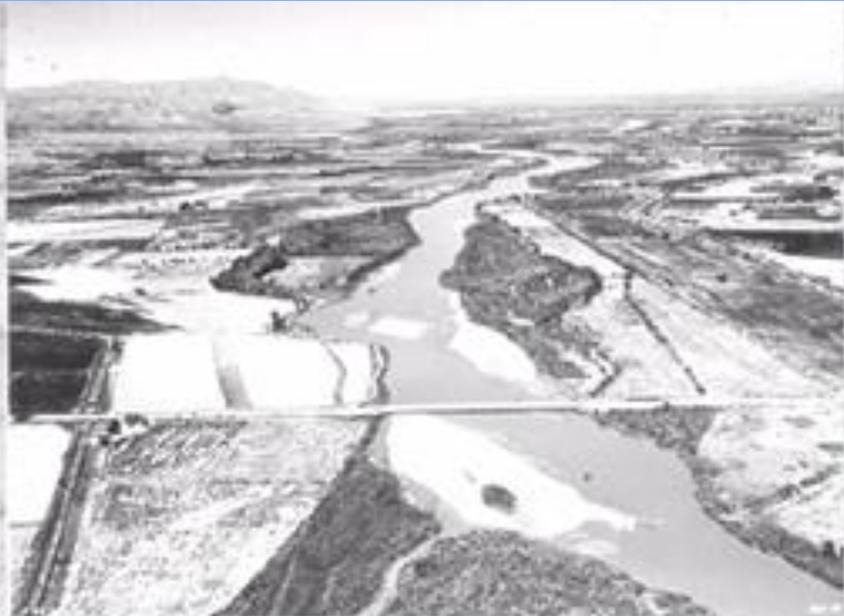
**October 1938 - Canalization Project.  
Looking upstream on Rio Grande at Picacho Bridge  
(U.S. 80) near Las Cruces, New Mexico, prior to levee  
construction and channel stabilization.**

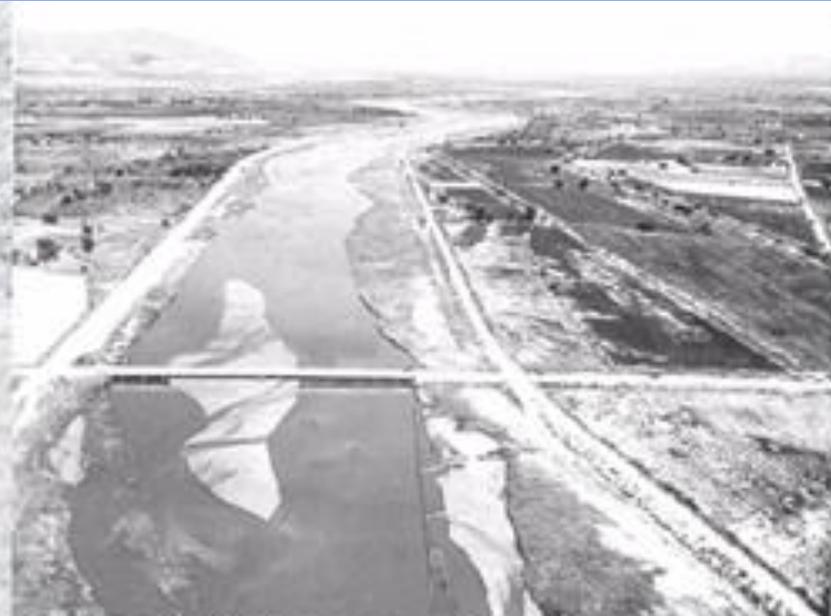
**October 1942 - Same scene after levee construction  
and at start of channel stabilization works.**

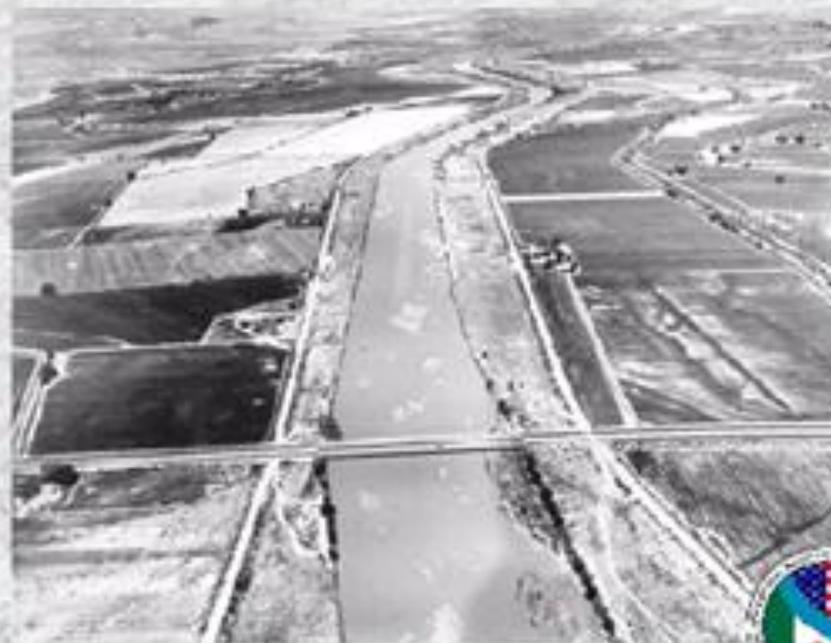
**August 1956 - Same scene after channel stabilization  
completion.**

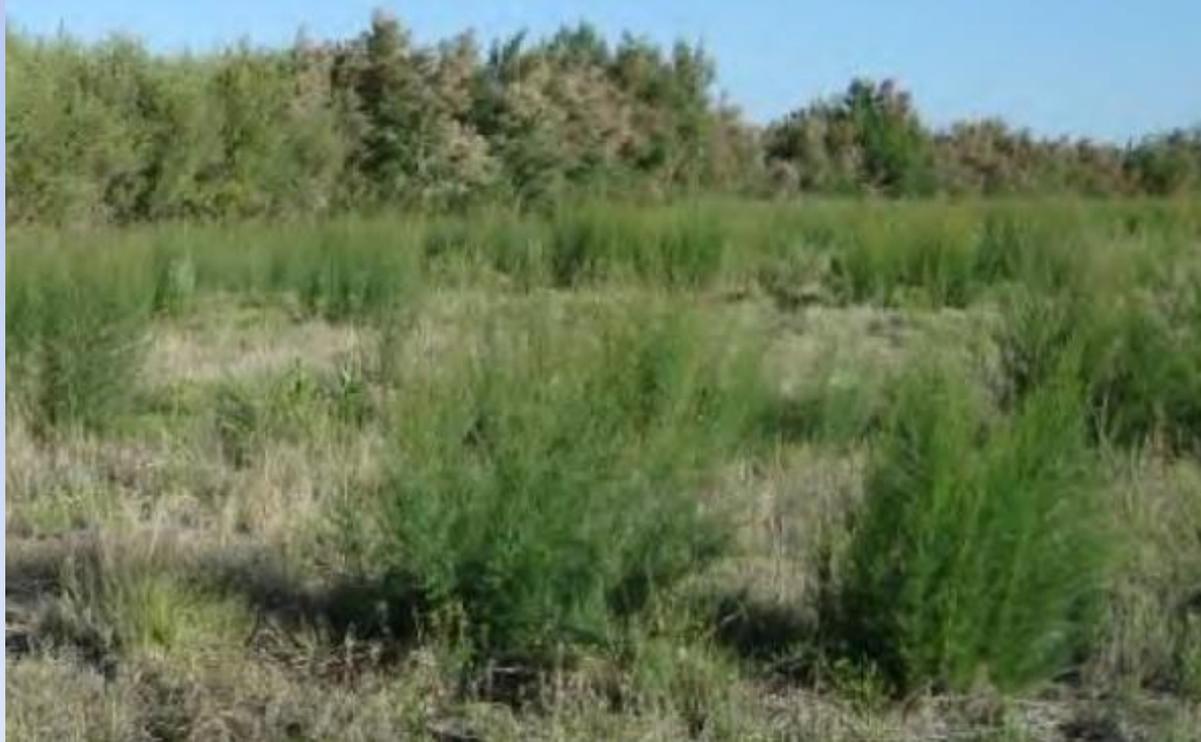
Before - Crow Canyon B, summer 2011

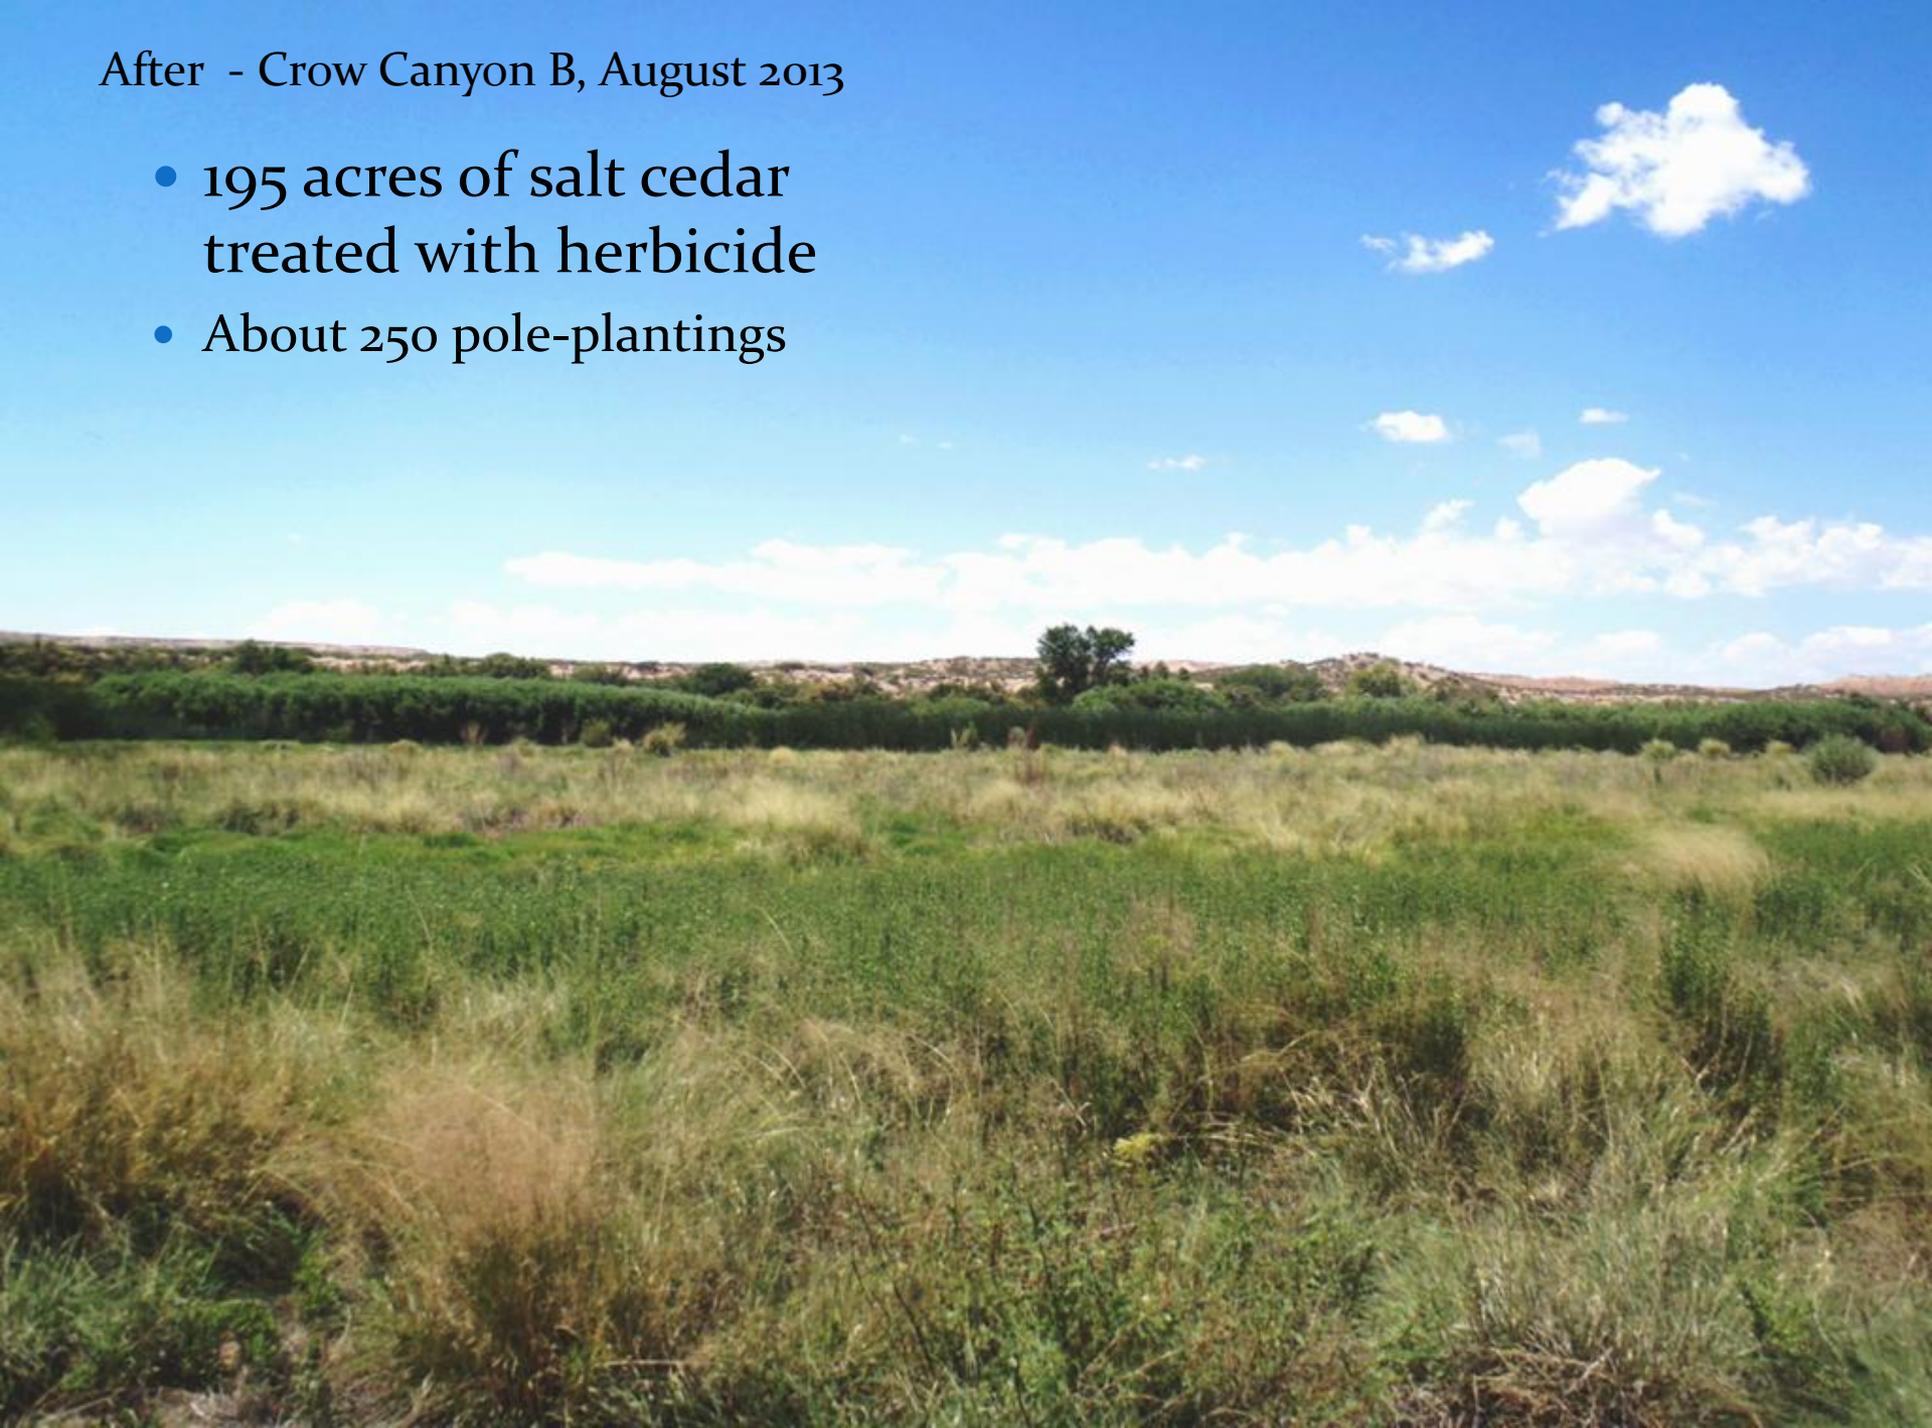
After - Crow Canyon B, August 2013

- 195 acres of salt cedar treated with herbicide
- About 250 pole-plantings

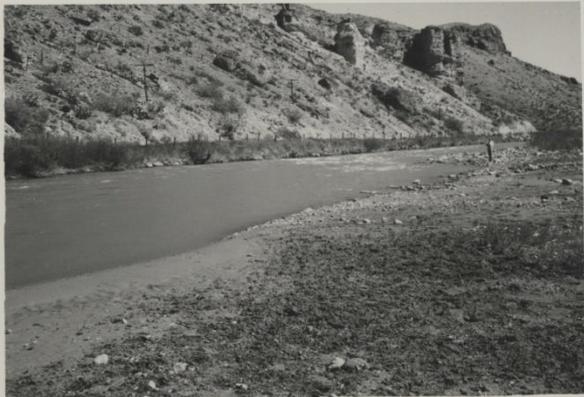
LOOKING DOWNSTREAM AT RAPIDS IN RIVER AT MOUTH  
OF BROAD CANYON, APRIL 25, 1940

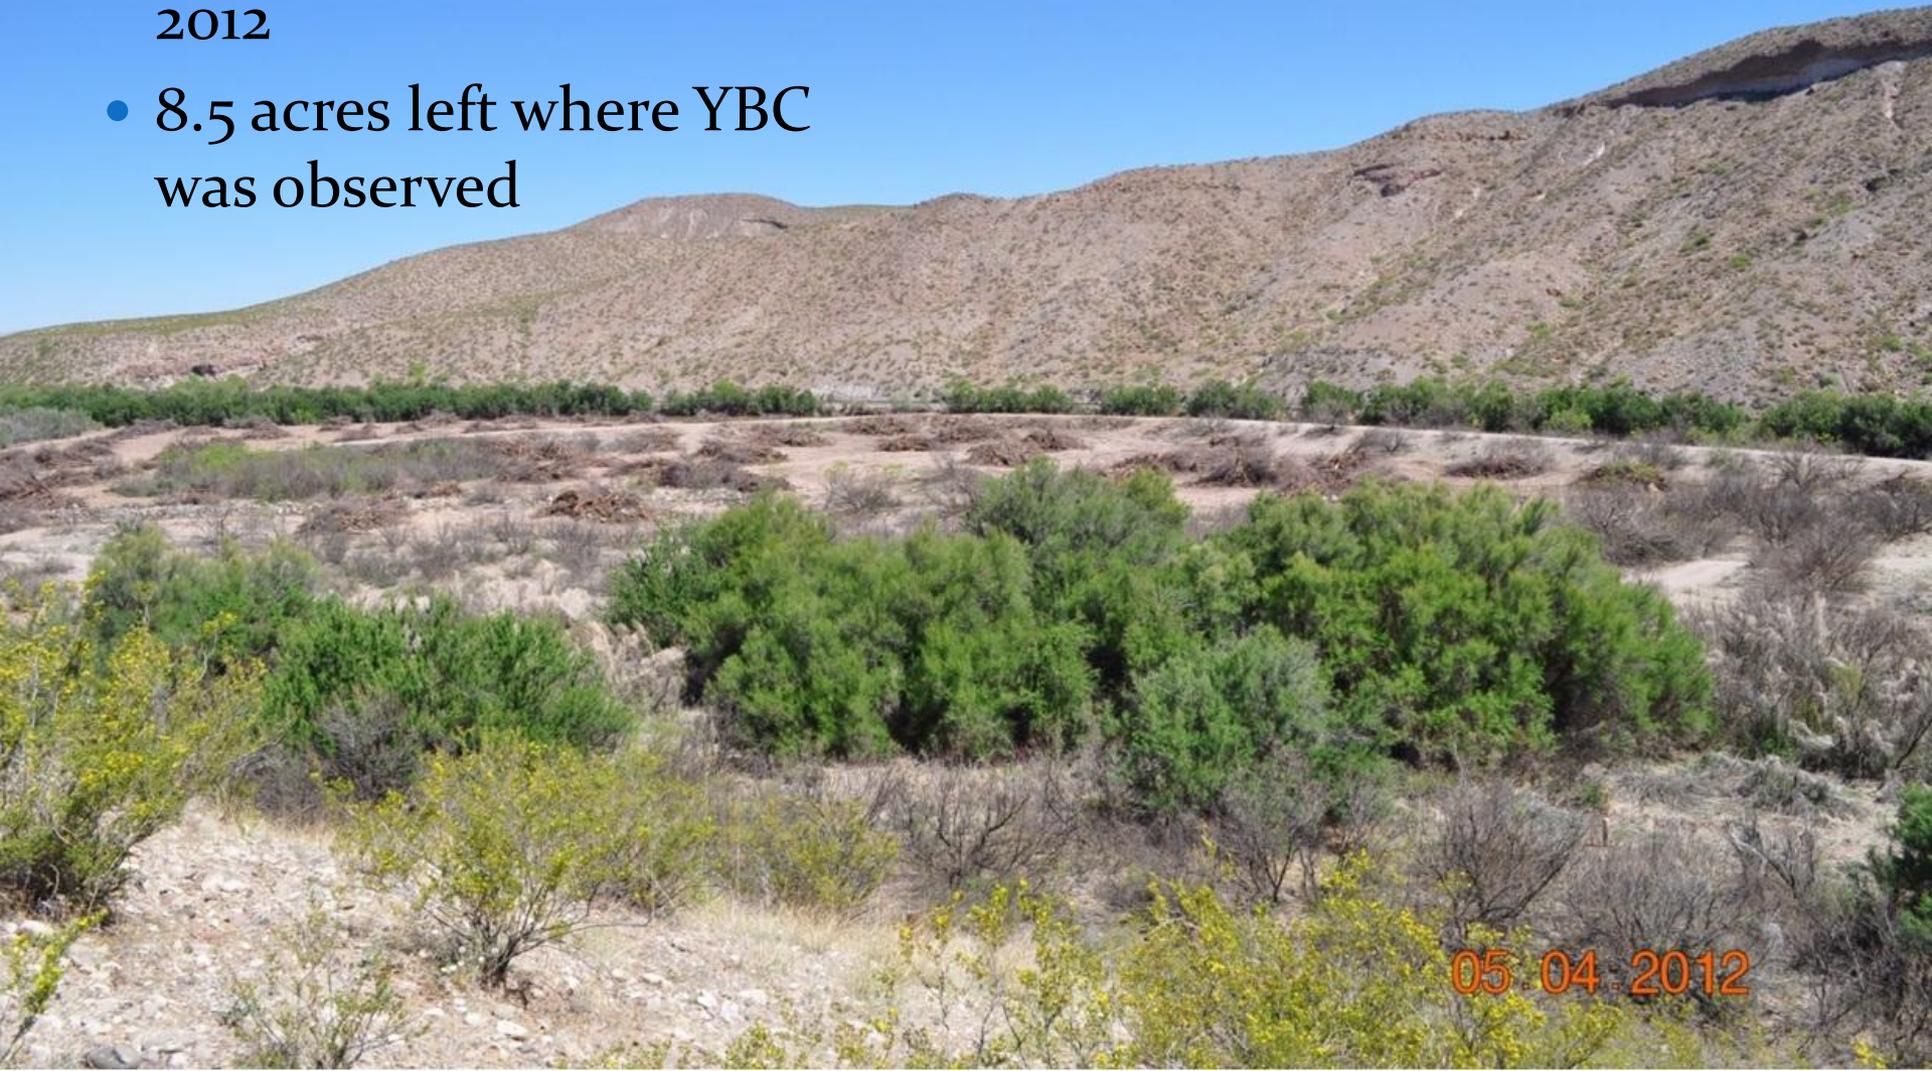
05.04.2012

- 20 acres of salt cedar treated by excavator in 2012
- 8.5 acres left where YBC was observed

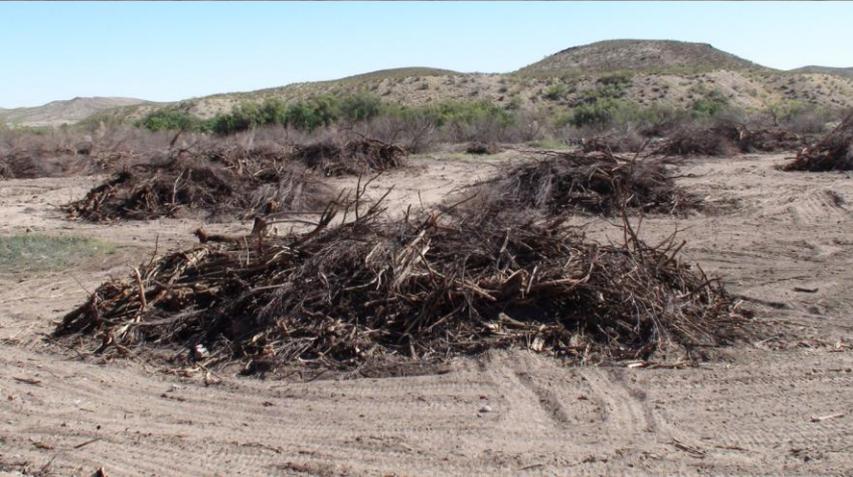
01.09.2013

- Prescribed burns for debris piles conducted January 2013

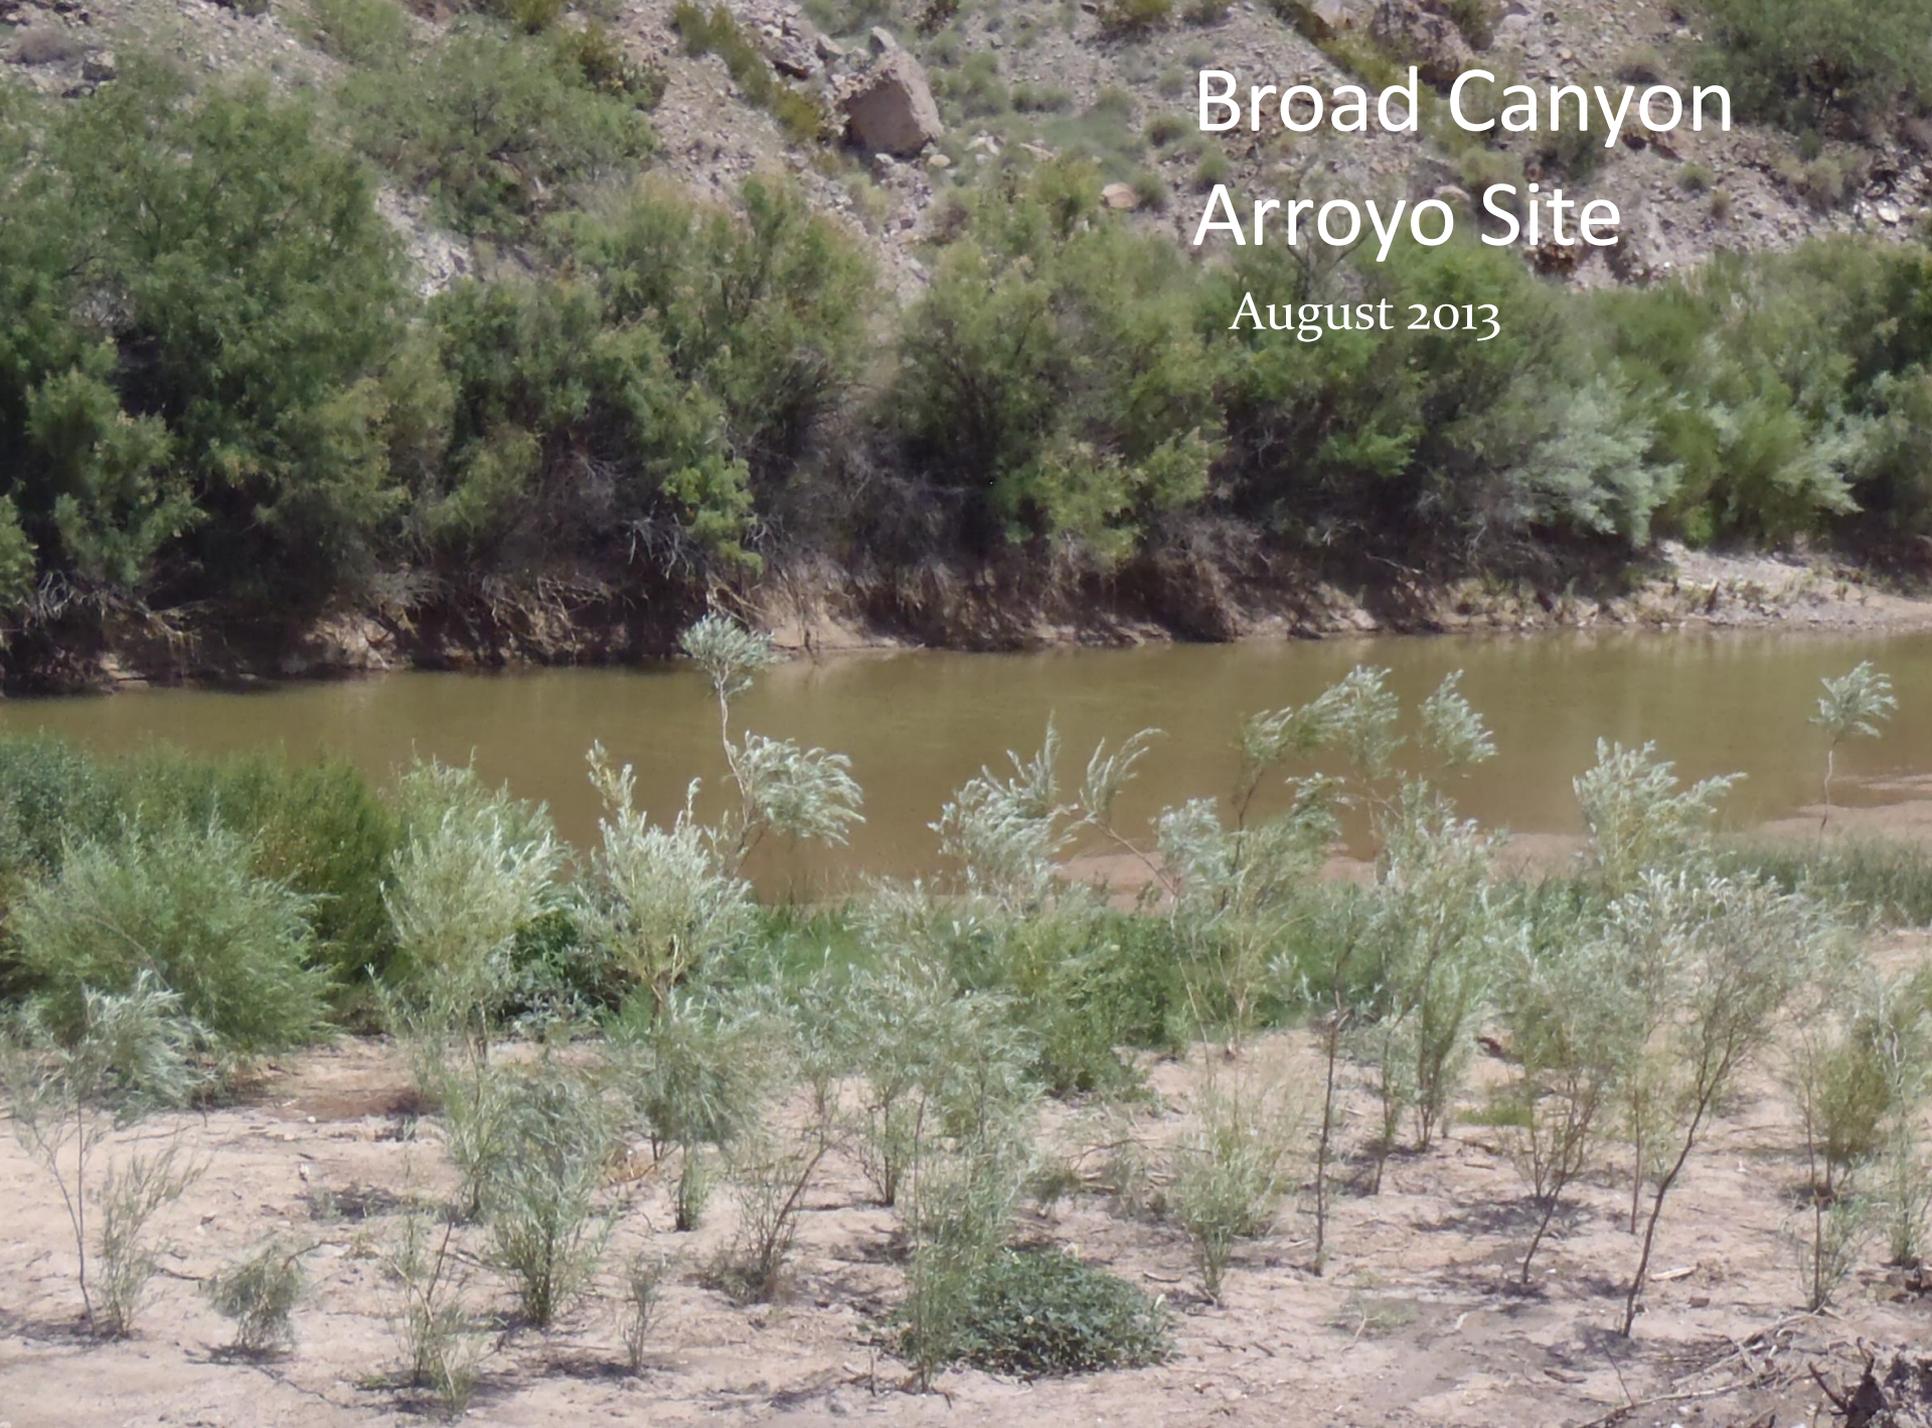
August 2013

- 30 acres salt cedar treated with stump cut herbicide treatment
- 1,500 pole-plantings

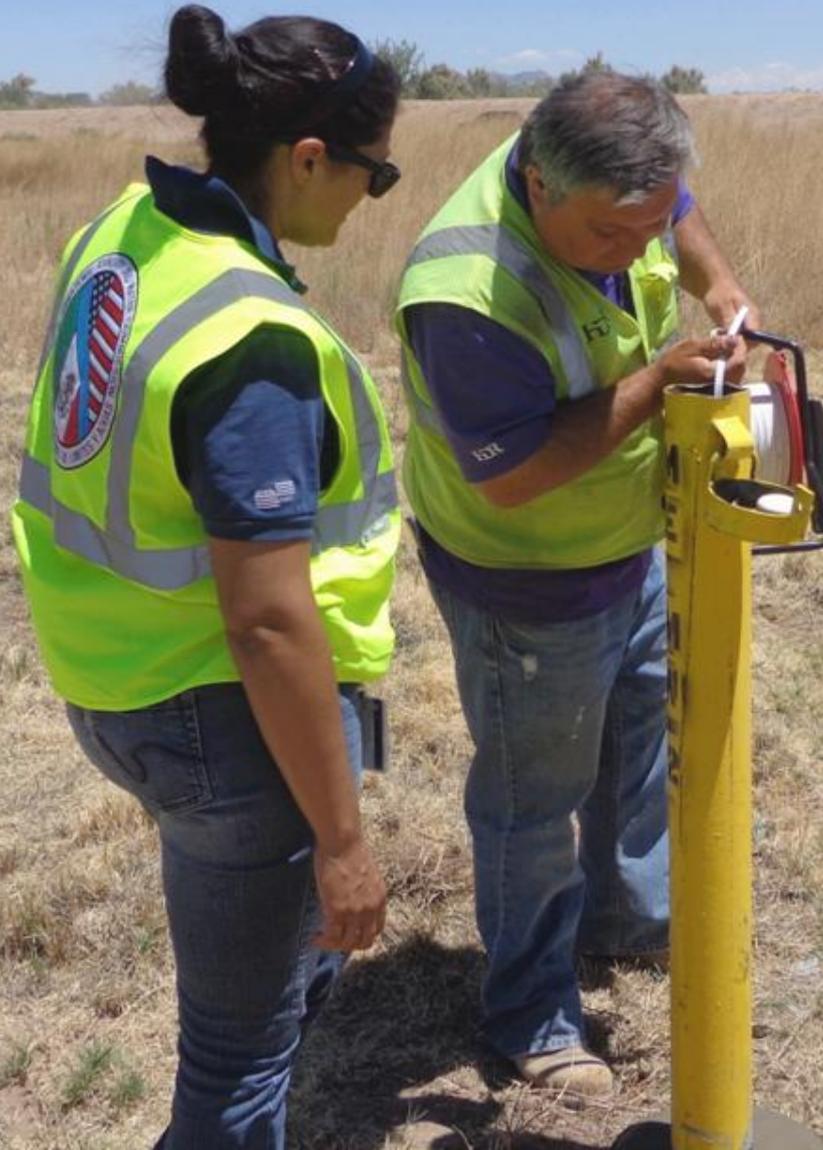
- 55 wells installed at 21 sites within the floodplain in 2013-2014
- Measure variation during drought and irrigation releases
