## Long-Term Stewardship Inspection Report

### Atlantic Coast Environmental (ACE) – Dover, Delaware – DED000796300

Date: December 17, 2014

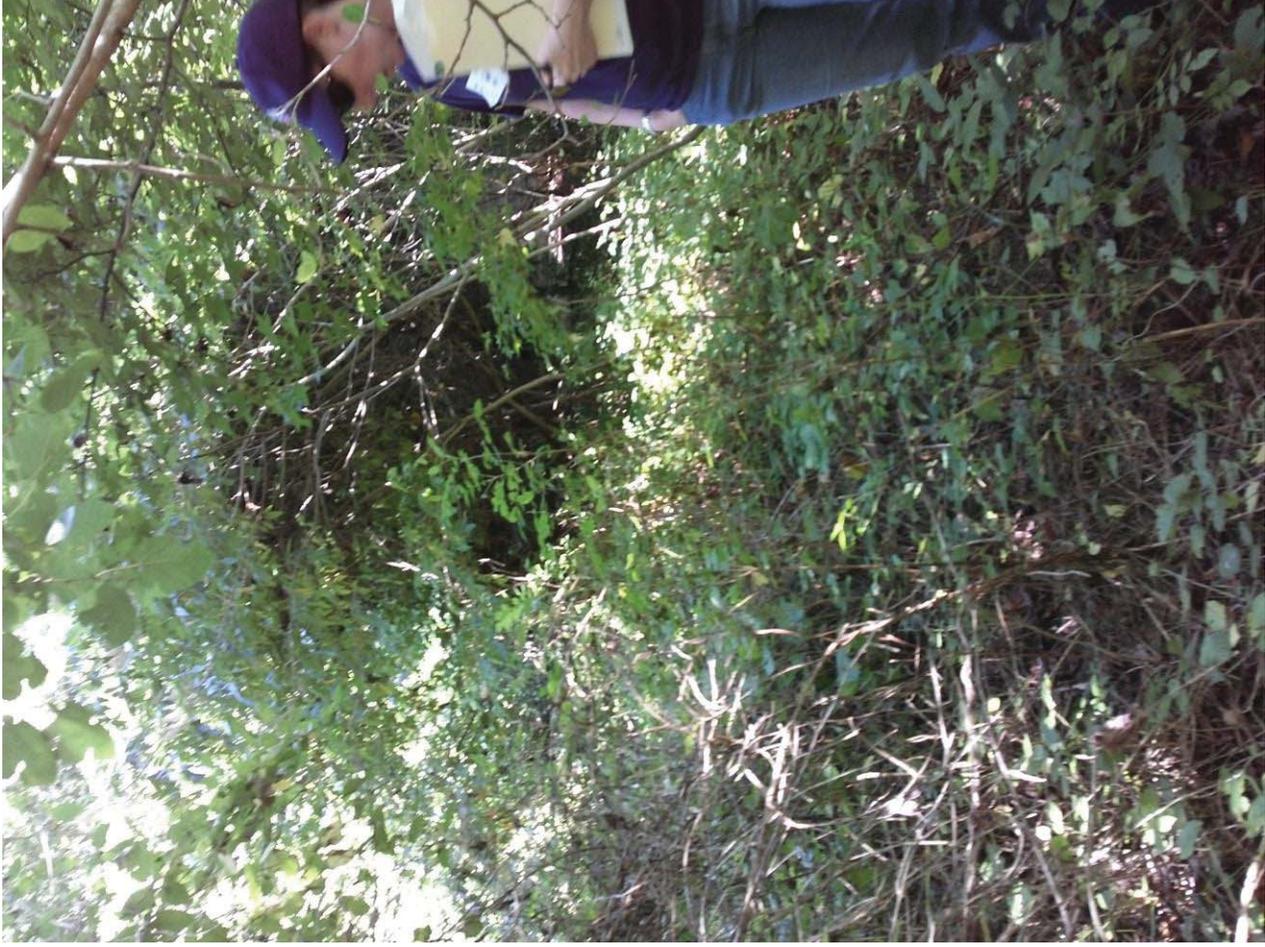
Placemark 1 – Waste Cap Area

On top of the cap, there was significant vegetation with a few small trees growing, but no larger trees were observed.

- Clear vegetation (trees) growing on the waste cap area to remove the potential for root penetration and damage to the waste cap that could occur if trees are allowed to remain.

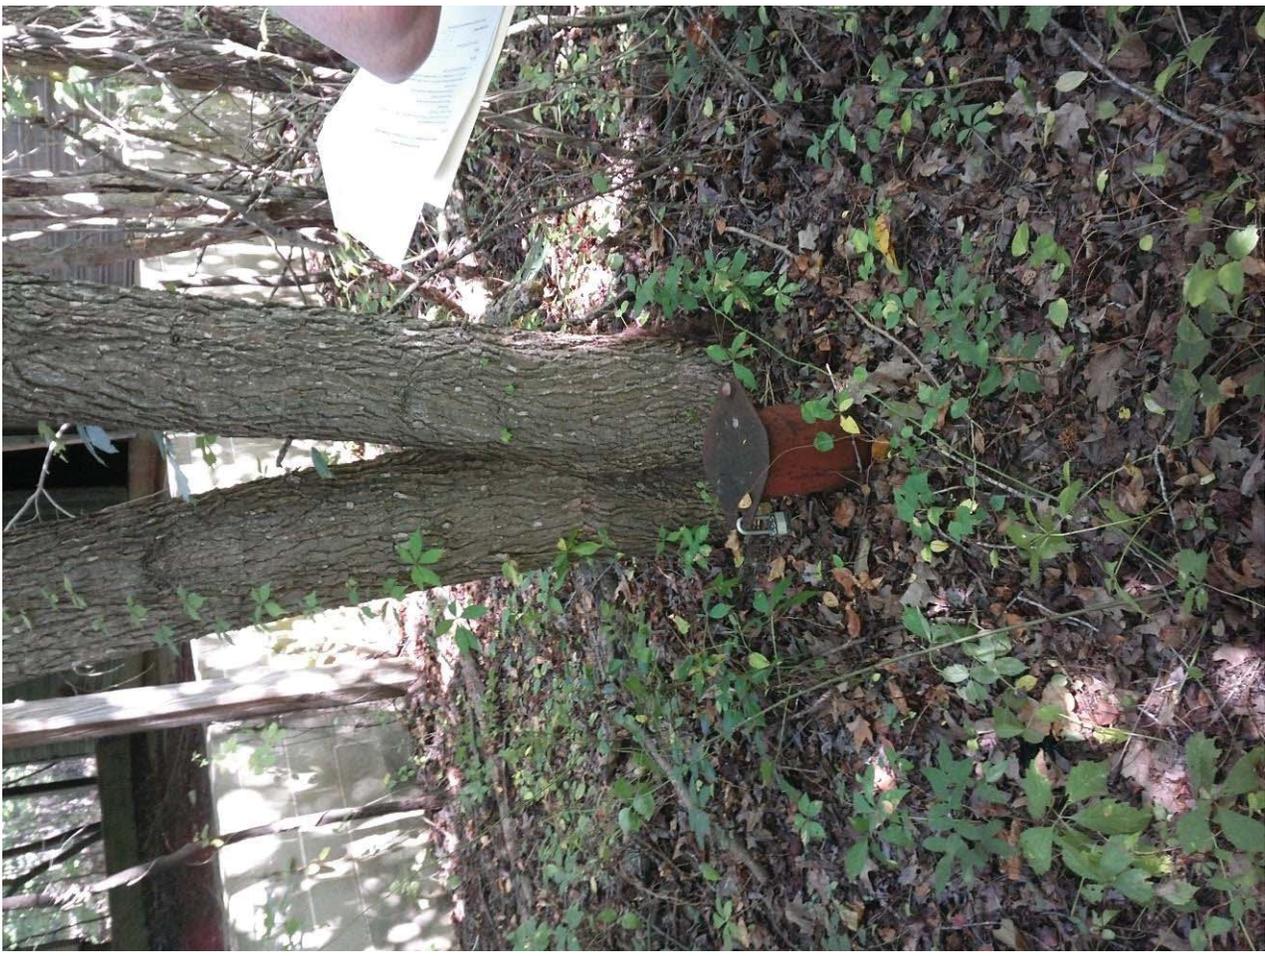
Placemark 2 – MW-4

All of the monitoring well locations were observed. All wells outside the fence line were damaged (plugged). For some of the wells, the surface casing had been pulled out of the ground (lying nearby) and all the wells were plugged with what appeared to be bentonite. These damaged monitoring wells included: MW-5, MW-5D, MW-6, MW-8, MW-9, MW-10 (see Attachment D). Wells MW-1, MW-1D, MW-2, MW-2D, MW-3, MW-4, and MW-7 located within the fence line all appeared in reasonably good condition and were locked.

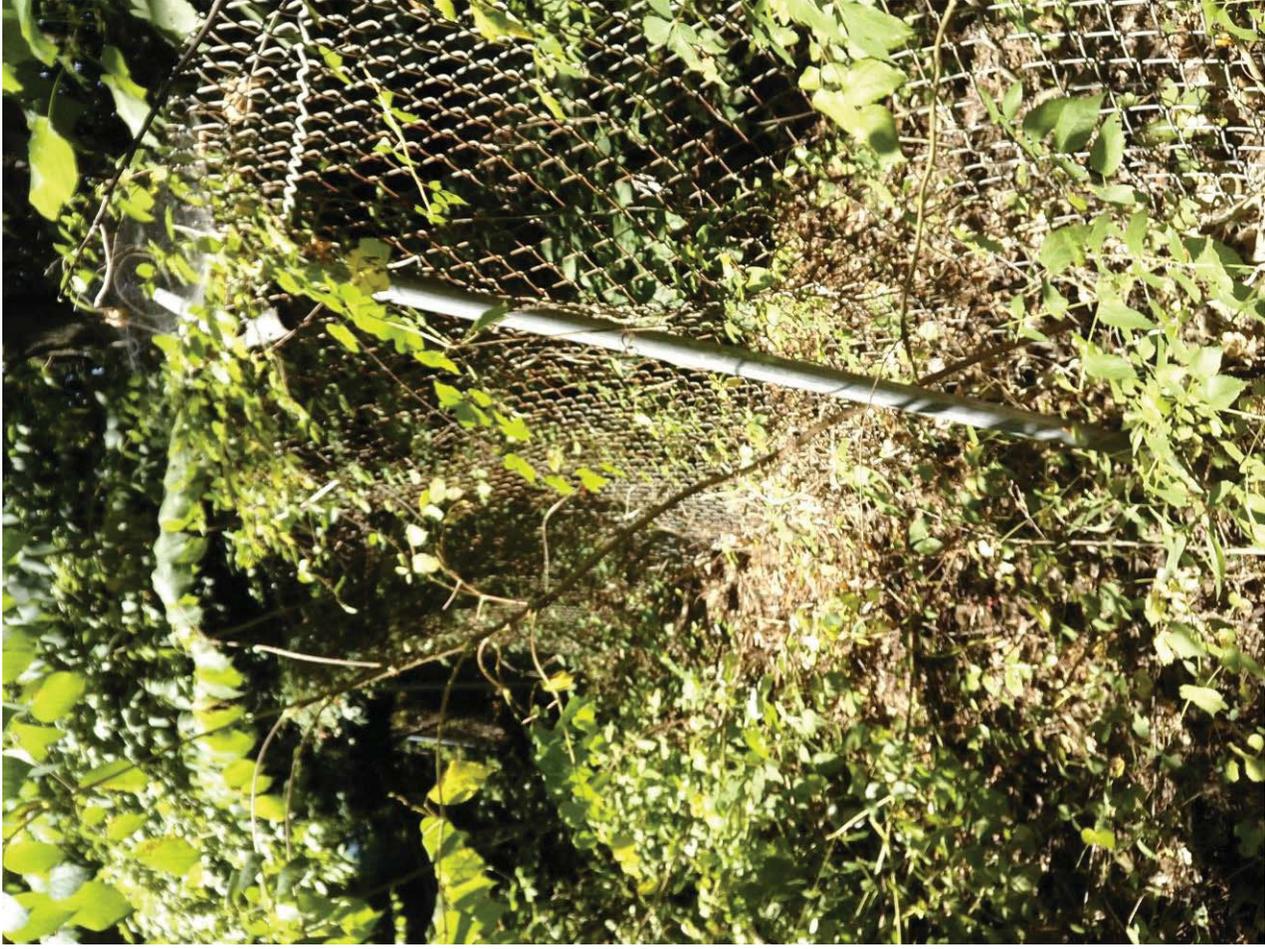
Placemark 9 – Damaged fence

While walking along the fence line, there were some areas observed in which the fence was damaged (see Attachment D). In one instance, the fence was slightly buckling, and in another, a tree was on top of the fence.

- Update the fact sheet on the EPA web page for this facility to reflect current monitoring frequency.
- Require maintenance of the fence line: remove trees that have fallen onto the fence; repair fence as needed.
