NONPOINT SOURCE PROGRAM SUCCESS STORY

Hawaii

Restoring Native Vegetation Reduces Sediment Entering Coastal Waters

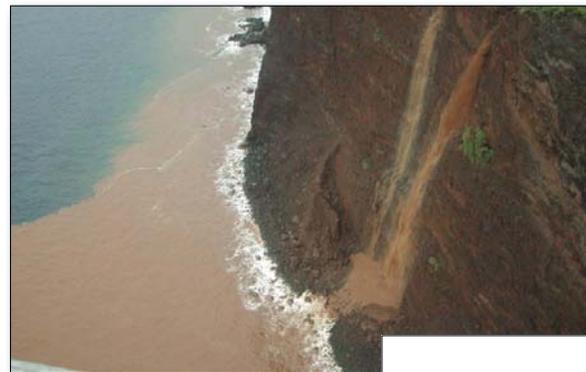
Figure 1. A lack of vegetation leads to excessive erosion on Kahoʻolawe, which in turn causes sediment loading into adjacent marine waters.

An estimated 1.9 million tons of soil per year is eroded from Kahoʻolawe (Figure 1). This erosion results in extremely high ocean turbidity following rainfall events, affecting coral health and reproduction (although this seems to be improving as a result of long-term revegetation efforts). In 1990 litigation ended the U.S. Navy's use of the island as a bombing range and resulted in transfer of the island to the Kahoʻolawe Island Reserve Commission (KIRC). A cleanup project conducted from 1993 to 2004 set the stage for restoration.

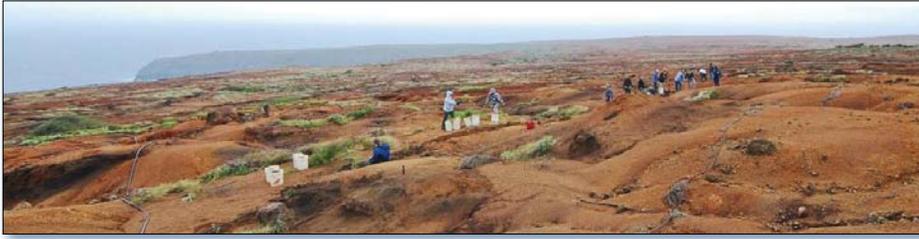
Figure 3. Volunteers plant native shrubs and grasses for Hakiowa's revegetation.

annually. Specific activities undertaken by the project include developing erosion control BMPs, removing and controlling alien animal and plant species, and refining revegetation techniques (Figure 3).
