Section 319 NONPOINT SOURCE PROGRAM SUCCESS STORY

New Hampshire Stakeholders Cooperate to Stabilize River and Restore Habitat

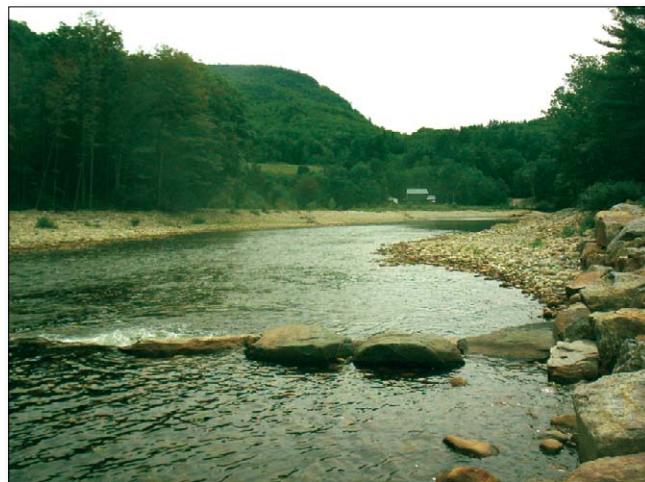
Figure 1. A porous rock weir helps to stabilize the restored section of the Pemigewasset River.

The Pemigewasset River (Figure 1) originates in central New Hampshire's Franconia Notch State Park and flows south through the White Mountains until it merges with the Winnipesaukee River. In the late 1970s, sand and gravel were excavated from the river's active floodplain and used in constructing Interstate 93 near Woodstock, New Hampshire. The extraction created a 30-acre pit area and a large pond with depths up to 30 feet. The removal of floodplain materials caused the river to jump its bank (a process known as an avulsion) during a period of heavy rain when the river flow accessed the damaged floodplain. The river's new course flowed through unconsolidated materials and the pond.

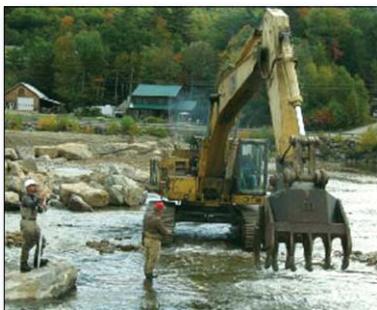
Figure 2. Construction contractors and the project's fluvial geomorphologist used heavy equipment to construct in-stream features.

Project partners corrected the channel's alignment, elevations, and dimensions by using large boulders to construct more than a mile of cross-vanes and rock vanes, adding targeted streambank toe protection, and creating more than 900 linear feet of floodplain stabilization structures (Figure 2). Project partners planted more than 150 mature willow clumps and more than 50 trees ranging from one to five inches in diameter. They also planted wetland grasses, plants and

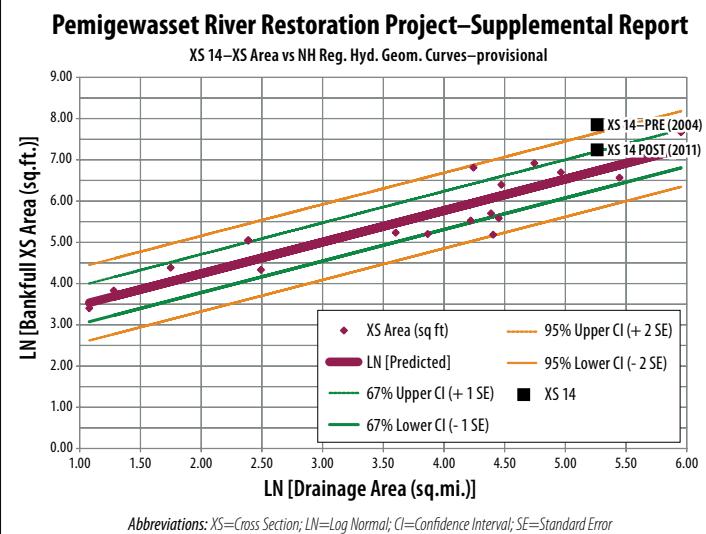
Figure 3. A regional hydrologic geometry curve shows how pre-project (2004) and post-project (2011) stream channel measurements for cross section 14 (black squares) compare to predicted stable channel condition dimensions (includes area between the upper and lower confidence intervals). Data show that the restored segment falls within the upper confidence interval, indicating that it maintains stable channel dimensions. Similar graphs were analyzed for multiple cross sections and stability indicator metrics.

Members of Trout Unlimited, with technical assistance from the project's consulting team, monitor channel cross-section dimensions (cross-sectional area, bankfull width, and bankfull depth) as the prime indices of channel stability. To assess the stability of the restored stream reach to determine whether it supports the designated use for aquatic life, DES reviewed geomorphic survey data collected in 2011. Analysis confirms that, despite significant destruction of transplanted riparian vegetation by beavers and record flood flows experienced in the fall of 2011, the geomorphic indices in the project area continue to remain within acceptable ranges and are considered stable (Figure 3). The stream reach now provides physical conditions supportive of the aquatic life designated use. On the basis of these data, NHDES will not classify the river segment as impaired for aquatic life use by flow regime alterations in the state's 2012 CWA section 305(b) report. Pemigewasset River assessment unit NHRIV700010203-01 remains on the CWA section 303(d) list of impaired waters due to aluminum, pH and mercury.
