# NONPOINT SOURCE PROGRAM SUCCESS STORY

## Group Restores Stream Degraded by Abandoned Coal Mine Discharges

EPA 841-F-11-001AA  
April 2011

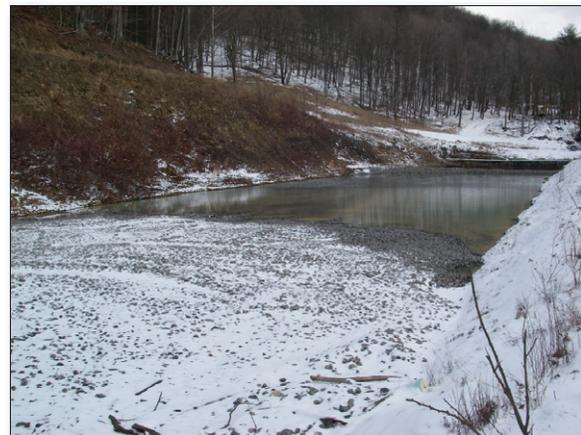
Figure 1. This limestone pond treats AMD in the Miller Run watershed.

AMD sources are typically addressed through a variety of remediation approaches. For example, the alkalinity of the polluted streams is increased to neutralize the acidity of the water and reduce metal loads, enabling aquatic organisms to return. SRWA installed passive treatment systems in the Miller Run watershed, including several limestone ponds (Figure 1) and wetlands, which allow metal precipitates to settle out. Limestone sand added

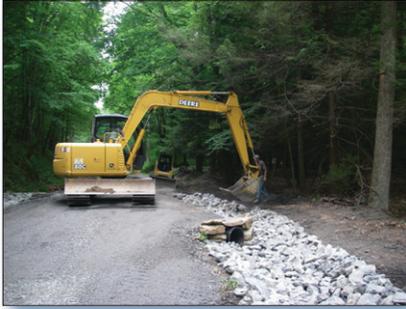
Figure 2. Partners added limestone rock to roadside ditches on the State Game Lands #67 access road to provide passive treatment for runoff.

In one reclamation effort, SRWA and the Huntingdon County Conservation District (HCCD) partnered to install a passive alkalinity project for an unpaved access road to State Game Lands #67, which runs along Miller Run. The

road had been built out of coal mine spoil and was contributing AMD to Miller Run with each runoff-producing rainfall event. The partners removed the acid-producing material from the roadway and replaced it with limestone rock. They also placed limestone rock in more than a mile of roadside ditches to reduce erosion and raise the alkalinity of runoff flowing to Miller Run (Figure 2).
