NONPOINT SOURCE PROGRAM SUCCESS STORY

Tennessee

Implementing Agricultural Best Management Practices Improves Water Quality in Cloyd Creek

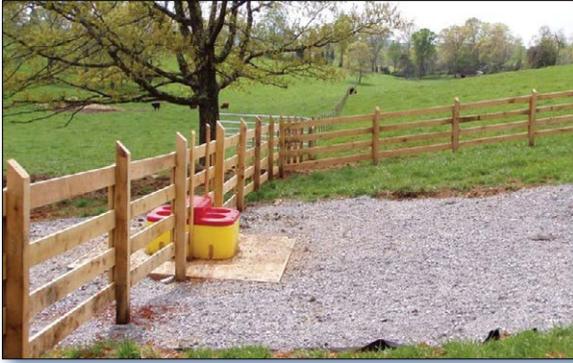
Figure 2. Landowners installed BMPs like this watering system for livestock, which includes exclusion fencing and heavy-use area protection.

BMPs were installed along Cloyd Creek and in the surrounding watershed from 1999 through 2011 to reduce siltation and physical substrate habitat alterations. BMPs installed within the watershed included 2.5 acres of critical area planting, one pond, 2,000 feet of fence, 3,762 feet of fencing for livestock exclusion, 4,540 feet of fencing for rotational grazing systems, one grade stabilization structure, 62 acres of pasture and hay planting, 20 acres of cropland conversion, 43 acres of pasture renovation, 5,936 feet of pipeline, 13 heavy-use areas, a stream crossing, and 13 watering facilities (Figures 2 and 3). Figure 1 shows the location of the BMPs installed along the creek.

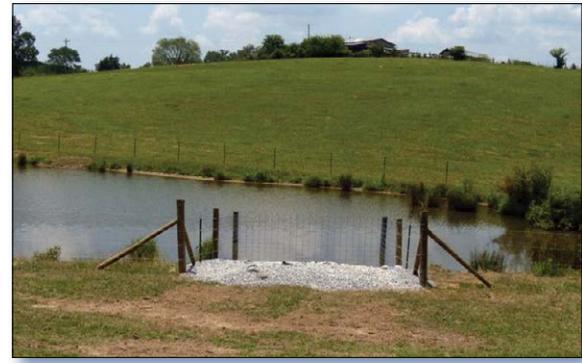
Figure 3. Fencing restricts livestock access to this pond when the water is not clean. A heavy-use area ramp helps to reduce sedimentation.
