# NONPOINT SOURCE PROGRAM SUCCESS STORY

# North Carolina

## Watershed Partnership Pays Off for Brasstown Creek

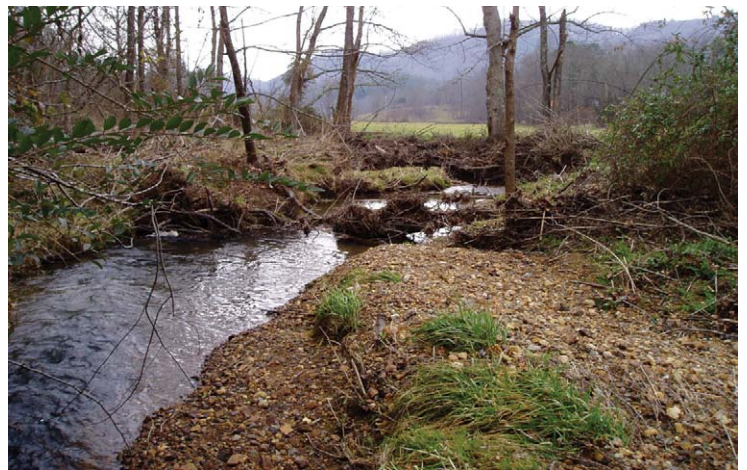
**Before:** Channel instability and bank erosion along this Brasstown Creek tributary were caused by historic channelization, lack of riparian vegetation, and cattle access.

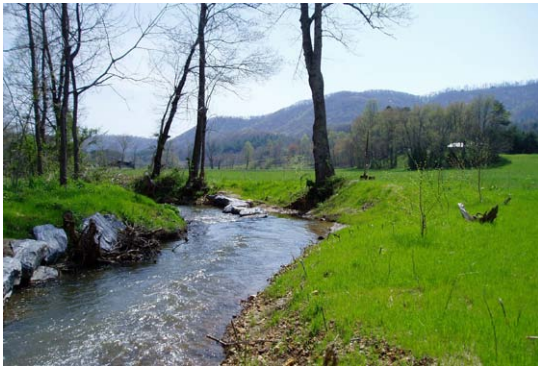
**After:** The rebuilt channel was designed with a more stable pattern, modeled after a similar, relatively undisturbed stream.

livestock exclusion fencing; reconstructed stream channels; and created, enhanced, or protected 48 acres of forested riparian buffer from 1999 through 2004. In addition, project partners installed stock trails, stream crossings, wells, and spring developments in heavy-use areas, thereby improving more than 2,000 acres of pastureland. These practices kept an estimated 650 tons of soil, 162 pounds of nitrogen, and 45 pounds of phosphorus out of Brasstown Creek annually.
