Section 319

NONPOINT SOURCE PROGRAM SUCCESS STORY

Stakeholders Cooperate to Control Sediment Inputs and Restore Navigability

EPA 841-F-09-001EE
September 2009

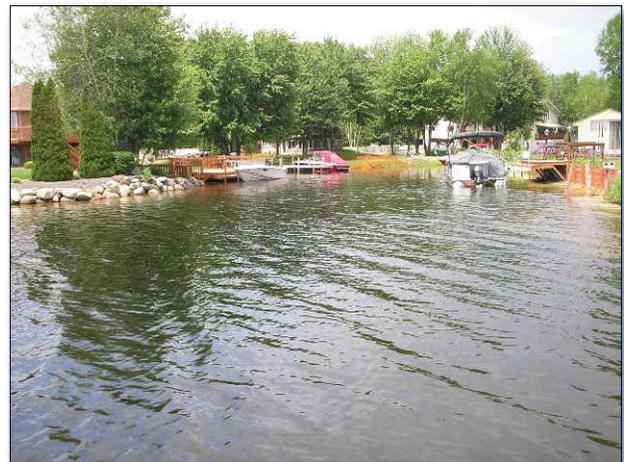
Figure 1. Summer 2008 photograph showing boats in the restored Middle Brook Canal.

Middle Brook is a tributary that enters Lake Winnepesaukee's Moultonborough Bay in the town of Moultonborough. Situated in a 75-acre sub-watershed, the canal is a 2,000-foot-long by 50-foot-wide man-made inlet at the mouth of Middle Brook (Figure 1). The canal provides access to boat docks for 39 canal-front residents. There is a boat ramp and a beach located on the southeast corner of the canal's confluence with Moultonborough Bay. The canal is within the Balmoral homeowner's association neighborhood. Balmoral consists of approximately 400 homes, about half of which are seasonal homes, and the other half are primary residences.

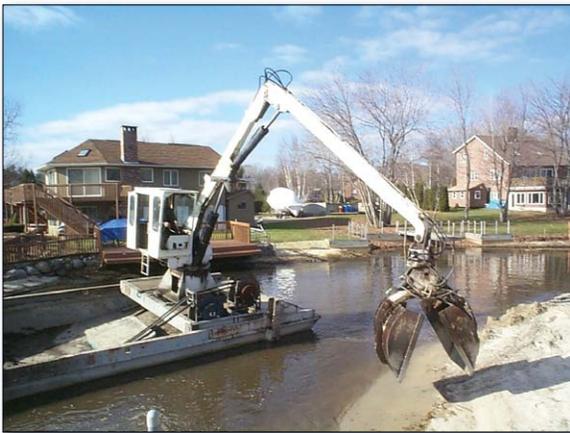
Figure 2: Dredge removing accumulated sediment from the mouth of Middle Brook Canal (Fall 2004).

After addressing the major erosion problems in the watershed, BIA received a U.S. Environmental Protection Agency (EPA) section 319 grant to restore the canal to navigable depths. An engineering firm hired by BIA completed a dredging plan, submitted permit applications for approval, and collected sediments for laboratory analysis. A local dredging company then removed tons of accumulated sediment from the canal (Figure 2) and created a 5.5-foot deep trapezoidal channel to allow for safe boat passage.
