# NONPOINT SOURCE PROGRAM SUCCESS STORY

# Vermont

## Stream Restored through Improved Agricultural Practices and Erosion Control Work

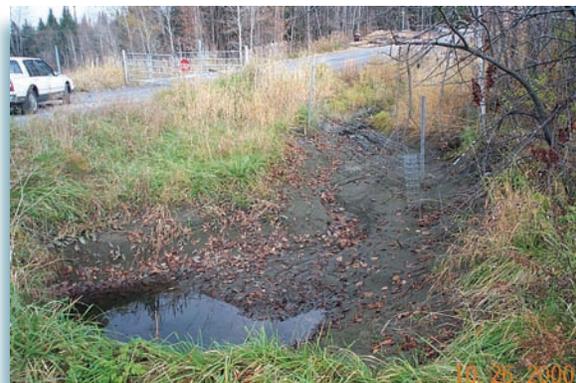
Ditch near Adams Brook prior to being lined with rock. Rock lining reduced sedimentation into Adams Brook.

the summer of 2002, the Vermont Agency of Transportation lined the eroding roadway ditches with stone and stabilized erosion at a nearby parking lot. All these actions contributed to bringing the stream into compliance with Vermont's water quality standards.

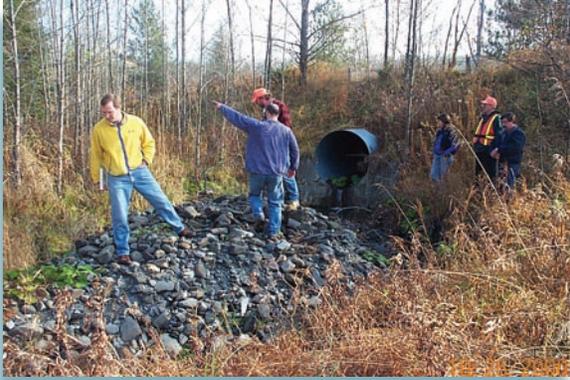
Geomorphic instability and an unauthorized culvert (upstream of the location in this photo) caused heavy erosion and the dumping of rock piles at the culvert shown here. Removing the unauthorized culvert helped to address the instability and reduce the water quality impacts on Adams Brook.

In 1998, the U.S. Department of Agriculture and the Vermont Agency of Agriculture, Food and Markets worked with a local farmer to plug a leak in the farm's manure storage pit. They also expanded the pit size to better accommodate the volume and type of animal waste being generated. These actions helped to significantly reduce nutrient loading to the waterbody. Other activities helped to reduce sedimentation. In 2001, VT DEC secured the removal of an unauthorized culvert at an upstream tributary, thereby reducing the erosive force of stormwater in the channel. During
