# Emission Reduction Strategy: Prioritizing Repairs & Replacements

Consolidated Edison Company of New York

February 4, 2009

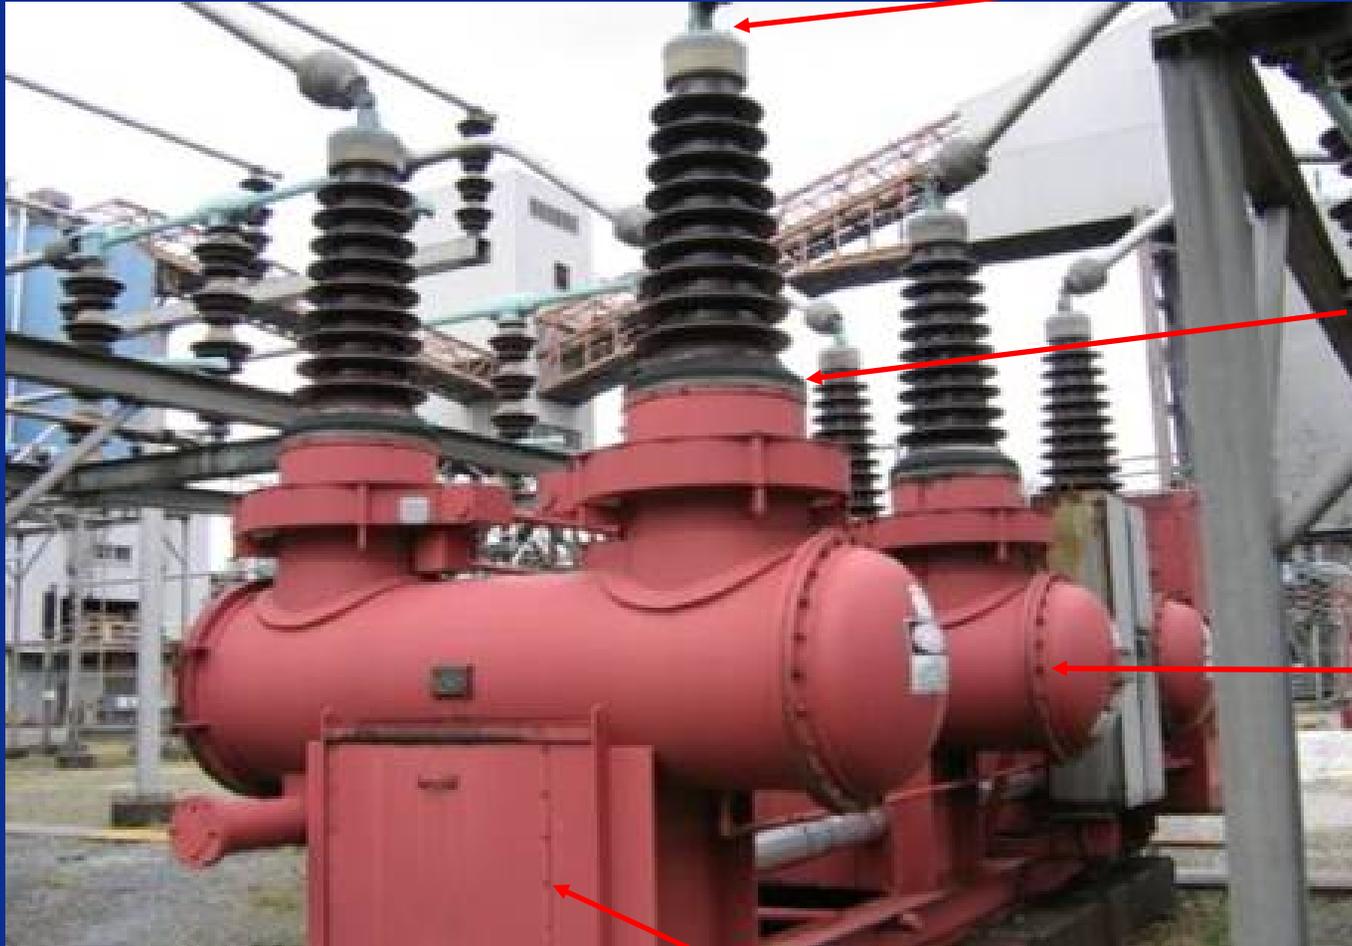
# Typical Leak Locations

Solder Seal

Bushing Base

Tank Flange

High Pressure Tank

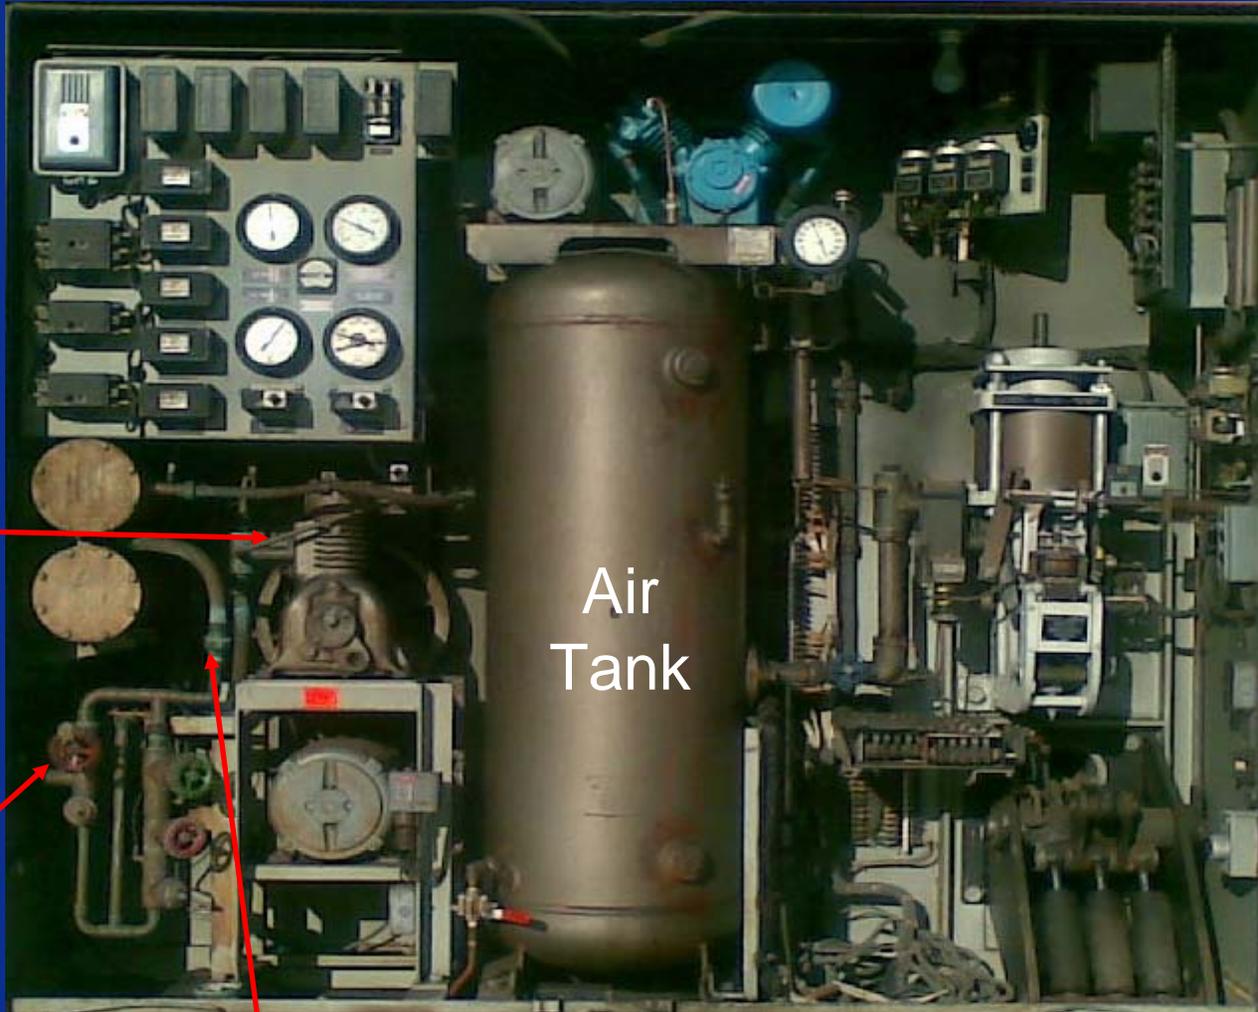
# Control Cabinet Leaks

Gas  
Compressor

Air  
Tank

Valve

Piping Connection
