SF₆ Equipment Maintenance, Repair, and Replacement and Emissions Programs

U.S. EPA's 2012 Workshop
on SF₆ Emission Reduction
Strategies. April 17, 2012

ITC Holdings Corp
Mike McNulty, Environmental Department
Joe Jasinski, Asset Management

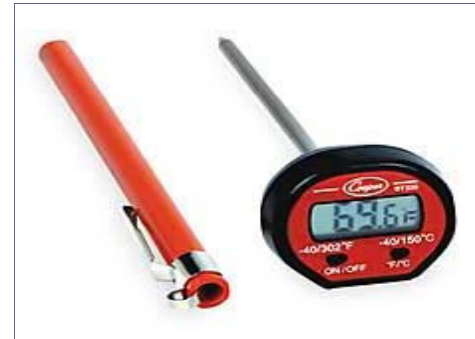
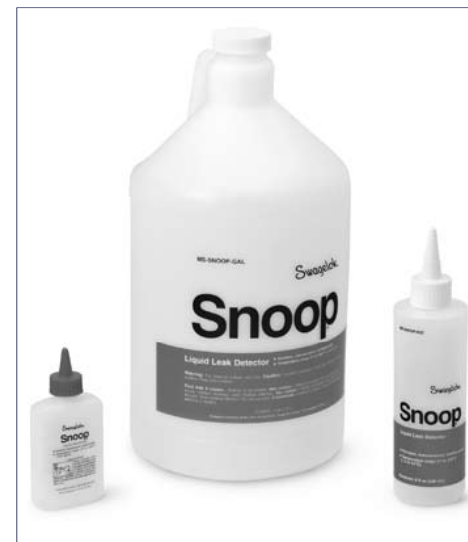
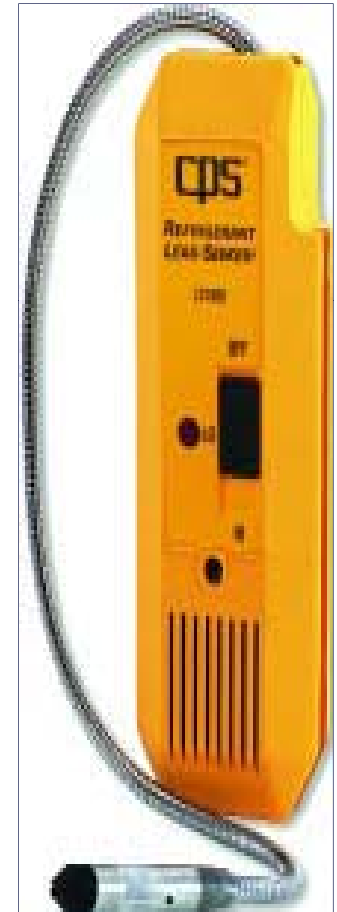
- Leaks identified - the low-gas density alarm included with the circuit breaker
- Problem recorded in Asset Sentry
 - work request is issued to identify/repair leak
 - Don't just add gas to raise pressure
- Actively investigate leaks via the “leak kit”
- Inexpensive electronic leak detectors
 - Thermometer
 - CPS brand refrigerant leak detector, Model LS790B
 - Snoop liquid leak detector
- Leak history investigated during pre-breaker preventative maintenance
 - Avoid subsequent shutdowns
- Repair leak avoiding future refill visits and associated costs
 - Install bolted-on clamp/seal rings around leaking gas breaker bushings
 - Repair gas breaker tube fittings
 - Replace seals at interrupter flanges

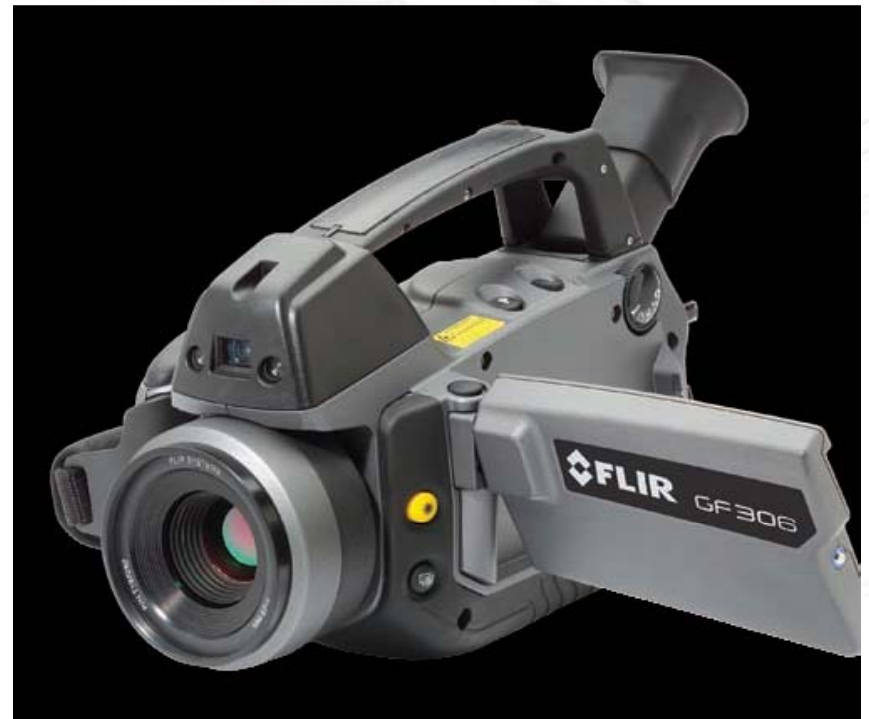
SF₆ Gas Detection FLIR Camera

- Worse performers surveyed throughout system with FLIR camera
- Check for leaks otherwise inaccessible/dangerous places without the need for a shutdown
 - Bushings
- Used the camera to pursue known manufacturing defect on ABB 145PM breakers (bushing flange corrosion)
 - Repaired 17 in 2011

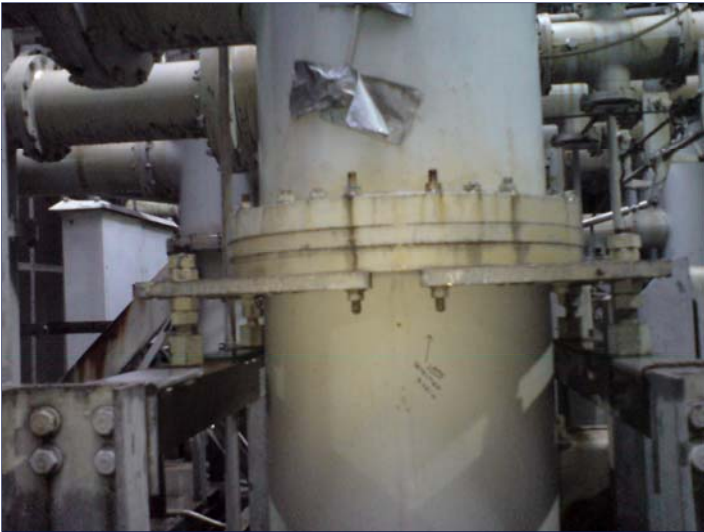
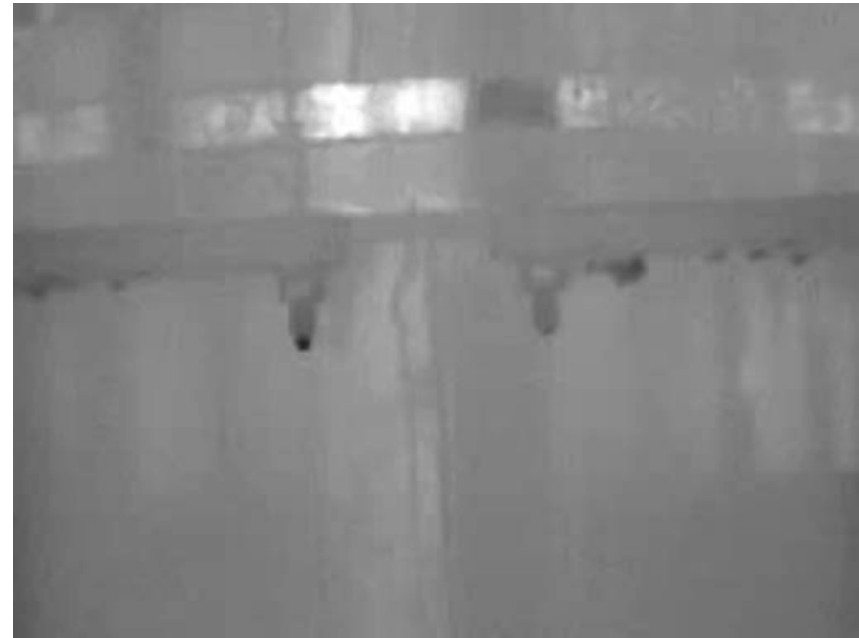
Cato GIS Disconnect Leak

Conventional Photo

FLIR Camera Screen Shot

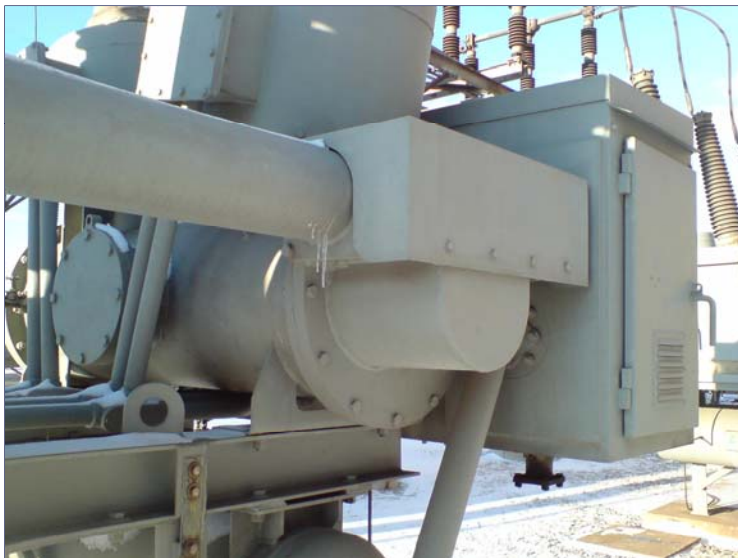
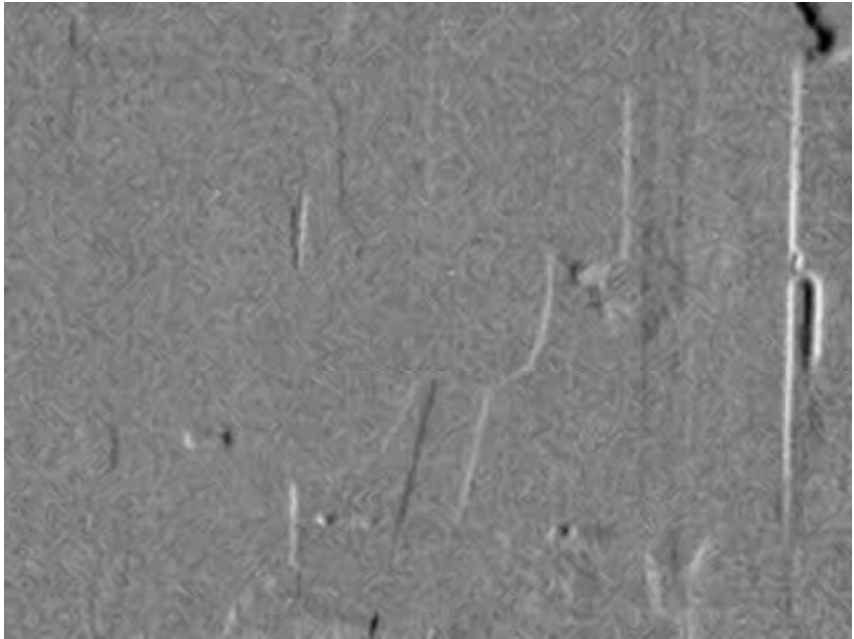
GE-Hitachi HVB145 Breaker Defect

Conventional Photo

FLIR Camera Screen Shot

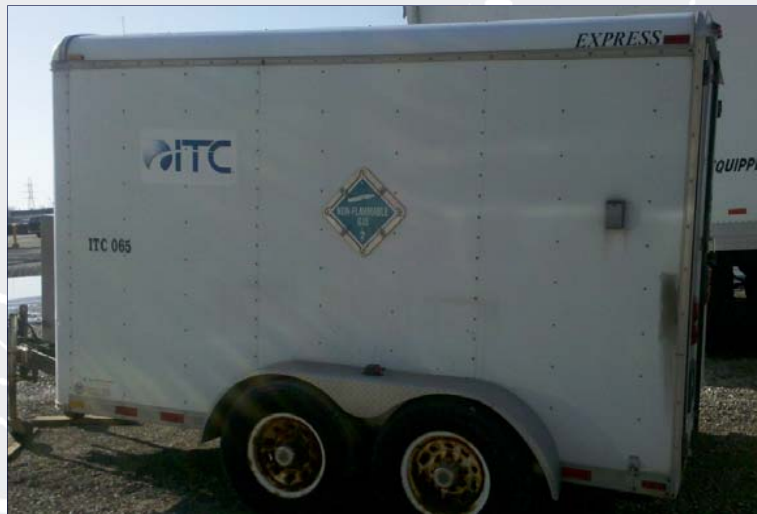
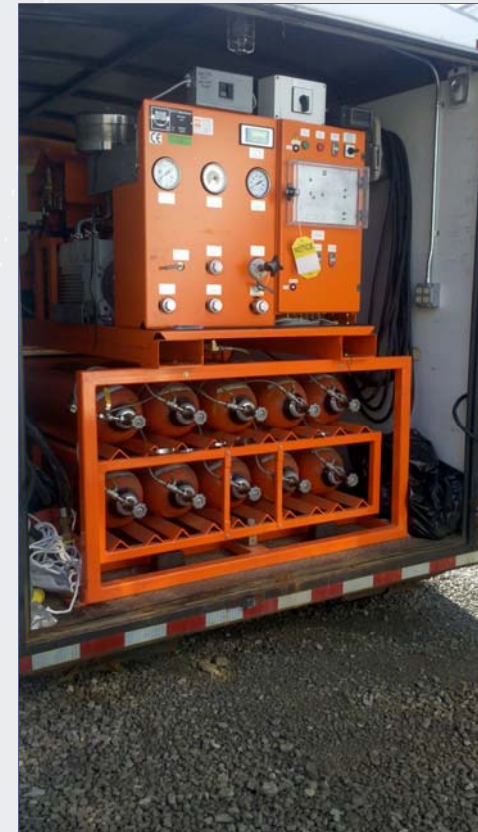
Dilo SF₆ Trailer

- Recover and filter SF₆.
- Evacuate air and moisture prior to filling equipment.
- Cylinder transfer
- Liquid storage

DILO SF₆ Gas Reclaim Trailer

12 Dilo Trailers in ITCT, METC and ITCM

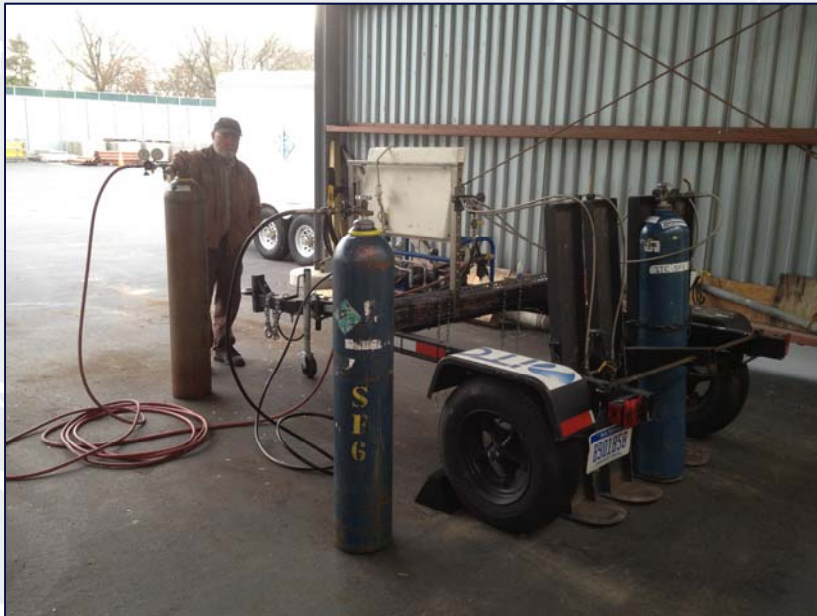
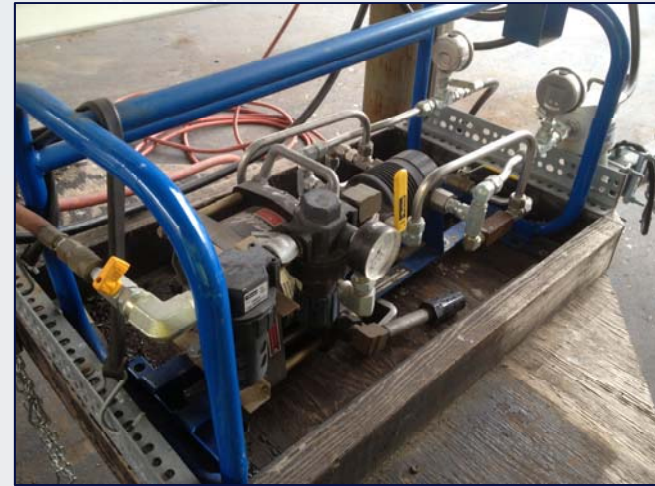
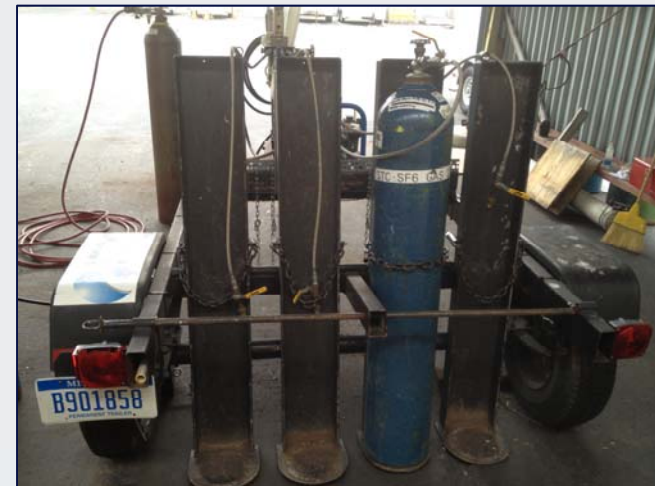
Liquid-Liquid Transfer Trailer

- Quick and efficient means of transferring liquid SF₆ and consolidating cylinders
- Provides means to separate contaminants in gaseous form

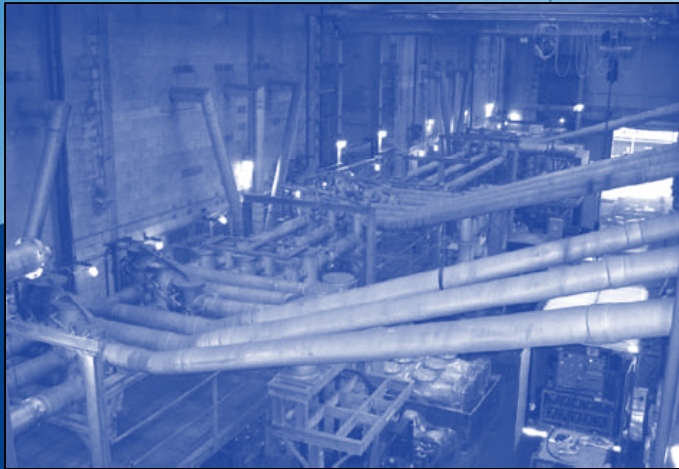
Original St. Antoine ITC GIS

- Acquired five in-service GIS sites manufactured between 1970 and 1972
 - St. Antoine , Caniff, Midtown, Goss and Cato
- GIS substations were a significant source of SF6 emissions
 - Leaks and intensive maintenance
- ITC has replaced 4 of the 5 stations at a cost of about \$10,000,000 per station
 - Cato Station is being replaced this year.
- Replacement has resulted in a significant reduction in emissions and recovery of reusable SF6 gas
- GIS replacement at the St. Antoine site alone
 - Eliminated approximately 104 man-hours of labor in the winter and 24 man-hours in the summer
 - eliminated purchase approximately 16 cylinders of SF6 gas annually (about 1,840 pounds) to replace losses from the leaking equipment.

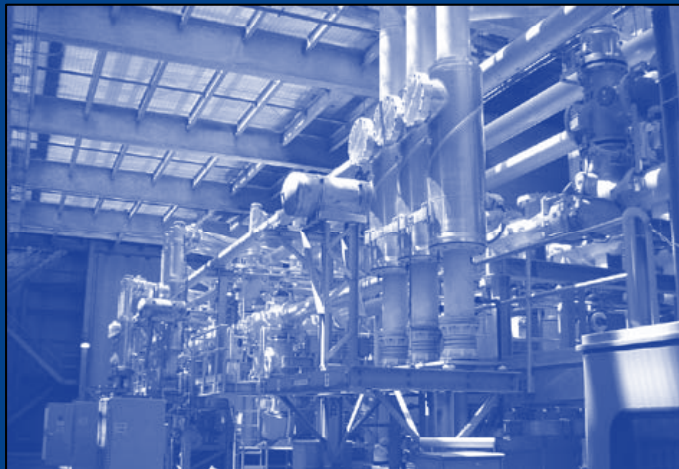
New St. Antoine MEPPI GIS

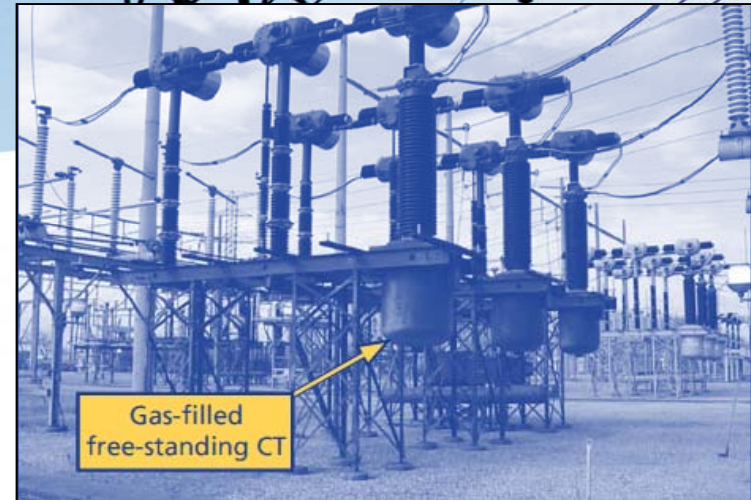
GE ATB-7 with free standing gas CT

- Maintenance costs and performance records of leaking equipment are compared to cost of replacement and additional benefits of new equipment
- ITC has selected variations of SFMT models supplied by Mitsubishi Electric as its equipment replacements
- Since beginning the circuit breaker replacement project in 2004, ITC has replaced or decommissioned 81 SF6 circuit breakers
- The cost of breaker replacement ranges from \$200,000 for a 120kV breaker up to \$500,000 for a 345kV breaker

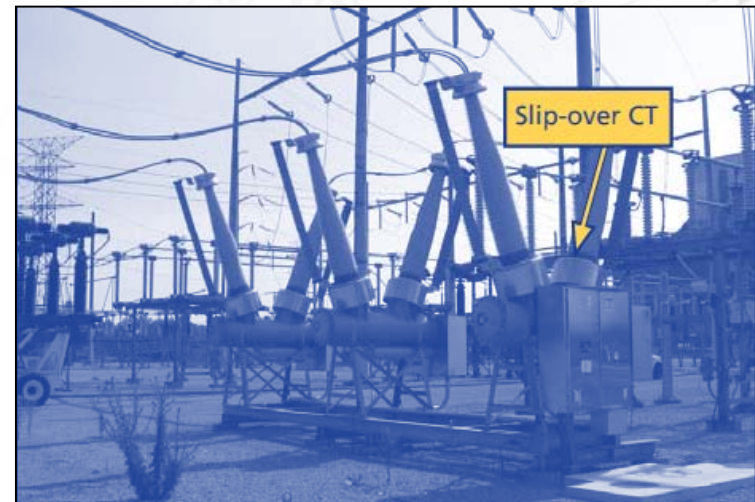
Mitsubishi 300SFMT-63E
with slip-over non-gas CTs
