# FOSC Desk Report for the Enbridge Line 6b Oil Spill Marshall, Michigan

April 2016

This report has been written as outlined in 40 Code of Federal Regulations 300.165 (b) which tasks the Federal On Scene Coordinator (FOSC) to *record the situation as it developed, the actions taken, the resources committed and the problems encountered*. This FOSC Report documents all phases of the response to the rupture and resultant diluted bitumen heavy crude oil discharge from the 30-inch Enbridge Energy, Limited Partnership and its affiliates (Enbridge) Line 6b Pipeline which occurred on or about July 25, 2010.

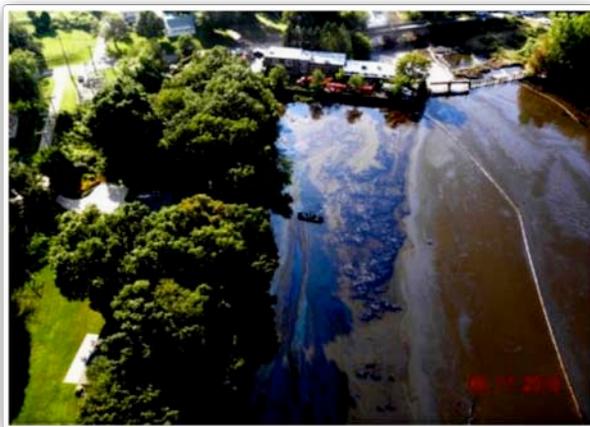
**Figure 1 – Discharged Oil Accumulating Upstream of Ceresco Dam (7/26/2010)**

strategic locations along the spill path. Containment installation began on July 26, 2010 and continued thereafter throughout the spill response. Sorbent and containment boom were initially placed on Talmadge Creek, on the first 12 mi of the Kalamazoo River (downstream of its confluence with Talmadge Creek), and at Morrow Lake. On July 27, 2010 containment was installed at additional locations in the spill path (Figure 1).

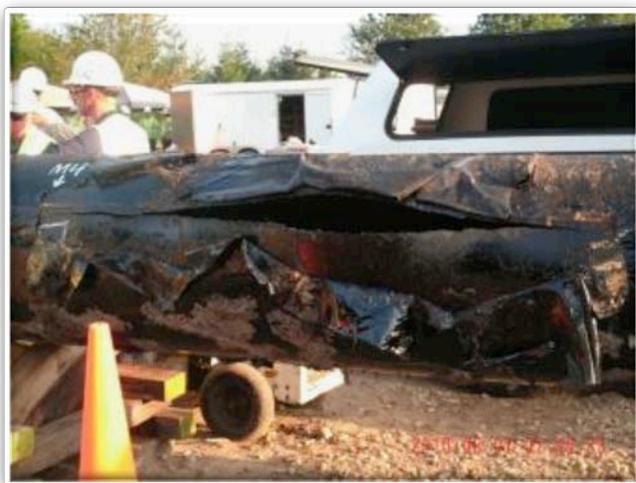
**Figure 2 – Ruptured Portion of Line 6B Pipeline**

long trench box allowed for dewatering and access to the pipeline. A portion of the pipeline was exposed for 50 ft on either side of the failed pipe joint to examine for corrosion, coating condition, and other issues. Following this inspection, a 50-foot length of pipe, which included the ruptured portion (Figure 2), was removed and shipped to NTSB's Materials Laboratory. Under direction of the Pipeline and Hazardous Materials Safety Administration (PHMSA) and in accordance with 49 C.F.R. Part 195, Enbridge installed 51 ft of new pipe to repair the failed section. The trench box was removed following completion of pipeline repair, product recovery, and soil removal activities and the area was backfilled. On August 30, 2010 Enbridge successfully completed an integrity validation pressure test along 13 mi of Line 6B. PHMSA authorized a staged restart of Line 6B beginning on September 27, 2010. The restart was completed on September 28, 2010.

On July 26, 2010 Enbridge initiated an emergency shut-down of the pipeline and isolated the line by closing the nearest upstream and nearest downstream block valves. A sheet pile trench box was constructed in the Source Area, immediately parallel to the ruptured pipeline. The approximately 180-foot

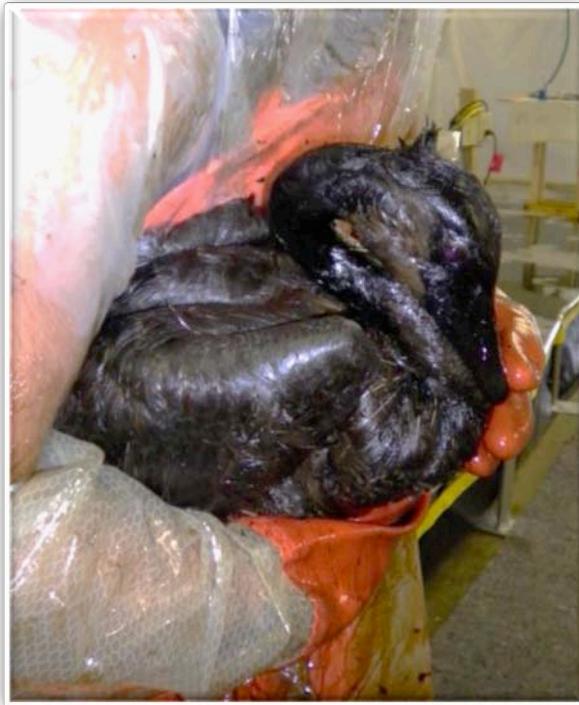
**Figure 3 – Oiled Canada Goose (Photograph Courtesy of USFWS)**

Oiled wildlife including Canada geese (Figure 3) had already been observed on July 26, 2010, so the USFWS and EPA immediately initiated a Pollution Removal Funding Authorization (PRFA) so that USFWS could provide technical assistance to EPA and oversee wildlife response operations.

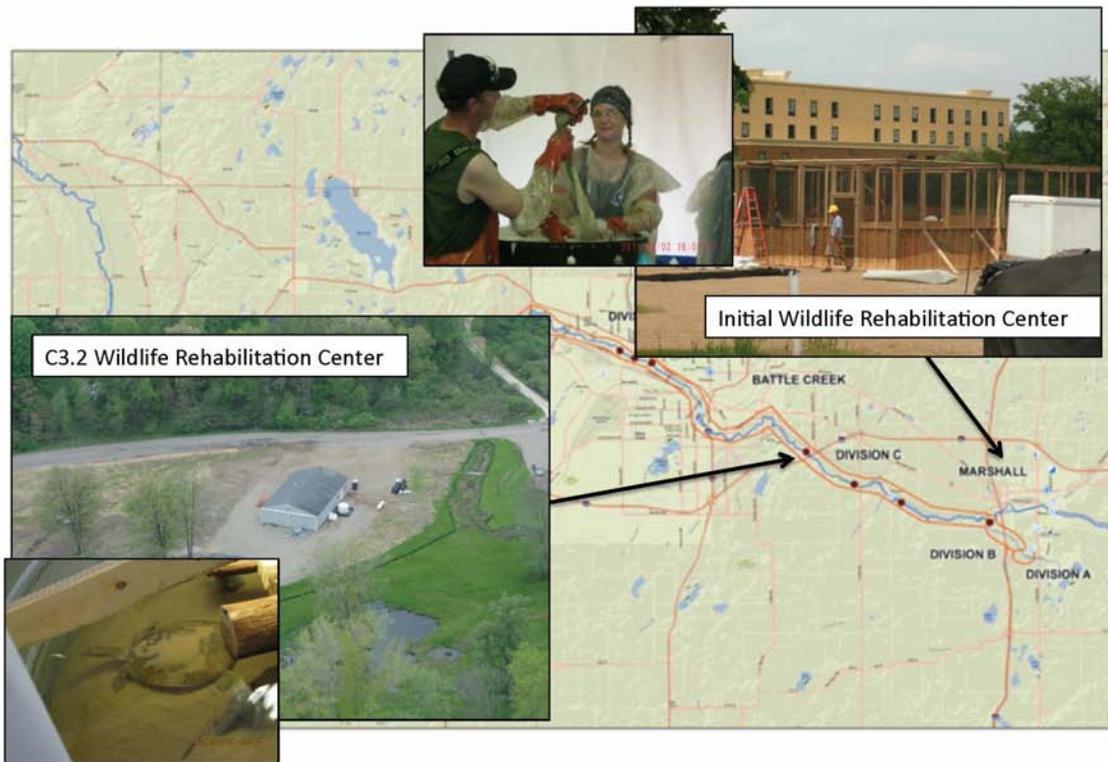
**Figure 10 – Wildlife Rehabilitation Locations**

Enbridge constructed the Wildlife Rehabilitation Center (WRC) at a site located at 14998 Old U.S. 27 N. in Marshall, Michigan (Figure 10). The site had an existing building with offices, a conference room, a kitchen and a large warehouse space, and another pole barn was also present on the site. Although the main building already had electricity and plumbing installed, both systems needed to be expanded for the necessary wildlife care and washing capacity. On-demand hot water heaters were installed inside the building, and large-capacity tanks were installed just outside the building to collect wastewater. Adequate floor space for wildlife intake, rehabilitation, and conditioning allowed for flexibility in use and design. The physical structure within the building changed frequently to address the changing needs of wildlife care. Areas within the main building included an intake clinic area; stabilization and care areas for birds, mammals, and

turtles; washing and recovery areas; animal food preparation; locking freezers; critical care clinic and laboratory; PPE and equipment storage; and cleaning/decontamination. The pole barn was used as a recovery area for birds following washing, as well as additional storage. A large on-site parking area allowed for convenient parking of personnel and response equipment. In addition, a large conditioning facility, complete with water pools, filtration, and secure housing, was established close to the main building, yet far enough from the main parking lot to avoid disturbances to recovering wildlife by vehicles and other equipment. Storage was available in two large sea containers.

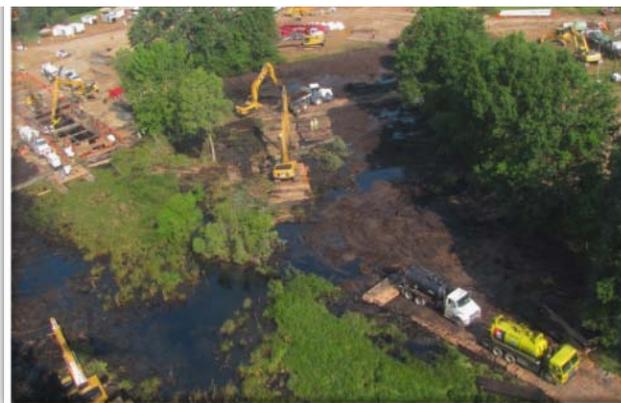
**Figure 12 – Recovery Operations at the Source Area (8/2/2010)**

Area. On July 26, 2010 Enbridge response crews began installing containment and barriers to stop the flow of oil into Talmadge Creek. By July 28, 2010 containment and recovery equipment was deployed, including hard boom, soft boom, oil skimmers, vacuum trucks, and frac tanks.

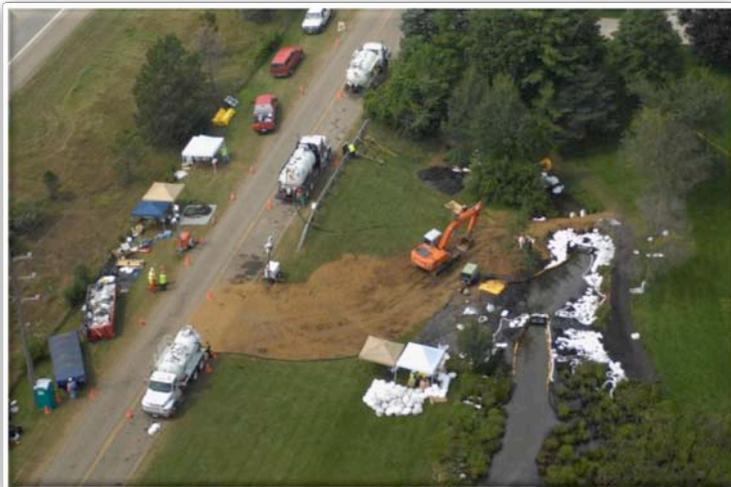
**Figure 13 – Recovery Actions and Devices at Talmadge Creek (8/2/2010)**

Containment boom was installed at various access points within Division B (Figure 13) to contain and direct surface oil to accessible collection points. Additionally, Enbridge constructed a flume

system consisting of a series of inverted weirs in Talmadge Creek. Drum skimmers and/or vacuum trucks recovered oil from the collection points and flume system. Recovered oil was transported to Frac Tank City, the frac tank staging area discussed in Section 4.6.3, and offloaded to frac tanks for temporary storage.

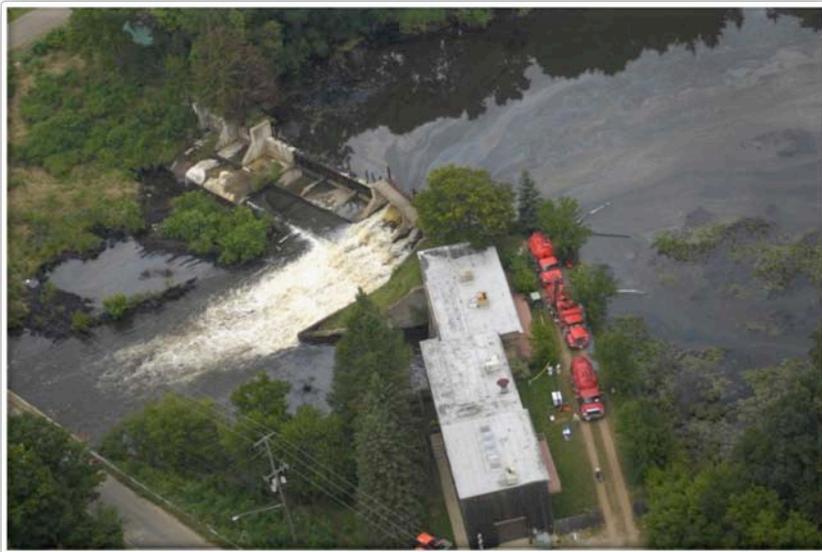
**Figure 15 – Vacuum Trucks Collecting Oil at Ceresco Dam  
(8/27/2010)**

Early response activities in Division C focused heavily on the Ceresco Dam area (Figure 15). The dam structure provided a barrier that slowed the downstream migration of oil; consequently, the upstream impoundment area provided a prime location for oil recovery activities. Several hard boom configurations were constructed to contain surface oil. Multiple vacuum tankers were stationed at Ceresco Dam and operated continuously to collect surface oil and water immediately upstream and downstream of the dam where heavy oil accumulated. Work crews also used

flushing hoses to steer surface oil toward the collection and recovery points.

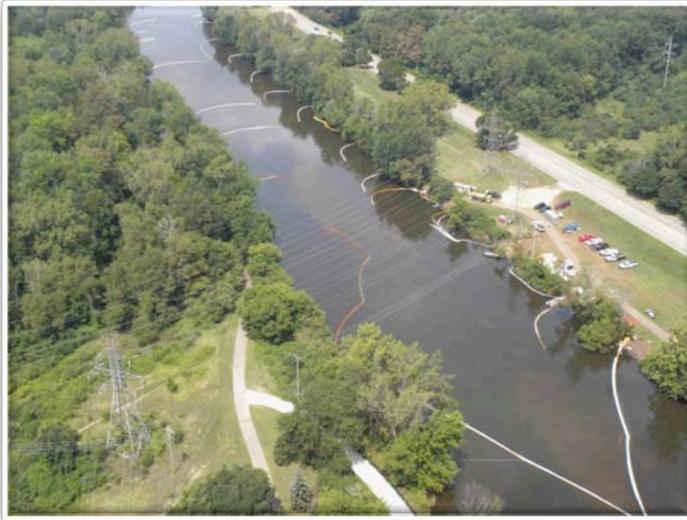
**Figure 16 – Containment Boom in Cascade Configuration in Division D (8/7/2010)**

Division D was established from the Battle Creek Spillway to the Calhoun County/Kalamazoo County Line. Initial response activities in Division D focused primarily on installation and maintenance of control points at key locations. Control points consisted of shore-to-shore hard boom lined with sorbent boom.

Drum skimmers and vacuum trucks were used to recover the oil and oily water accumulated at the collection points.

Sorbent boom was deployed along the shoreline and around the river's islands to prevent oil leaching out of the shoreline from migrating back into the river. Sorbent pads, sorbent sweeps, and snare booms were also used to recover free oil accumulated within the sorbent booms between the shoreline and the river channel. Figure 16 shows

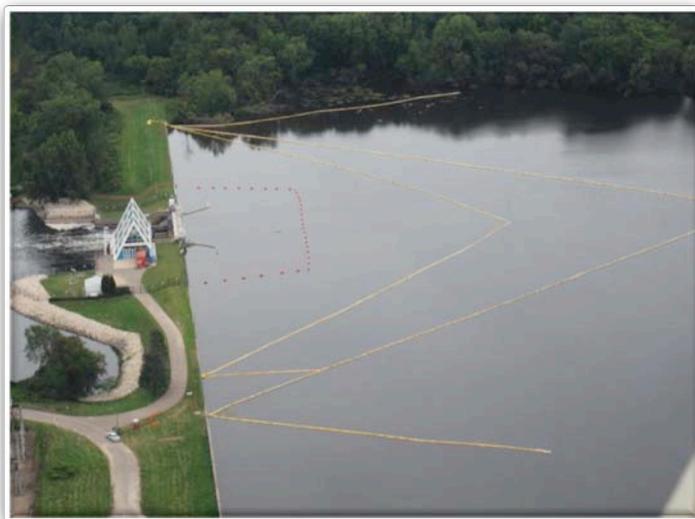
**Figure 17 – Double Chevron Boom Upstream of Morrow Lake Dam (8/14/2010)**

Although initial visual observations did not identify surface oil at the Morrow Lake Dam, a double chevron containment boom configuration was installed as a precautionary

measure to ensure surface oil did not migrate beyond the Morrow Lake Dam (Figure 17).

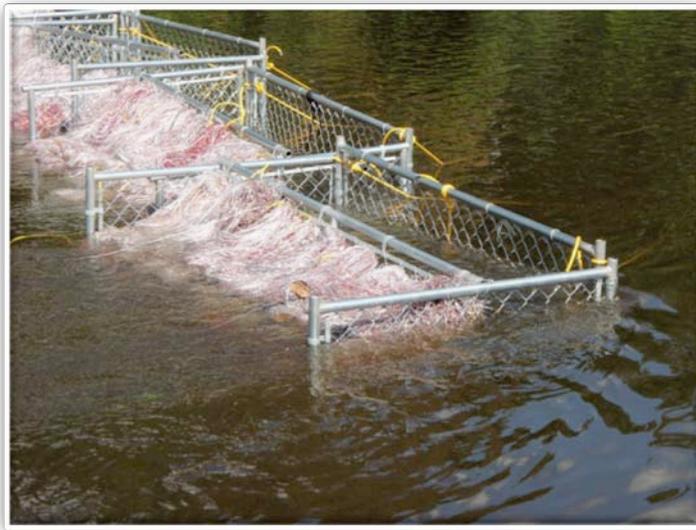
**Figure 18 – Gabion Basket in the Kalamazoo River  
(1/28/2012)**

During the initial response actions, various anthropogenic structures (i.e., silt curtains, gabion baskets, and a sediment basin) were placed in the river and along Talmadge Creek in an attempt to contain submerged oil and/or oil-containing sediment from further migration. Like the natural structures, these installed structures created preferential depositional areas in the river system. Several subsurface containment structures were installed within the affected portion of Talmadge Creek and the Kalamazoo River,

- underflow dams and hay bale structures at various locations within Talmadge Creek,
- an in-situ stream sediment basin upstream of the confluence of Talmadge Creek with the Kalamazoo River,
- surface boom with sediment curtain at the confluence of Talmadge Creek with the Kalamazoo River,
- gabion basket structures (Figure 18) containing sorbent snare boom at two locations across portions of the river (MP 12.5 and MP 18) to contain suspended oil-containing sediment and submerged oil,
- surface containment with silt curtain installed at numerous control points along the Kalamazoo River, and
- surface boom with X-Tex® sediment curtain (oleophilic synthetic filtering material designed to sorb oil while allowing water to pass through) in the neck area between the Morrow Lake Delta and Morrow Lake.

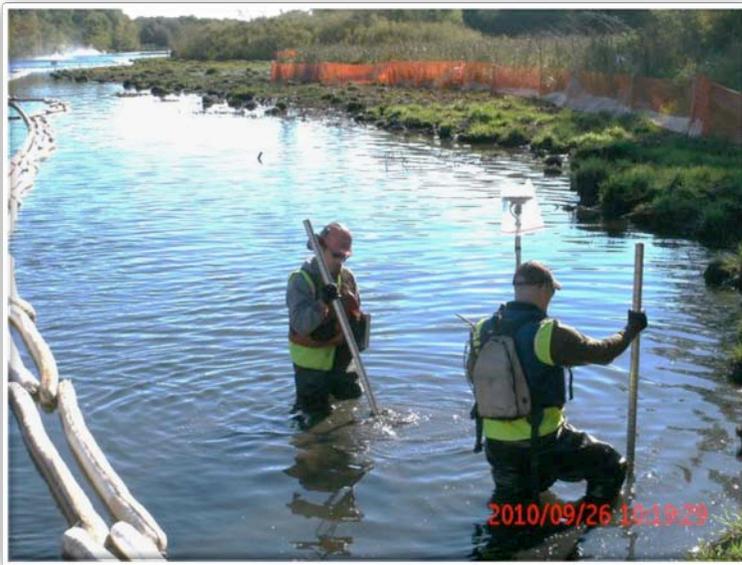
**Figure 19 – Submerged Oil Task Force Poling Team, Kalamazoo River (9/26/2010)**

A phased approach was implemented to investigate the presence and relative distribution of submerged oil in the Kalamazoo River and Morrow Lake. Initially, a qualitative assessment was conducted to quickly identify areas with the presence of submerged oil, identify depositional areas, prioritize sites based on a relative comparison of affected sites, and obtain information on the depositional/erosional characteristics of the geomorphic settings. This was accomplished through an initial visual assessment followed by

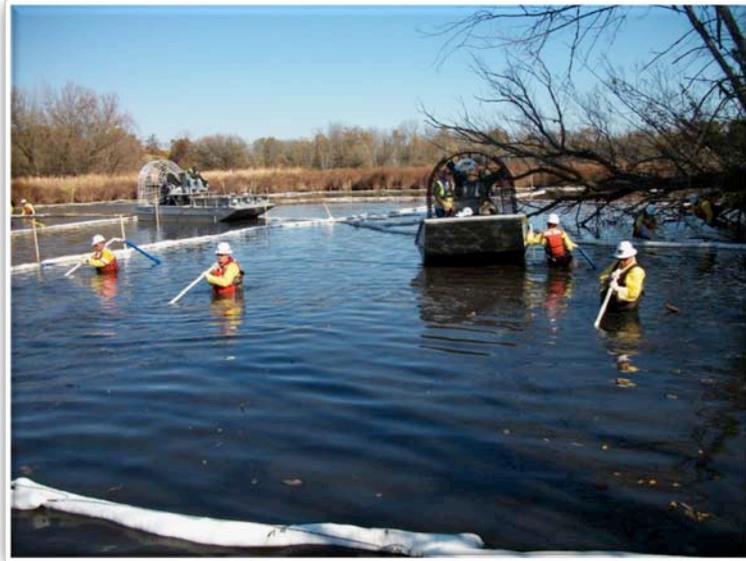
**Figure 21 – Oil Recovery via Sediment Agitation using River Water (10/16/2010)**

Following a two-day rest period to allow for site conditions to settle, EPA and Enbridge inspected a recovery site to determine whether visible oil was present. A post-sediment aeration assessment was performed following the same procedures used for initial site assessment. The SOTF compared the initial and post-recovery results to determine the effectiveness of the submerged oil recovery effort.

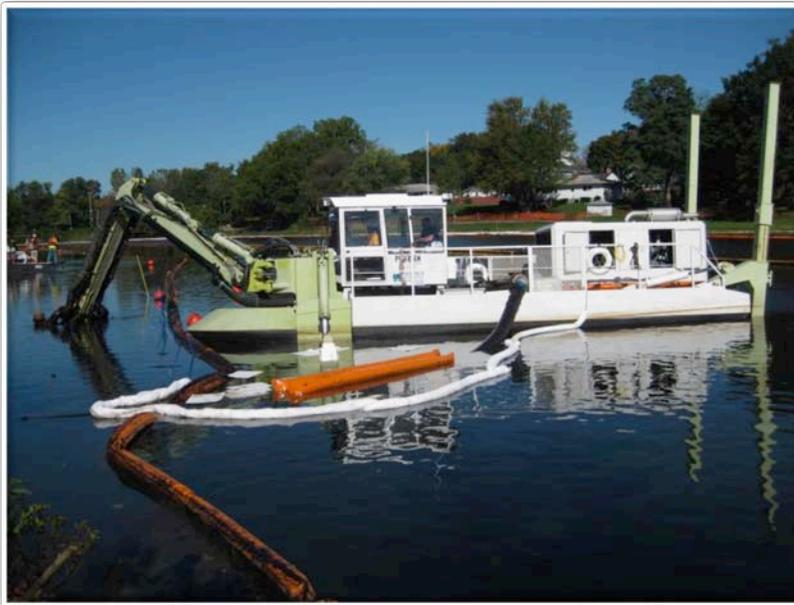
**Figure 22 –Dredging at MP 5.75 Ceresco Impoundment (9/30/2010)**

Because the Ceresco Impoundment was the first major deposition location in the flow path of the released oil, it was the first location where a substantial amount of submerged oil was present where it could be readily removed via dredging. As a result, Enbridge dredged submerged oil and/or oil-containing sediment at priority locations within the Ceresco Dam Impoundment, immediately upstream and downstream of the former train trestles. Dredging was performed using an

Amphibex dredge, which integrated a hydraulic cutterhead dredge with a positive-displacement pump (Figure 22). In addition to the Amphibex, two other dredges were used to supplement its production. A smaller dredge was used at MP 5.63 South and a cutterhead dredge was used in the deeper waters of MP 5.75 Northwest.

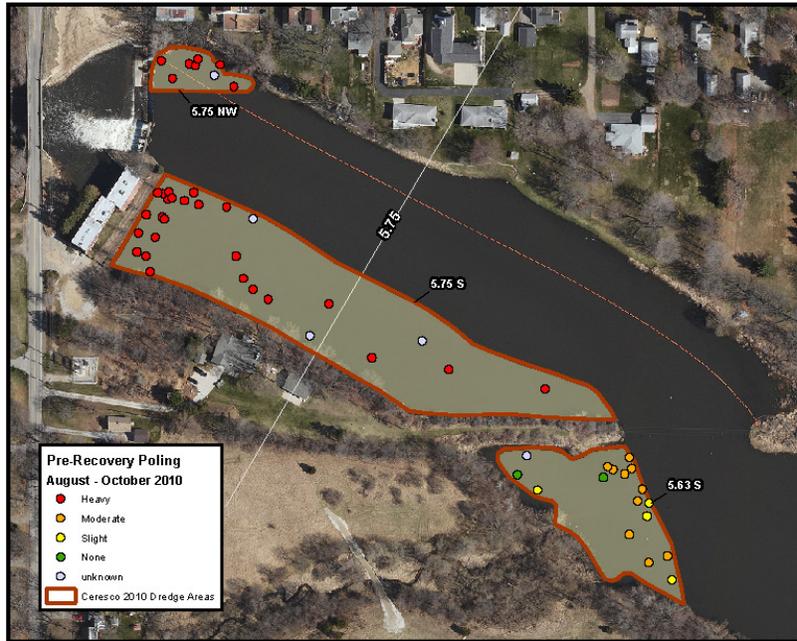
**Figure 23 – 2010 Pre-Dredging Poling Results (Ceresco Impoundment)**

Continuous, real-time surface water quality measurements were performed at locations downstream and upstream of dredging operations. Teams monitored turbidity, pH, dissolved oxygen, specific conductivity, and temperature. Turbidity measurements were successfully used as part of the best management practices to ensure that dredging operations did not create sustained periods of downstream turbidity greater than two times upstream levels. If turbidity levels exceeded the actionable threshold, then dredging operations were temporarily halted and containment inspected/revised to minimize the downstream migration of turbidity plumes. The placement and maintenance of containment boom and turbidity curtains successfully contained sheen and turbidity within the dredge area.

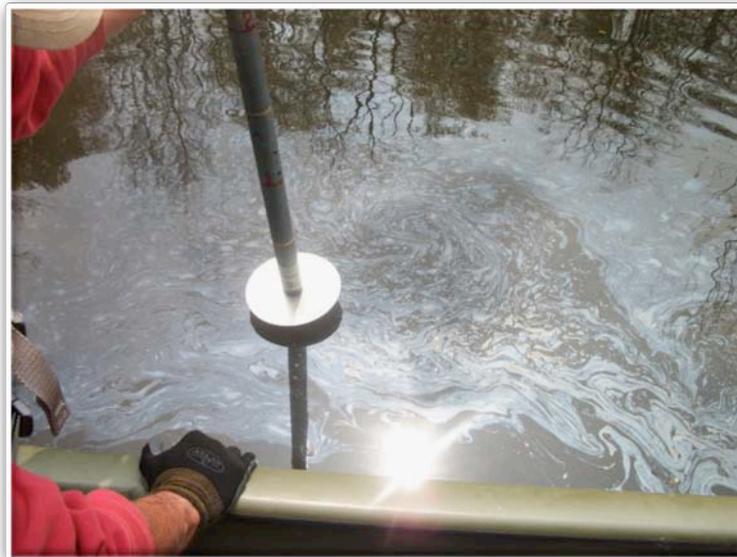
**Figure 26 – 'Heavy' Sheen Observed During Poling of a Submerged Oil Location (5/11/2011)**

Reassessment poling activities focused on areas confirmed in 2010 to have ‘heavy’ and/or ‘moderate’ submerged oil accumulations and in areas in which submerged oil was expected to accumulate based on interpretation of geomorphic data. In addition, poling was conducted along transects that were perpendicular to channel orientation in low- and high-sinuosity sections of the river, near bridges and other public access areas, and in low gradient areas upstream of dams.

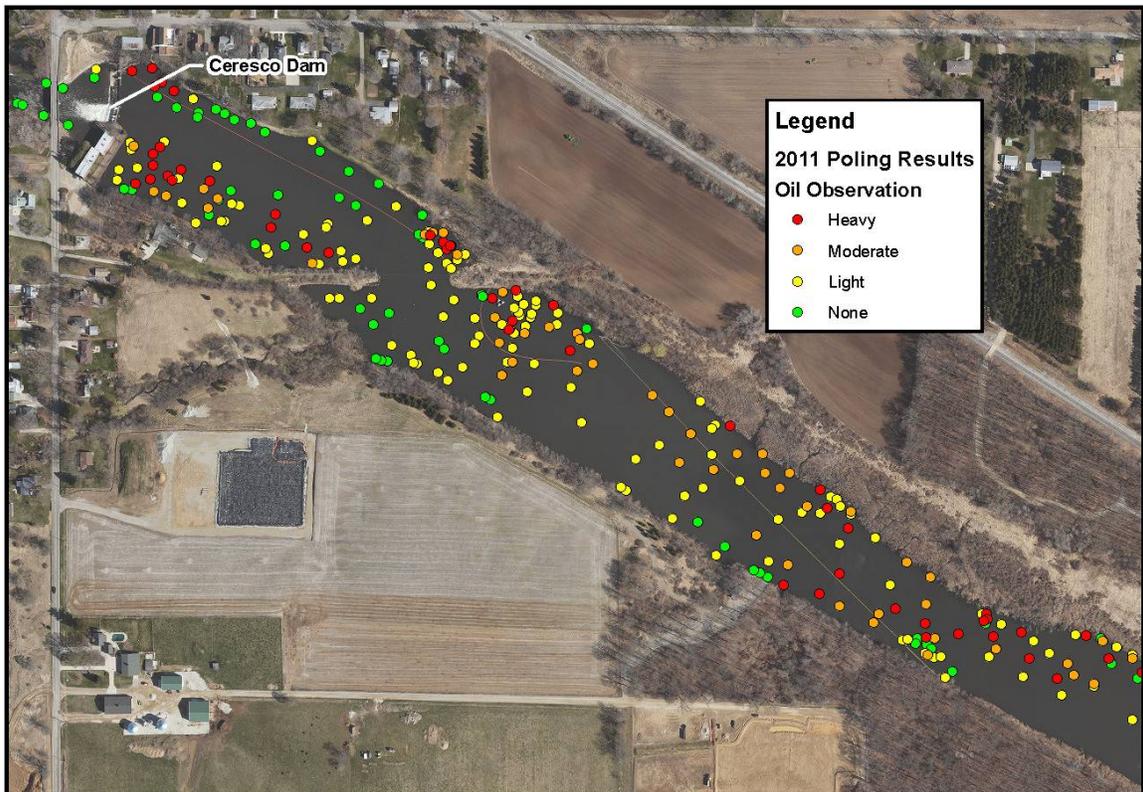
**Figure 27 – Spring 2011 Submerged Oil Reassessment Results at Ceresco Impoundment**

Results of the Spring 2011 Submerged Oil Reassessment also indicated that submerged oil was transported downstream during a May 2011 flood event. Evidence of this migration was found in

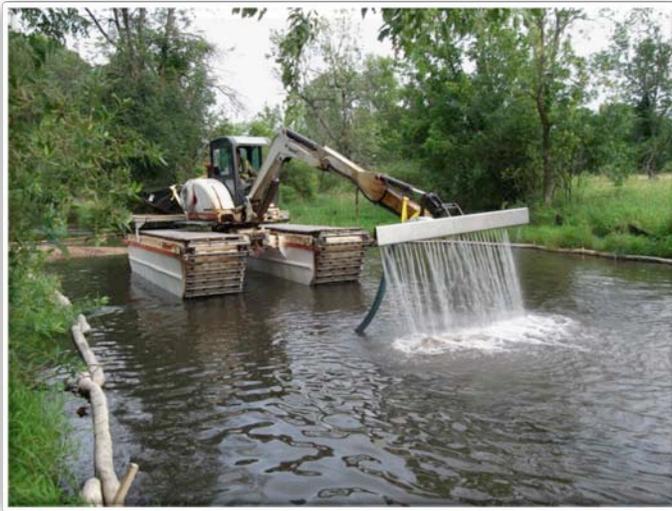
**Figure 28 – Excavator with Hydraulic Spray Bar Agitating Sediment (7/28/2011)**

On June 17, 2011 the FOSC directed Enbridge to perform recovery of submerged oil, oil sheen, and oil-containing soils and sediments. Sediment agitation techniques were used to liberate submerged oil from the sediment and bring it to the water surface for recovery. Agitation

techniques, or tool box techniques, included manual rakes, handheld tillers, handheld stingers, rotating stingers, vessel-mounted water injectors, vessel-mounted pipe drags, and hydraulic flushing (Figure 28). Oil released to the surface was recovered using sorbent materials including booms, pads, and snares. The agitation and recovery process was repeated until no oil was visibly released from the area. Prior to implementation, pilot studies were conducted for each tool box technique to evaluate its effectiveness. Pilot study results were submitted for review and approval by EPA and MDEQ.

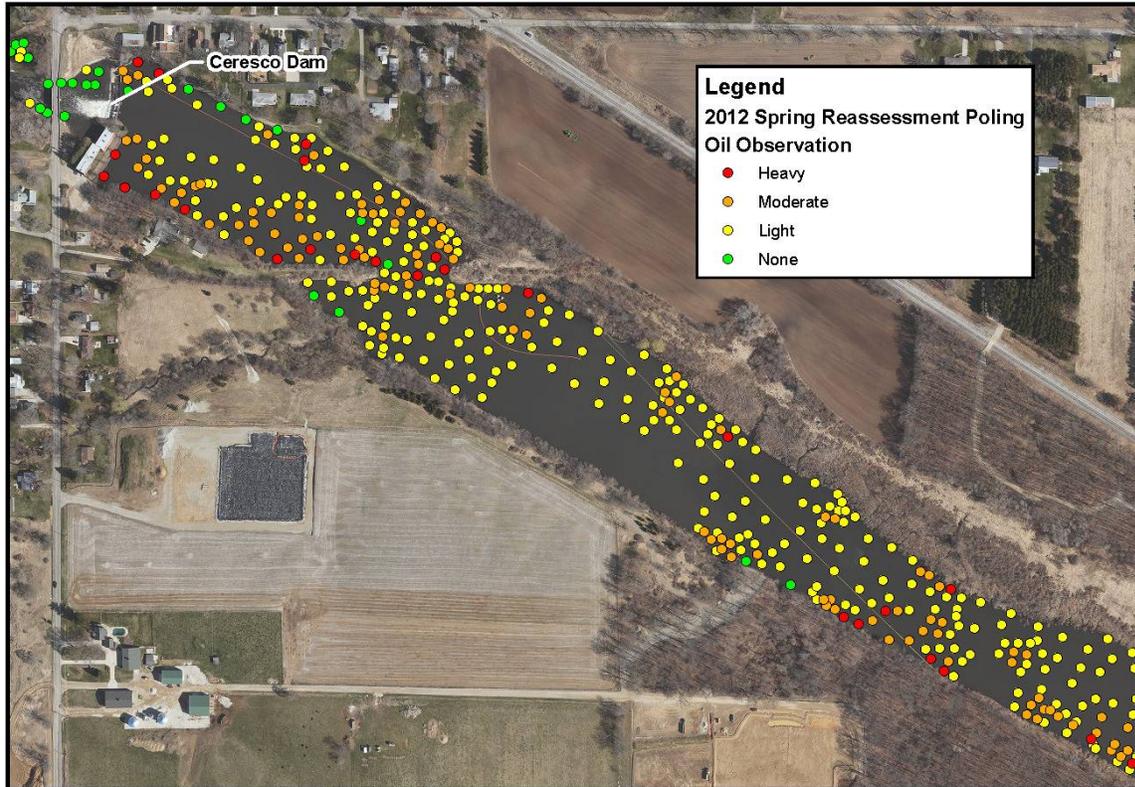
**Figure 31 – Spring 2012 Submerged Oil Reassessment Results at Ceresco Impoundment**

Results of the Spring 2012 Submerged Oil Reassessment indicated that MP 4.5 to MP 5.0 no longer had any bank to bank moderate or heavy designations and that overall there were fewer moderate or heavy designations as compared to 2011 LSR. Yet, MP 5.0 to MP 5.85 demonstrated a substantial increase in locations classified as ‘moderate’ or ‘heavy.’ The relative patterns demonstrated by two rounds of poling in the same locations, which had just undergone extensive recovery actions, were reliable evidence that submerged oil had migrated downstream.

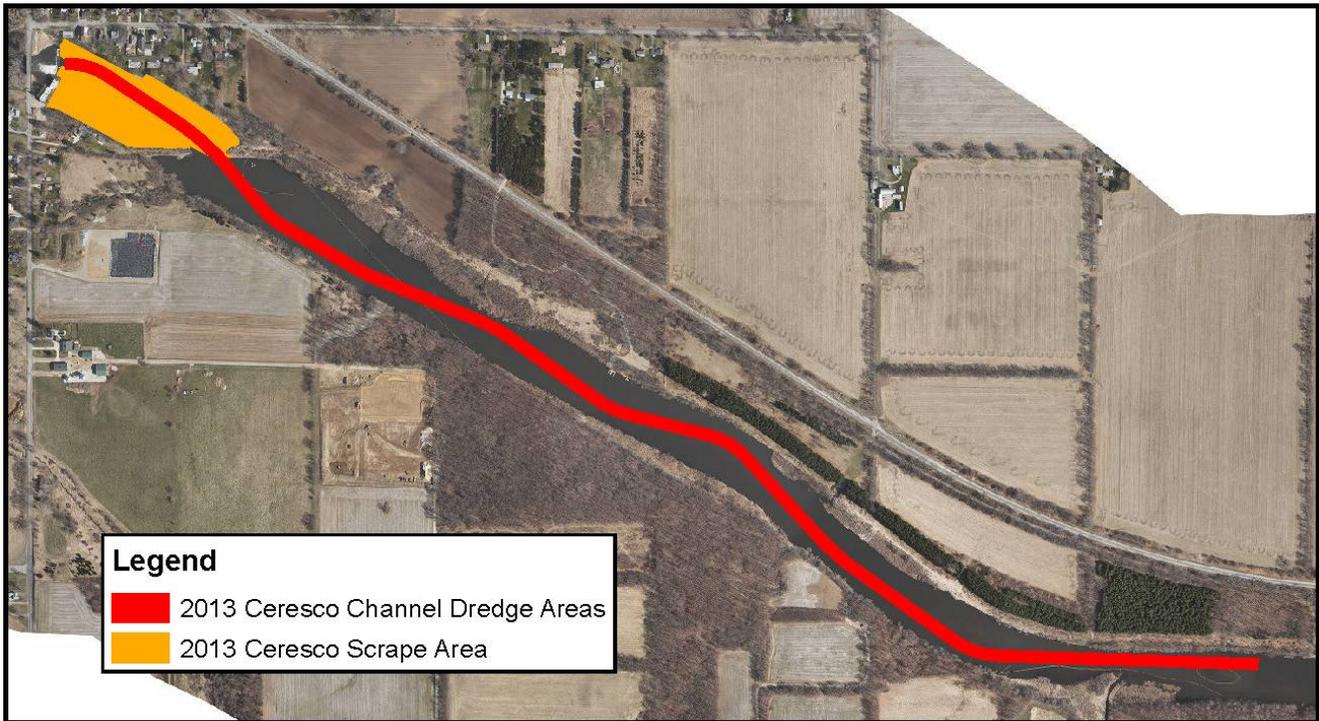
**Figure 33 – Dredge Areas (2013) at Ceresco Impoundment**

Prior to dredging the pilot channel, Enbridge constructed a 20-acre dredge pad adjacent to the south bank of the river. The dredge pad contained a mixing and staging area and two dewatering pads. The pads were constructed with impervious polyethylene liner and overlaid with sand and stone. The drainage layer sloped to a sump. Each dewatering pad was surrounded by a lined berm to ensure dredge material stayed within the pad.

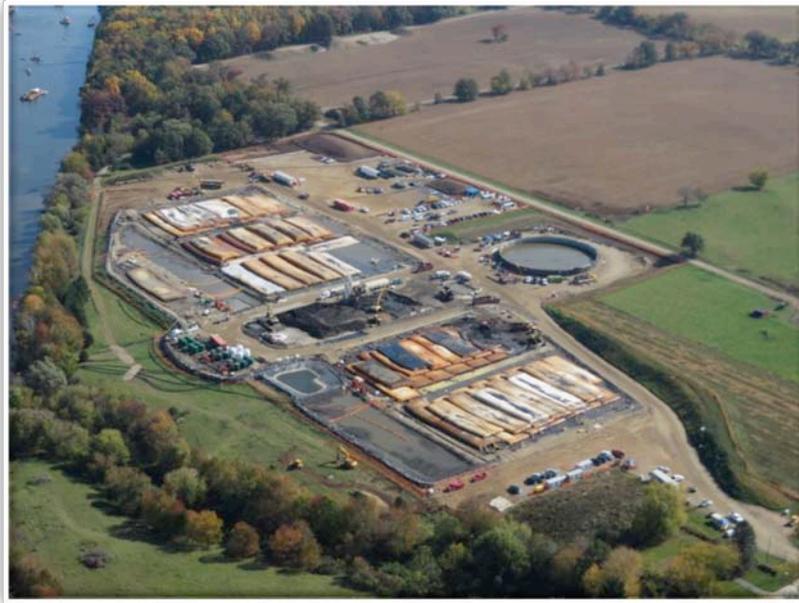
**Figure 34 – Sediment Dewatering and Processing Pad at Ceresco Impoundment (10/18/2013)**

Dredged sediment was transferred through discharge pipes as slurry to the dredge pad (Figure 34) where it was dewatered in

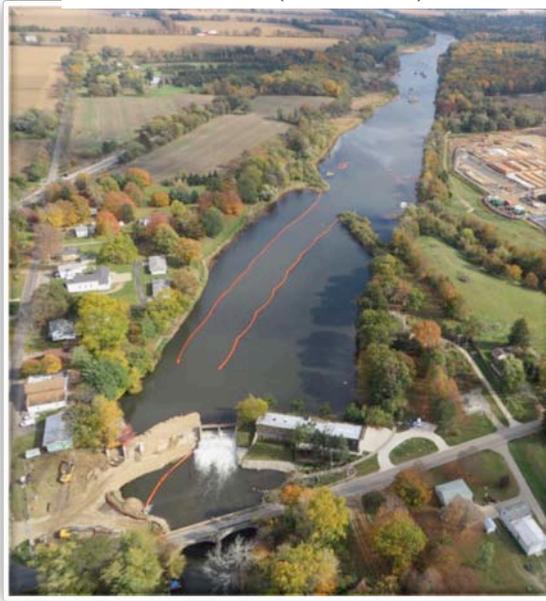
**Figure 35 – Ceresco Impoundment  
Dredge Area Prior to Notching Ceresco  
Dam (10/18/2013)**

Following installation of the pilot channel containment, Enbridge notched the Ceresco Dam spillway to gradually lower the water level in the impoundment. Notching was conducted daily from October 30 through November 5, 2013 (Figures 35 and 36), lowering the water level by approximately four ft. Enbridge removed an additional 1.7 ft from the dam from November 17 through 19, 2013 to further dewater some of the overbank areas that were still saturated. Enbridge conducted dam notching and final dam structure removal activities pursuant to the MDEQ Order.

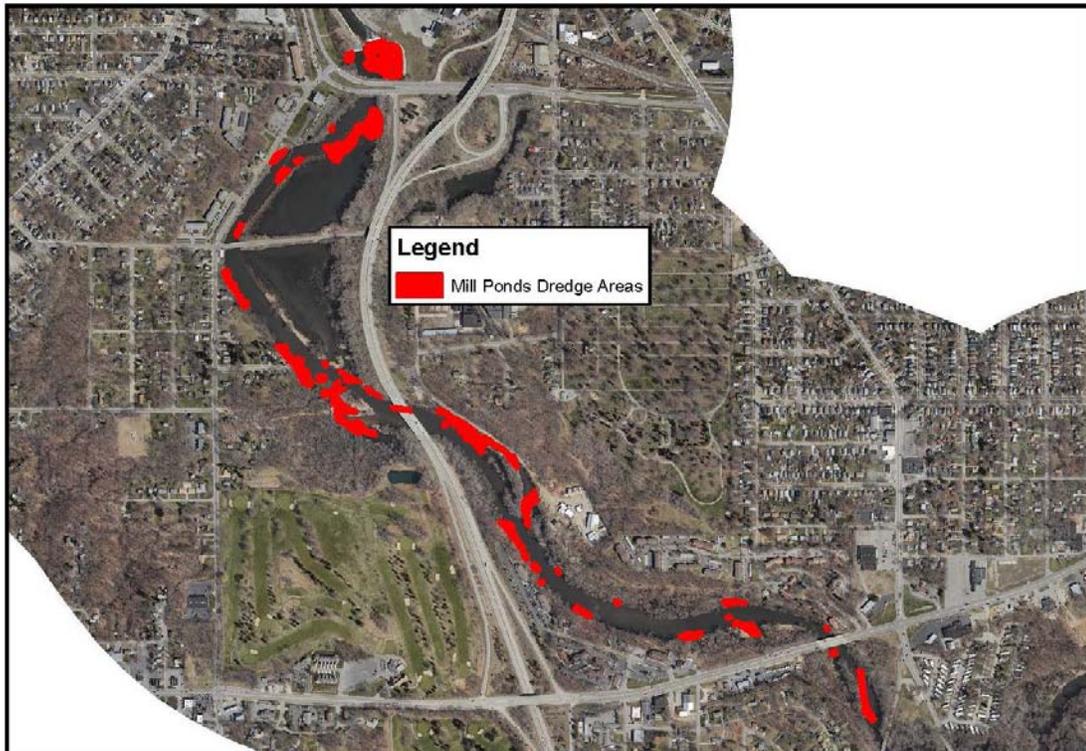
**Figure 37 – 2013 Target Dredge Areas in the Mill Ponds Impoundment**

Sediment removal was conducted by hydraulic dredging from late August through December 2013. A Toyo pump connected to a pontoon excavator and conveyance line was also used to remove sediment from two dredge polygons close to the dam at MP 15.70. Operations were suspended due to weather conditions in December 2013.

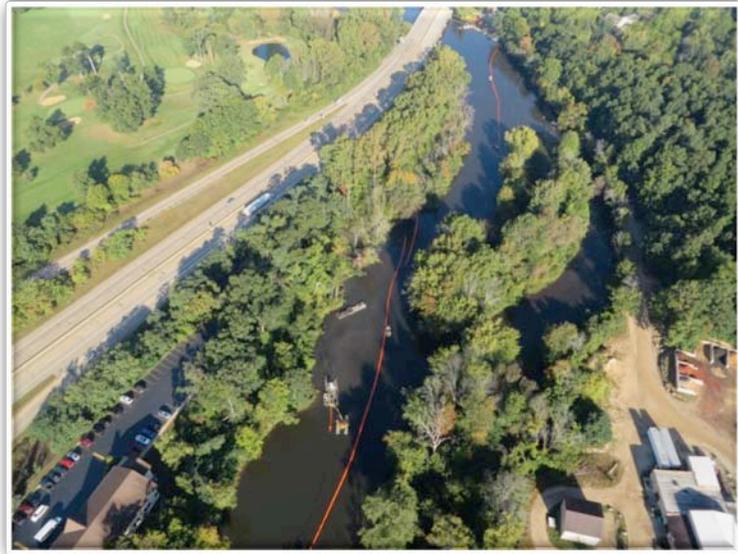
**Figure 38 – Dredge Unit Operating at the Mill Ponds Impoundment (9/25/2014)**

Hydraulically dredged sediment was pumped as slurry through a conveyance line to an adjacent dewatering and processing pad. Slurry was dewatered in geotextile bags. Sediment from the Toyo pump operations was collected in weir tanks, pumped in tanker trucks, transported to the dredge pad, and dewatered in geotextile bags. Dewatered sediment was solidified and transported to an approved off-site disposal facility. Water from dredging operations was collected in a sump, treated to remove particulates and soluble phase organics, sampled, and discharged to the river, in accordance with the NPDES permit requirements. Dredging was completed at 32 polygons during 2013 prior to river icing conditions preventing the continuation of work in December. Completion of the remaining six polygons would be conducted during the spring/summer of 2014. As a result of 2013 dredging operations at the Mill Ponds Impoundment, Enbridge removed approximately 22,000 cubic yards of sediment and treated approximately 43,000,000 gallons of water.

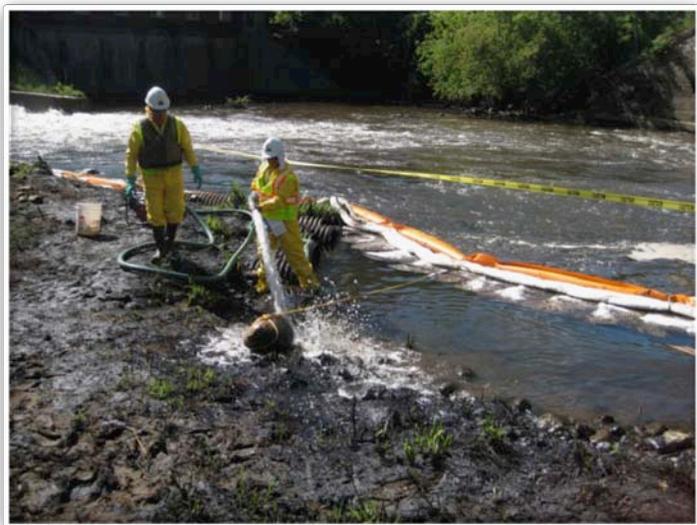
**Figure 40 – Personnel Flushing Impacted Shoreline at MP 6.00 (8/15/2010)**

On August 10, 2010 Enbridge, EPA, USFWS, and MDNRE completed development of Phase 1 shoreline cleanup methods. These methods included gross oil removal by cutting oiled vegetation, removing oiled debris and soil, and low-pressure ambient water flushing (Figure 40). SCAT teams provided recommendation for implementation of specific shoreline cleanup methods within each 0.25-mi segment.

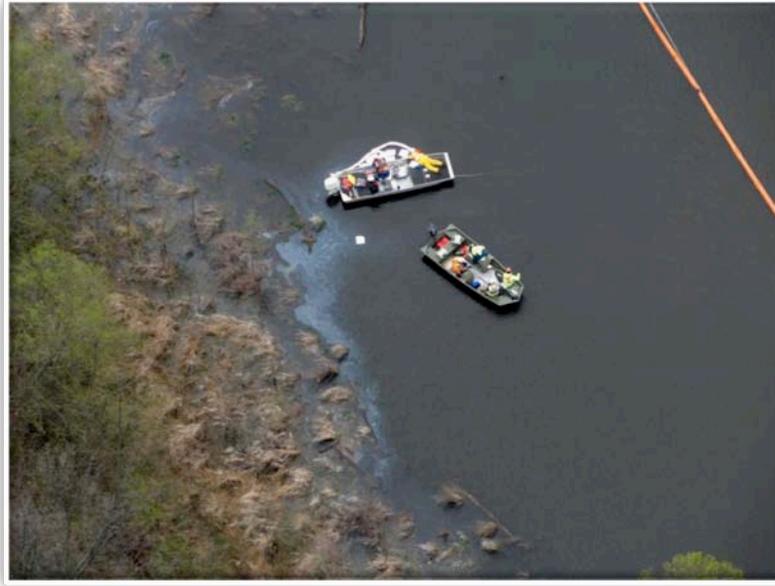
**Figure 42 – Response to Observations of Sheen Eminating from the Kalamazoo River Bank (4/28/2011)**

EPA and Enbridge conducted regular inspections of the sites, recorded observations on the daily O&M tracking spreadsheet, and prepared recommendations for response activities. Recovery operations requested by O&M teams including flushing, bagging, utilizing absorbent materials (Figure 42), vacuum recovery techniques, and skimming operations. Sites were cleared or transferred to MDEQ primary oversight based on a series of field observations.

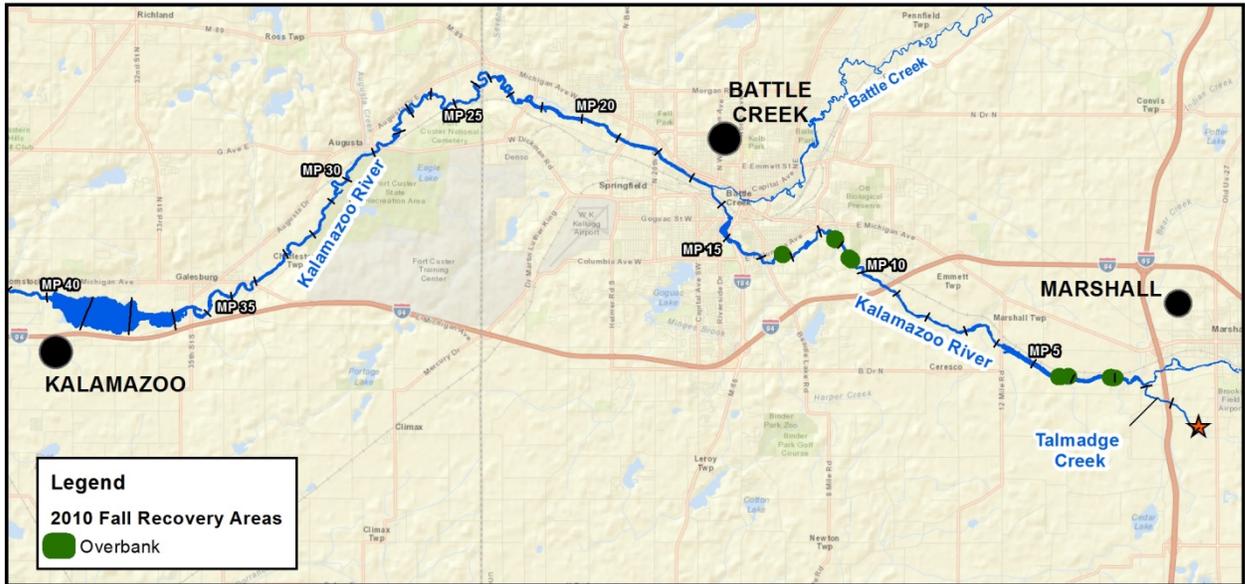
**Figure 43 – Fall 2010 Overbank Recovery Areas**

In the fall of 2010, preliminary results of the O&M process were used to identify locations requiring immediate overbank recovery activities. Enbridge excavated the overbank portion of these sites but did not excavate the shoreline pursuant to the request of MDNRE. Figure 43 depicts the overbank sites addressed during the fall of 2010.

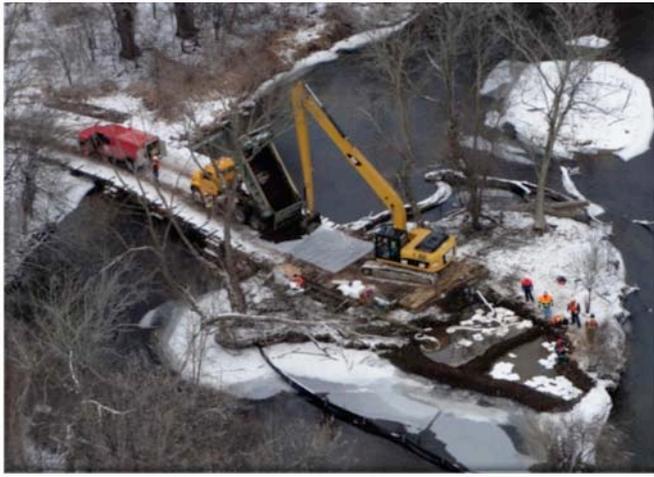
**Figure 44 – Excavation of MP 2.75 Island during Winter 2010 Overbank Recovery Activities**

to continue clean up through winter excavation techniques (Figure 44) which minimized impact to sensitive environments.

The cold weather and associated subsurface frost allowed crews to access remote and ecologically sensitive wetland and overbank areas, causing less adverse effects on the ecology

than would occur if access were made during thawed or warmer conditions. Innovative and ecologically-friendly methods, such as driving frost, were used to construct temporary access roads to remote areas.

Once site access was made via ice roads, Enbridge conducted excavation activities using low ground pressure equipment with wide pads, tracked dump trucks, dozers, small excavators, pumps, and isolation materials, including portable aqua dams. Cold temperatures solidified the oily sediment making it easier to remove, and excavated material was transported off site via ice roads. Figure 45 depicts the sites which were excavated from December 2010 through March of 2011.

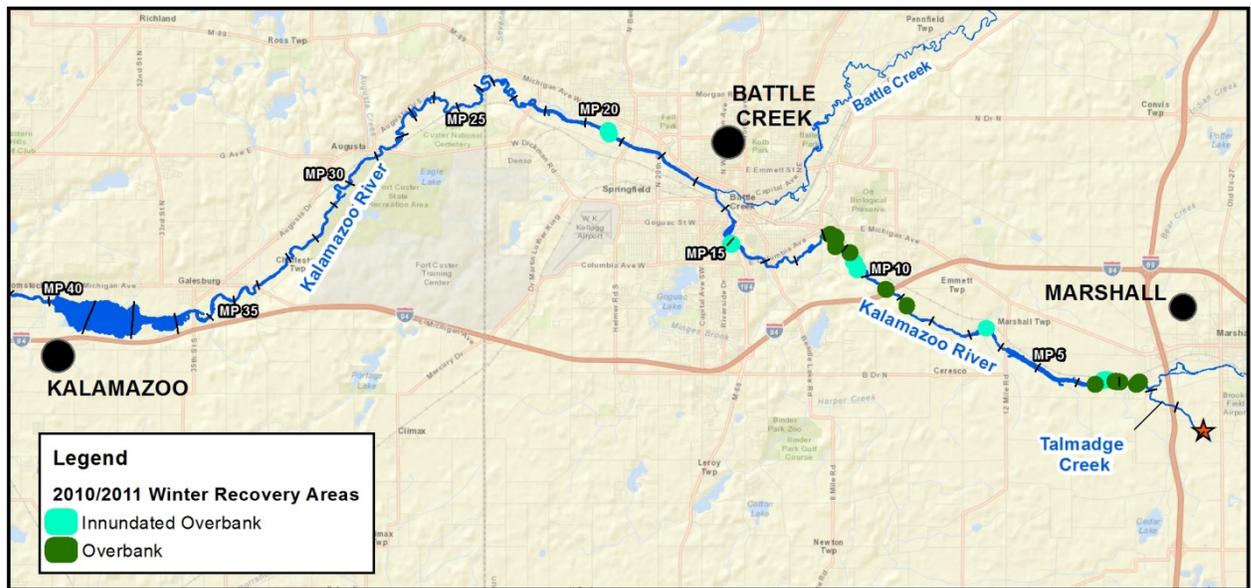
**Figure 45 – Winter 2010/2011 Overbank Recovery Areas**

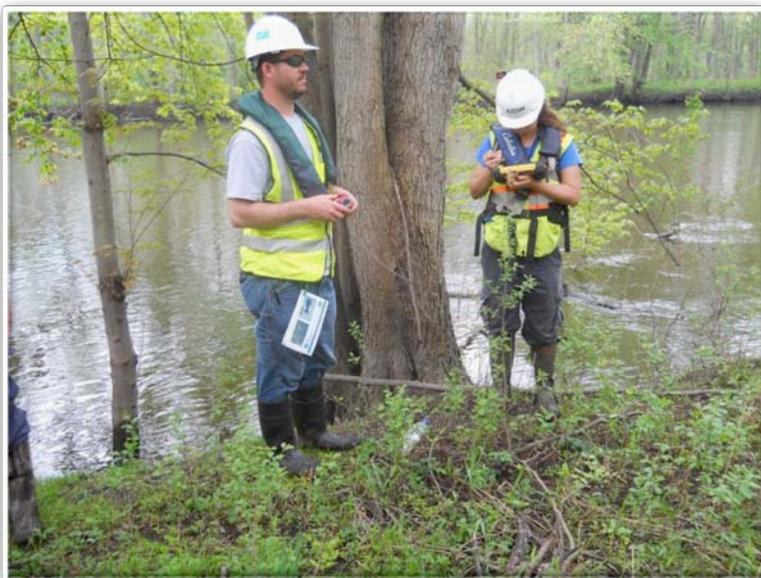
**Figure 46 –SORT Team Performing Surveys on the Kalamazoo River (5/12/2011)**

The Spring 2011 Shoreline and Overbank Reassessment (2011 SORT) (Figure 46) was conducted to identify locations of oil along the shoreline and overbank area from Talmadge Creek to the Morrow Lake Dam and to assess the effectiveness of the previously conducted shoreline and overbank recovery activities. The reassessment addressed all areas inundated at the time of the spill as defined by the USGS Inundation Model for most of Calhoun County. The Federal

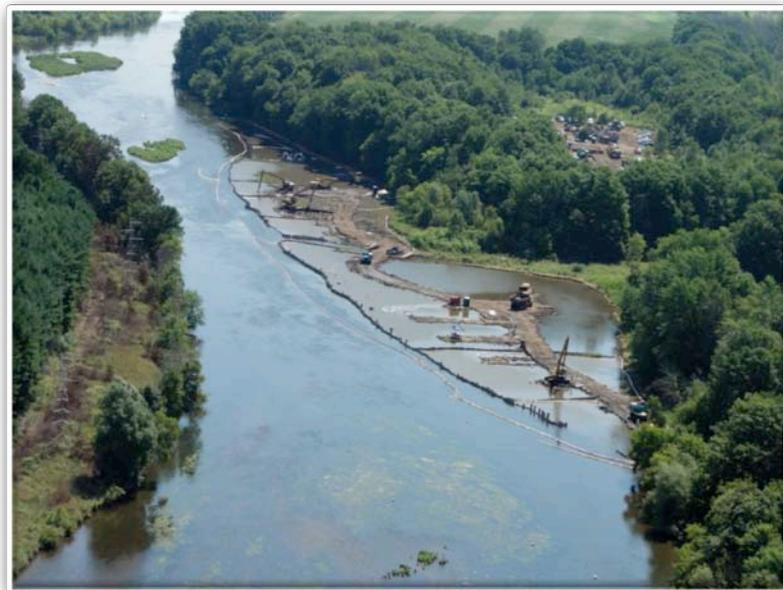
**Figure 47 – Excavation of MP 4.50 LDB (8/9/2011)**

Overbank recovery work was conducted throughout the summer and fall of 2011 at the locations identified during 2011 SORT. Excavations (Figure 47) were conducted in accordance with approved site-specific work plans at overbank and inundated overbank sites depicted in Figure 48.

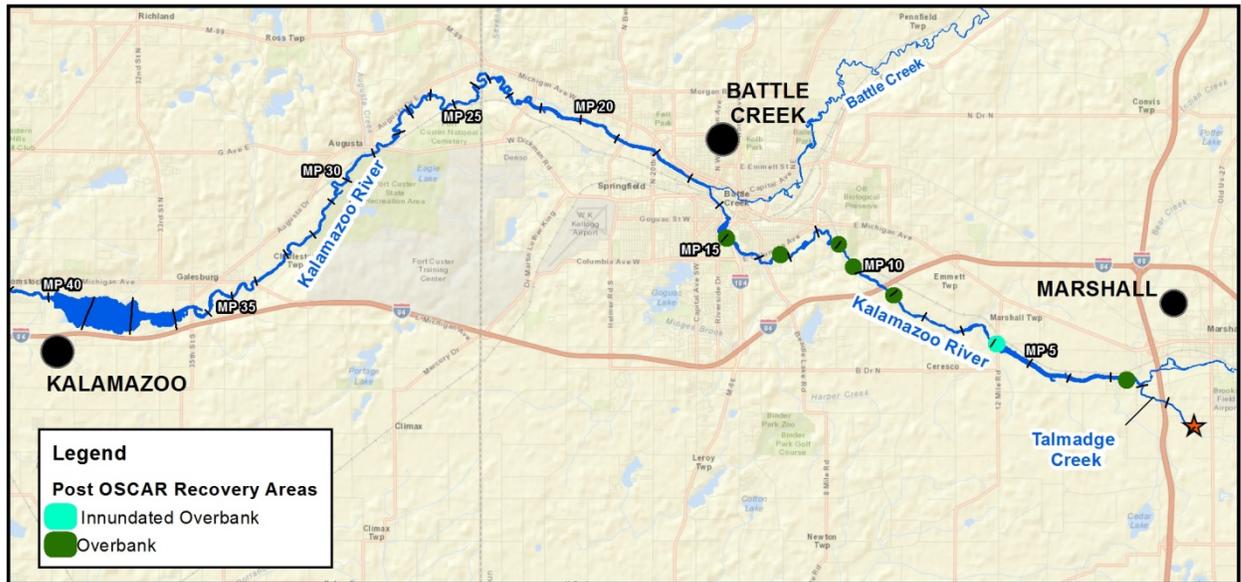
**Figure 50 – Post OSCAR Recovery Areas**

As a result of the OSCAR process, Enbridge conducted excavations in the fall of 2011, winter of 2011/2012, and spring of 2012 at the locations depicted in Figure 50, in accordance with approved site-specific work plans. Following excavation, EPA and Enbridge performed visual assessments to ensure that all oil-impacted sediments were removed. A secondary inspection was completed once all backfill and restoration was completed. Once the site was determined to be in compliance with the EPA Order, the site was transitioned to MDEQ primary oversight.

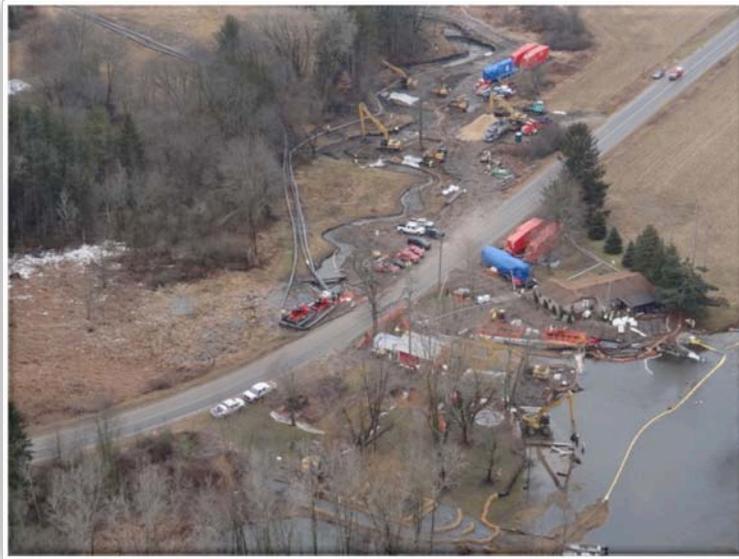
**Figure 51 – Excavation of Talmadge Creek at the Confluence with the Kalamazoo River (3/1/2012)**

In accordance with work plans approved by MDEQ (to optimize achievement of MDEQ long-term cleanup objectives), excavation of the creek began in November 2011 at the Source Area and continued working down gradient toward the confluence of the creek with the river. The horizontal and vertical extents of the excavation were defined by the RI, as well as visual assessments performed by Enbridge, MDEQ, and EPA during the excavation. Removal actions included recovery of any impacted material from the creek bed, banks, and overbank areas. Enbridge constructed sheet piling weirs and diverted the creek around the excavation areas. The diversion was accomplished by pumping the water approximately a quarter mile downstream to a hay bale dewatering structure which allowed the water to filter back into the creek with a minimal rise in turbidity. Excavation of Talmadge creek was completed in March 2012. Approximately 36,000 tons of sediment and overbank soil were removed from the two mi of affected creek (Figure 52).

As the excavation progressed down gradient from the Source Area, restoration was conducted concurrently. Clean fill was used to replace the excavated material. Topsoil was used to fill in excavated overbank areas, while sand and gravel was used to replace the creek bottom. Coir logs were used to stabilize the banks of the creek and prevent erosion. Native grasses were planted on the overbank areas to prevent erosion.

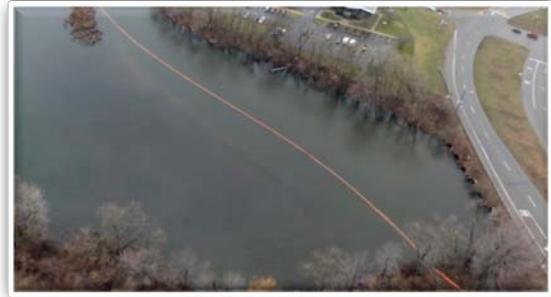
**Figure 53 – Shore-to-Shore Boom, Mill Ponds Impoundment (4/8/2011)**

- The shore-to-shore booming configuration (Figure 53) required a single span of boom deployed to cover the entire width of the river.
- The chevron booming configuration (Figure 54) required a single span of boom deployed to deflect oil around a sensitive area or to direct oil to recovery points on both banks.
- The cascade booming configuration (Figure 55) required deployment of multiple booms across the width of the river, allowing for vessel traffic up and down the river. Each additional segment was installed downstream in an overlapping position.
- The gate, or open chevron, booming configuration (Figure 56) required two segments of boom deployed across the width of the river to allow for vessel traffic up and down the river. The
