# FOSC Desk Report for the Enbridge Line 6b Oil Spill Marshall, Michigan

April 2016

This report has been written as outlined in 40 Code of Federal Regulations 300.165 (b) which tasks the Federal On Scene Coordinator (FOSC) to *record the situation as it developed, the actions taken, the resources committed and the problems encountered*. This FOSC Report documents all phases of the response to the rupture and resultant diluted bitumen heavy crude oil discharge from the 30-inch Enbridge Energy, Limited Partnership and its affiliates (Enbridge) Line 6b Pipeline which occurred on or about July 25, 2010.

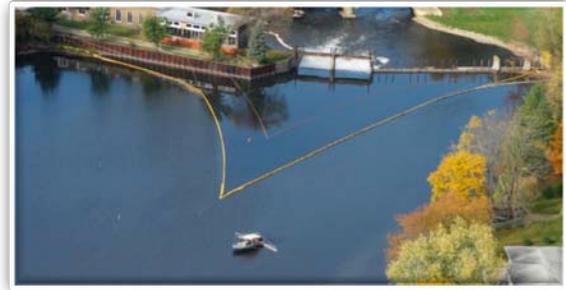
**Figure 54 – Chevron Boom Upstream of Ceresco Dam (10/11/2011)**

- The shore-to-shore booming configuration (Figure 53) required a single span of boom deployed to cover the entire width of the river.
- The chevron booming configuration (Figure 54) required a single span of boom deployed to deflect oil around a sensitive area or to direct oil to recovery points on both banks.
- The cascade booming configuration (Figure 55) required deployment of multiple booms across the width of the river, allowing for vessel traffic up and down the river. Each additional segment was installed downstream in an overlapping position.
- The gate, or open chevron, booming configuration (Figure 56) required two segments of boom deployed across the width of the river to allow for vessel traffic up and down the river. The

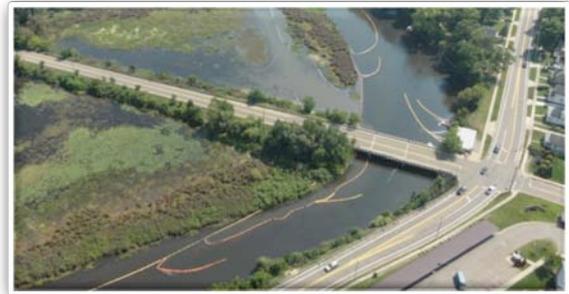
**Figure 55 – Cascade Boom at Mill Ponds (9/1/2011)**

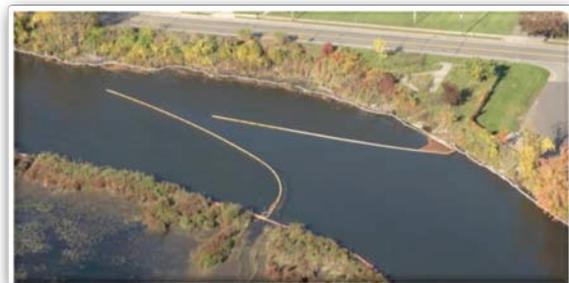
**Figure 56 – Gate Boom at Mill Ponds (10/8/2011)**

upstream ends of both booms were secured in an overlapping position.

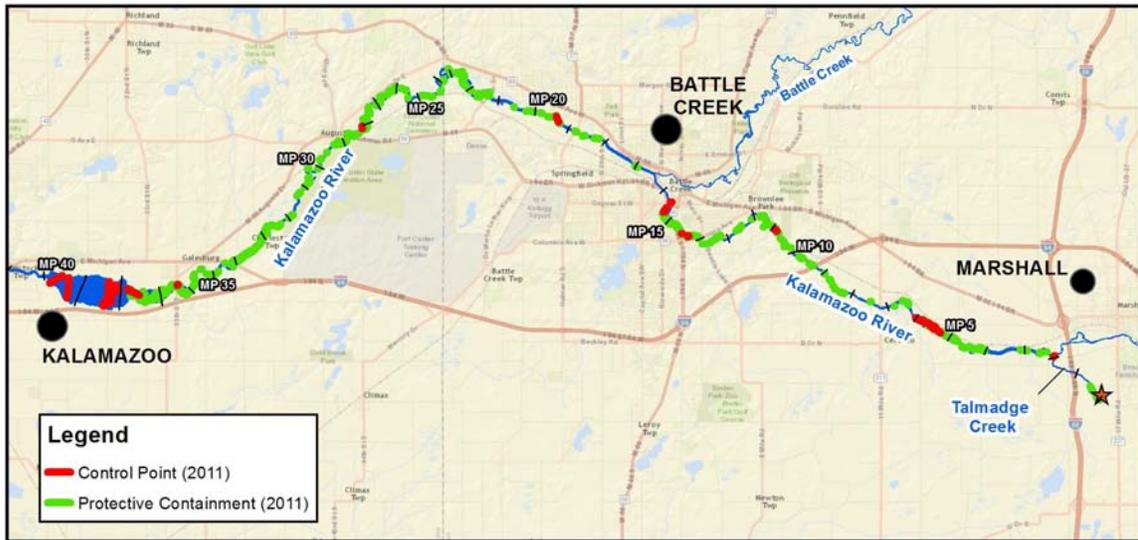
**Figure 57 – Control Point and Protective Containment Locations in 2011**

During the late winter of 2010 and early spring of 2011, O&M teams observed river conditions, including freezing, ice movement, debris movement, presence of surface oil, and submerged oil migration. The FOSC used this information to determine the priority sequence and timing of containment deployment throughout the river system. In the spring of 2011, Enbridge redeployed nine control points and approximately 46 protective containment points (Figure 57) as weather conditions allowed. The teams performed routine inspections of the containment sites. Containment was added, adjusted, or removed based on the inspection results. During the summer of 2011, the number of containment sites increased to 14 control points and 59 protection containment locations. In fall 2011, the FOSC transitioned containment inspections from the O&M Group to the Containment Branch Monitoring Group. By winter 2011, the only remaining control point boom location was at the confluence of Talmadge Creek with the Kalamazoo River at MP 2.25. Additionally, 14 protective containment point locations remained deployed from MP 2.00 to the oxbow at MP 21.50.

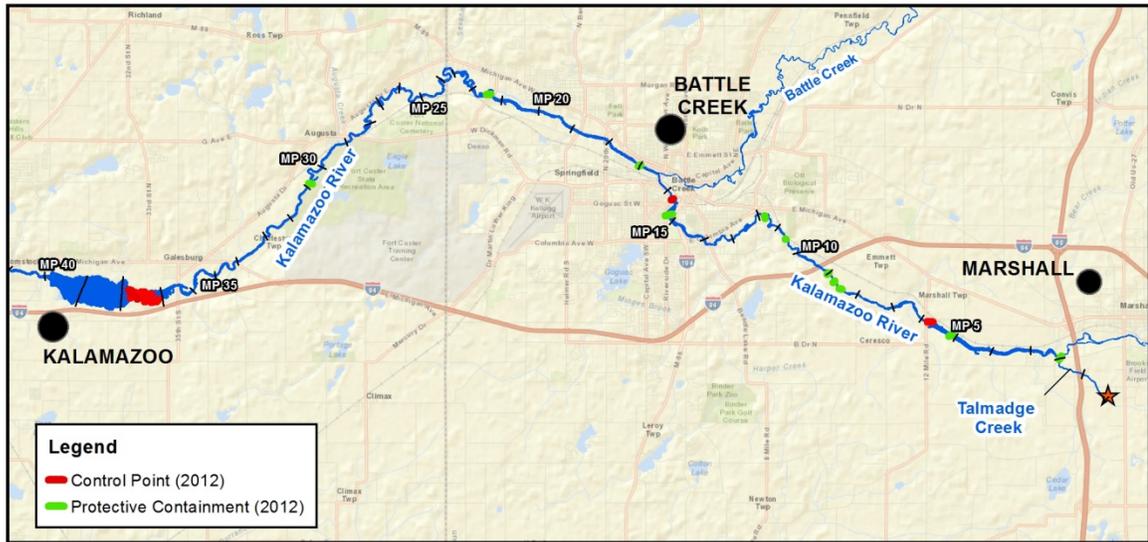
**Figure 58 - Control Point and Protective Containment Locations in 2012**

In addition to the nine containment sites monitored through the late winter, surface containment was installed at six locations (Figure 58) during the spring based on visual observations and locations where migration of sheen surfacing from submerged oil were of concern. Containment was deployed at C0.4 boat launch, Ceresco Dam, MP 14.98 I, MP 15.75, MP 30.8 LDB, and E4 control point (MP 37.75). By the end of spring 2012, containment locations remained at MP 10.75 LDB and the E4 control point.

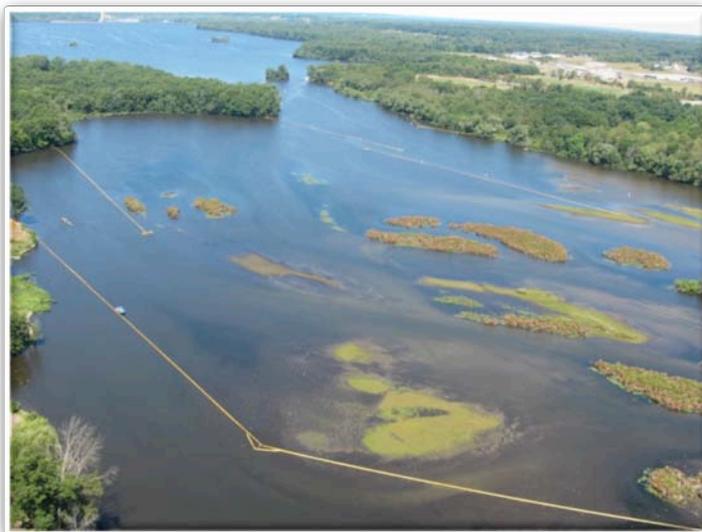
**Figure 59 – E4 Containment Structure at Morrow Lake Neck (7/10/2012)**

During late May and early June 2012, EPA and Enbridge met regularly to develop an alternative to the reinstallation of Control Point E4.5. Deployment of the alternative containment strategy, known as the E4 Containment System (Figure 59), began on June 22, 2012 and was completed on July 20, 2012. Construction was completed in accordance with the approved 2012 Morrow Lake Delta Alternative Containment Strategy. This new E4 Containment System consisted of an array of surface boom and half curtains in the Morrow Lake Delta and Neck. The completed system (Figure 60) consisted of nine boom segments (Booms A through F2) that used steel anchor posts, hard boom, and a partial X-Tex® sediment curtain with adjustable slings to accommodate fluctuating flow rates. A maximum flow rate of 5,000 cubic feet per second was assumed for design calculations to ensure stability and maintenance. A sediment half curtain was suspended from the booms and held to the river bottom with ballast chains. The top of the curtain was adjusted to be approximately one half of the total water depth, leaving the top half to allow water to pass through. The E4 Containment System increased the depositional properties within the Morrow Lake Delta and Fan and also allowed public use within the main channel of the delta and the boat launch for Morrow Lake.

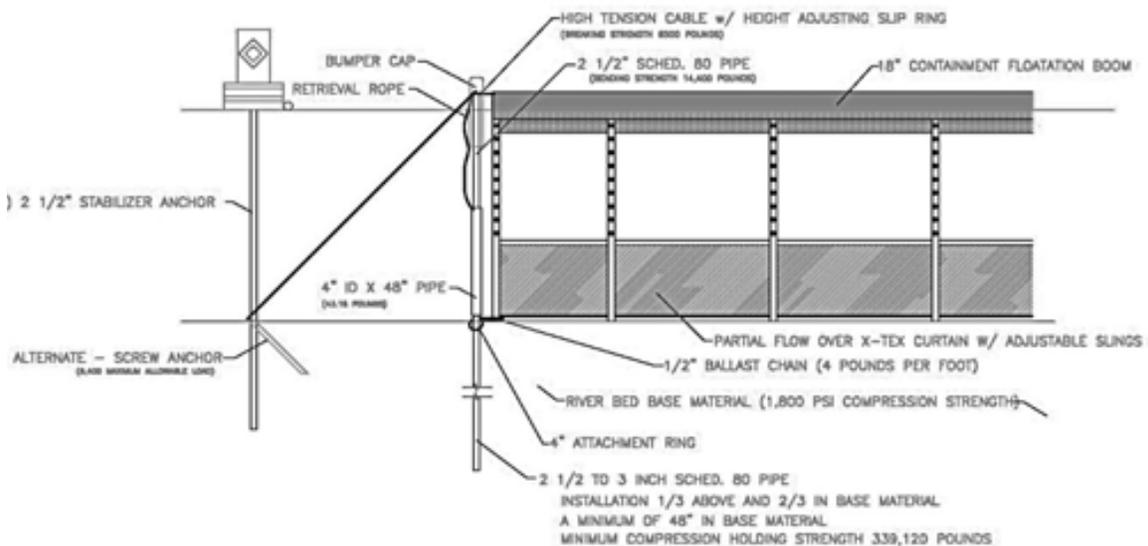
The E4 Containment System (Figure 61) remained in place throughout the summer and fall of 2012. Enbridge monitored the anchor systems, surface containment boom, and subsurface curtain on a daily basis for the first week following installation and continued on a regular basis to ensure the integrity of the containment system. Monitoring activities included visual inspection, video documentation of the subsurface ballast chain, and poling. Additional monitoring was completed

In advance of river icing, Enbridge removed the E4 Containment System on November 30, 2012 in accordance with the approved Fall 2012 E 4.0 Containment Removal Plan (Enbridge, 2012c).

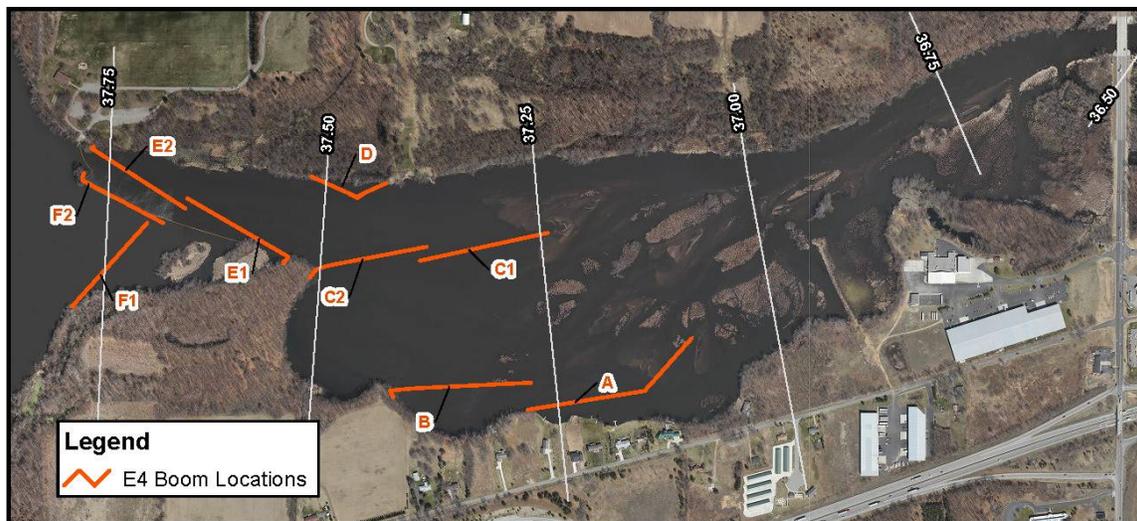
**Figure 61 – E4 Containment System (2012)**

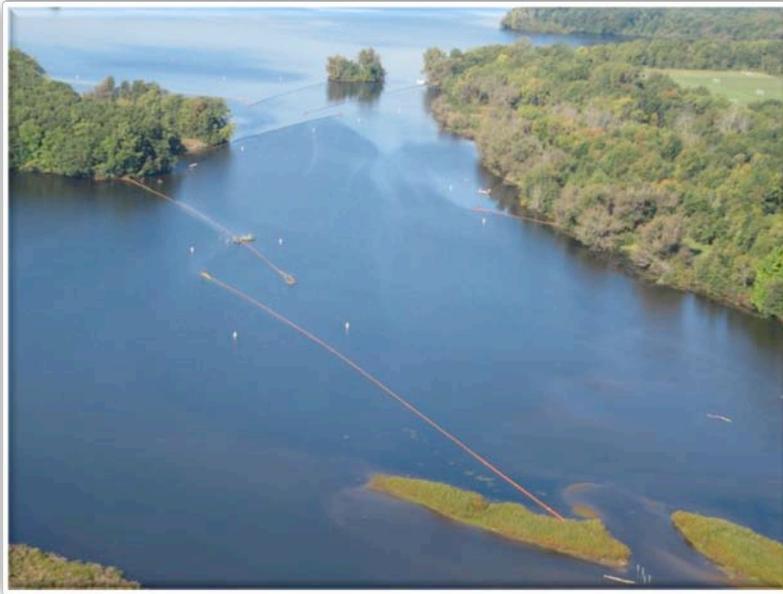
**Figure 63 – E4 Containment Structure (9/25/2013)**

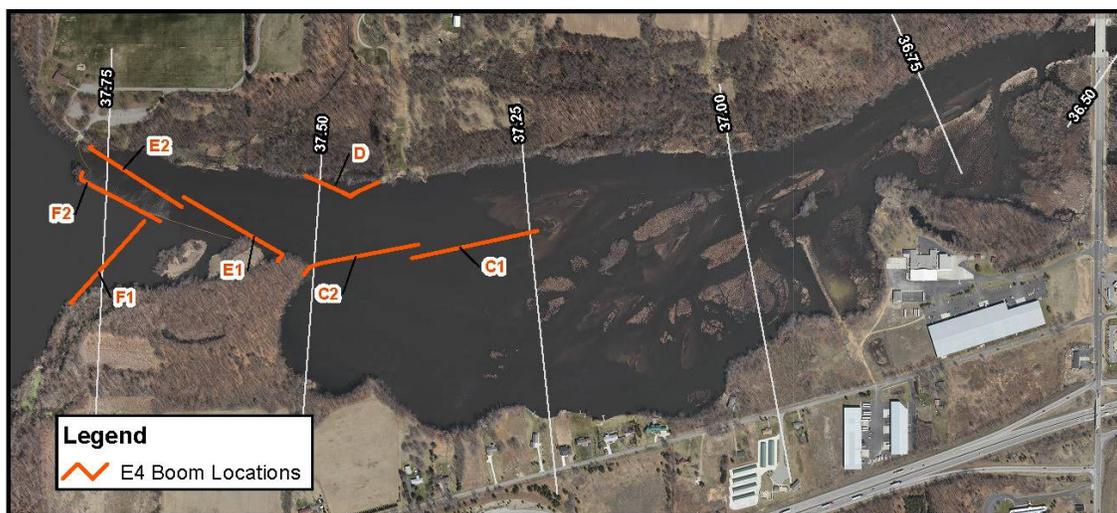
**Figure 64 – E4 Containment System Boom (2013)**

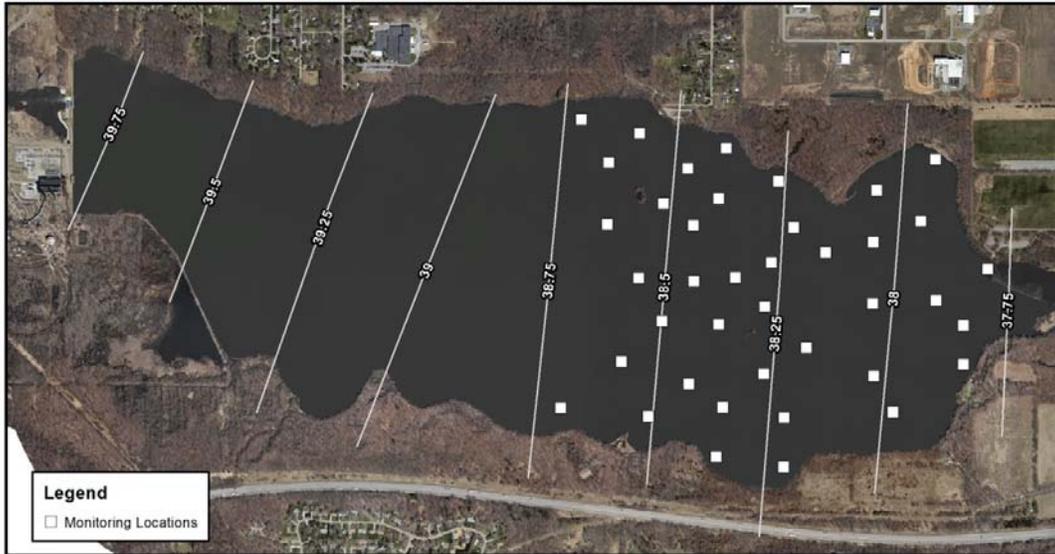
**Figure 65 – Morrow Lake Submerged Oil Monitoring Locations (2011)**

Lake Delta and Fan. Monitoring was conducted at 40 fixed locations, depicted in Figure 65. The cycle was completed every second day during recovery operations. Monitoring results indicated that the distribution of submerged oil in the eastern portion of Morrow Lake remained relatively constant during submerged oil tool box agitation and recovery operations.

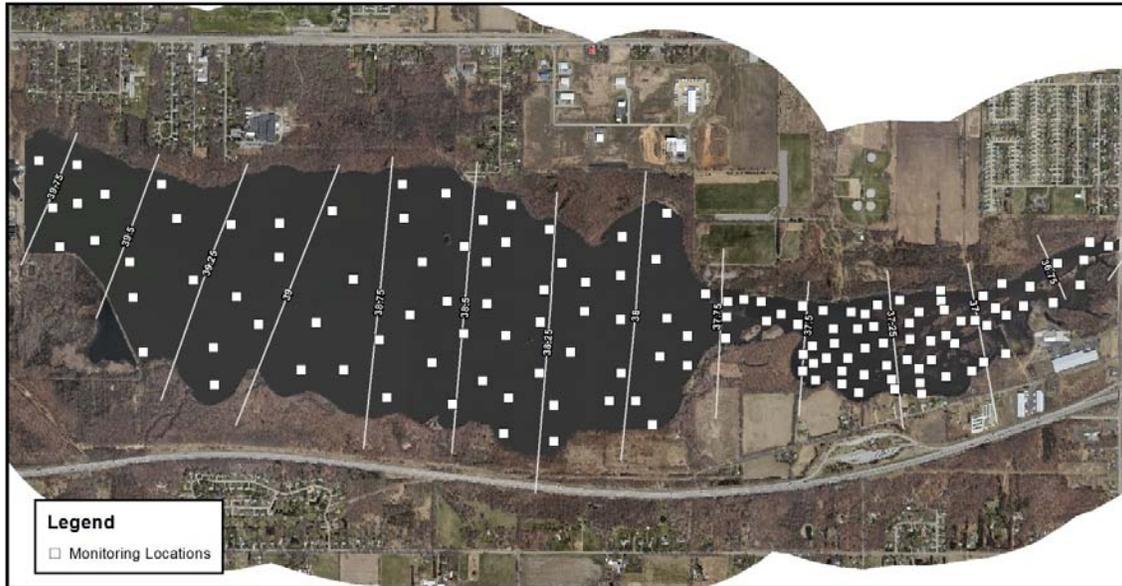
**Figure 66 – Morrow Lake and Delta Submerged Oil Monitoring Locations (2012)**

The Morrow Lake Delta and Morrow Lake Monitoring program was re-implemented in the spring of 2012 to monitor submerged oil distribution and movement in the Morrow Lake Impoundment. Under direction of the FOOSC, Enbridge developed the Morrow Lake Delta and Morrow Lake Monitoring and Management Work Plan (Enbridge, 2012a) to formalize the monitoring locations while developing a containment strategy for Morrow Lake, as discussed in Section 5.4.3. Initially, monitoring was conducted at 40 poling locations in the eastern half of Morrow Lake. At the end of April 2012, poling locations were added to the Morrow Lake Delta. In May 2012, additional locations were added in the western portion of the lake. Additional minor adjustments were made to the monitoring locations, as results were evaluated. The approved locations, depicted in Figure 66, included 67 locations in the Morrow Lake Delta/Neck and 69 locations in Morrow Lake.

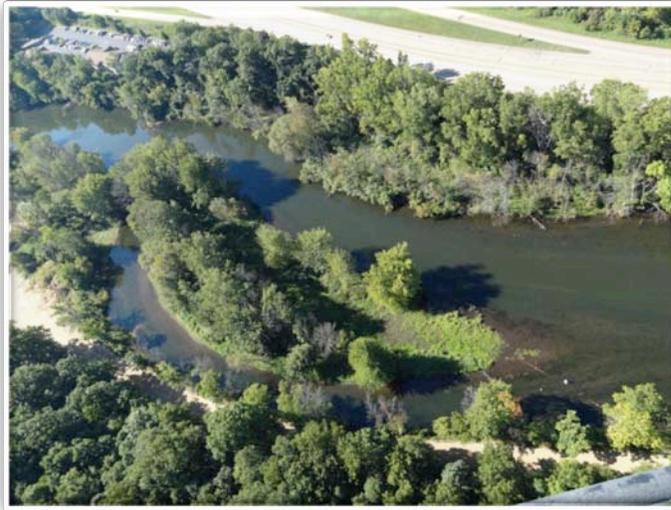
**Figure 68 – Sediment Trap at MP 14.75  
(9/12/2012)**

Based on the results of sediment fate and transport studies, preliminary hydrodynamic modeling, and previous assessment activities, 25 sites with varying geomorphic settings were initially identified as potential sediment trap locations (see Figure 68 for example). The potential locations were further evaluated, and 16 in-channel sediment trap locations were selected (Table 6). In addition, one overbank trap location was identified (MP 11.79 LDB), which consisted of an impacted overbank floodplain area where no recovery activities had occurred due to the existence of a high-quality

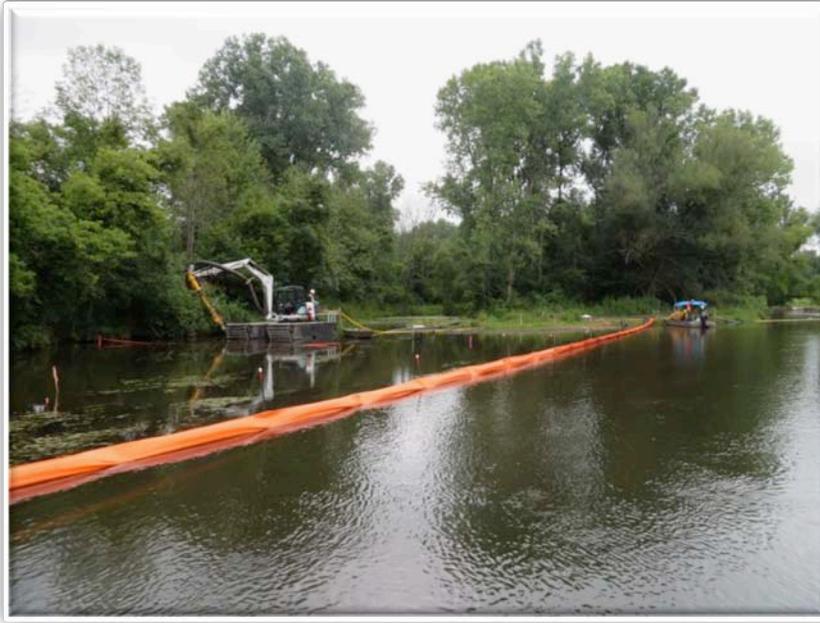
**Figure 73 – Sediment Removal via Vacuum at MP 10.40  
(8/2/2013)**

For dredging operations at the MP 10.40 N sediment trap, Enbridge constructed a combined channel margin depositional bar and backwater geomorphic feature pursuant to the approved SORA Work Plan (Enbridge, 2013a). Enbridge used a SedVac® system (Figure 73) to remove sediment from 3 dredge areas within the sediment trap. Sediment was pumped as a slurry to a

dewatering and mixing station, solidified, and transported to an approved off-site disposal facility. Water was pumped into an on-site water treatment system consisting of weir tanks connected in series with a GAC system. Treated effluent was discharged back into the river in accordance with NPDES permit requirements. Dredging was completed on August

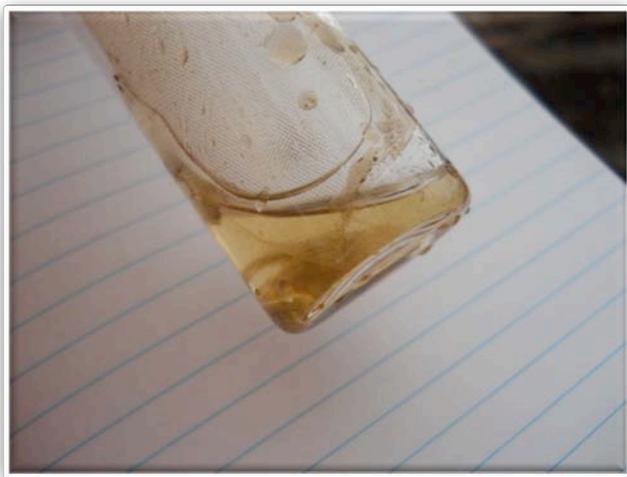
**Figure 75 – Hexane Test (3/2/2012)**

The hexane test was based on the solubility of petroleum hydrocarbons in non-polar solvents, and the non-solubility of naturally occurring biological materials in the solvents. Teams collected sheen from the water surface using a small piece of sheen net. The net was inserted into a glass vial containing hexane. The vial was shaken, allowed to stabilize, and assessed. Oil sheen dissolved in hexane causing the hexane to discolor (Figure 75), while biogenic sheen did not dissolve or discolor the hexane.

The ultraviolet (UV) test involved viewing the hexane test vials under ultra violet light. Oil sheen fluoresced, while biogenic sheen did not fluoresce.

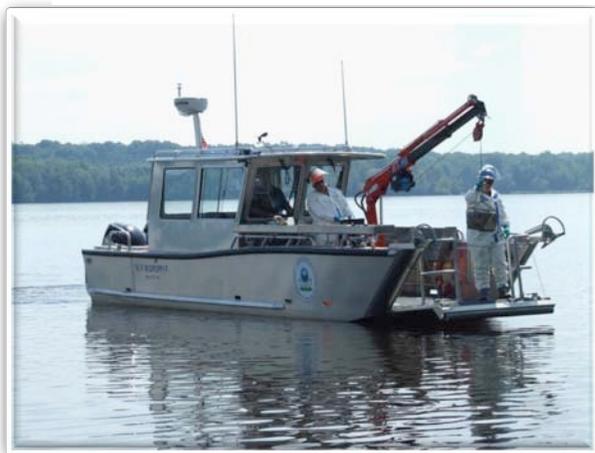
**Figure 76 – Mudpuppy II Collecting Sediment Samples (8/29/2010)**

Beginning in August 2010, EPA mobilized the Great Lakes National Program Office's (GLNPO) sampling vessel, the *Mudpuppy II* (Figure 76), for surface water and sediment sampling at Morrow Lake to determine if oil was present in the water and surface sediment. GLNPO technicians operated the vessel and collected samples daily from ten fixed stations within Morrow Lake. Sediment samples were collected using a standard Ekman bottom grab sampler. Surface water samples were collected in two-foot intervals to the lake bottom using a Niskin water bottle sampler.

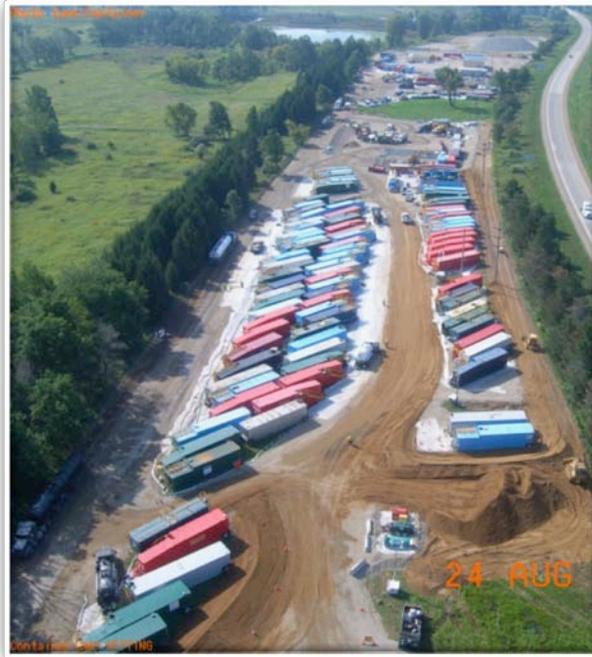
**Figure 77 – Frac Tank City, adjacent to I-69  
(8/24/2010)**

At the peak of the spill response operations, there were approximately 200 frac tanks on site. All

but a few of these were staged in an area referred to as Frac Tank City (Figure 77). Vacuum trucks were used to transfer material in and out of the tanks. The approved Frac Tank Secondary Containment Plan (Enbridge, 2010) established best management practices and administrative controls for secondary containment at frac tank staging areas.

Wastewater generated from Frac Tank City operations was sampled when approximately 100,000 gallons had been processed. The samples were submitted to an approved laboratory for TPH (DRO, GRO, and ORO) analysis.

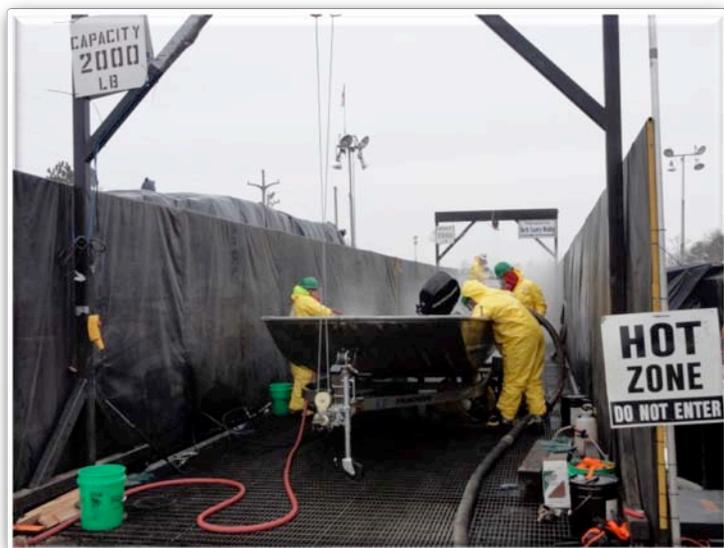
**Figure 79 – Boat Decontamination at C0.5  
(12/11/2010)**

Multiple decontamination methods were utilized during the response, including power washing, EPA-approved cleaning agents, chemical wipes, and dry decontamination methods. At the peak of the response as many as 94 pieces of heavy equipment, 102 vacuum truck and tankers, 126 frac tanks, and 267 watercraft were involved in the response efforts. Accordingly, decontamination areas were required throughout the entire response area. Satellite decontamination stations were established along the affected reaches of river at locations

where boom was deployed, at boat launches, and at overbank work areas. By the end of October 2010, Enbridge consolidated the satellite decontamination locations into three locations located at the soil staging area in Division A, Talmadge Creek Yard 4 Staging Area Cell 12, and the C0.5 Decontamination Pad (Figure 79). These locations operated until December 2010, when a winterized decontamination area was built in Frac Tank City. The decontamination pads located within Frac Tank City operated as the primary decontamination area through the remainder of the response. When the Kalamazoo River reopened to the public in June 2012, remote decontamination stands with Simple Green wipes were stationed at selected portage locations throughout the affected area of the Kalamazoo River. These helped to ensure that members of the public who encountered incidental oil residuals could clean their watercraft.

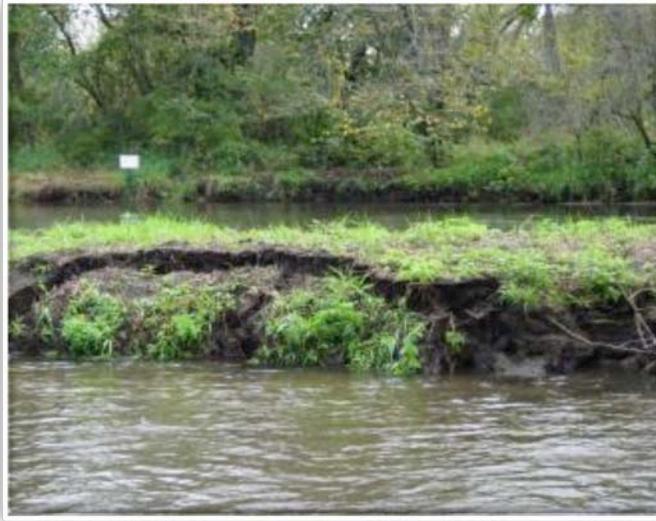
**Figure 89 – Bank Erosion During 2010 Response Activities (Courtesy USFWS)**

From August 9 through September 2, 2010, the NRDA Trustees conducted ground surveys in the Kalamazoo River floodplain to document the extent and degree of oiling in floodplain habitats (Figure 89). These surveys were conducted cooperatively with Enbridge under jointly approved NRDA work plans. The field teams walked transects that were approximately 50 meters apart from each other in floodplain habitats on both sides of the river from Talmadge Creek to Morrow

Lake. Selected areas (e.g., islands, areas of heavy oiling of at least 50 square ft in the floodplain) were surveyed at a more detailed level. Field crews surveyed a total of 742 transects on both sides of the river. Field teams recorded percent of oil present on soil and vegetation, habitat type, and some habitat features (e.g. vernal pools, downed trees).

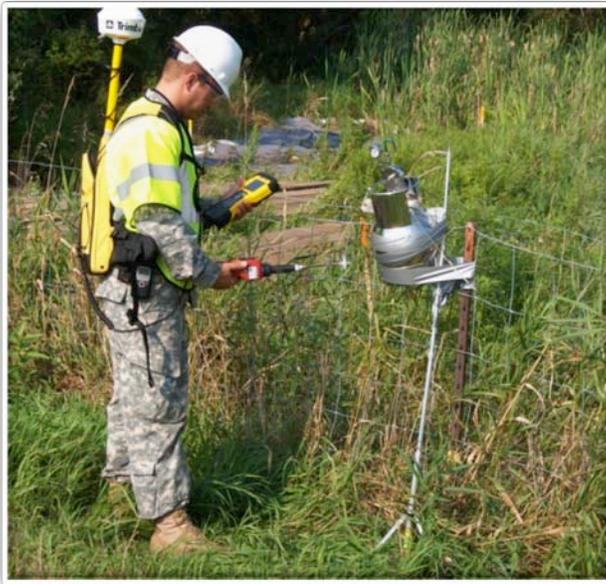
**Figure 90 - Air Monitoring and Sampling by 51st CST Personnel (8/1/2010)**

Teams collected air samples from fixed community locations where health officials were concerned about public exposure and from locations near oil collection points (Figure 90). Samples were collected in regulated evacuated Summa and mini canisters (24-hour time-integrated and/or grab) and analyzed for VOCs using EPA Method TO-15.

On July 27, 2010 EPA began enhanced air monitoring activities using ppbRAEs, MultiRAEs, and AreaRAEs to monitor for total VOCs, as well as UltraRAEs and Draeger tubes and chips to monitor for benzene. In addition, the 51<sup>st</sup> Civil Support Team (CST) verified benzene UltraRAE readings utilizing several mobile HAPSITE field gas chromatograph instruments. Benzene is the most toxic of the VOCs that were released from the discharged oil and was therefore used as an index parameter for real-time air monitoring.

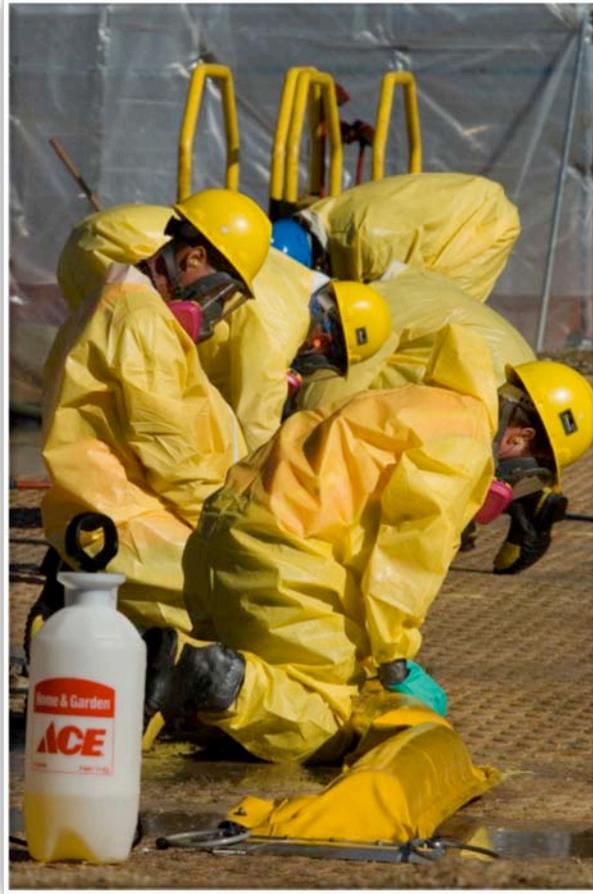
**Figure 98 – Personal Protective Equipment during Boom Decontamination (10/5/2010)**

Safety personnel monitored worker safety and health throughout phases of the response to ensure that appropriate protection was used based upon hazard and risk. OSHA Levels B, C, and D were used during the response (Figure 98). The use of Levels B and C was limited to specific tasks or locations that dictated the need for higher levels of respiratory protection, as discussed in Section 5.9.3. This strategy prevented adverse effects from the overprotection of workers.

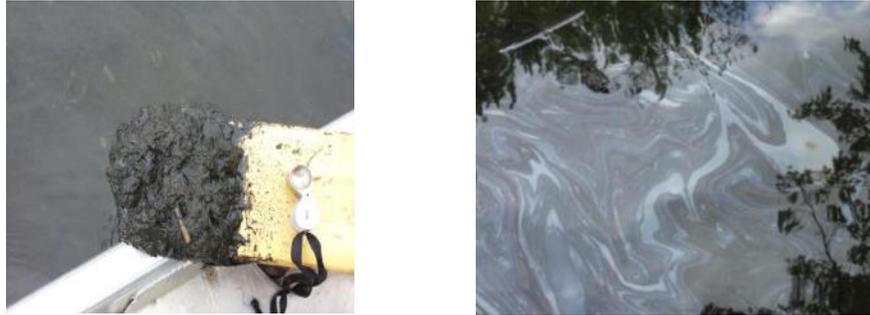
**Figure 99 – Oiled Sediment and Emerging Sheen from Oiled Sediments**

An understanding of the geomorphic characteristics of the Kalamazoo River provided the backbone for submerged oil assessment, monitoring, and recovery activities because of submerged oil's association with depositional areas of the river and affinity for aggregation with fine-grained sediment (silt, clay, and organic matter). These particles, associated with depositional areas in the river, had important direct and indirect roles in the formation of OPA from the mixing of bitumen with the sediment. As the initial mass of oil broke up and formed droplets, the bitumen had a high affinity for silt, clay, and organic matter in suspension in the water column, as well as on the river bed and banks (Figure 99). While the range of mechanisms for the formation of OPA in freshwater riverine environments are being investigated in laboratory studies, the geomorphic and sediment conditions in the Kalamazoo River were especially conducive to the formation of OPA. The resuspension, transport, and settling of OPA were also studied in laboratory flume tests to obtain data inputs for numerical models aiding in the Kalamazoo River cleanup. Similar to fine-grained sediment and organic matter, OPA can be deposited in low gradient areas of the main channels, such as in impoundments, during low flows, but then during high flows these areas can become erosional, corresponding to increased velocities. Some areas of the river are always depositional even under high flow conditions, such as offchannel backwaters in wide sections of the river or disconnected side channels and oxbows. Other areas may be depositional during low flow, but with high flows, soft sediment and remaining oil, and OPA may be transported downstream.

Areas of slow-moving water containing submerged oil included reaches where the slope of the river flattened, such as at the three main impoundments (Ceresco Dam, Mill Ponds, and Morrow Lake Delta), or where the river widened enough to allow for depositional zones along channel margins. Submerged oil also was associated with secondary channels, oxbows, the downstream side of islands, and tributary mouths.
