Navajo Abandoned Uranium Mine

Site Screen Report

Mine Name: Lemuel Littleman No. 2

Mine ID: 127

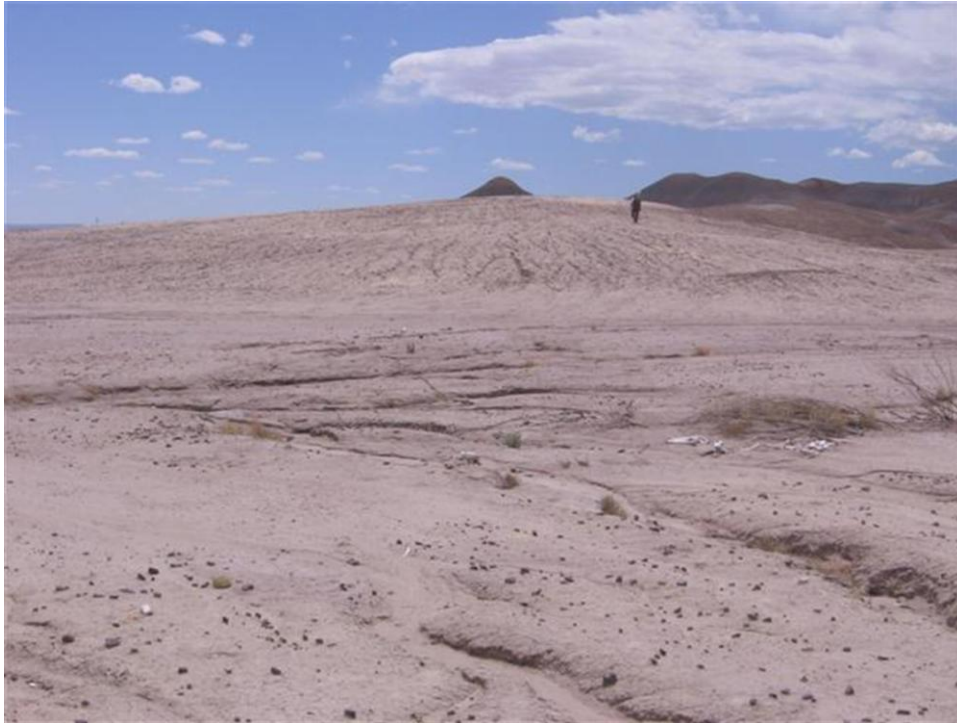
Photo 2: Mine Site #127; Reclamation area

2 reclamation caps
