# **Navajo Abandoned Uranium Mine**

## **Site Screen Report**

### **Charles Huskon No. 3 AUM Site**

**Weston Solutions, Inc.**

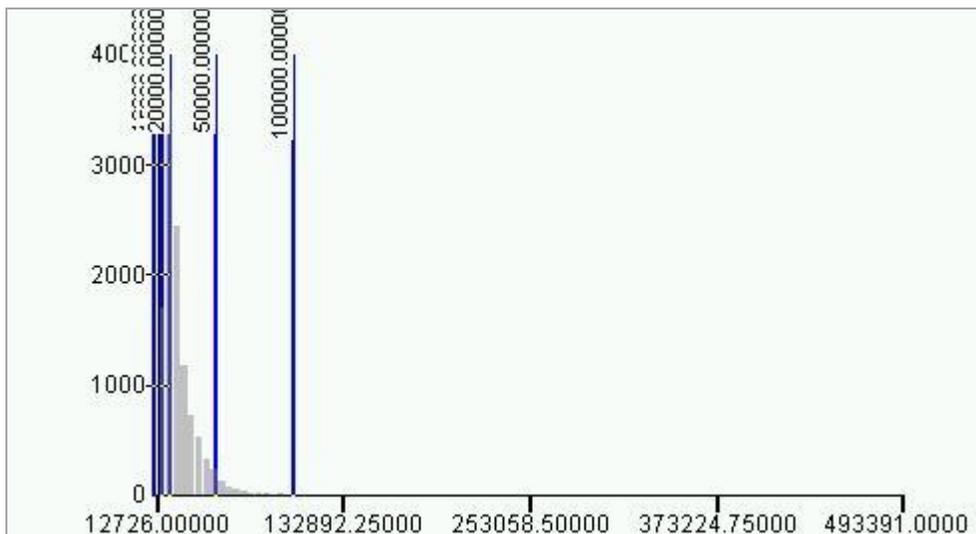
The following chart and statistics were generated by ESRI ArcGIS 9.3.1, and show the general distribution of the site gamma radiation measurements. The horizontal X axis represents the gamma radiation reading levels in cpm (lowest levels to the left). The vertical Y axis represents the frequency of each gamma radiation level.

Count:	11299
Minimum:	12726.00000
Maximum:	493391.00000
Sum:	319689964.00000
Mean:	28293.65112
Median:	22820.00000
Standard Deviation:	25912.81454

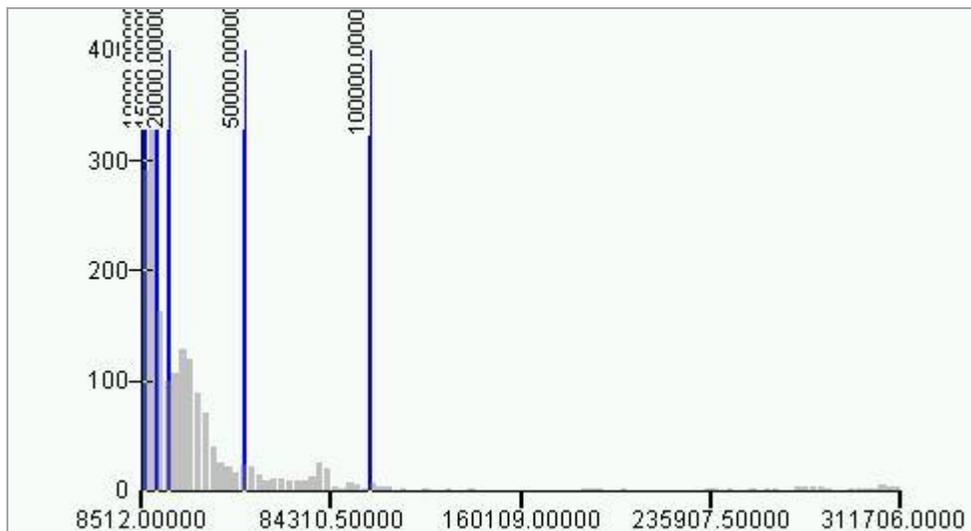
The following chart and statistics were generated by ESRI ArcGIS 9.3.1, and show the general distribution of the site gamma radiation measurements. The horizontal X axis represents the gamma radiation reading levels in cpm (lowest levels to the left). The vertical Y axis represents the frequency of each gamma radiation level.

Count:	1794
Minimum:	8512.00000
Maximum:	311706.00000
Sum:	57805714.00000
Mean:	32221.69119
Median:	19720.00000
Standard Deviation:	43861.35267

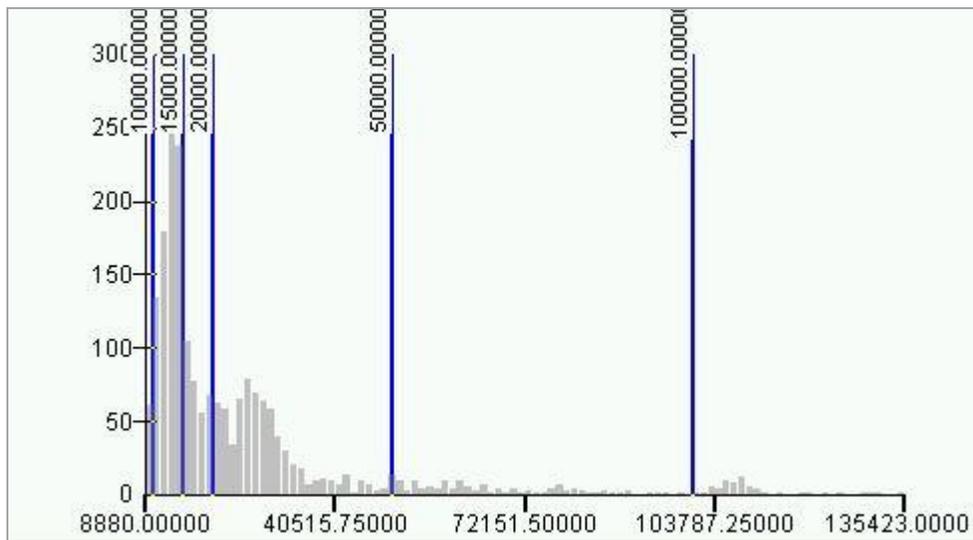
The following chart and statistics were generated by ESRI ArcGIS 9.3.1, and show the general distribution of the site gamma radiation measurements. The horizontal X axis represents the gamma radiation reading levels in cpm (lowest levels to the left). The vertical Y axis represents the frequency of each gamma radiation level.

Count:	2051
Minimum:	8880.00000
Maximum:	135423.00000
Sum:	51433448.00000
Mean:	25077.25402
Median:	17291.00000
Standard Deviation:	20592.71496

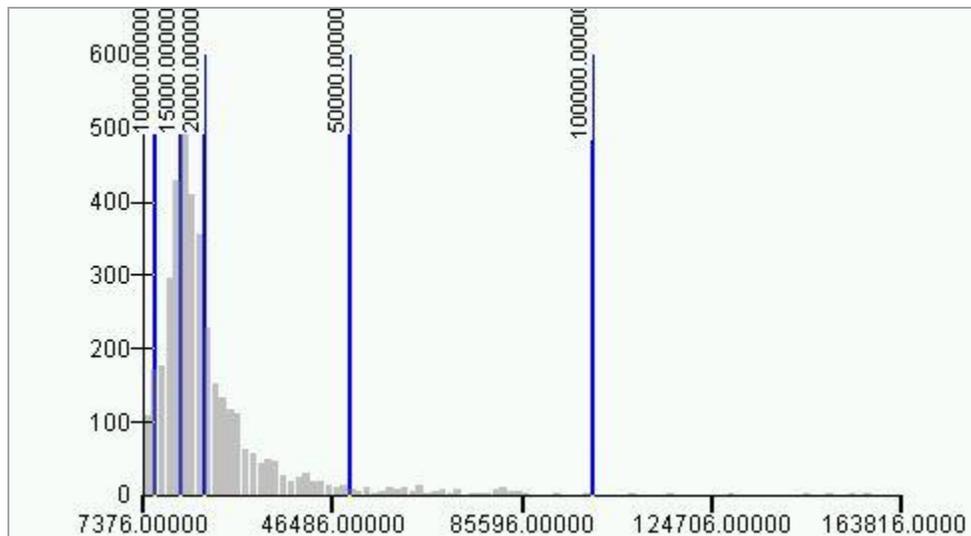
The following chart and statistics were generated by ESRI ArcGIS 9.3.1, and show the general distribution of the site gamma radiation measurements. The horizontal X axis represents the gamma radiation reading levels in cpm (lowest levels to the left). The vertical Y axis represents the frequency of each gamma radiation level.

Count:	3822
Minimum:	7376.00000
Maximum:	163816.00000
Sum:	84278252.00000
Mean:	22050.82470
Median:	17564.50000
Standard Deviation:	16264.42453

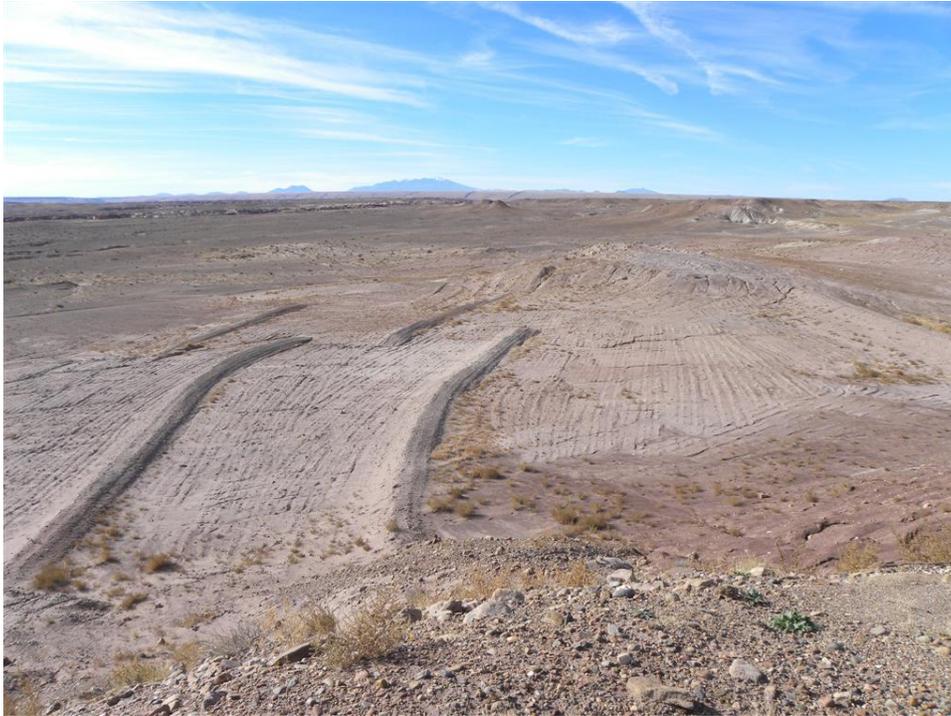
Photo 3. Charles Huskon No. 3, Site #137, reclamation berms

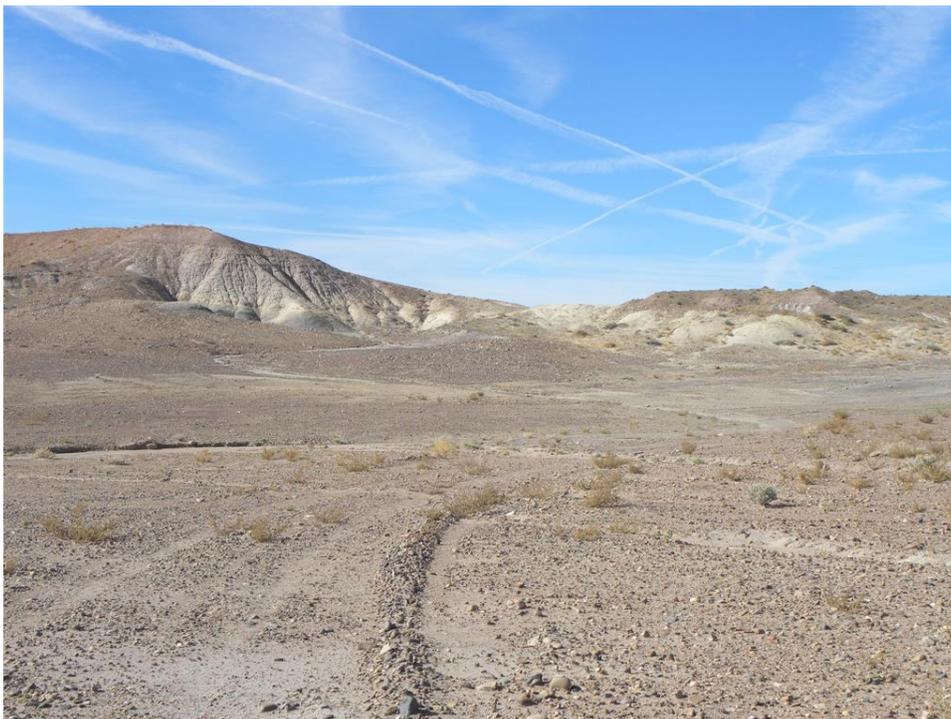
Photo 4. Charles Huskon No. 3, Site #137, reclamation berms

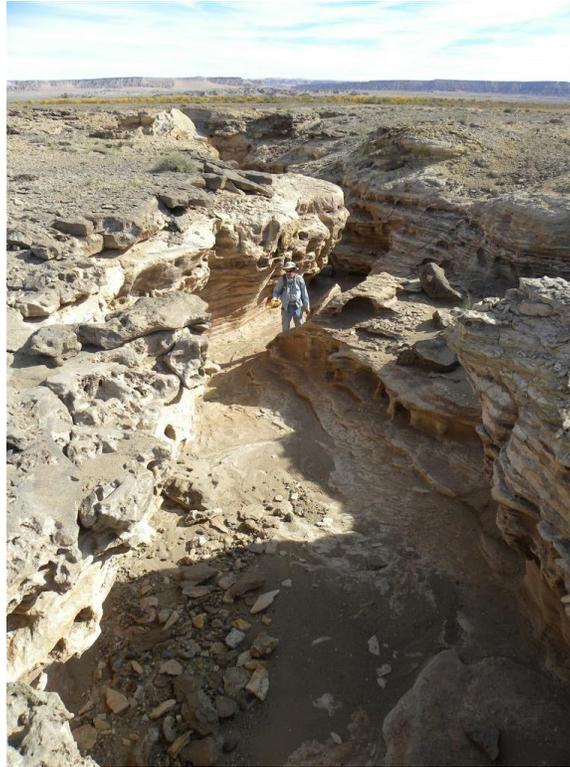
Photo 5. Charles Huskon No. 3, Site #137, gully with waste rock

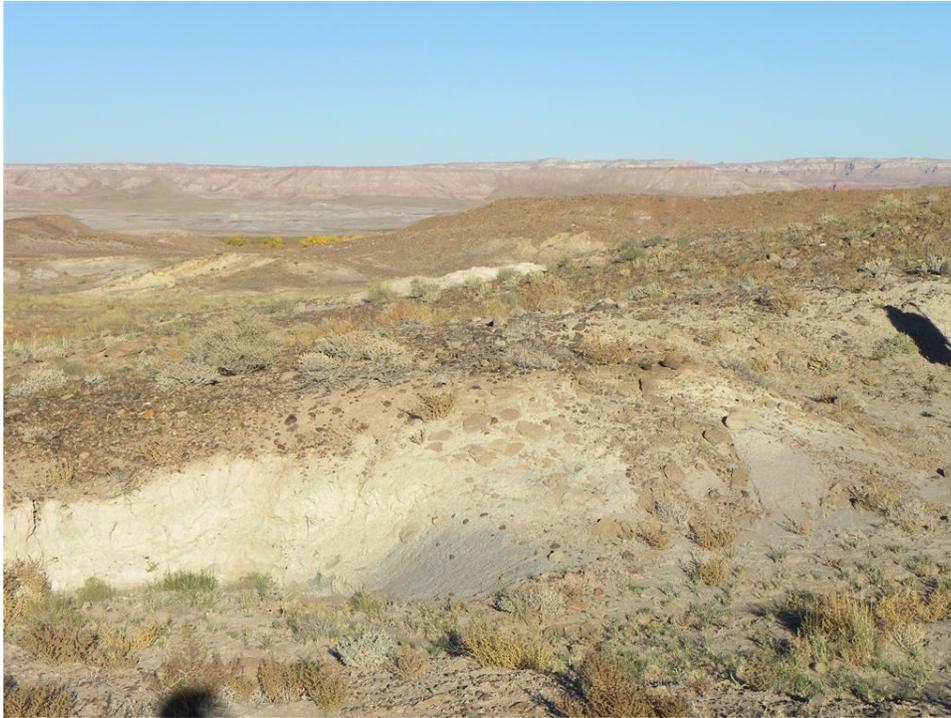
3 waste piles: 1 - 10' diameter x 4' h; 2 - 10' diameter x 4' h; 3 - 20' diameter x 4' h exposed material

Photo 7. Charles Huskon No. 3, Site #138, waste piles and exposed material

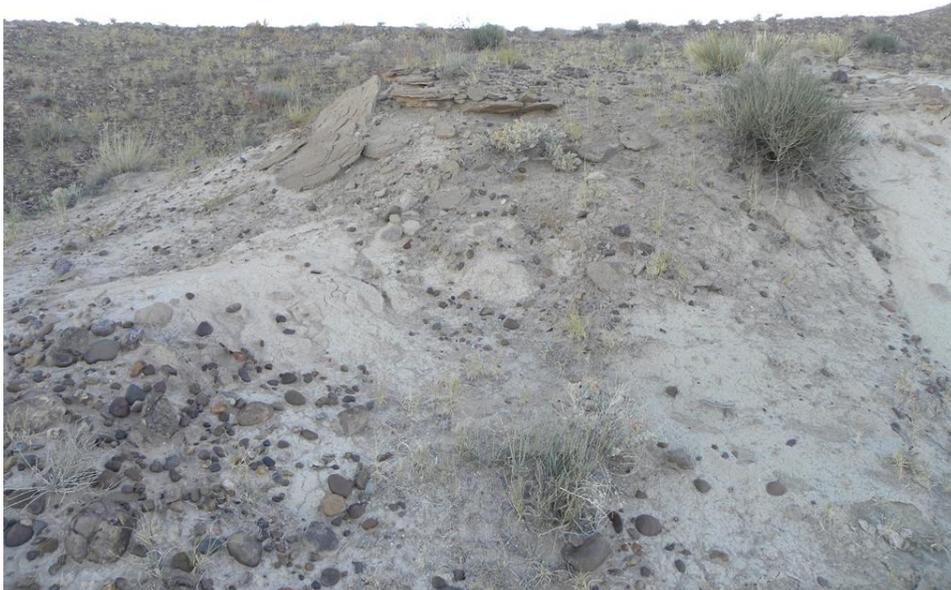
3 Waste piles: 1 - exposed yellow-brown material, 6' x 4' x 3'; 2 - larger pile of fine yellow-brown material, 20' diameter x 8' h; 3 - series of 3 small piles of yellow-brown material and petrified wood chips 8' diameter x 2.5' h

Photo 10. Charles Huskon No. 3, Site #139, waste pile

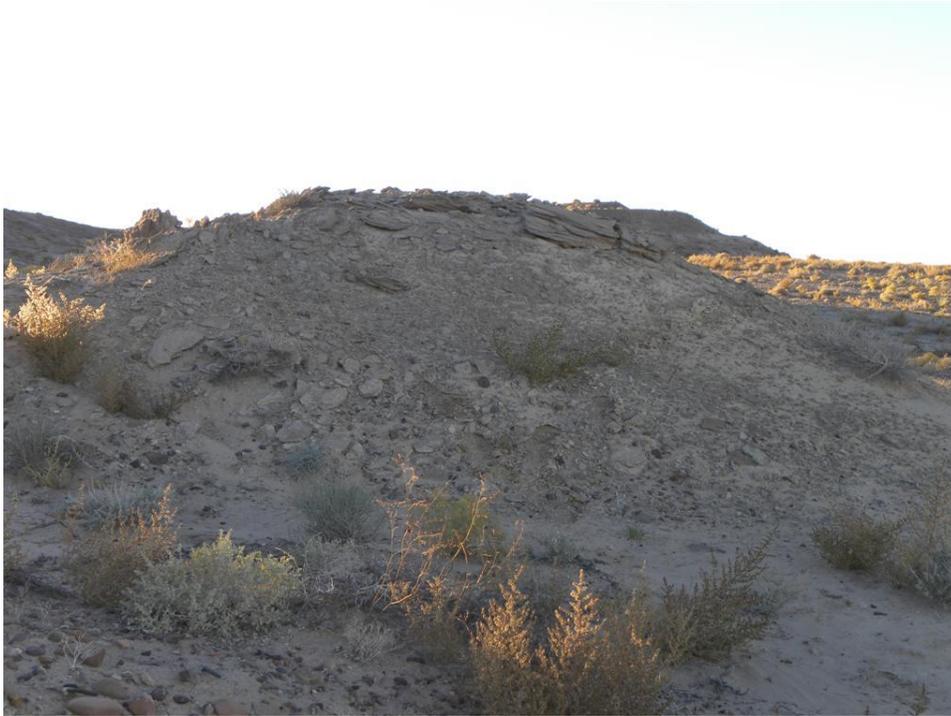
Photo 11. Charles Huskon No. 3, Site #139, waste pile

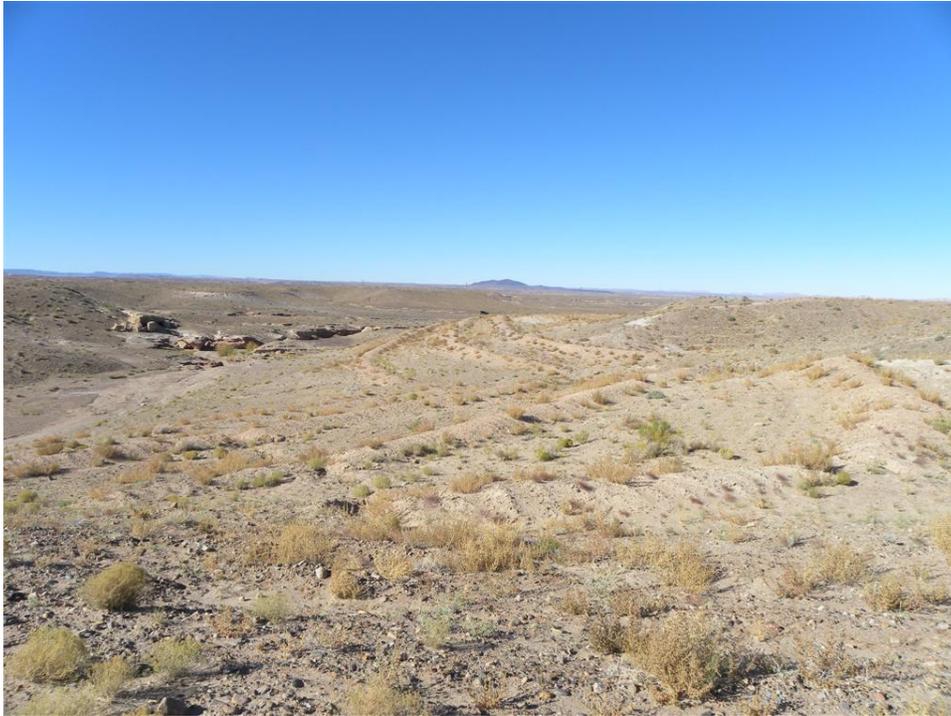
2 reclamation areas: 1 - 200' x 400' tiered with berms in southern portion of site; 2 - 150' x 750' tiered with berms, drainage below, in northern portion of site

Photo 13. Charles Huskon No. 3, Site #140, reclamation berms

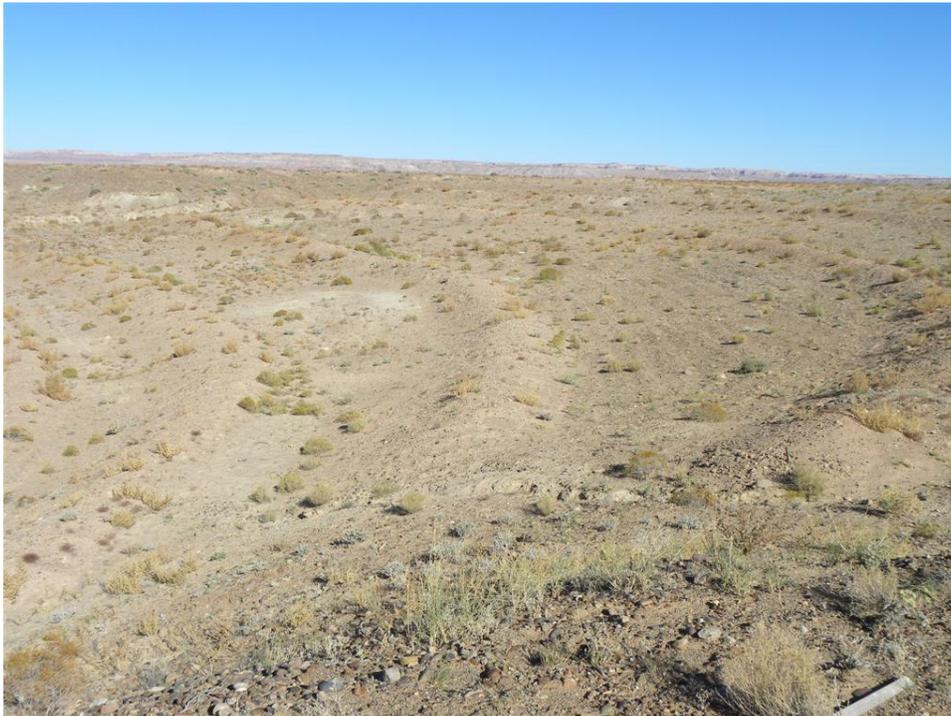
Photo 14. Charles Huskon No. 3, Site #140, reclamation berms

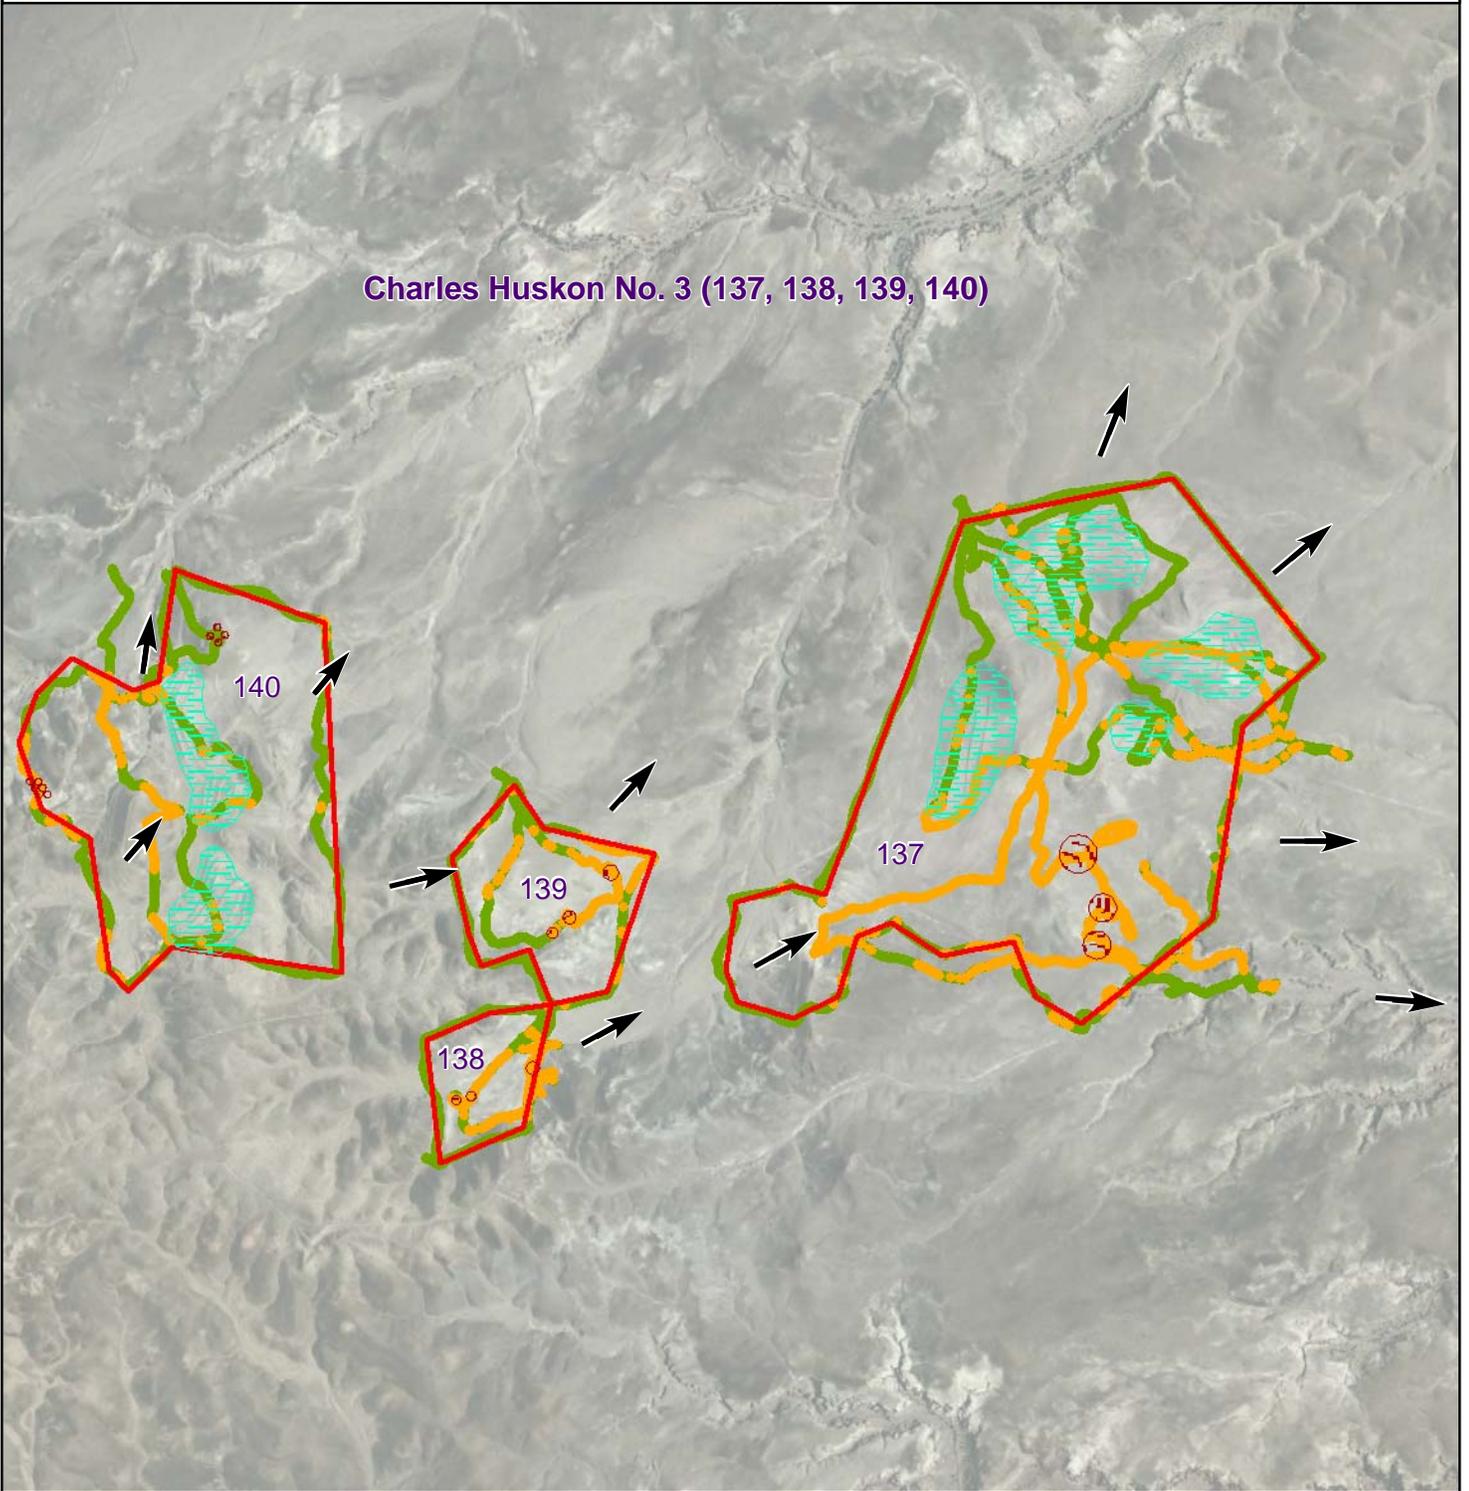
**Figure 1 - Gamma Radiation Measurements, Above Two Times Background  
Charles Huskon No. 3 (137, 138, 139, 140)  
Cameron Chapter, Navajo Nation**

Gamma survey conducted 11/2010  
Measured as counts per minute (cpm)

Average background 12,921 cpm

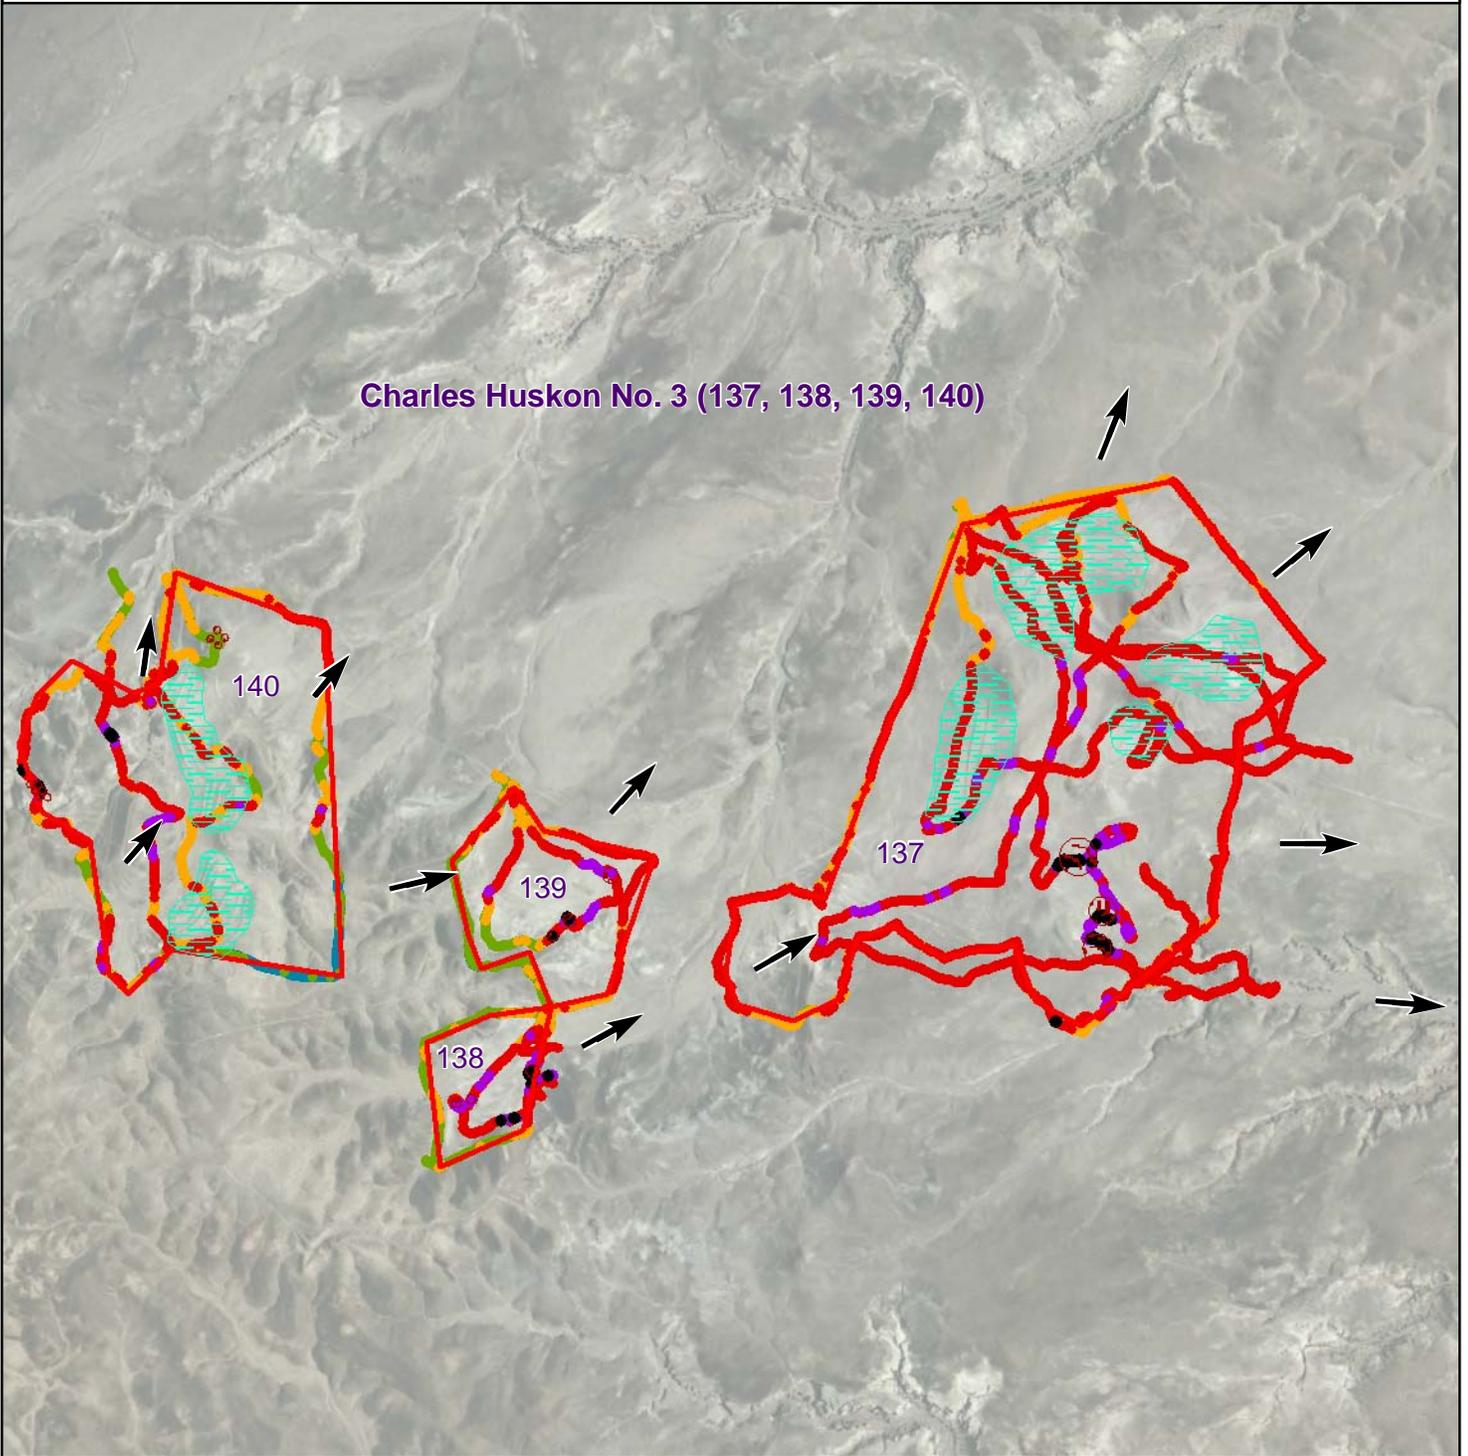
**Figure 2 - Gamma Radiation Measurements  
Charles Huskon No. 3 (137, 138, 139, 140)  
Cameron Chapter, Navajo Nation**

Gamma survey conducted 11/2010  
Measured as counts per minute (cpm)

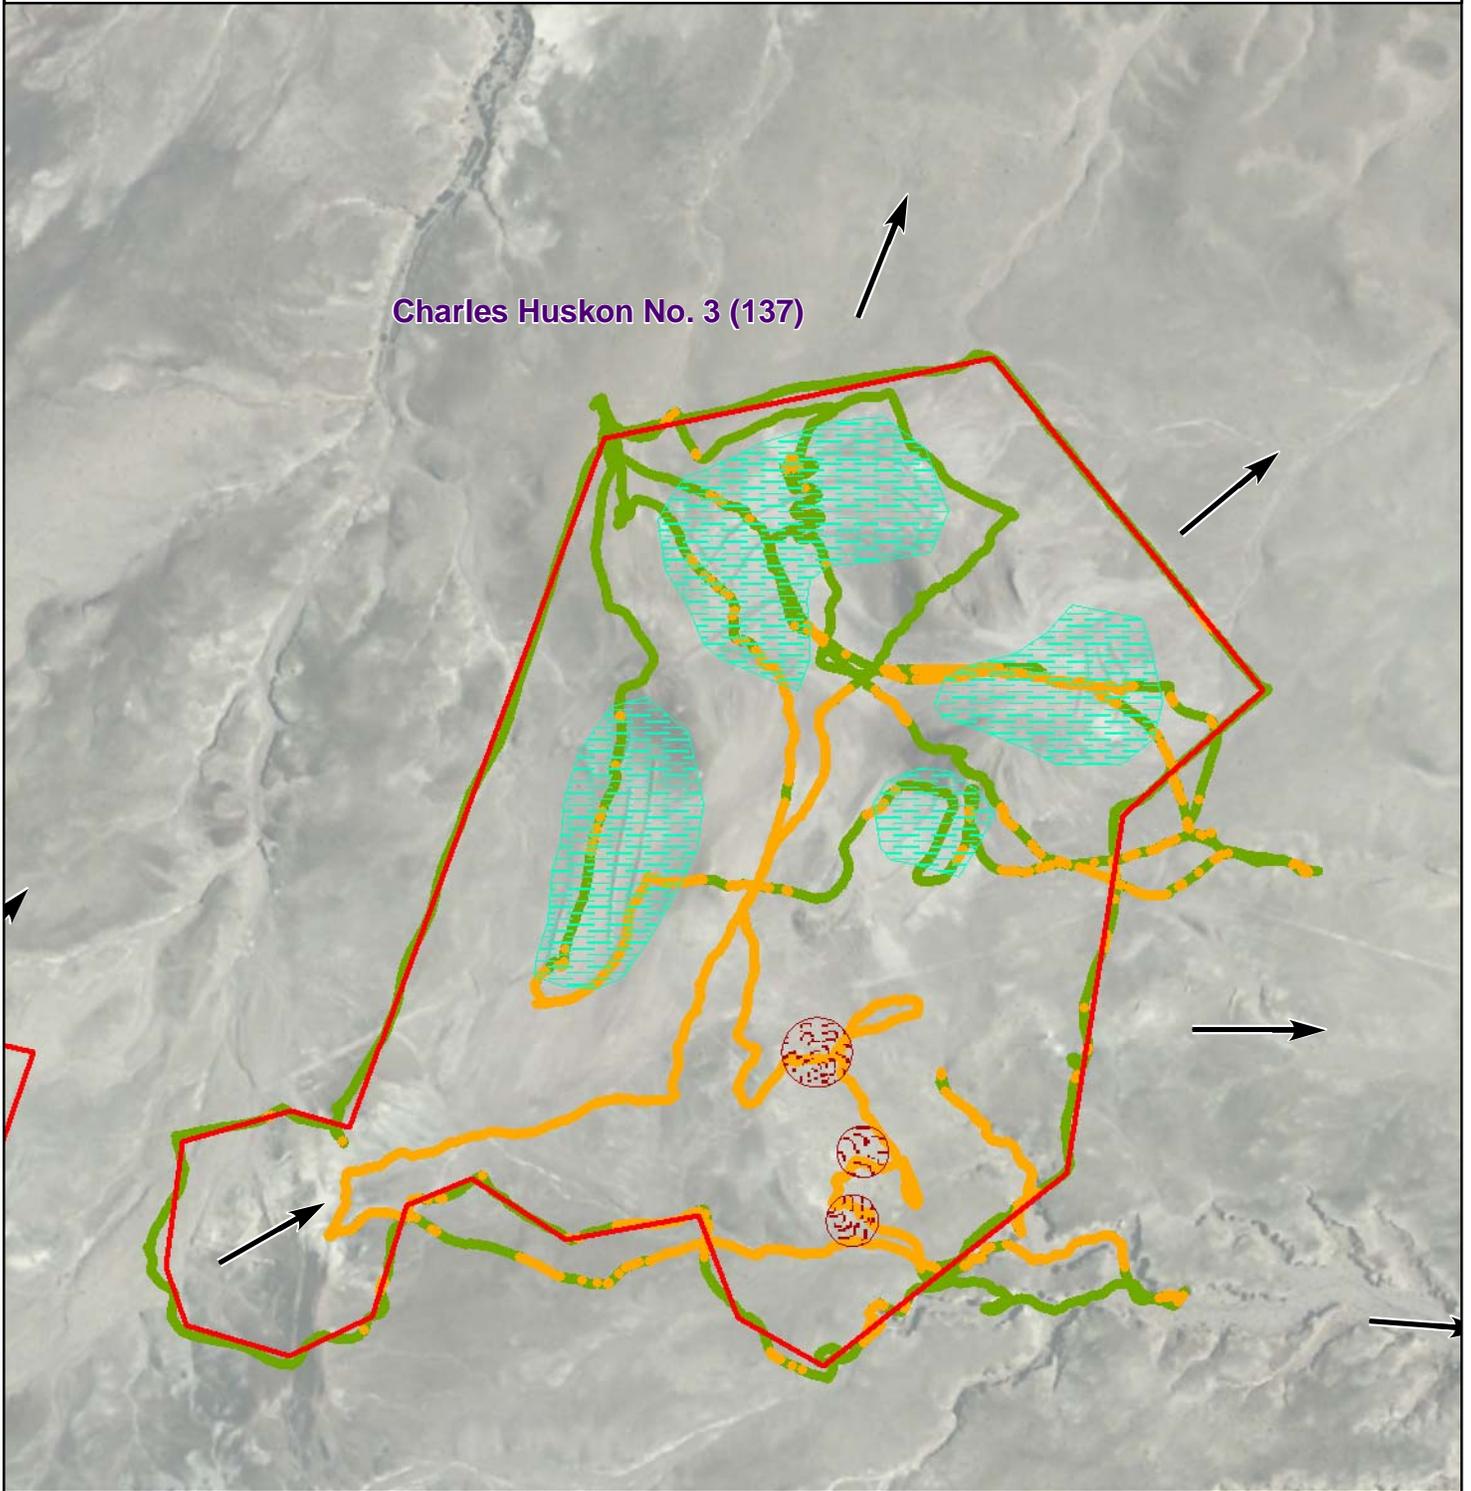
A total of 11,299 gamma radiation measurements were collected from the mine site, ranging from 12,726 cpm to 493,391 cpm. The measurements collected at the waste piles were found at maximum levels ranging from approximately 300,000 cpm to 500,000 cpm, and at the reclamation cap at average levels ranging from approximately 20,000 cpm to 40,000 cpm. The measurements are represented in Figures 1, 2, 3, and 4.

**Figure 3 - Gamma Radiation Measurements, Above Two Times Background  
Charles Huskon No. 3 (137)  
Cameron Chapter, Navajo Nation**

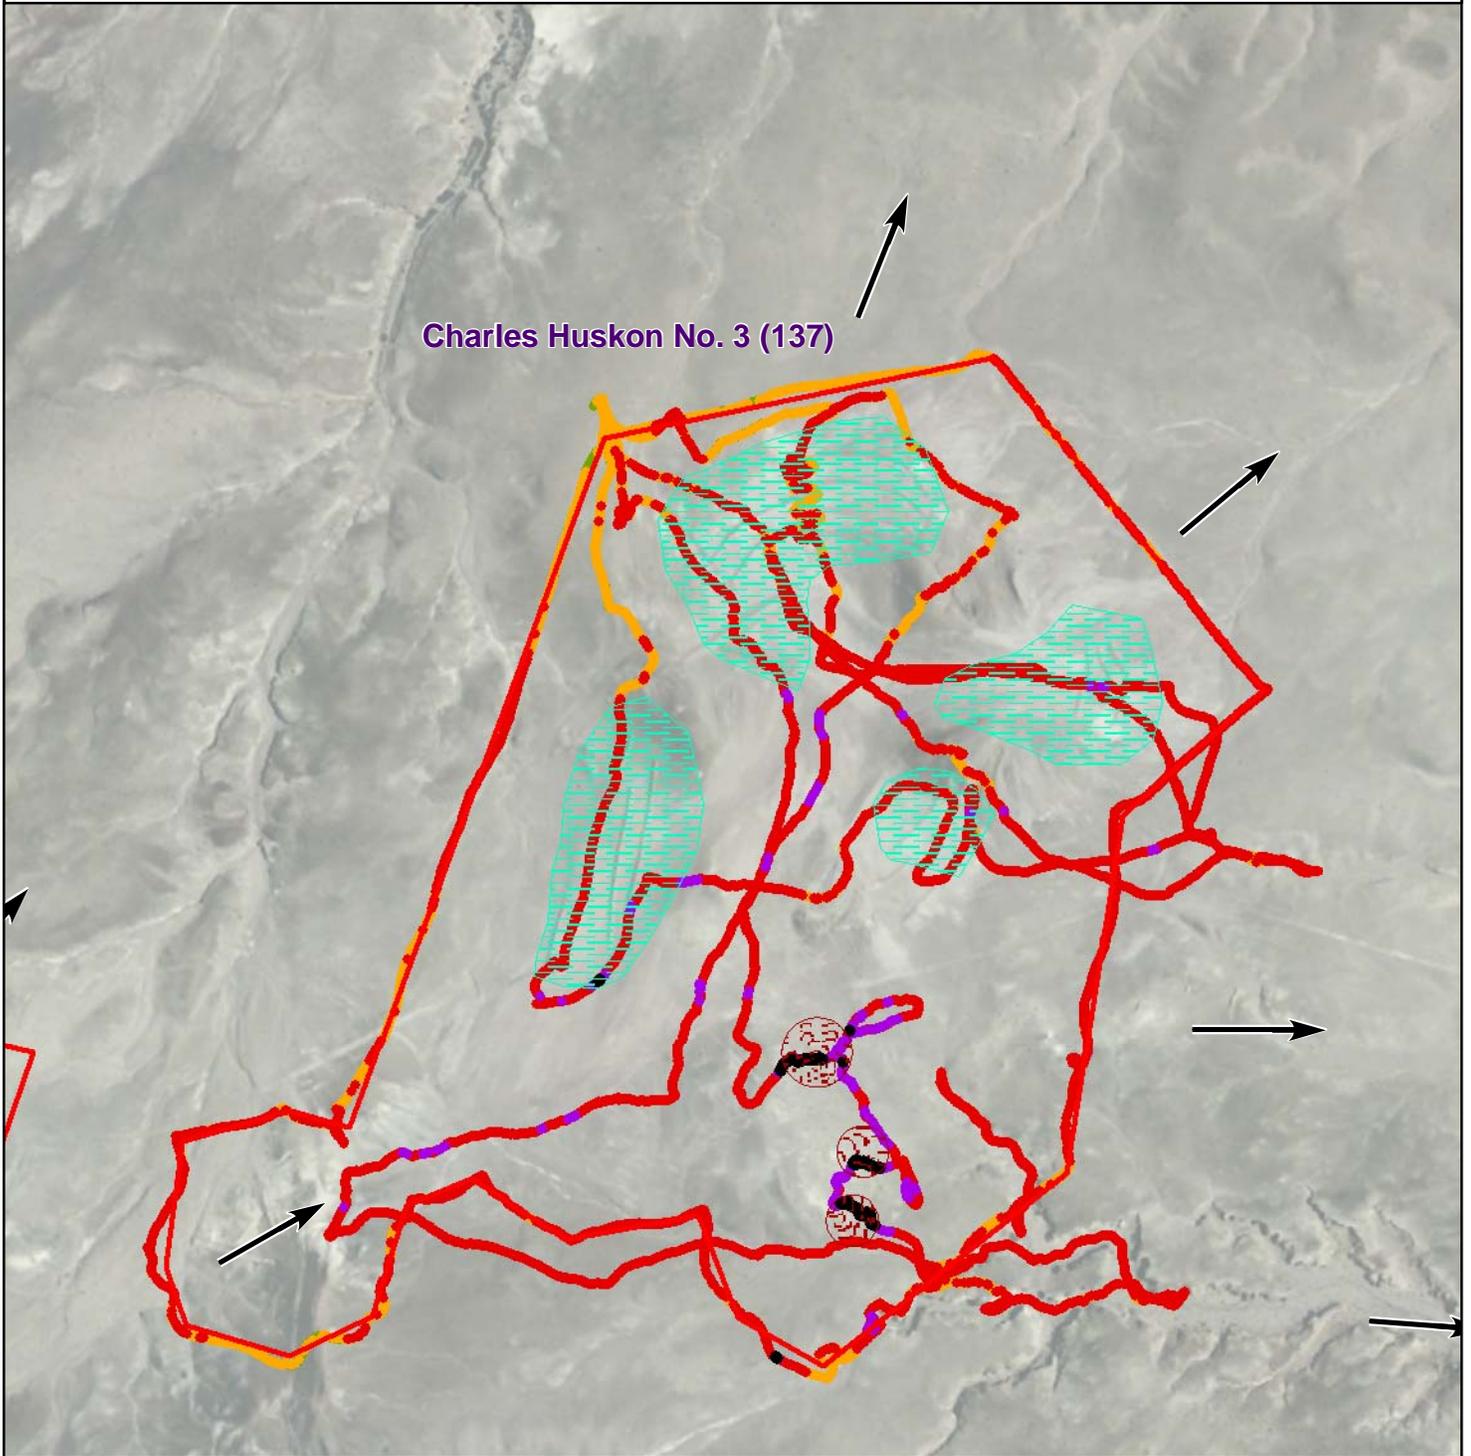
**Figure 4 - Gamma Radiation Measurements  
Charles Huskon No. 3 (137)  
Cameron Chapter, Navajo Nation**

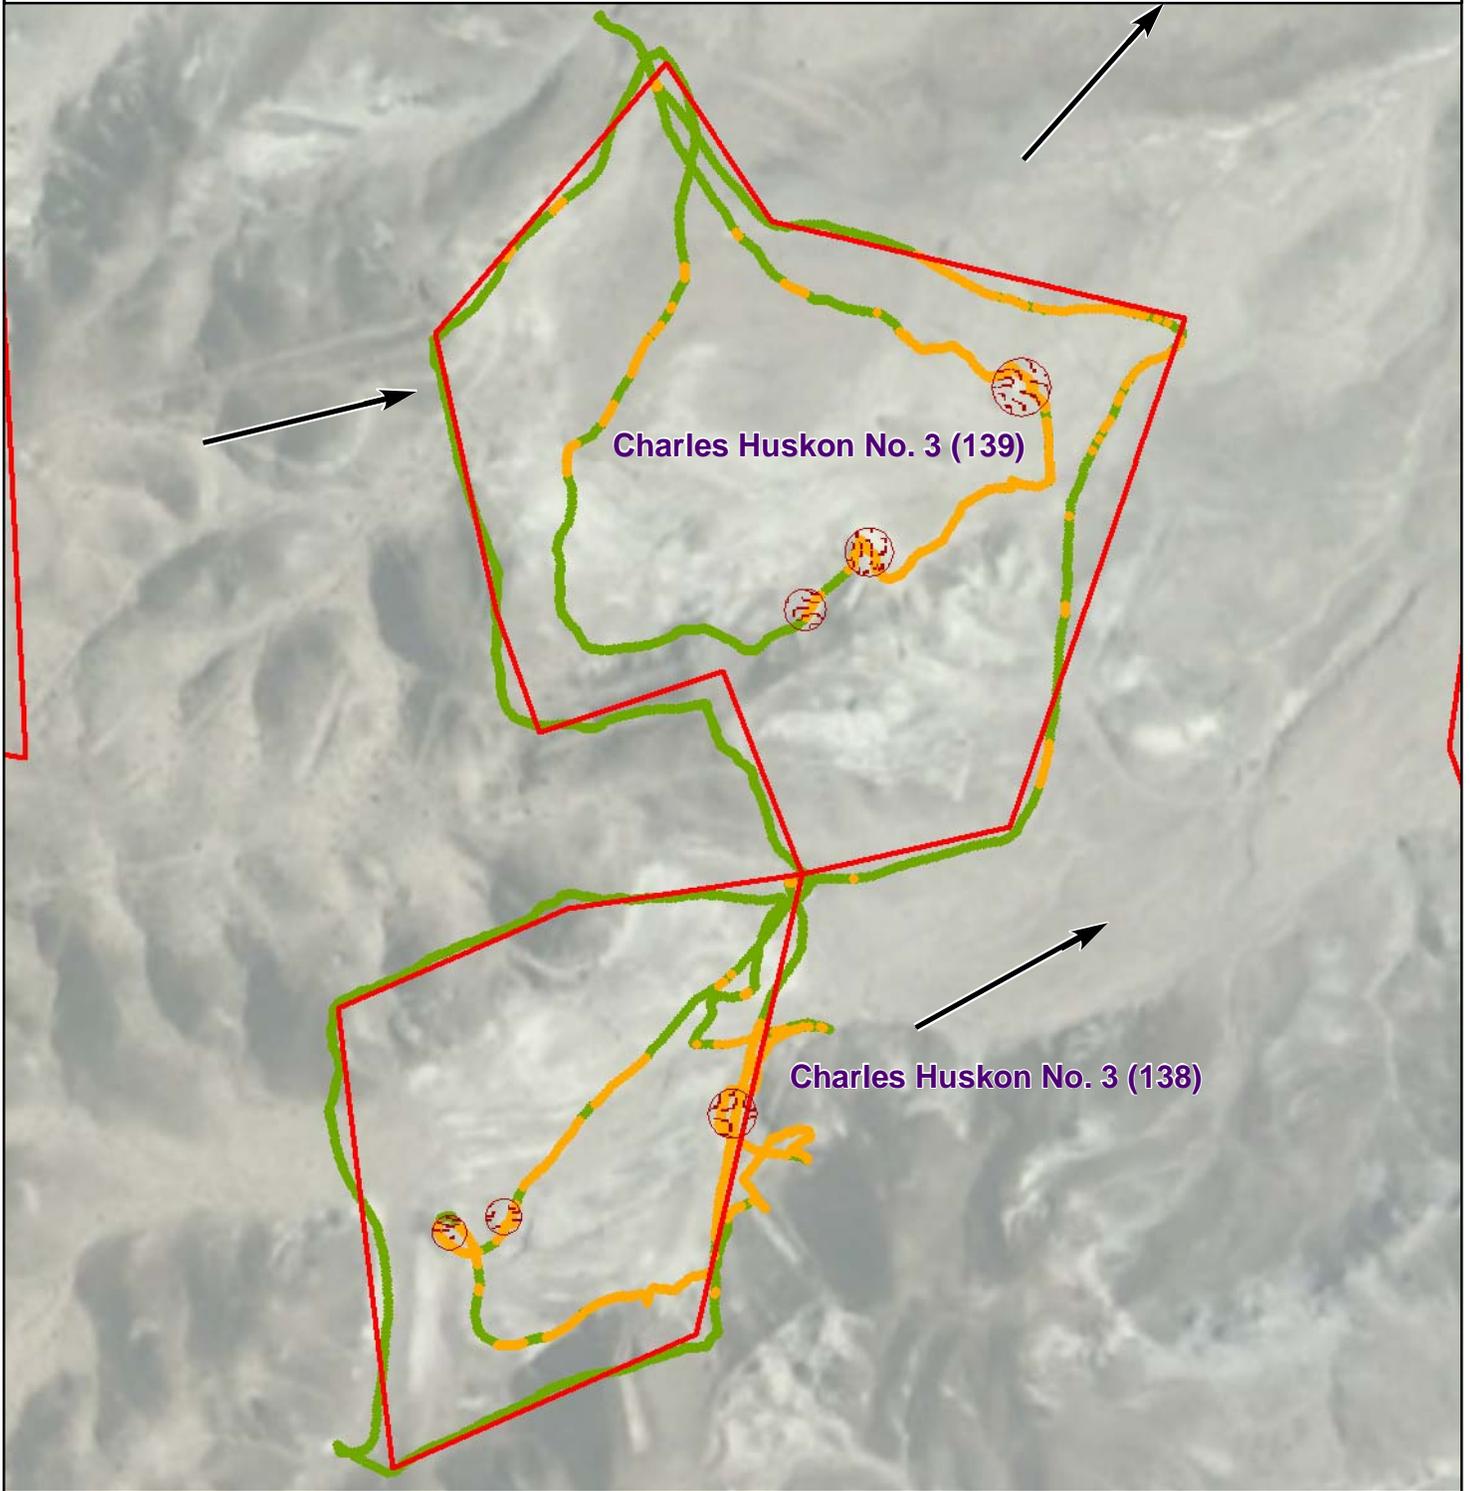
A total of 1,794 gamma radiation measurements were collected from the mine site, ranging from 8,512 cpm to 311,706 cpm. The measurements collected at the waste piles were found at maximum levels ranging from approximately 60,000 cpm to 300,000 cpm. The measurements are represented in Figures 1, 2, 5, and 6.

A total of 2,051 gamma radiation measurements were collected from the mine site, ranging from 8,880 cpm to 135,423 cpm. The measurements collected at the waste piles were found at maximum levels ranging from approximately 70,000 cpm to 130,000 cpm. The measurements are represented in Figures 1, 2, 5, and 6.

**Figure 5 - Gamma Radiation Measurements, Above Two Times Background  
Charles Huskon No. 3 (138, 139)  
Cameron Chapter, Navajo Nation**

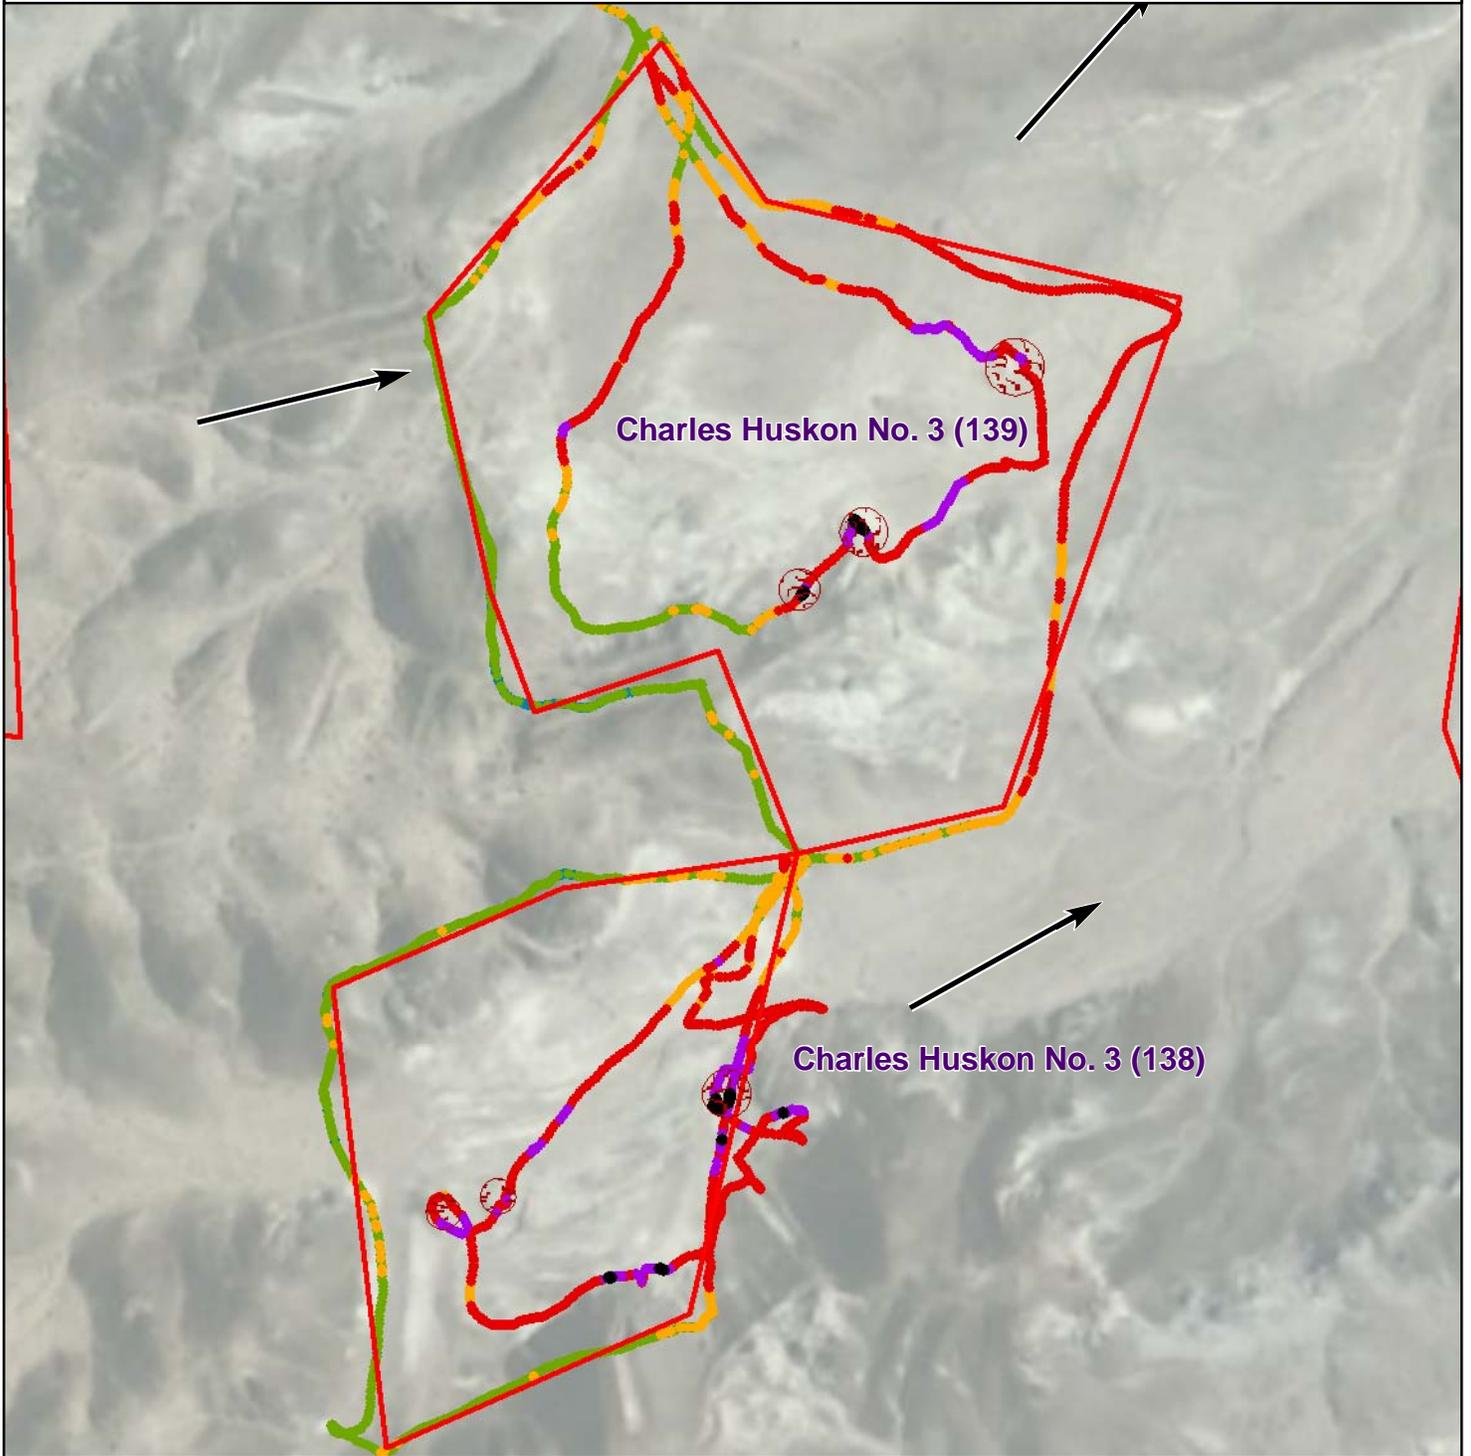
**Figure 6 - Gamma Radiation Measurements  
Charles Huskon No. 3 (138, 139)  
Cameron Chapter, Navajo Nation**
