# **Navajo Abandoned Uranium Mine**

## **Site Screen Report**

### **Charles Huskon No. 3 AUM Site**

**Weston Solutions, Inc.**

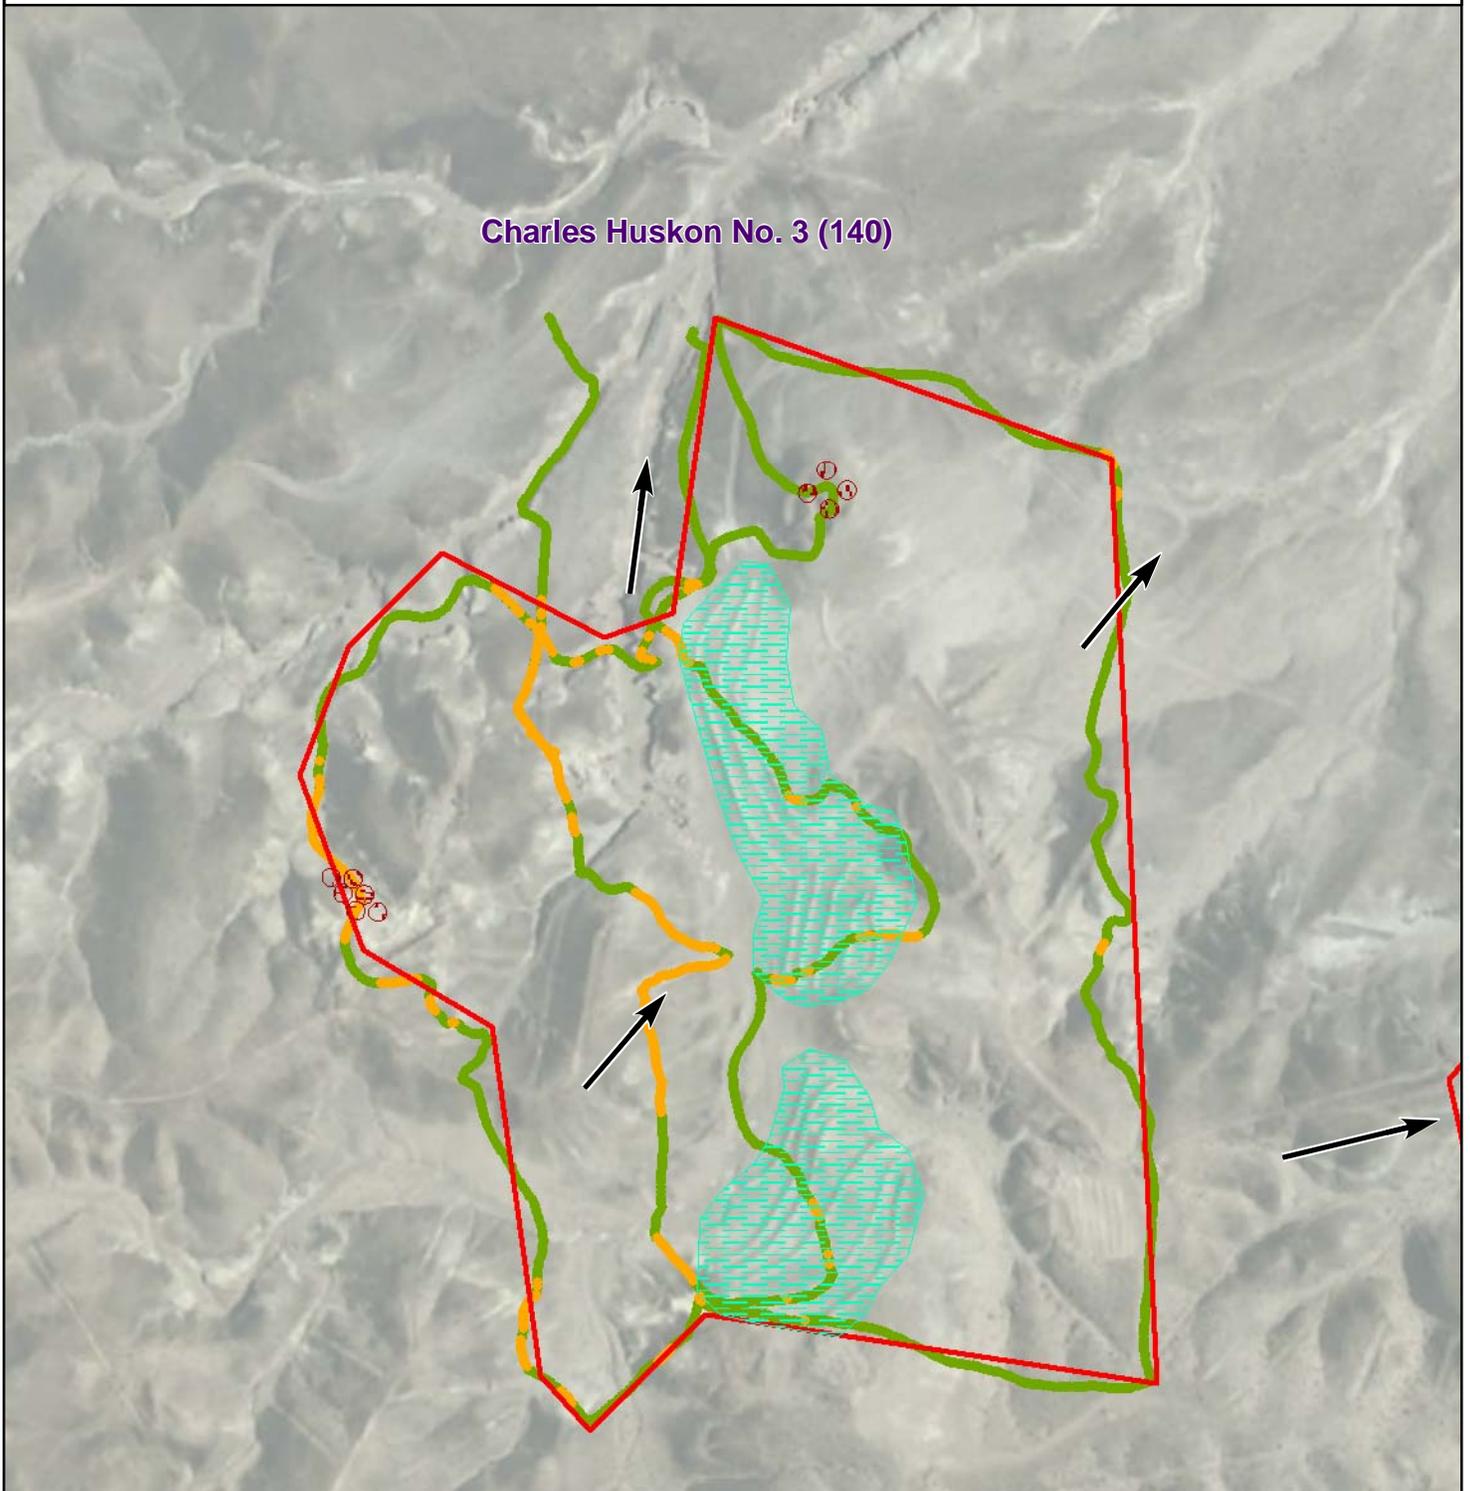
A total of 3,822 gamma radiation measurements were collected from the mine site, ranging from 7,376 cpm to 163,816 cpm. The measurements collected at the waste pile were found at a maximum level of approximately 160,000 cpm, and at the reclamation area at average levels ranging from approximately 15,000 cpm to 20,000 cpm. The measurements are represented in Figures 1, 2, 7, and 8.

**Figure 7 - Gamma Radiation Measurements, Above Two Times Background  
Charles Huskon No. 3 (140)  
Cameron Chapter, Navajo Nation**

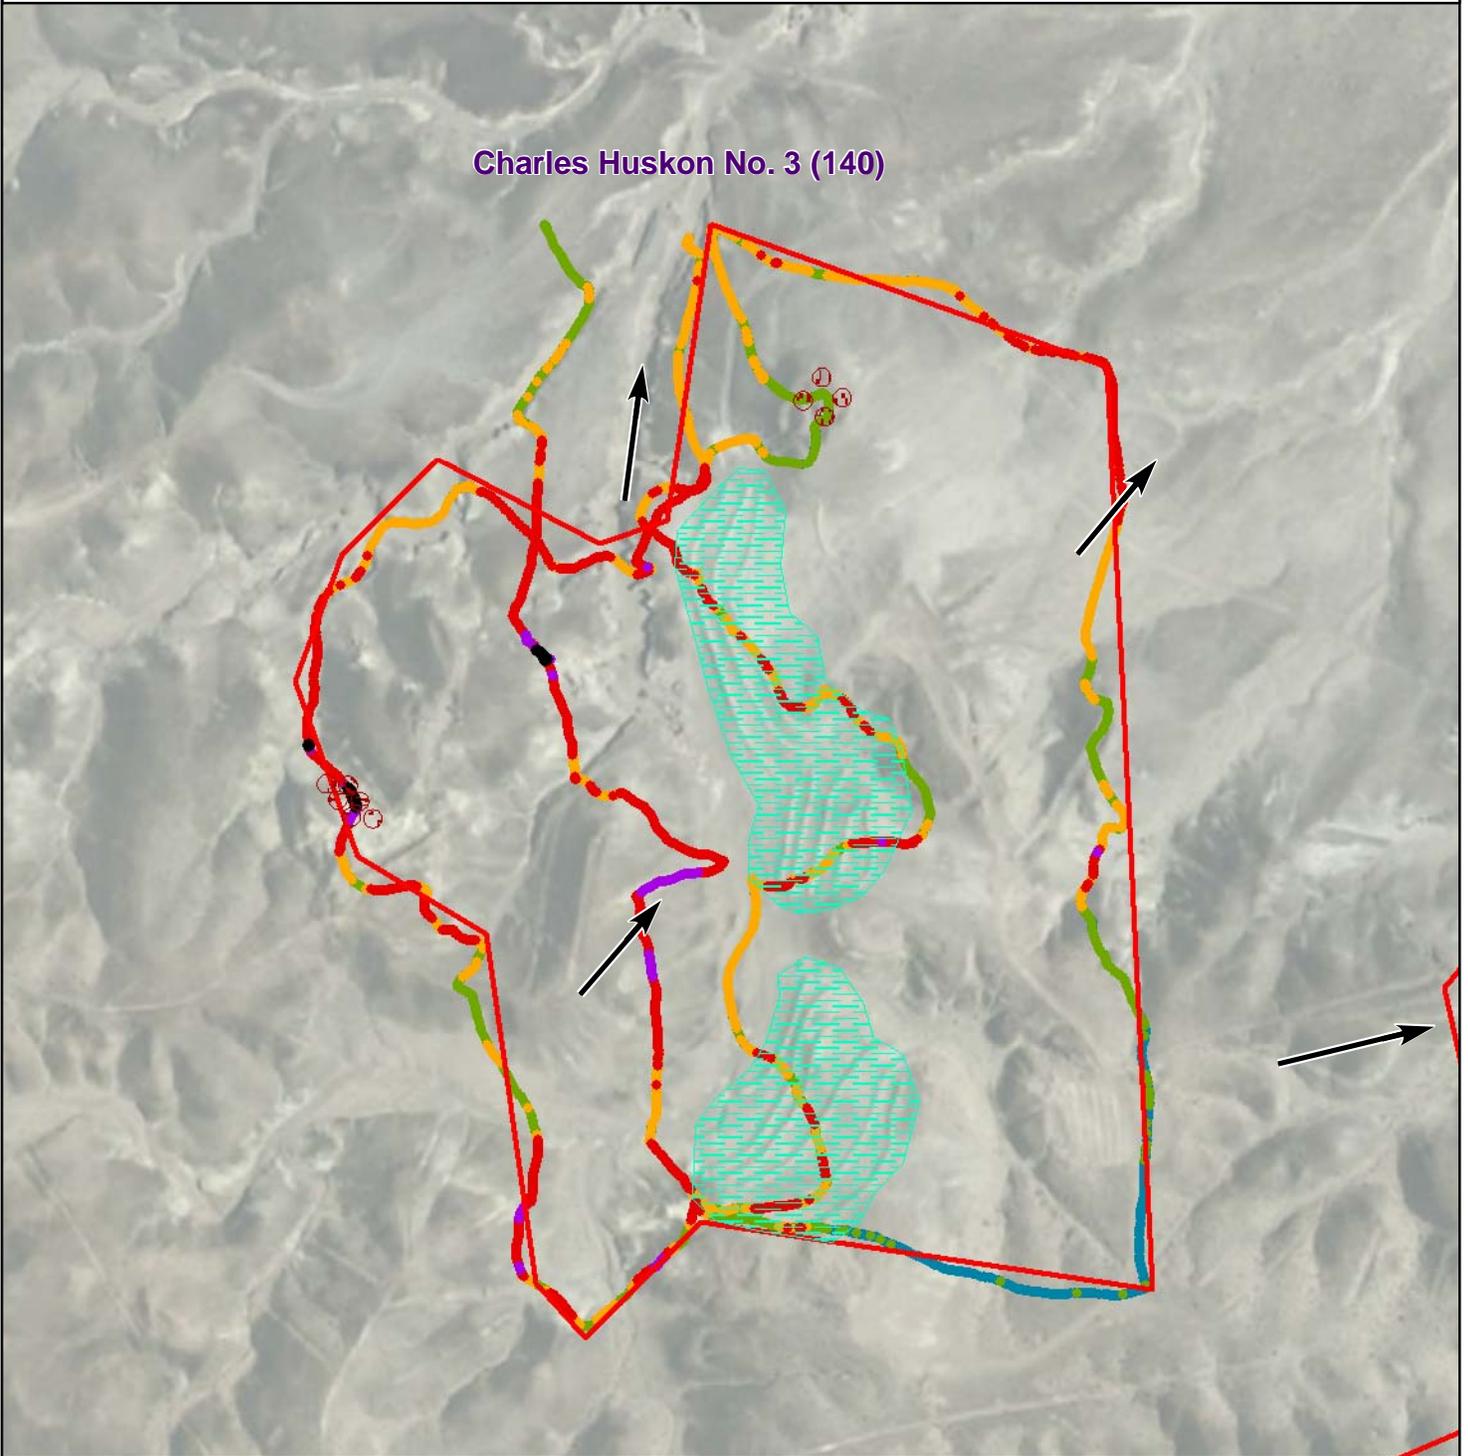
**Figure 8 - Gamma Radiation Measurements  
Charles Huskon No. 3 (140)  
Cameron Chapter, Navajo Nation**
