Navajo Abandoned Uranium Mine

Site Screen Report

Yazzie No. 102 AUM Site

January 2011

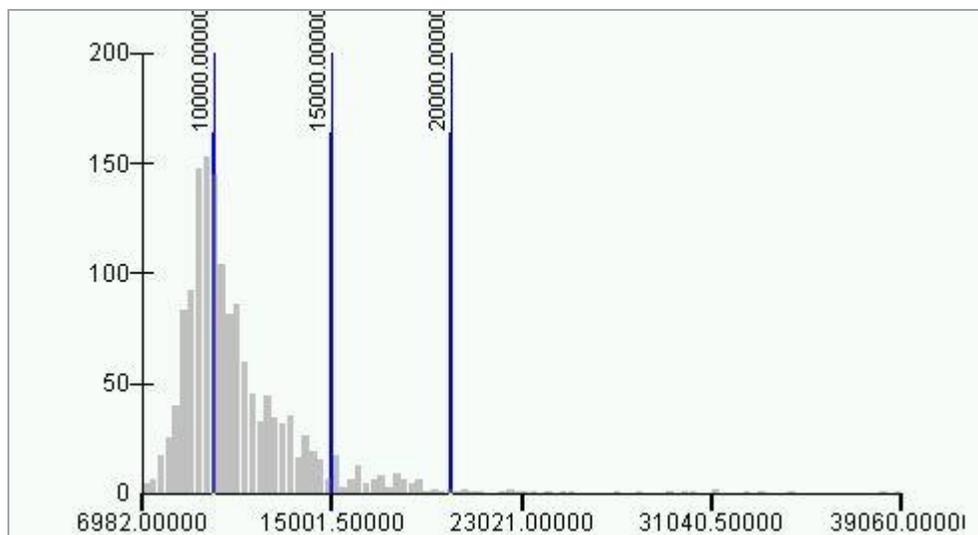
Distribution Chart and Statistics:

The following chart and statistics were generated by ESRI ArcGIS 9.3.1, and show the general distribution of the site gamma radiation measurements. The horizontal X axis represents the gamma radiation reading levels in cpm (lowest levels to the left). The vertical Y axis represents the frequency of each gamma radiation level.

Count:	1465
Minimum:	6982.00000
Maximum:	39060.00000
Sum:	16351792.00000
Mean:	11161.63276
Median:	10261.00000
Standard Deviation:	3119.82847

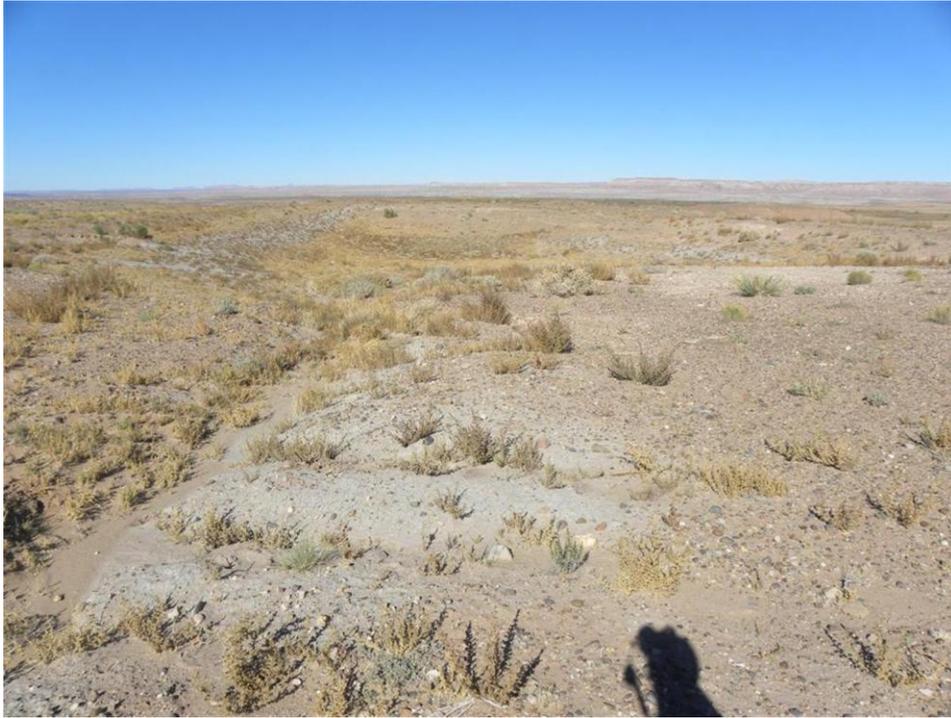
Photo 1. Yazzie No. 102 mine site

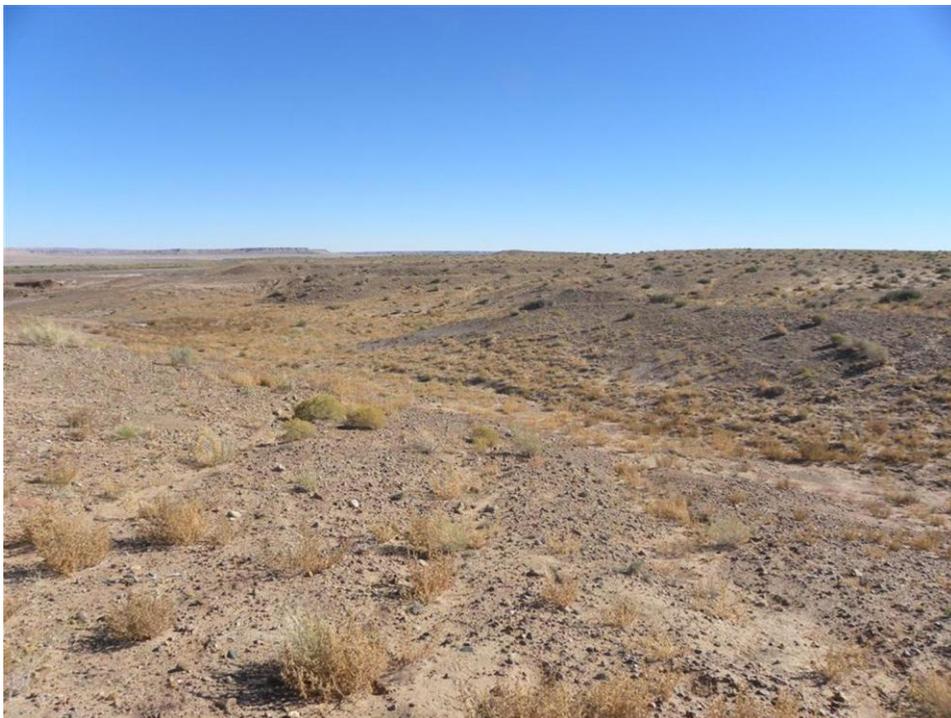
Large depression in the center of the site

Photo 2. Yazzie No. 102 mine site, depression area

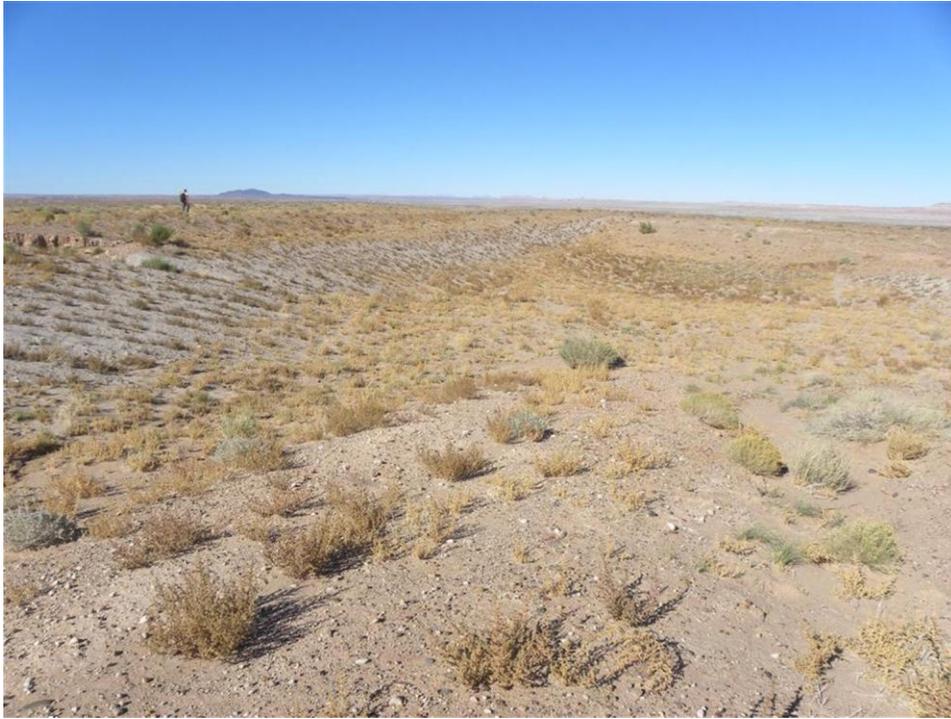
Photo 3. Yazzie No. 102 mine site, depression area

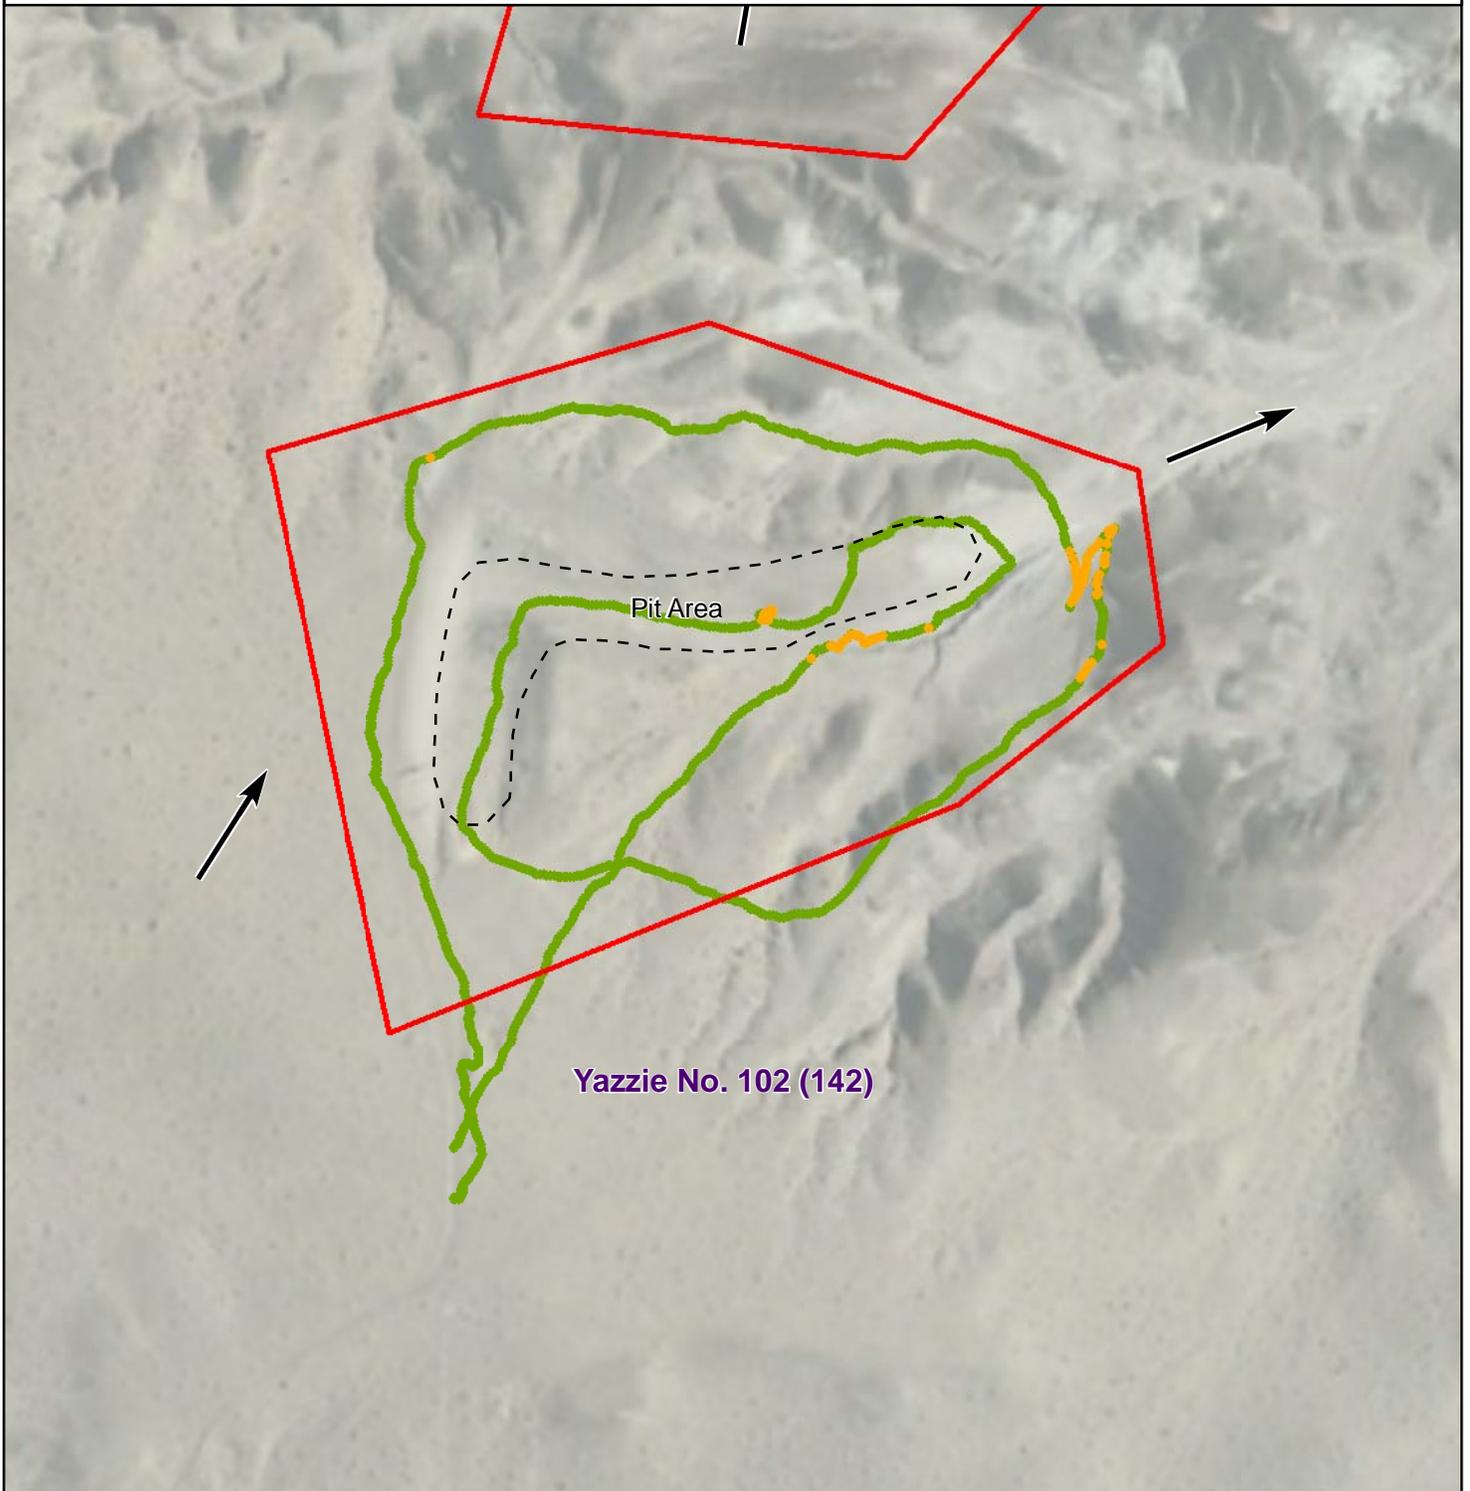
A total of 1,465 gamma radiation measurements were collected from the mine site, ranging from 6,982 cpm to 39,060 cpm. The measurements collected in the pit/depression area were found at levels ranging from approximately 20,000 - 40,000 cpm. The measurements are represented in Figures 1 and 2.

**Figure 1 - Gamma Radiation Measurements, Above Two Times Background
Yazzie No. 102 (142)
Cameron Chapter, Navajo Nation**

Gamma survey conducted 11/2010
Measured as counts per minute (cpm)

Average background 7,552 cpm

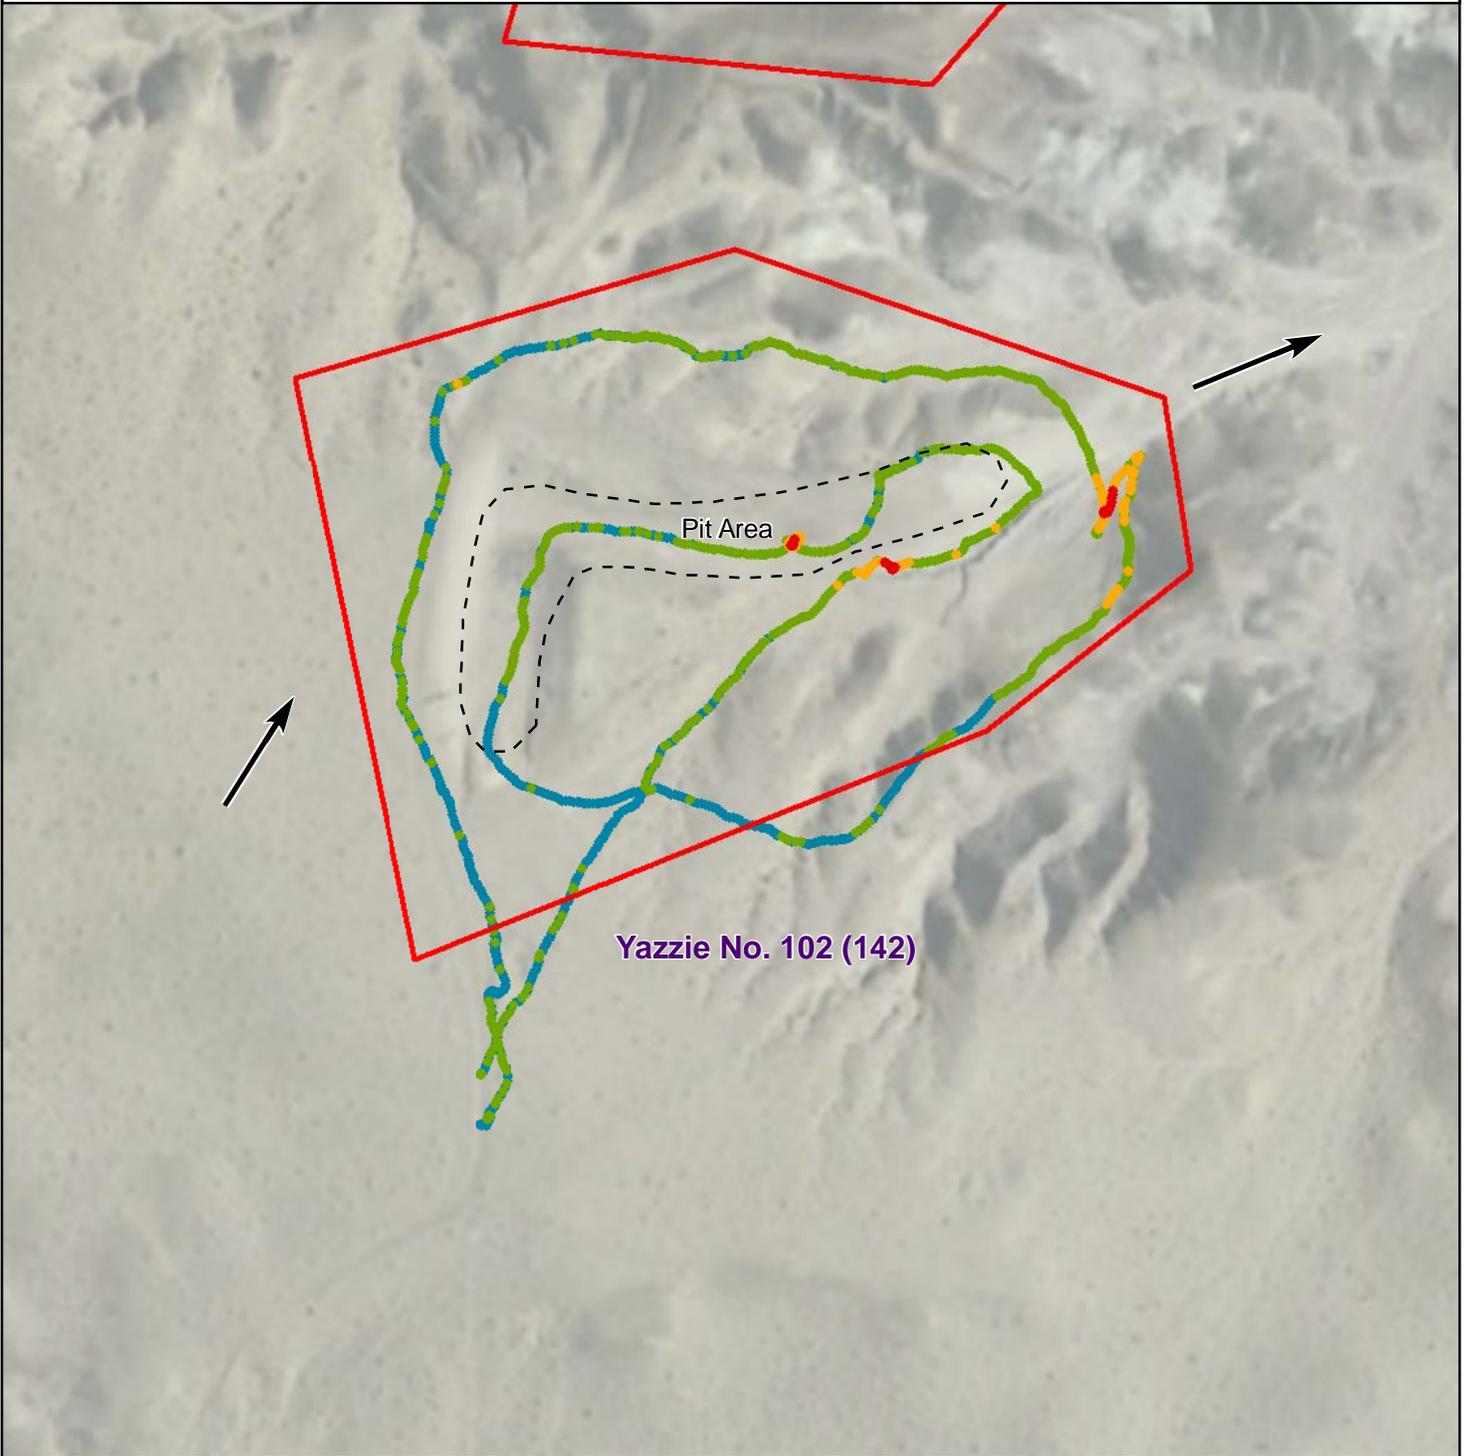
**Figure 2 - Gamma Radiation Measurements
Yazzie No. 102 (142)
Cameron Chapter, Navajo Nation**

Average background 7,552 cpm

Gamma survey conducted 11/2010
Measured as counts per minute (cpm)
