Navajo Abandoned Uranium Mine

Site Screen Report

Charles Huskon No. 17 AUM Site

January 2011

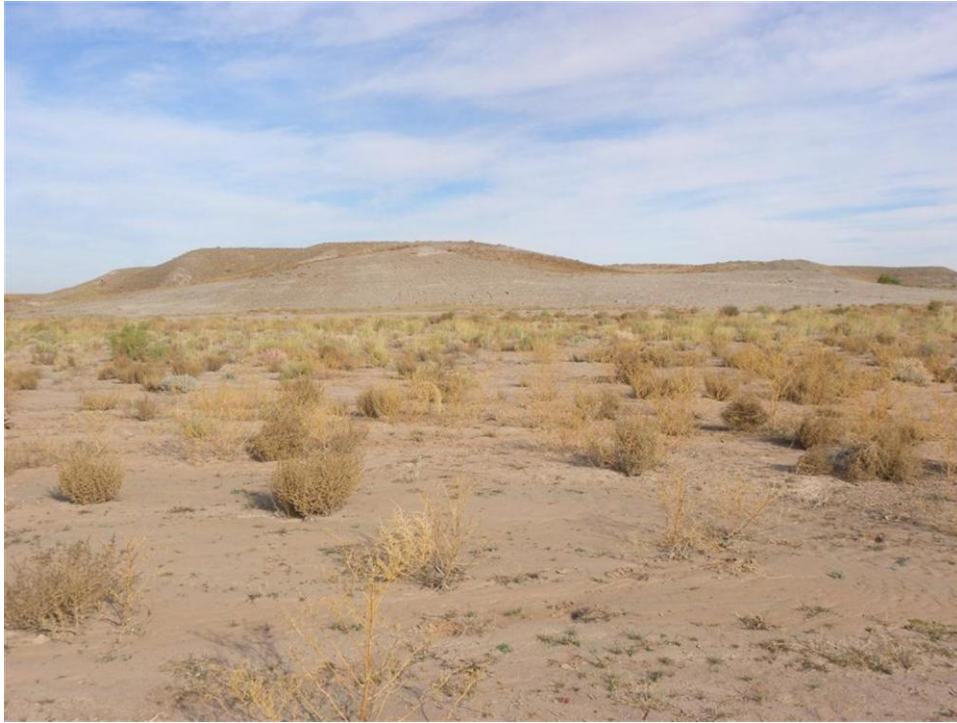
Photo 1. Charles Huskon No. 17 mine site

Some possible reclamation on E side of site, graded soil sloping downhill, evidence of reclamation markers and equipment (backhoe tooth)
