Navajo Abandoned Uranium Mine

Site Screen Report

Mine Name: Earl Huskon No. 3
Mine ID: 177

August 2011

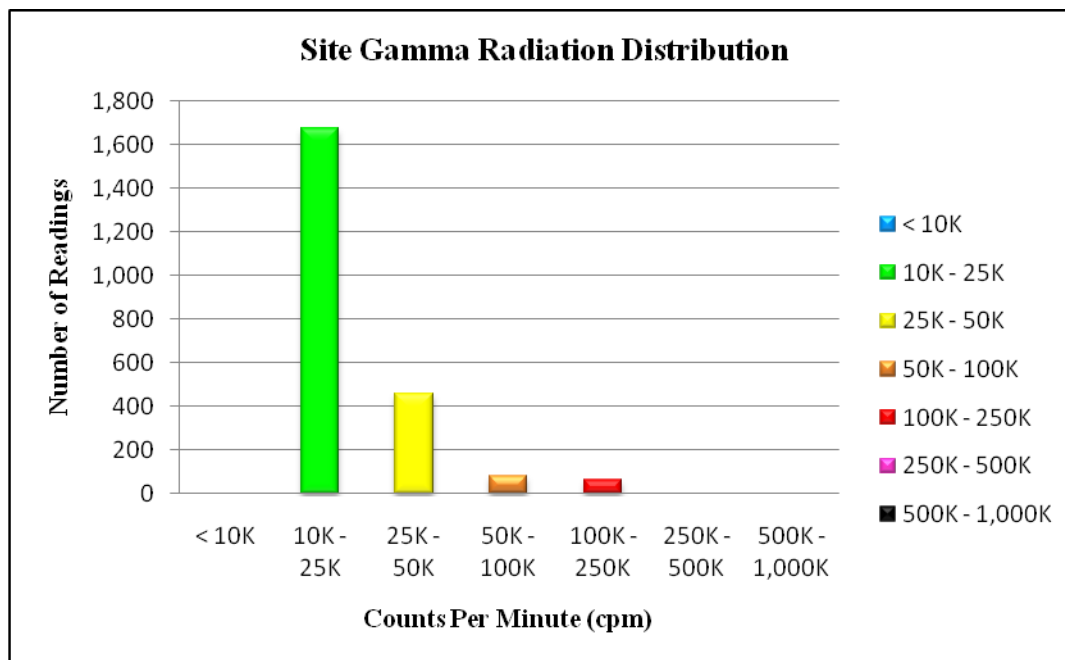
Distribution Chart and Statistics:

Site Gamma Radiation Statistics	
Number of Readings	2,277
Minimum (cpm)	13,702
Maximum (cpm)	207,171
Mean (cpm)	27,854
Median (cpm)	20,485
Standard Deviation	25,603

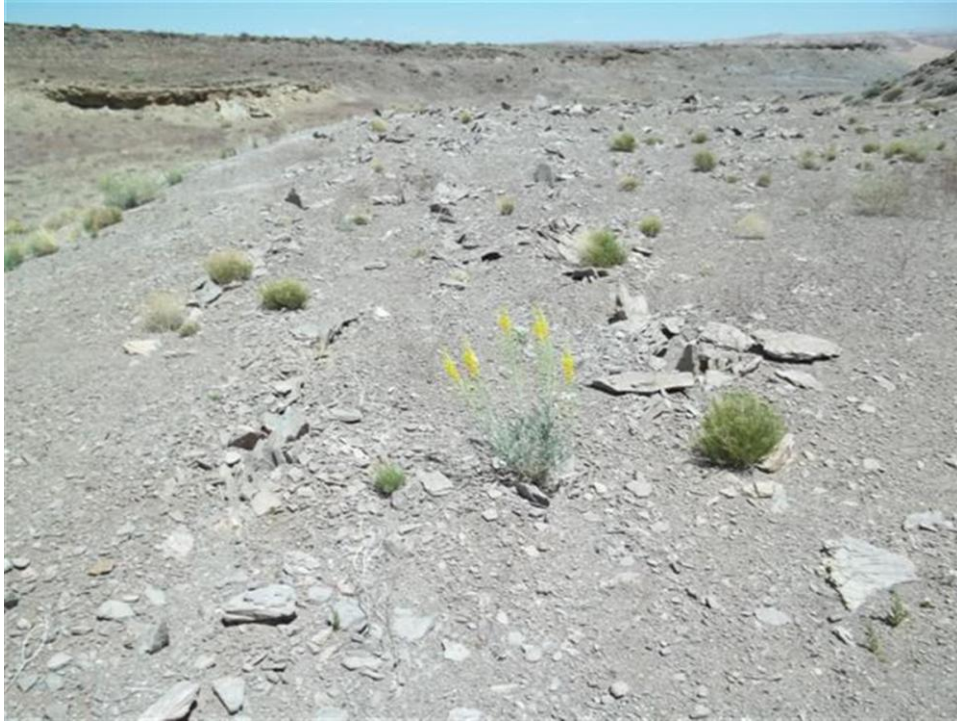
Photo 1: Mine Site #177; Possible workings

Worked area consisting of parallel rows of disturbed subsurface rock

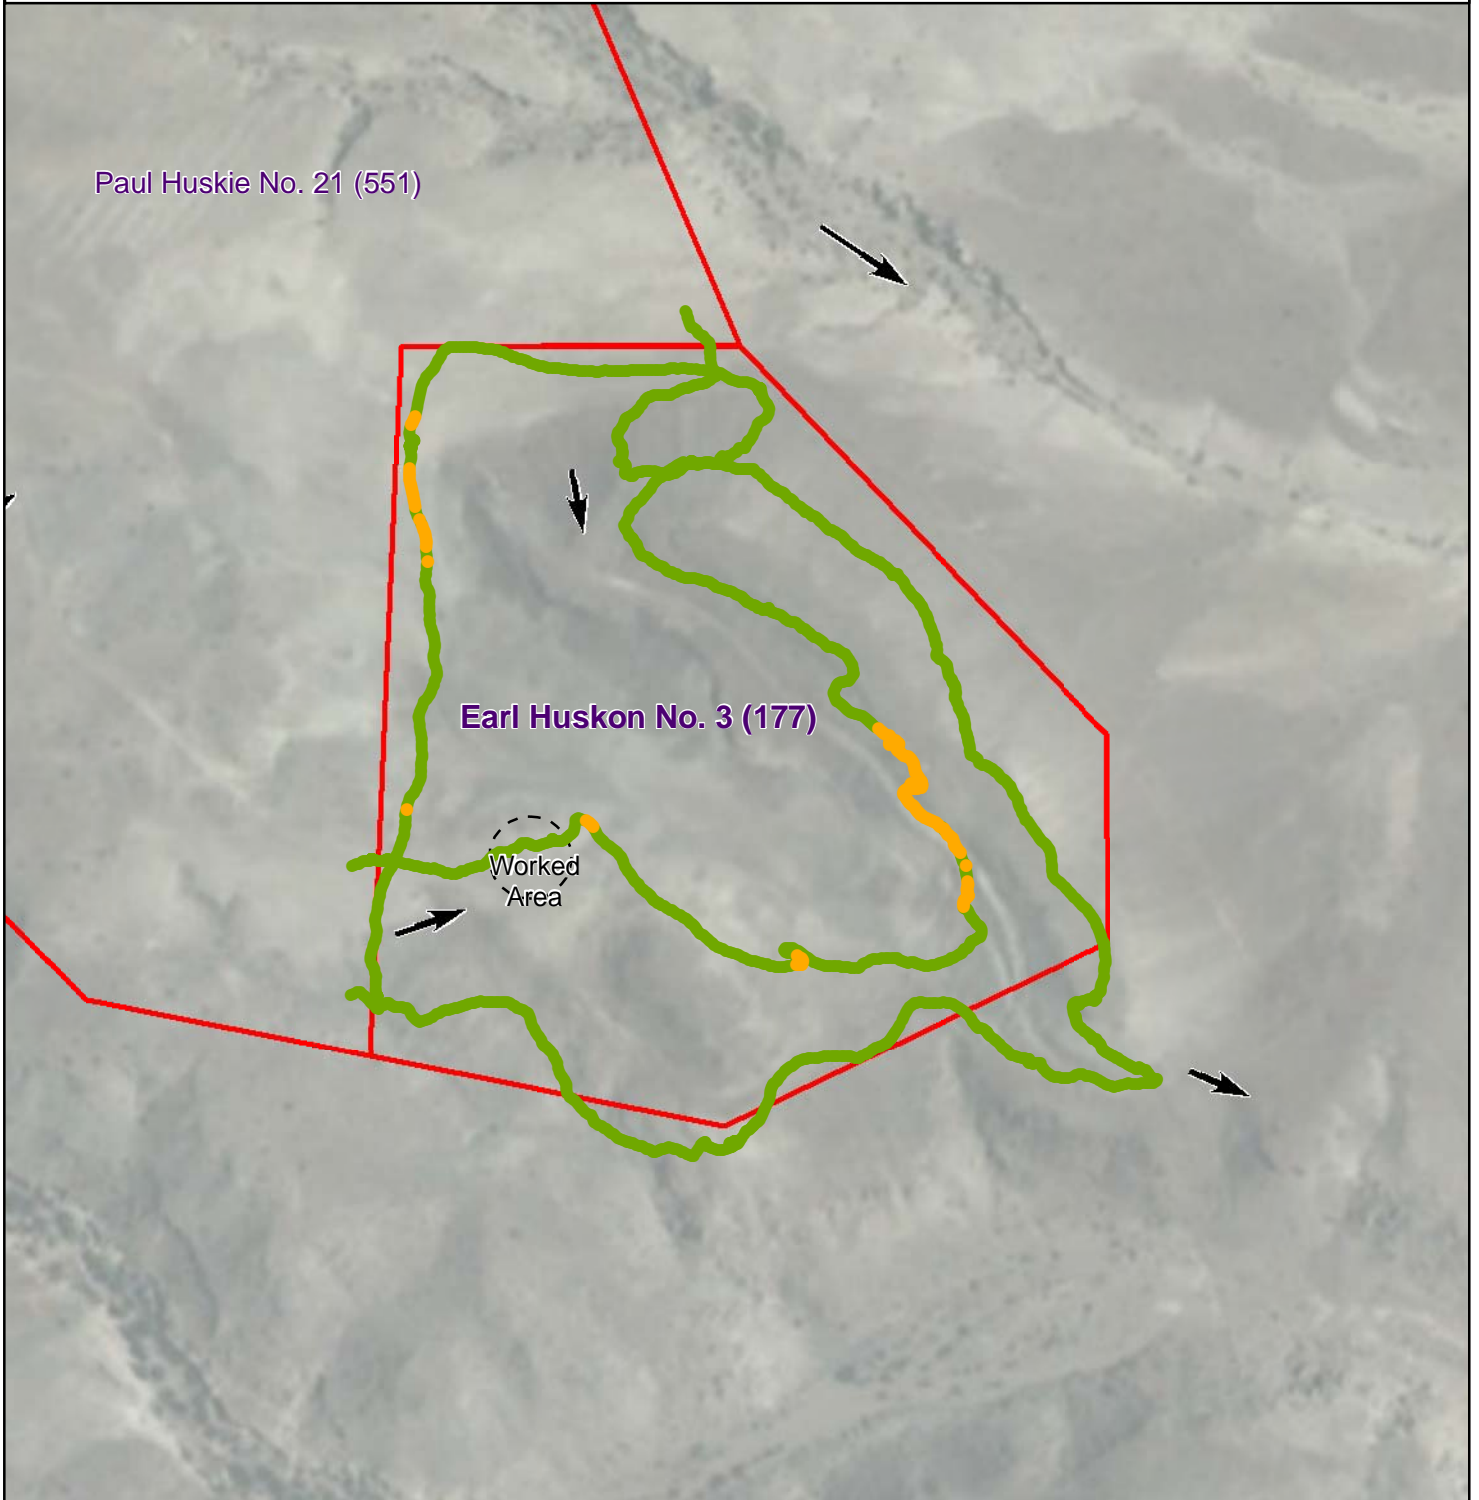
**Figure 1 - Gamma Radiation Measurements, Above Two Times Background
Earl Huskon No. 3 (177)
Bodaway / Gap Chapter, Navajo Nation**

Highest gamma radiation measurement: 207,171 counts per minute (cpm)

Background Average: 18,938 cpm **Two Times Background:** 37,876 cpm

A total of 2,277 gamma radiation measurements were collected from the mine site, ranging from 13,702 cpm to 207,171 cpm. Measurements collected in the vicinity of the workings were found at a maximum level of approximately 20,000 cpm. The measurements are represented in Figures 1 and 2.
