Navajo Abandoned Uranium Mine

Site Screen Report

Tom Morgan 1 AUM Site

Weston Solutions, Inc.

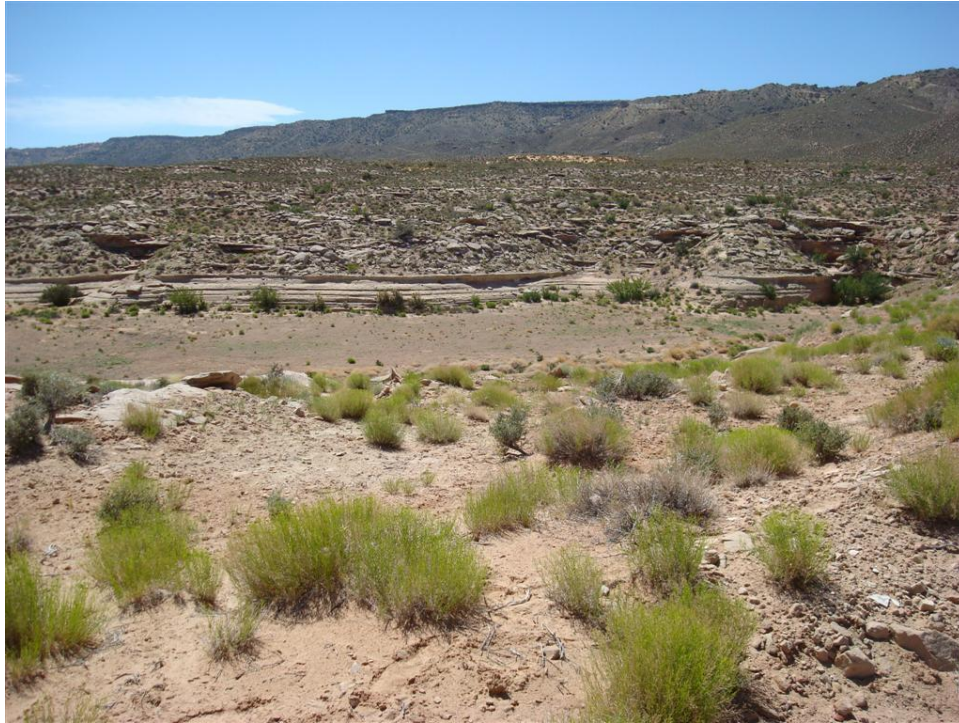
Photo 1. Tom Morgan 1 site

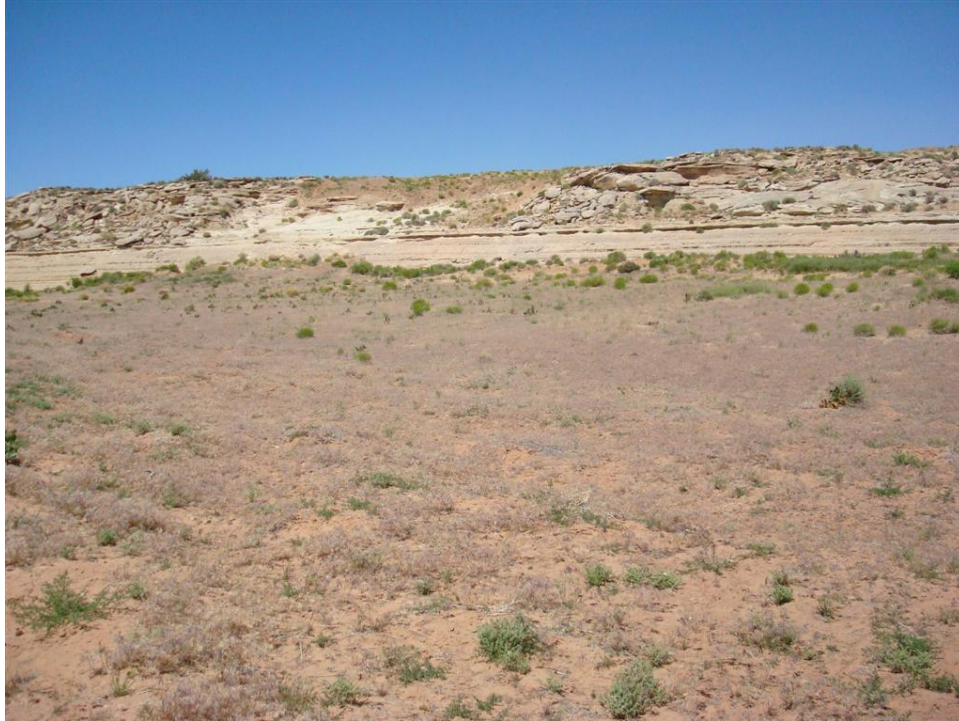
Is there a reclamation cap or sealed adit in place at the site? Yes

Is the cap/seal functionally intact? Yes

Is the cap/seal sufficiently degraded to create a concern about releases? No

Photo 2. Tom Morgan 1 site, capped area

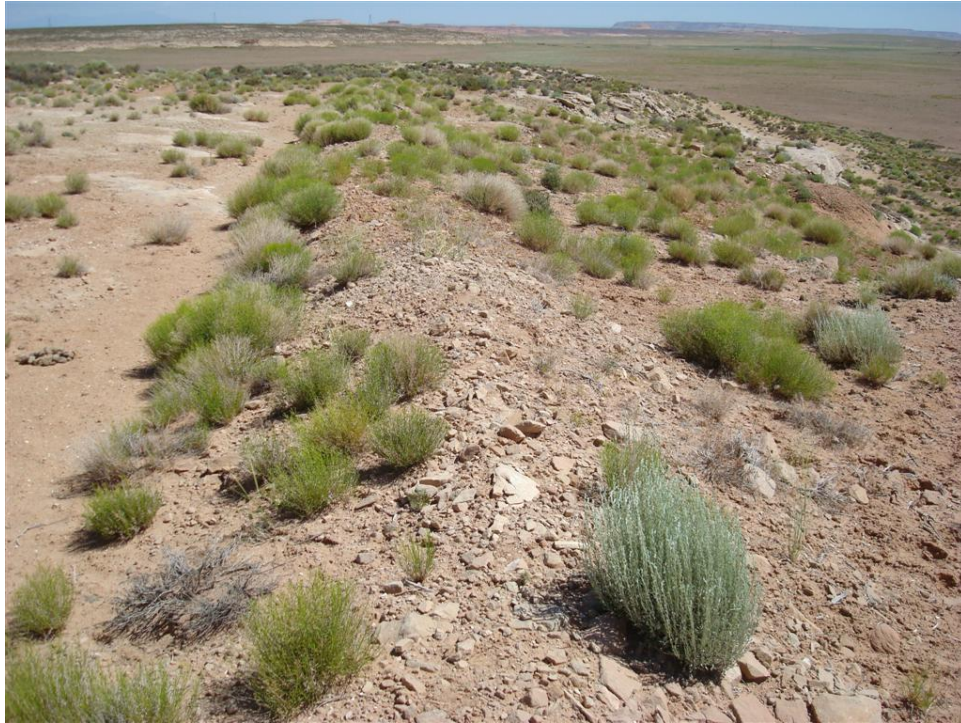
Reclamation cap and small berm immediately S of site

Photo 3. Tom Morgan 1 site, berm
