Navajo Abandoned Uranium Mine

Site Screen Report

Saytah Canyon AUM Site

Weston Solutions, Inc.

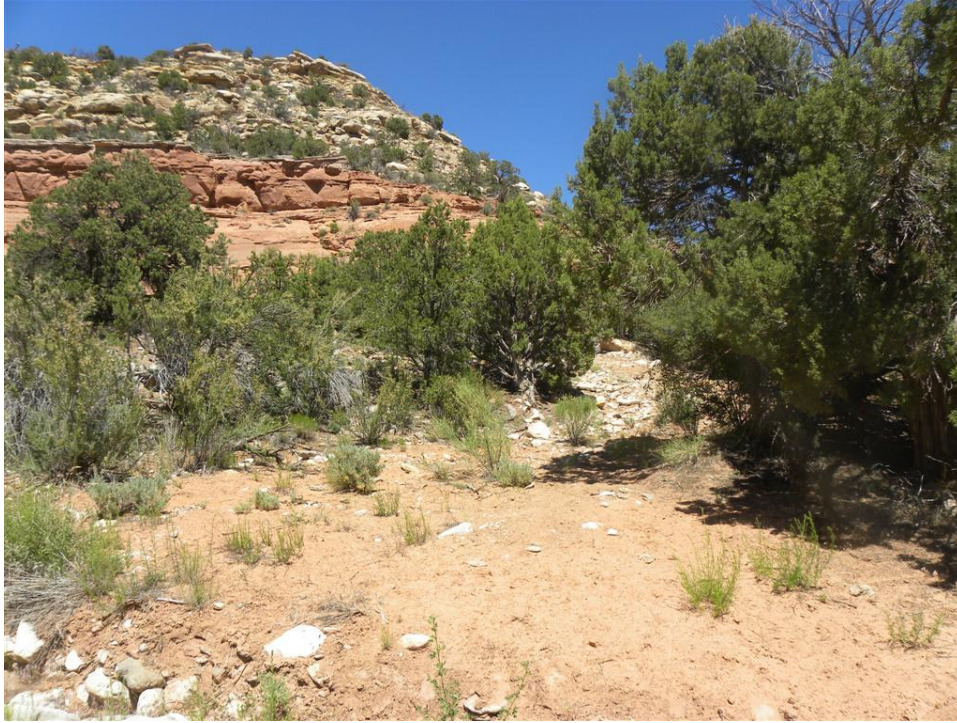
Photo 3. Saytah Canyon site #218

#218 – Reclaimed work area with stone marker
