# Navajo Abandoned Uranium Mine

## Site Screen Report

### Charles Huskon No. 20 AUM Site

**January 2011**

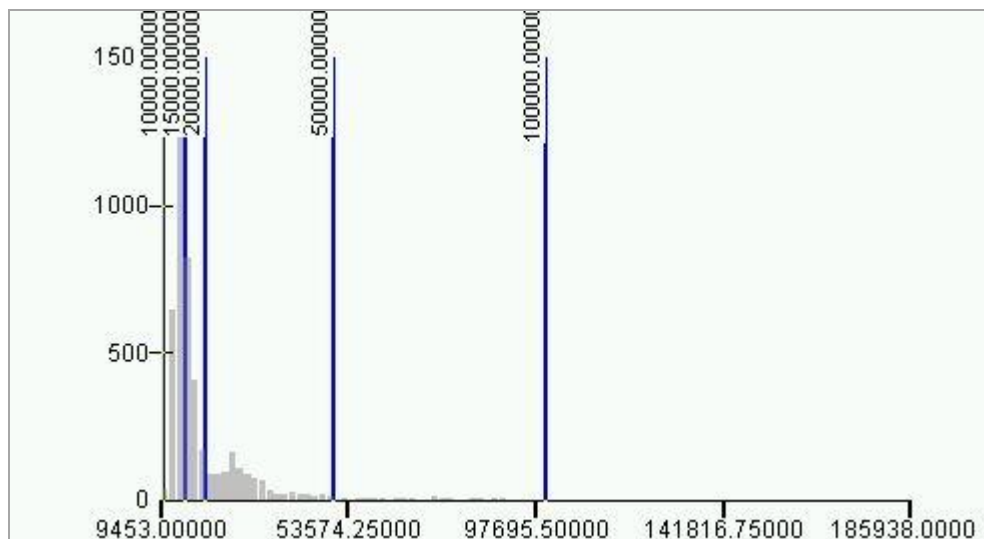
The following chart and statistics were generated by ESRI ArcGIS 9.3.1, and show the general distribution of the site gamma radiation measurements. The horizontal X axis represents the gamma radiation reading levels in cpm (lowest levels to the left). The vertical Y axis represents the frequency of each gamma radiation level.

Count:	4585
Minimum:	9453.00000
Maximum:	185938.00000
Sum:	91980934.00000
Mean:	20061.27241
Median:	15135.00000
Standard Deviation:	15137.10970

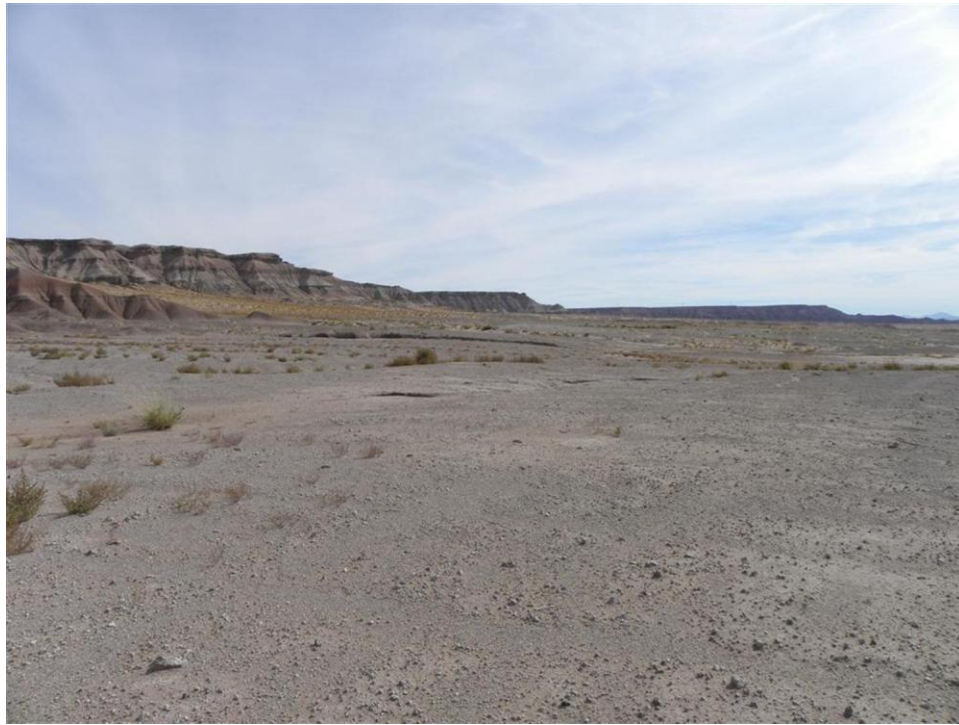
Large reclamation cap, presumably covering previous open pit mine, grey granular soil, drainage furrows expose some material

Photo 1. Charles Huskon No. 20 mine site

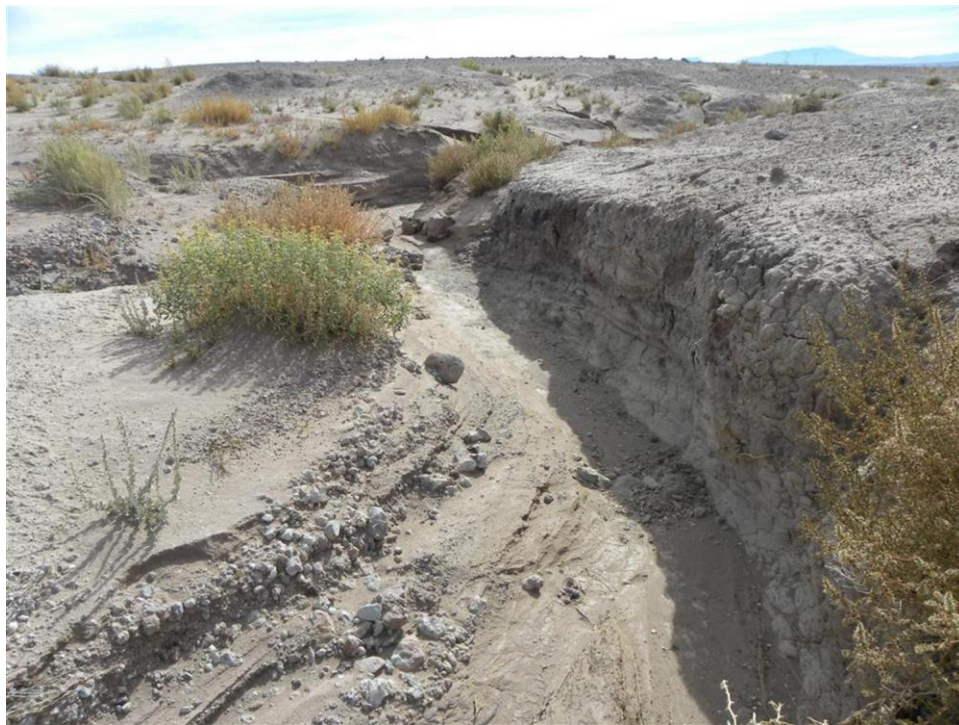
Photo 2. Charles Huskon No. 20 mine site, hot spot along drainage sidewall

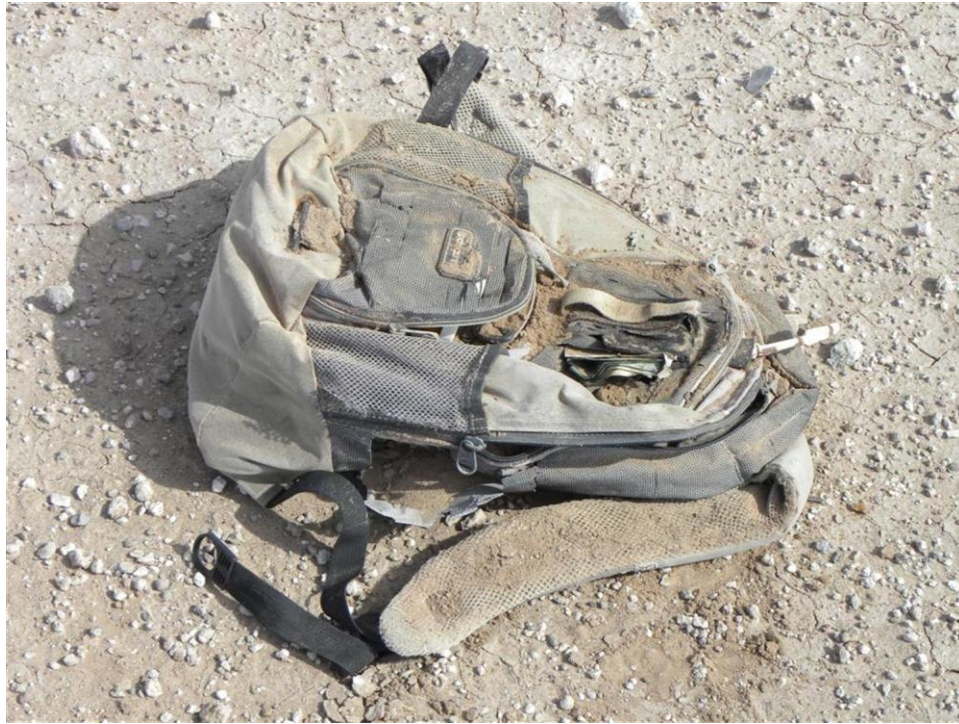
Photo 3. Charles Huskon No. 20 mine site, backpack found onsite

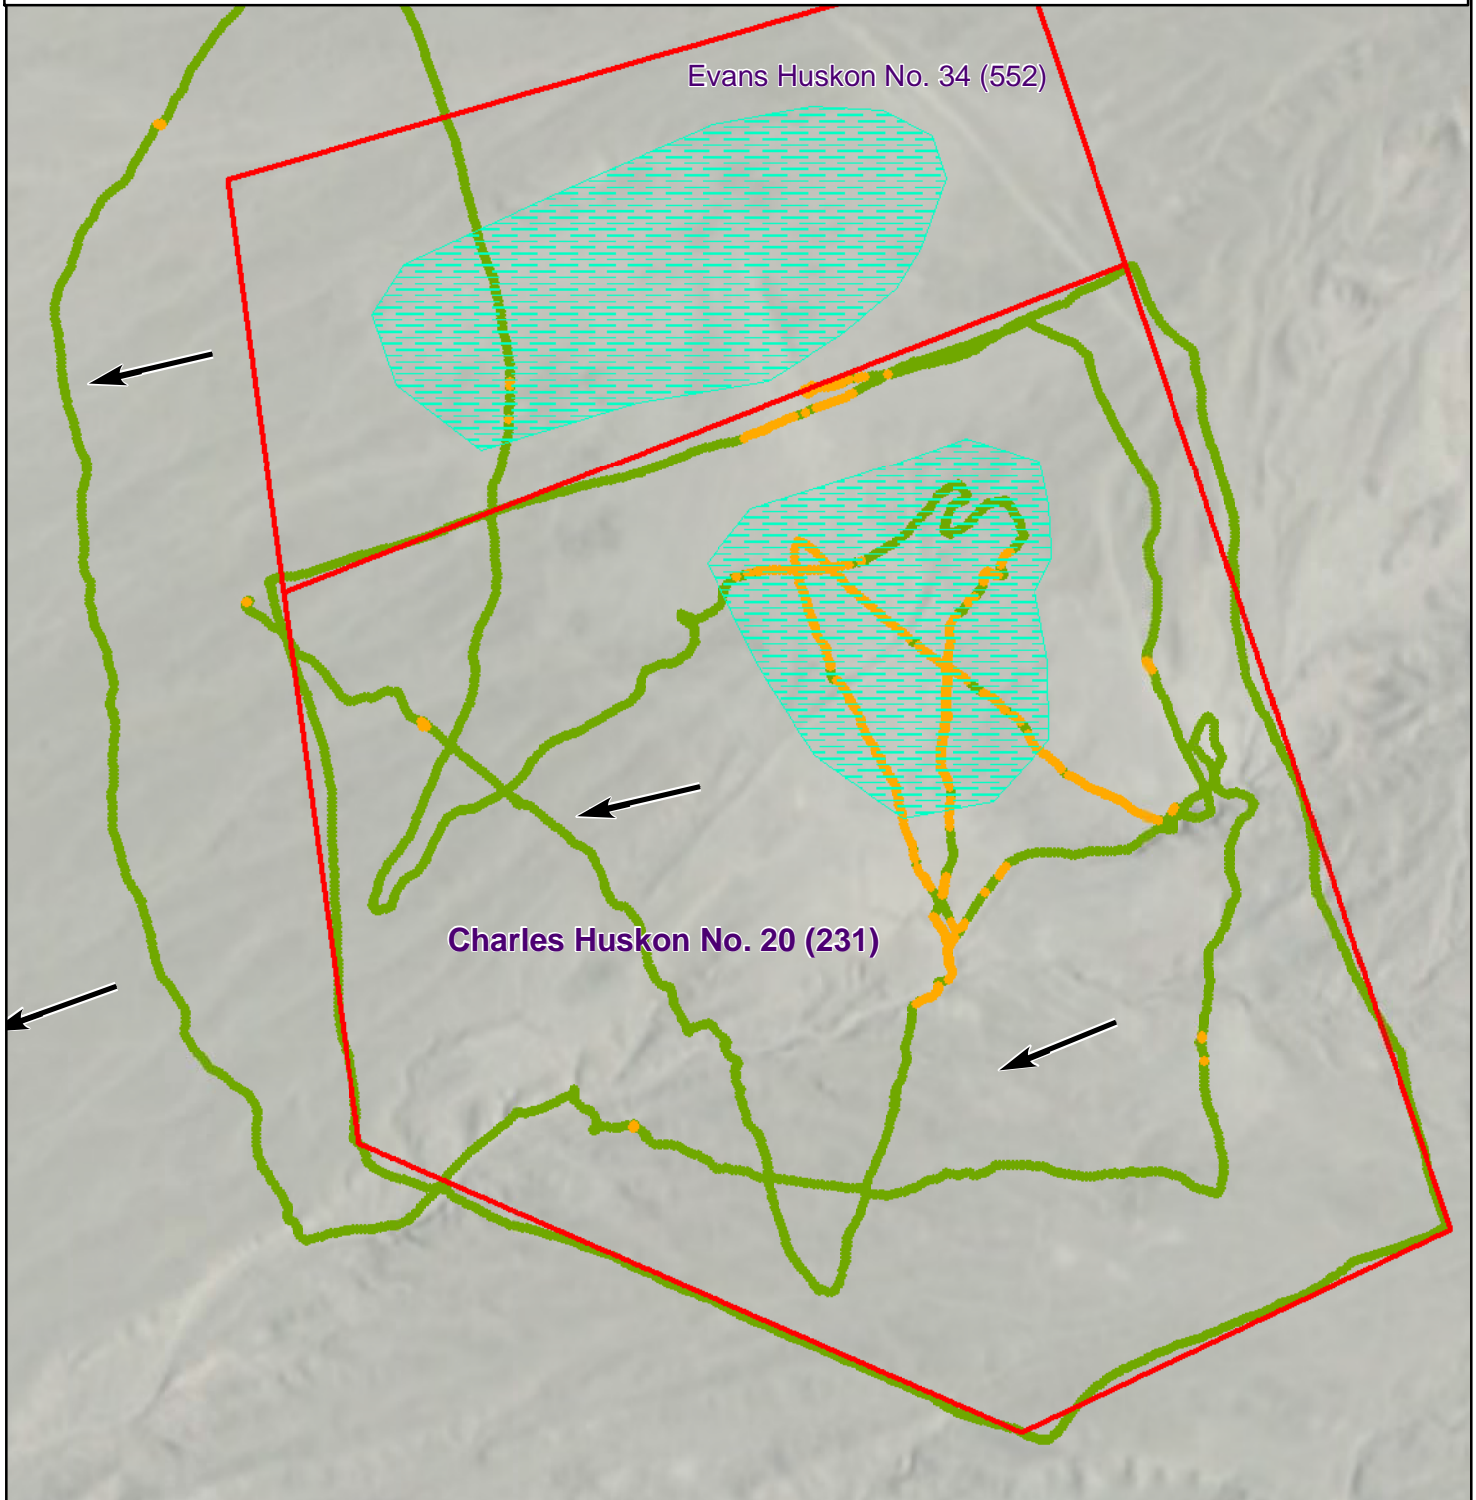
**Figure 1 - Gamma Radiation Measurements, Above Two Times Background  
Charles Huskon No. 20 (231)  
Coalmine Mesa Chapter, Navajo Nation**

A total of 4,585 gamma radiation measurements were collected from the mine site, ranging from 9,453 cpm to 185,938 cpm. The measurements collected at the reclamation cap were found at a maximum level of approximately 30,000 cpm. The measurements are represented in Figures 1 and 2.

Gamma survey conducted 11/2010  
Measured as counts per minute (cpm)

Average background 12,296 cpm

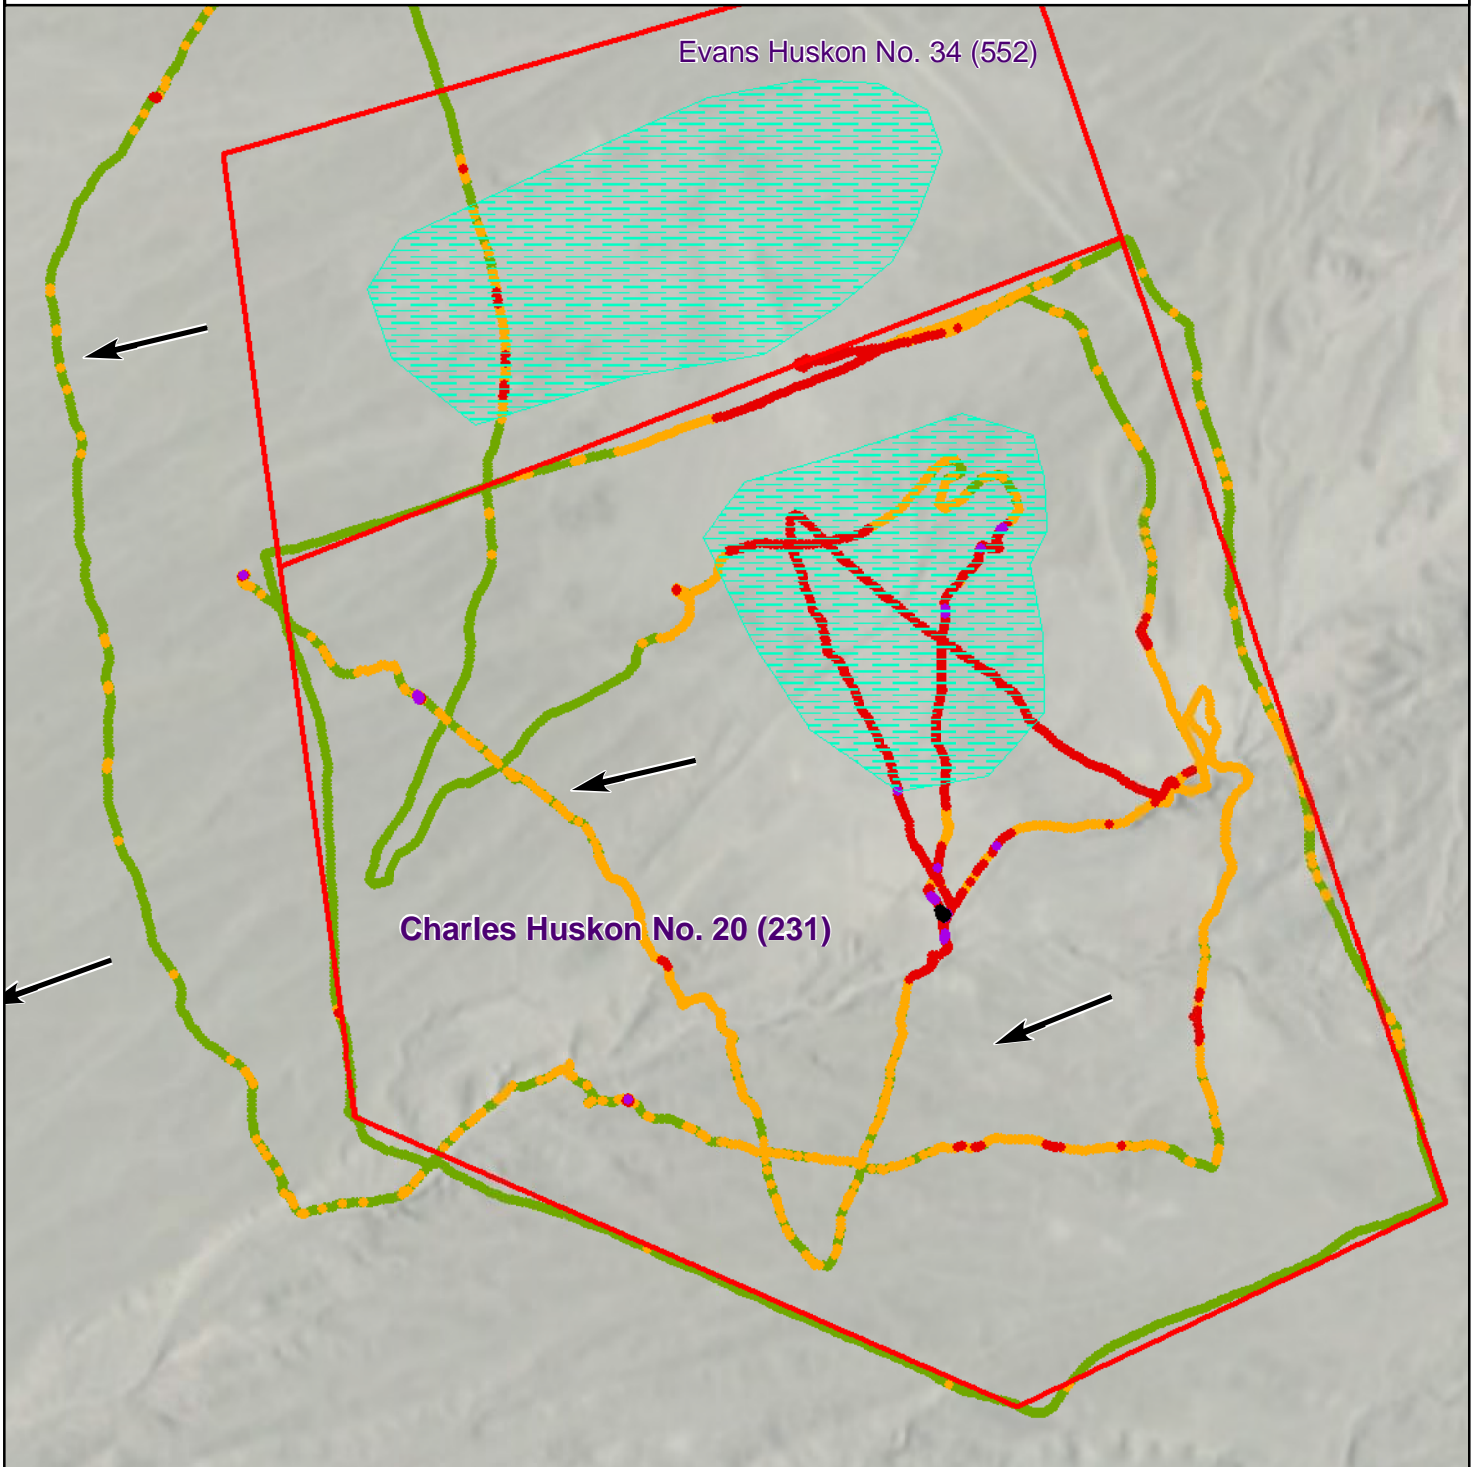
**Figure 2 - Gamma Radiation Measurements  
Charles Huskon No. 20 (231)  
Coalmine Mesa Chapter, Navajo Nation**

**Gamma survey conducted 11/2010  
Measured as counts per minute (cpm)**

**Average background 12,296 cpm**
