# Navajo Abandoned Uranium Mine

## Site Screen Report

### Max Johnson No. 7 AUM Site

**January 2011**

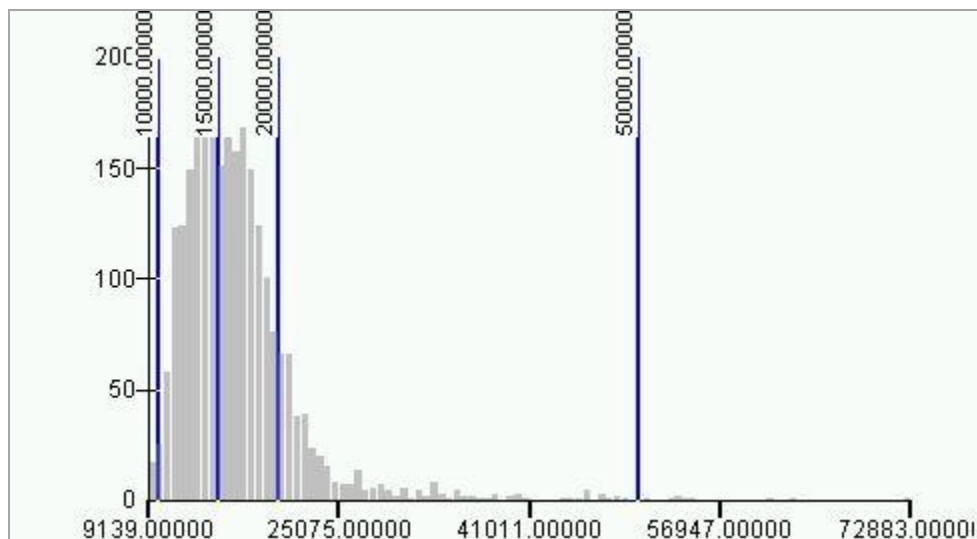
The following chart and statistics were generated by ESRI ArcGIS 9.3.1, and show the general distribution of the site gamma radiation measurements. The horizontal X axis represents the gamma radiation reading levels in cpm (lowest levels to the left). The vertical Y axis represents the frequency of each gamma radiation level.

Count:	2535
Minimum:	9139.00000
Maximum:	72883.00000
Sum:	42225319.00000
Mean:	16656.93057
Median:	15792.00000
Standard Deviation:	5409.61626

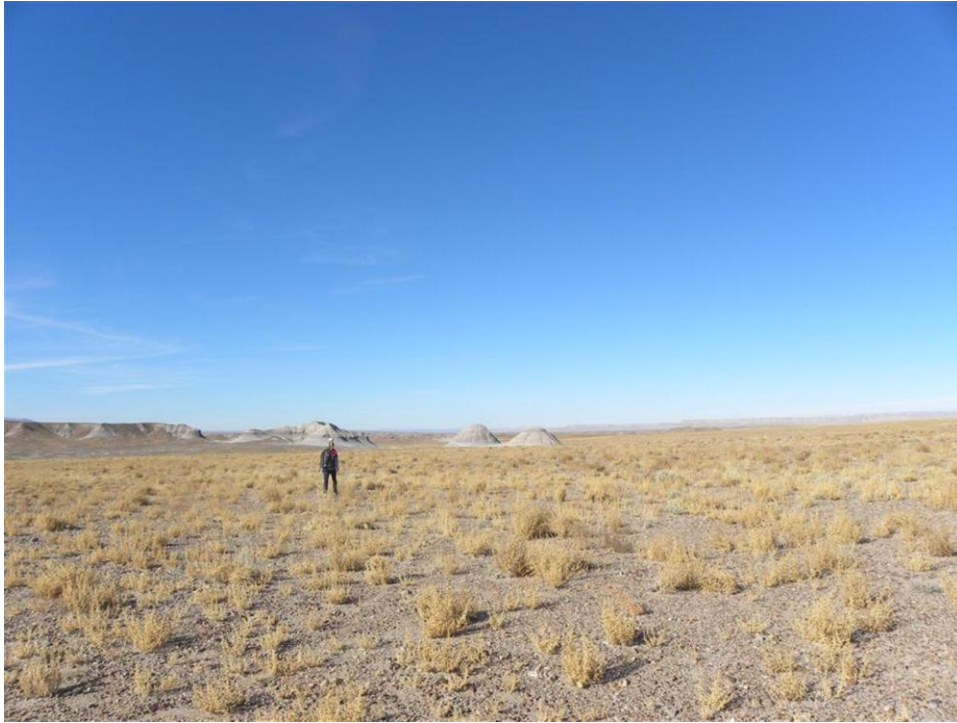
Photo 1. Max Johnson No. 7 mine site

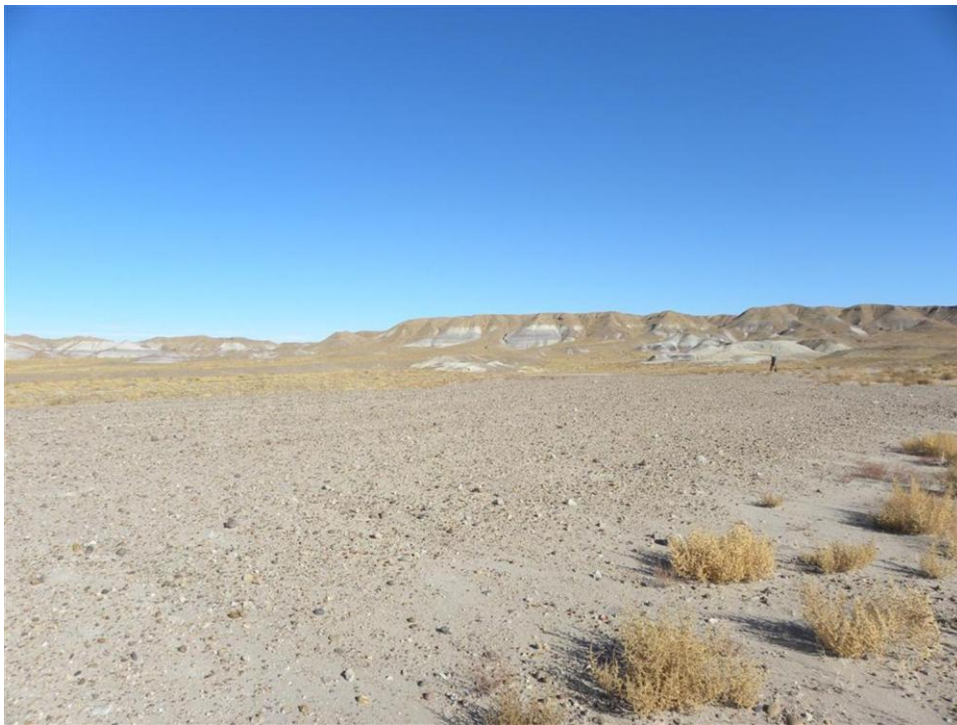
Reclamation cap in center of site, 75' x 250', flat

Photo 2. Max Johnson No. 7 mine site, reclamation cap

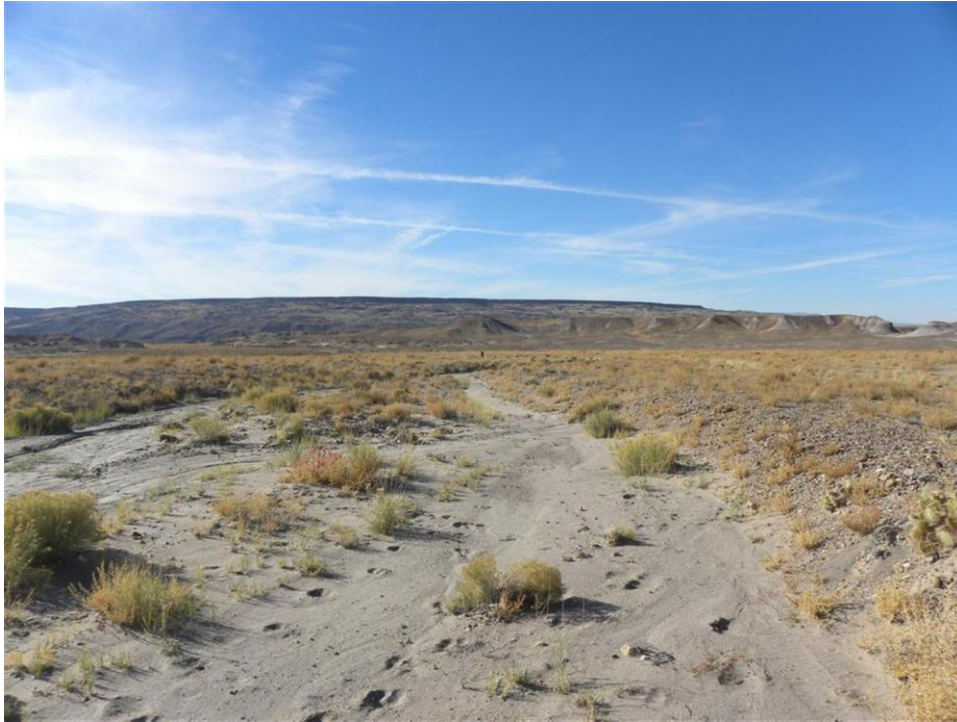
Photo 3. Max Johnson No. 7 mine site, drainage running site

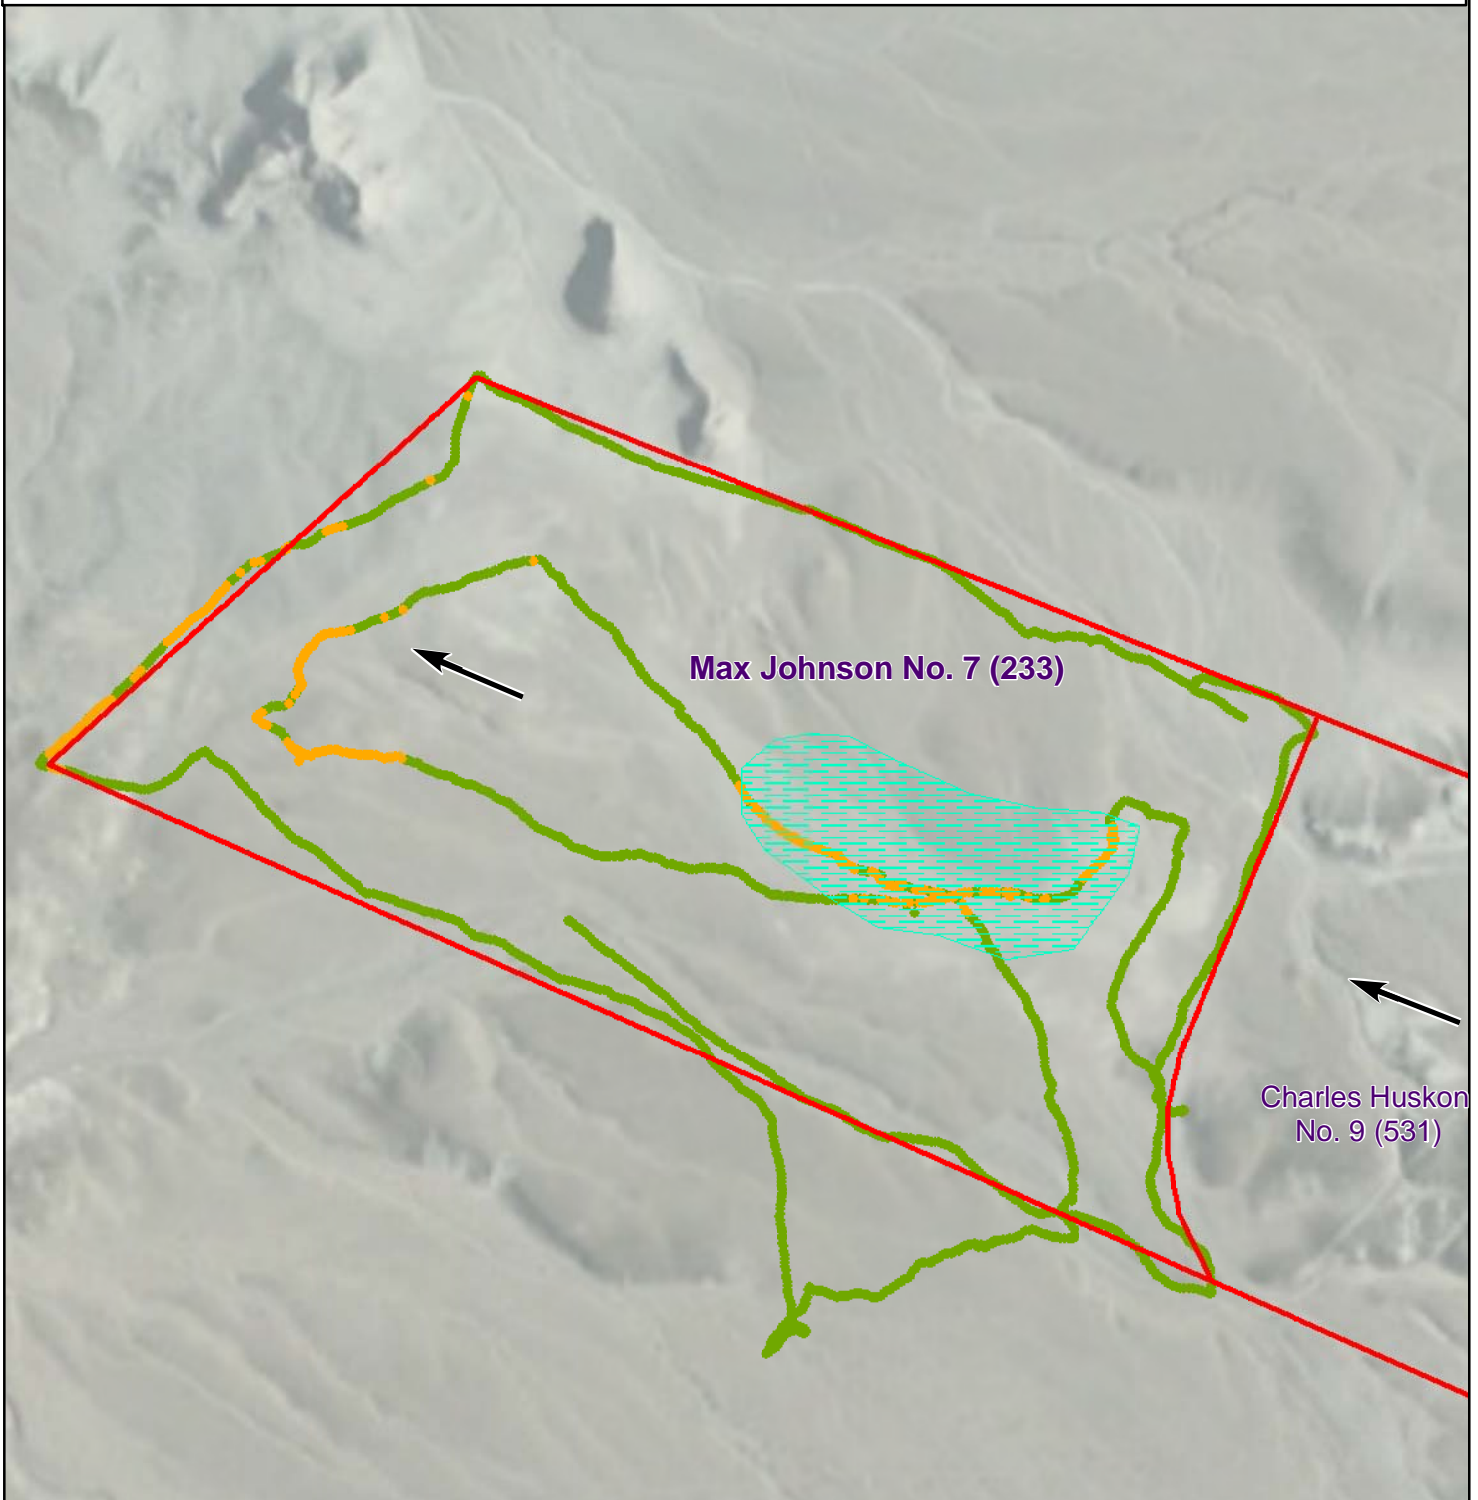
A total of 2,535 gamma radiation measurements were collected from the mine site, ranging from 9,139 cpm to 72,883 cpm. The measurements collected at the reclamation cap were found at a maximum level of approximately 70,000 cpm. The measurements are represented in Figures 1 and 2.

**Figure 1 - Gamma Radiation Measurements, Above Two Times Background  
 Max Johnson No. 7 (233)  
 Coalmine Mesa Chapter, Navajo Nation**

Gamma survey conducted 11/2010  
 Measured as counts per minute (cpm)

Average background 10,106 cpm

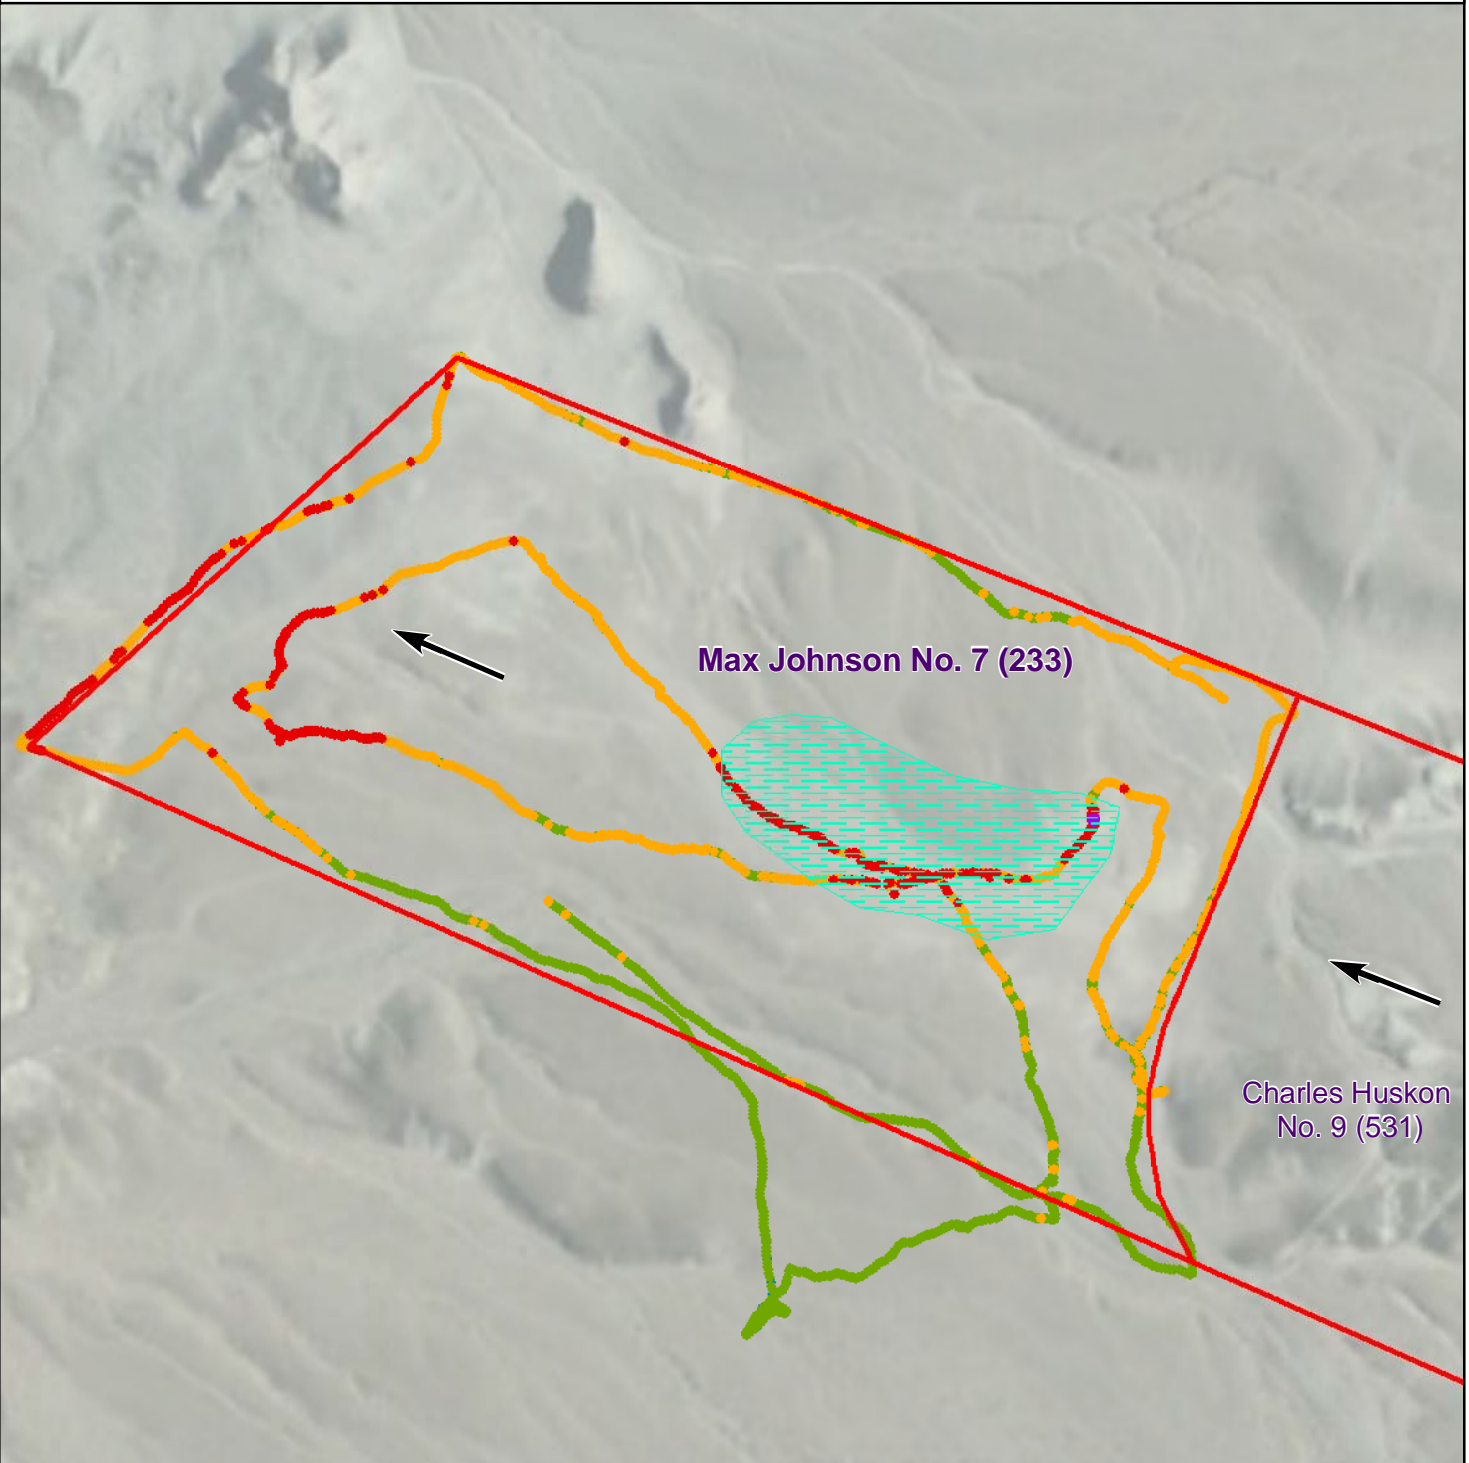
**Figure 2 - Gamma Radiation Measurements  
Max Johnson No. 7 (233)  
Coalmine Mesa Chapter, Navajo Nation**

**Gamma survey conducted 11/2010  
Measured as counts per minute (cpm)**

**Average background 10,106 cpm**
