Navajo Abandoned Uranium Mine

Site Screen Report

Mine Name: Black Rock Trench
Mine ID: 250

Navajo AUM North Central Region

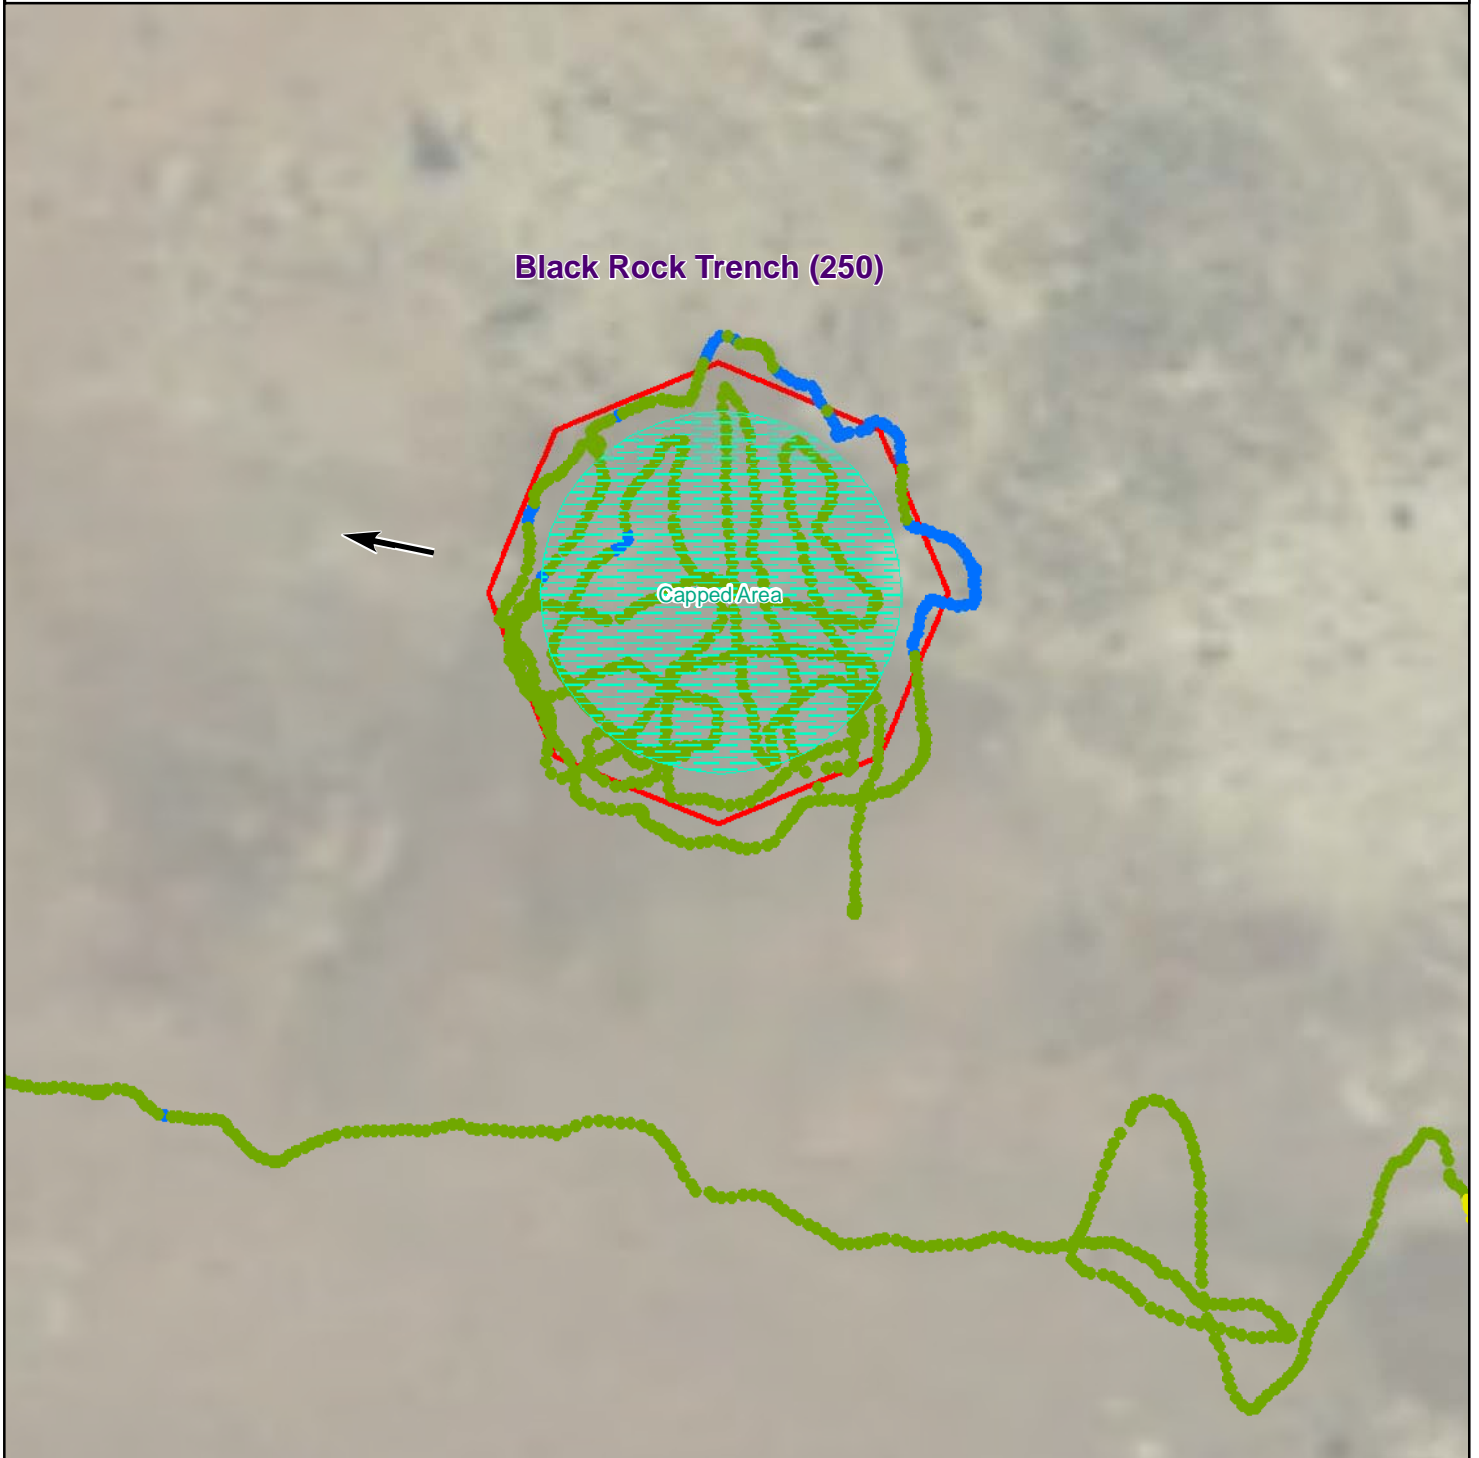
**Figure 2 - Gamma Radiation Measurements
Black Rock Trench (250)
Oljato Chapter, Navajo Nation**

Gamma Radiation Measurements

Average background 7,697 cpm

Measured as counts per minute (cpm)

A total of 1,026 gamma radiation measurements were collected from the mine site, ranging from 6,422 cpm to 23,194 cpm. Maximum levels of approximately 20,000 cpm were found near the reclamation cap. The measurements are represented in Figures 1 and 2.
