Navajo Abandoned Uranium Mine

Site Screen Report

Syracuse Mine AUM Site

March 2010

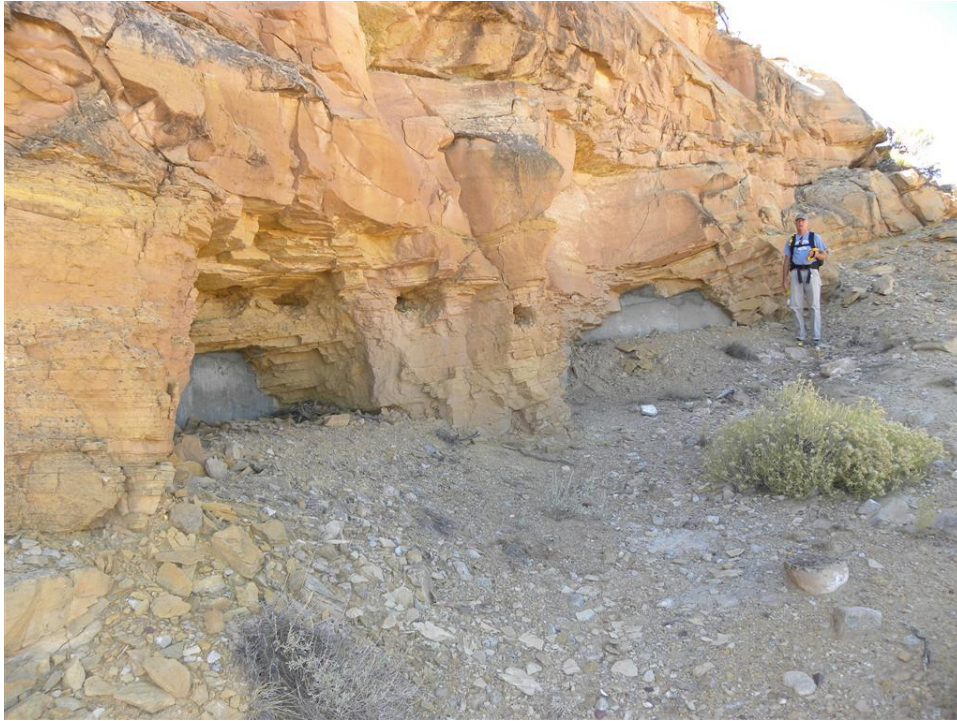
Photo 1. Sealed adits

3 concrete sealed adits

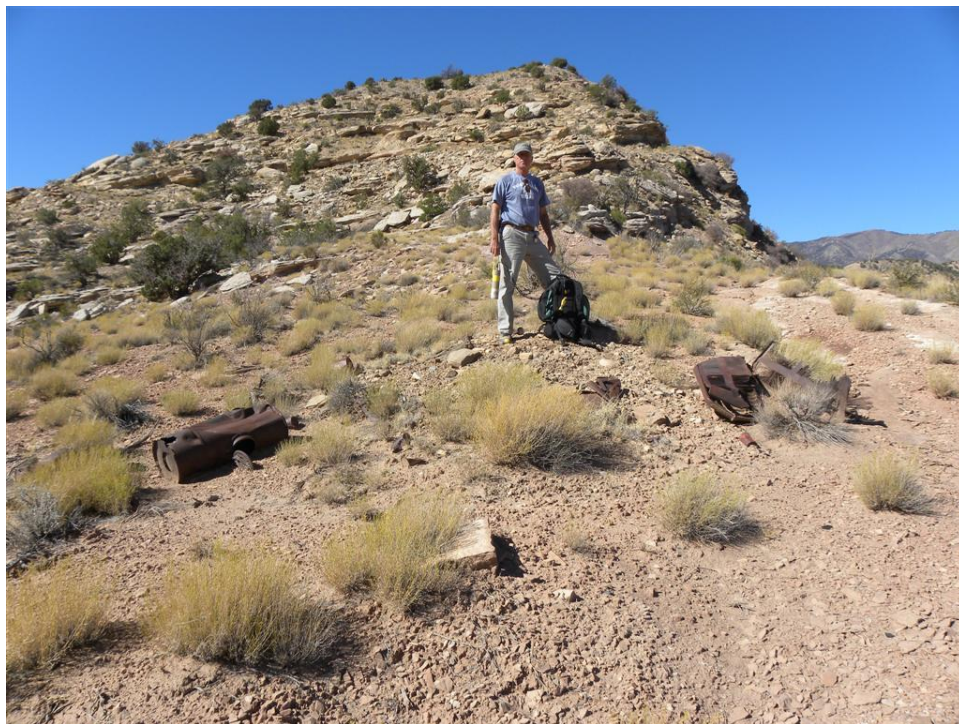
Photo 4. Mine site with waste debris

Waste pile with mechanical debris east of mine, 100' x 50', with a total estimated volume of 926 yd³

3 sealed adits; unreclaimed waste pile
