# Navajo Abandoned Uranium Mine

## Site Screen Report

**Mine Name: Taylor Reid No. 1**  
**Mine IDs: 261, 708**

**April 2012**

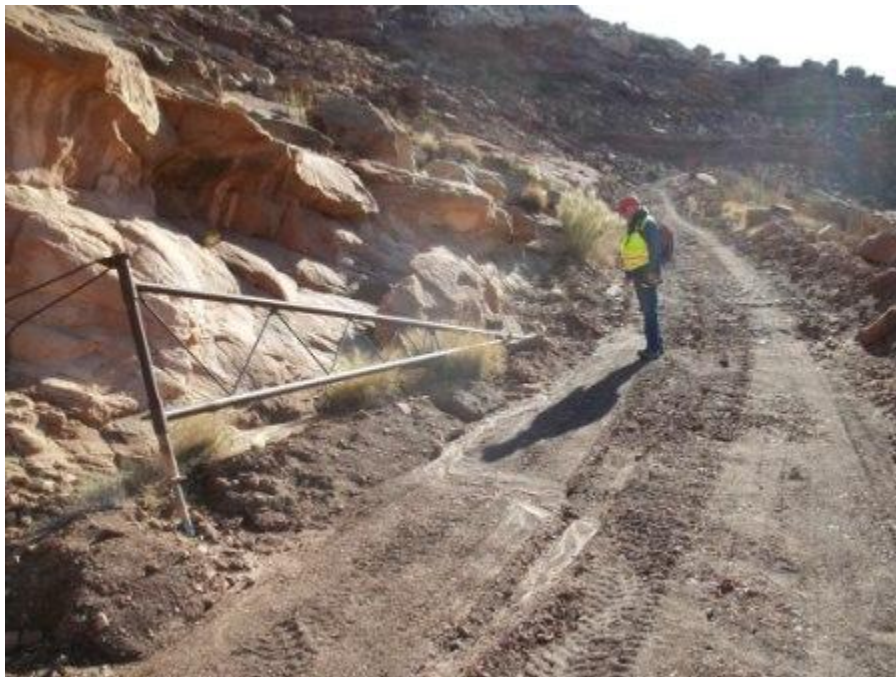
**Photo 2**

Mine Site #261 – Road / gate area

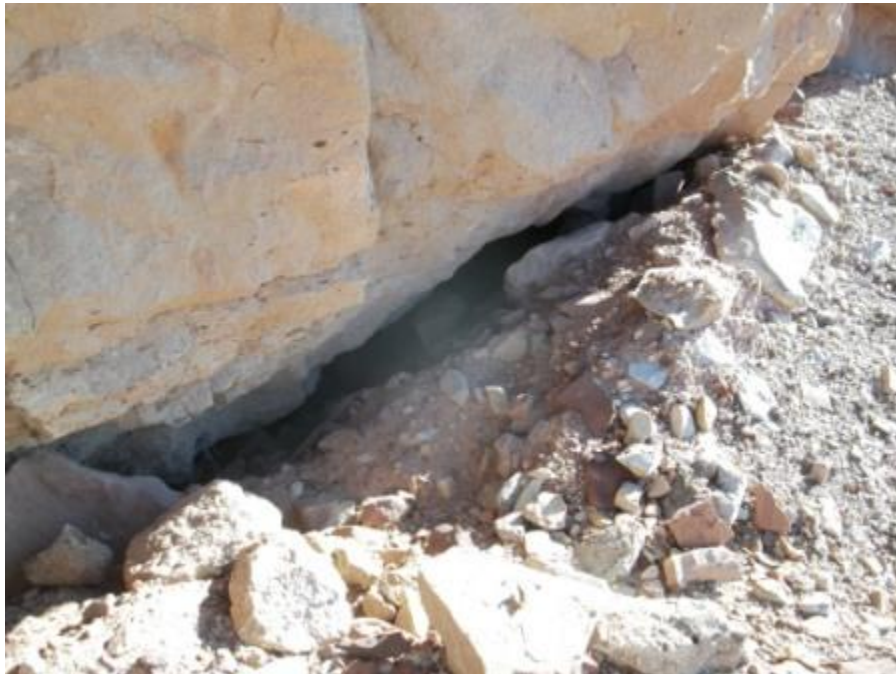
**Photo 4**

1 adit, covered with waste rock

Waste rock is pushed up against adit, and continues at least 200' downslope

Mine Site #261 - Adit

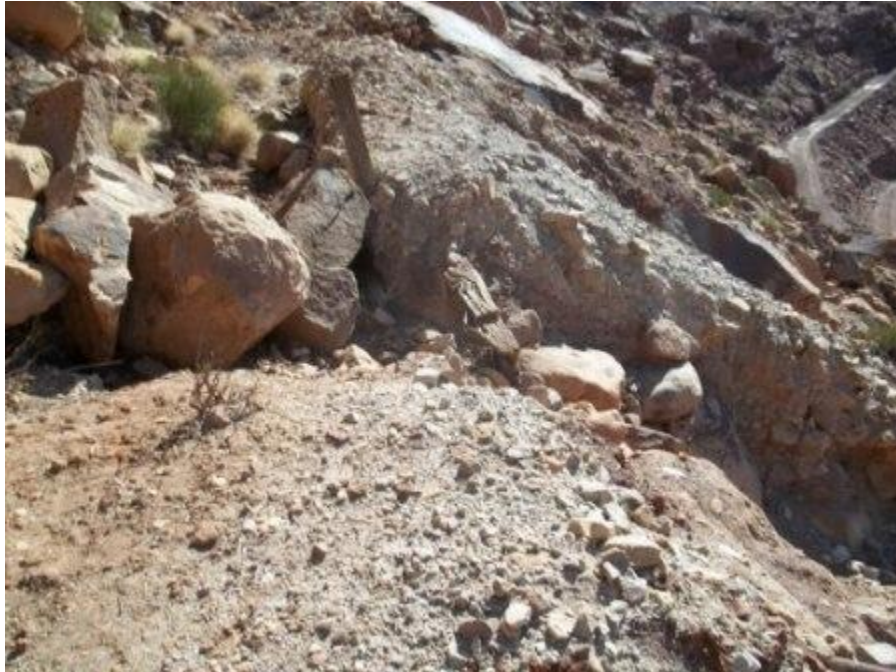
**Photo 11**

1 adit, appears caved in - waste rock pushed up against adit entrance

Waste rock piled against old road to site, and sheet of waste below

Mine Site #708 - Adit
