Navajo Abandoned Uranium Mine

Site Screen Report

Todakonzie No. 1 AUM Site

August 2010

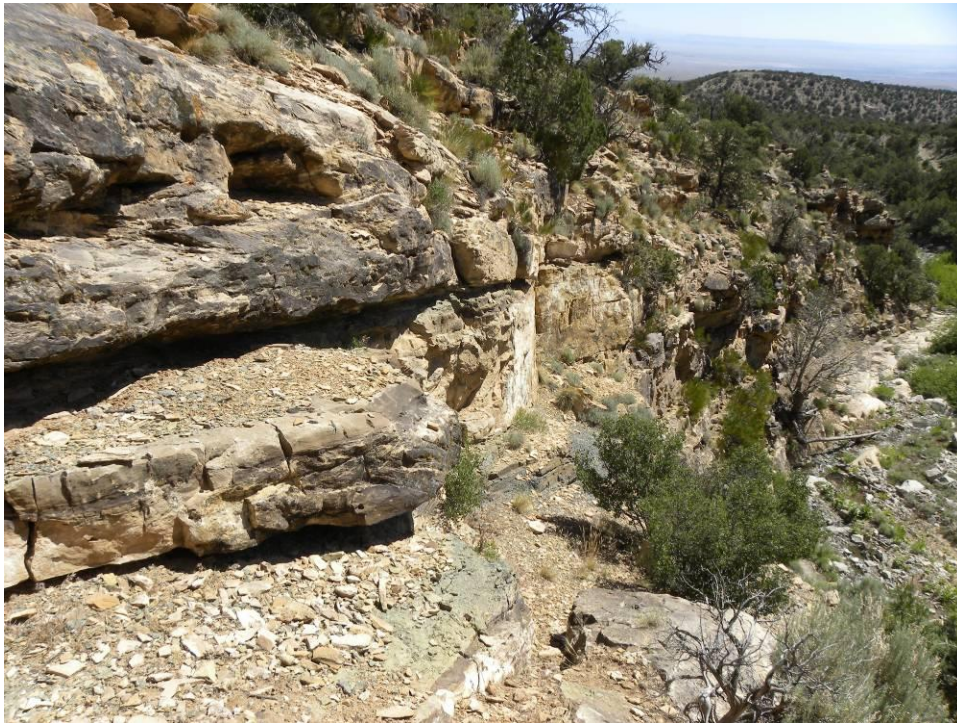
Apparent rim strip operation

Photo 2. Rim strip operations

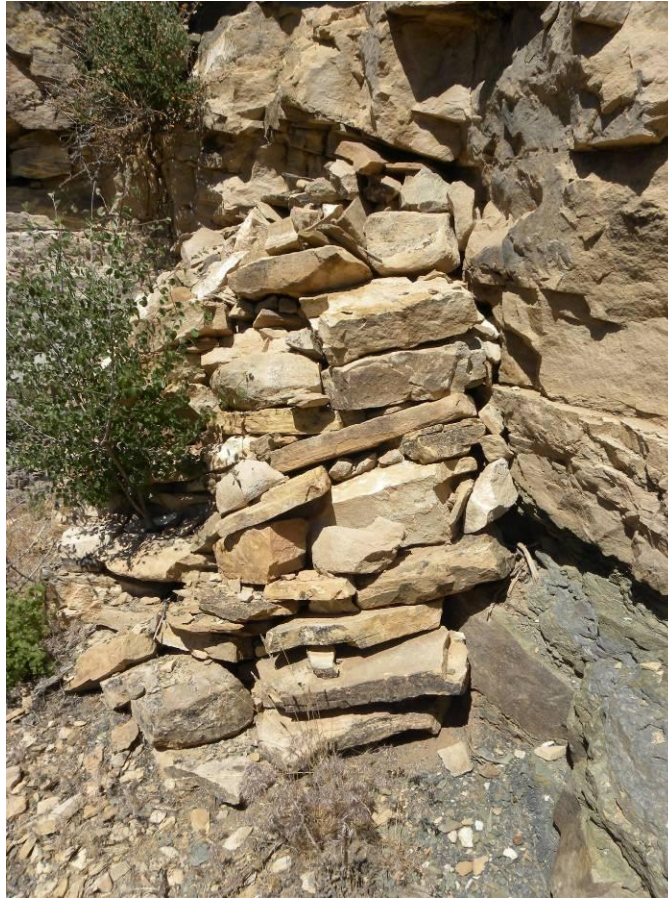
One adit, measuring 6' x 6', with a stone reclamation seal

Dark stone fragments with elevated gamma measurements were found adjacent to the adit

Photo 3. Adit with stone reclamation seal

Sealed adit; unreclaimed waste rock

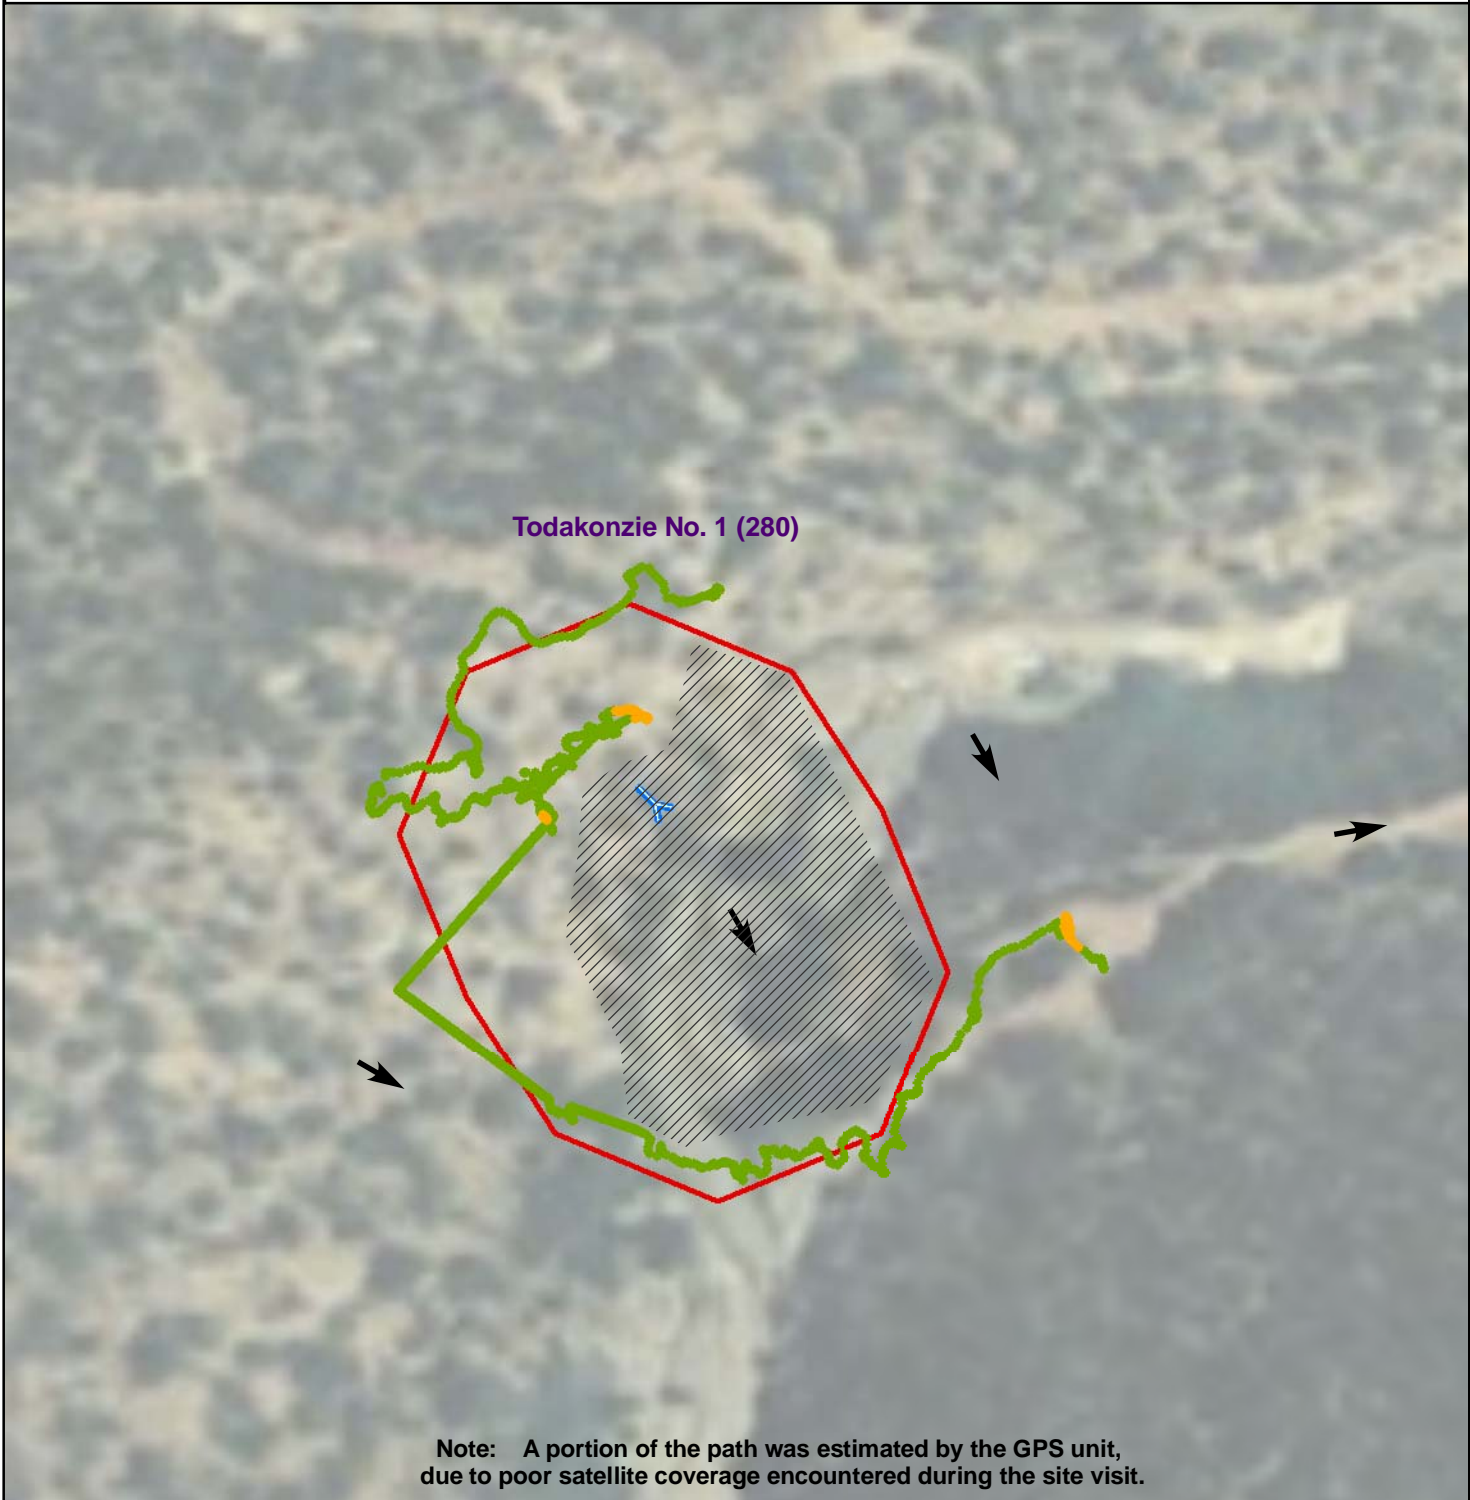
**Figure 1 - Gamma Radiation Measurements, Above Two Times Background
 Todakonzie No. 1 (280)
 Beclabito Chapter, Navajo Nation**

A total of 2,470 gamma radiation measurements were collected from the mine site, ranging from 7,528 cpm to 315,008 cpm. Measurements collected in the vicinity of the waste debris were found at levels ranging from approximately 150,000 cpm to 315,000 cpm, near the adit at levels up to approximately 96,000 cpm, and near the rim strip ranging from approximately 50,000 cpm to 80,000 cpm. The measurements are represented in Figures 1 and 2.

Note: A portion of the path was estimated by the GPS unit, due to poor satellite coverage encountered during the site visit.

Gamma survey conducted 06/2010
 Measured as counts per minute (cpm)
 Average background = 11,580 cpm
