Navajo Abandoned Uranium Mine

Site Screen Report

Rocky Flats No. 2 AUM Site

Weston Solutions, Inc.

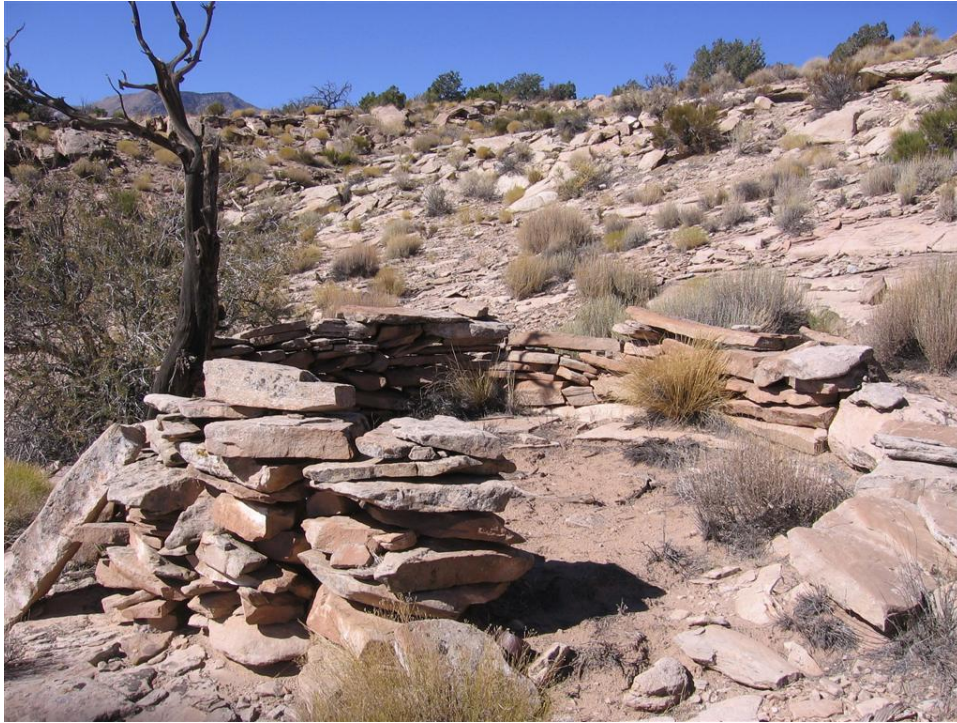
Ruins of a stone hogan were found at the site

Photo 1. Stone hogan ruins

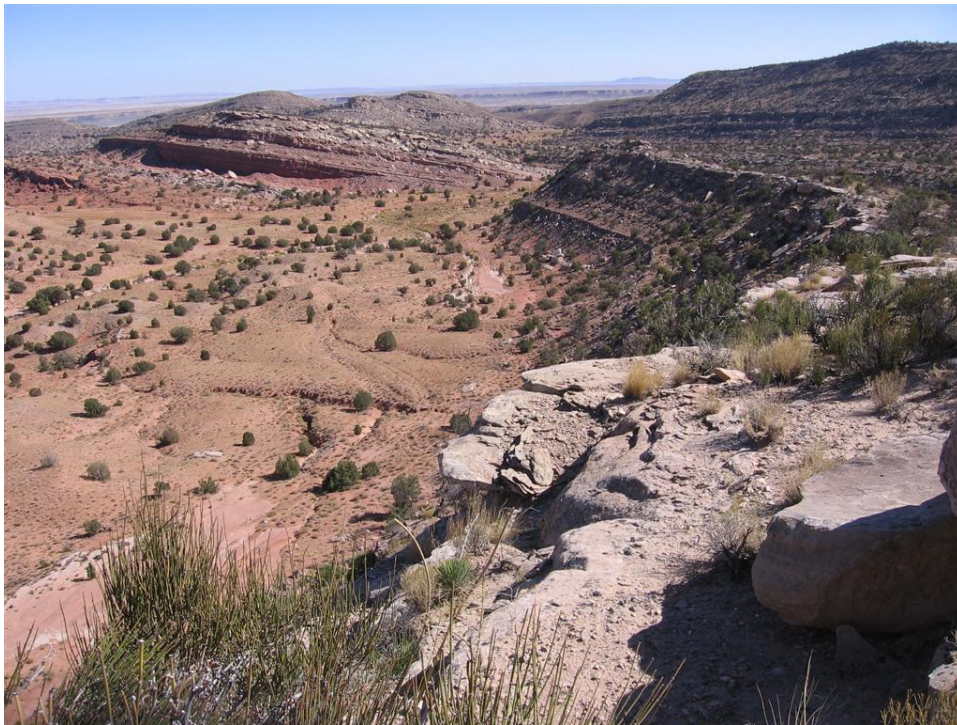
Photo 2. Mine site

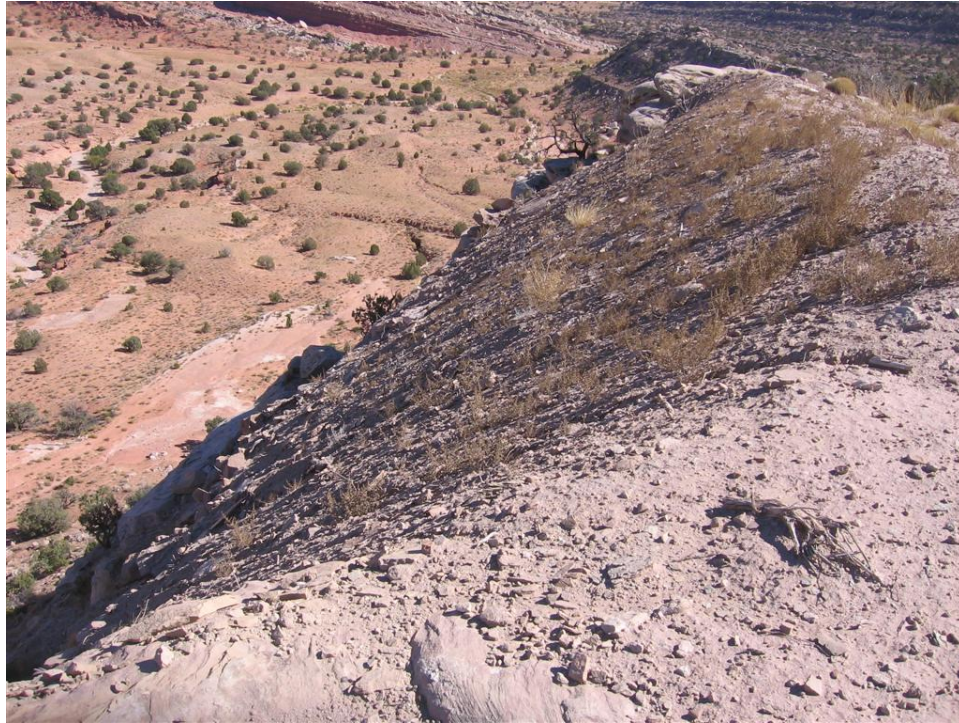
Waste pile extending 200' down northeast face, 150' x 200', with a total estimated volume of 3,703 yd³

Photo 3. Waste pile

Sealed adit; unreclaimed waste pile

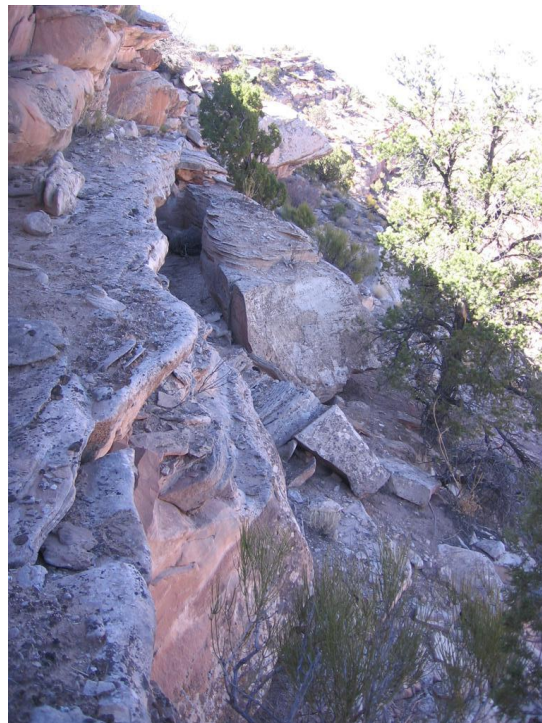
Adit (6' x 15' wide) at the top of northeast face

Photo 4. Waste rock and sealed adit location

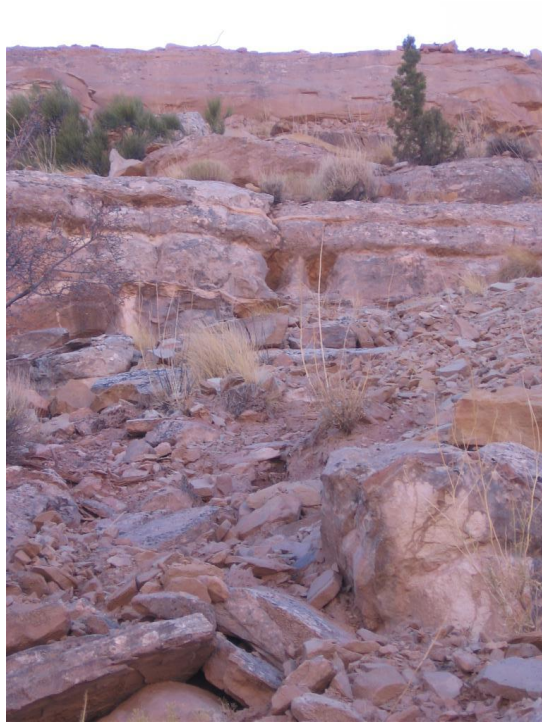
Photo 5. Waste rock
