# Navajo Abandoned Uranium Mine

## Site Screen Report

## Upper Red Canyon AUM Site

**August 2010**

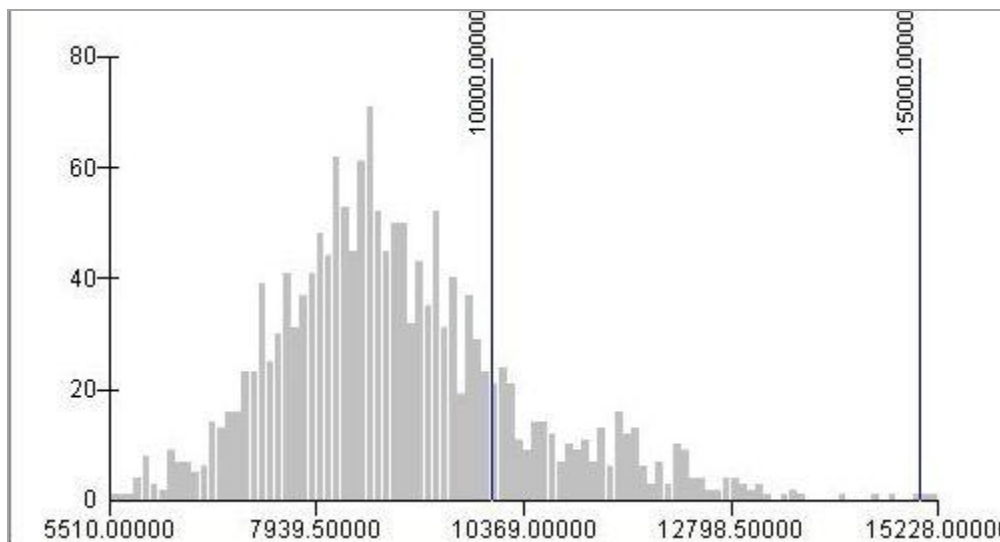
The following chart and statistics were generated by ESRI ArcGIS 9.3.1, and show the general distribution of the site gamma radiation measurements. The horizontal X axis represents the gamma radiation reading levels in cpm (lowest levels to the left). The vertical Y axis represents the frequency of each gamma radiation level.

Count:	1632
Minimum:	5510.00000
Maximum:	15228.00000
Sum:	14524635.00000
Mean:	8899.89890
Median:	8670.50000
Standard Deviation:	1450.93160

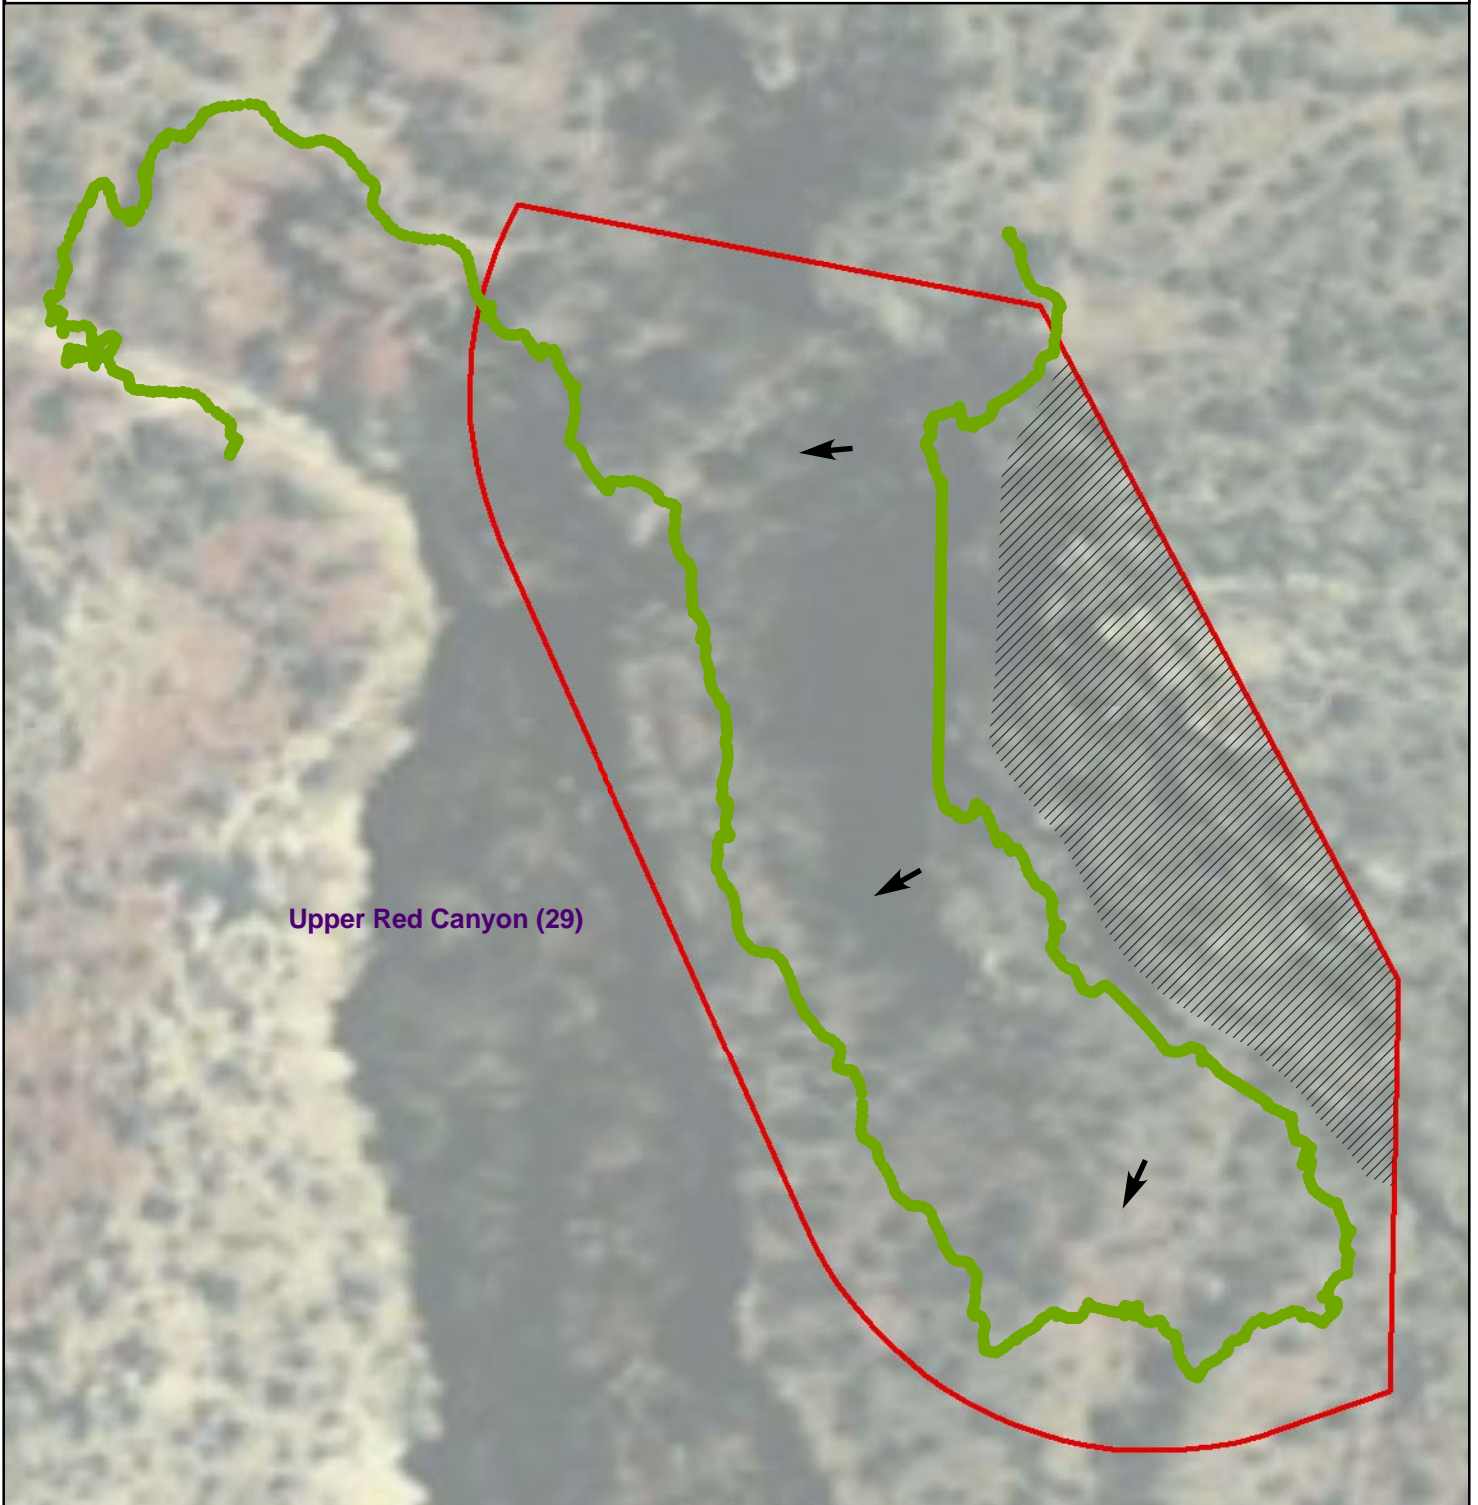
**Figure 1 - Gamma Radiation Measurements, Above Two Times Background  
Upper Red Canyon (29)  
Beclabito Chapter, Navajo Nation**

A total of 1,632 gamma radiation measurements were collected from the mine site, ranging from 5,510 cpm to 15,228 cpm. The measurements are represented in Figures 1 and 2.

Gamma survey conducted 06/2010  
Measured as counts per minute (cpm)

Average background = 11,102 cpm

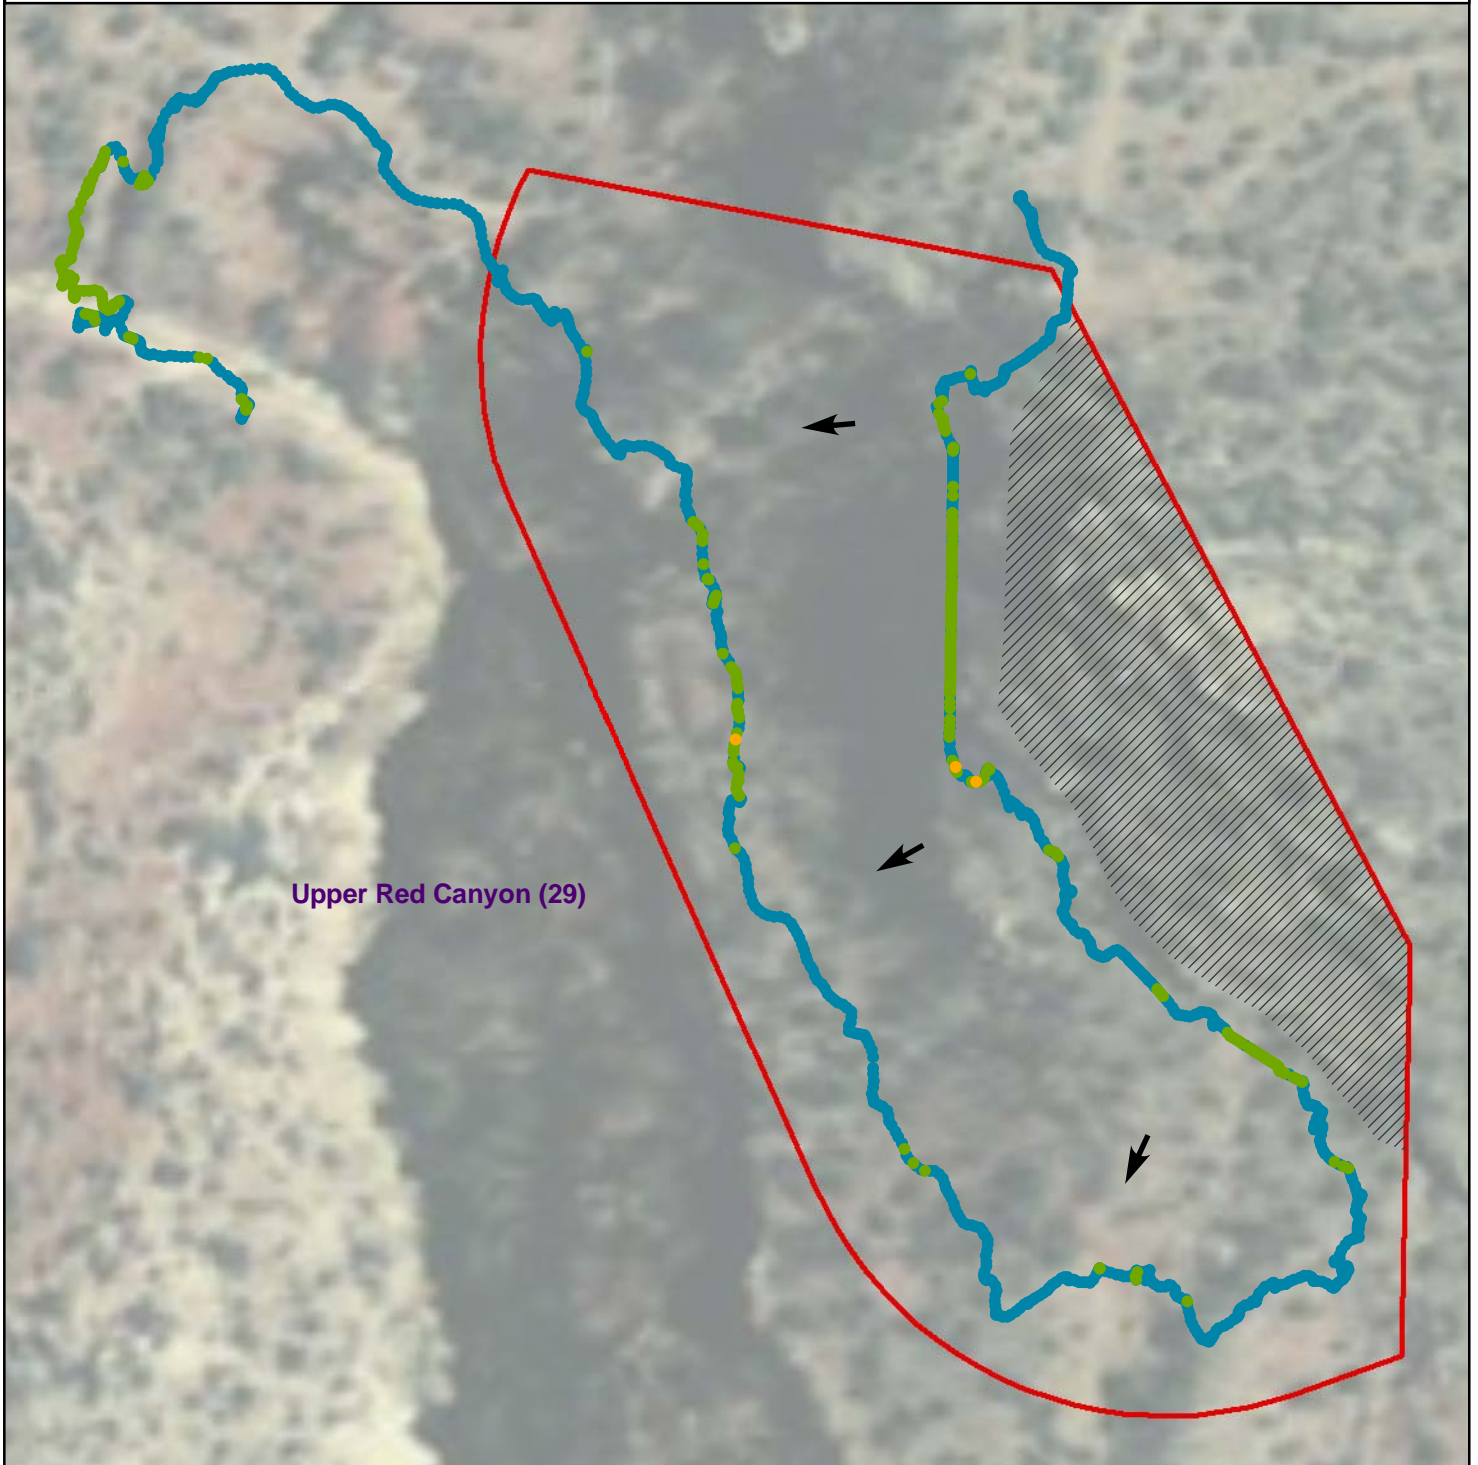
**Figure 2 - Gamma Radiation Measurements  
Upper Red Canyon (29)  
Beclabito Chapter, Navajo Nation**

Gamma survey conducted 06/2010  
Measured as counts per minute (cpm)

Average background 11,102 cpm
