Navajo Abandoned Uranium Mine Site Screen Report

Red Top AUM Site

Navajo AUM Eastern Region

May 2009

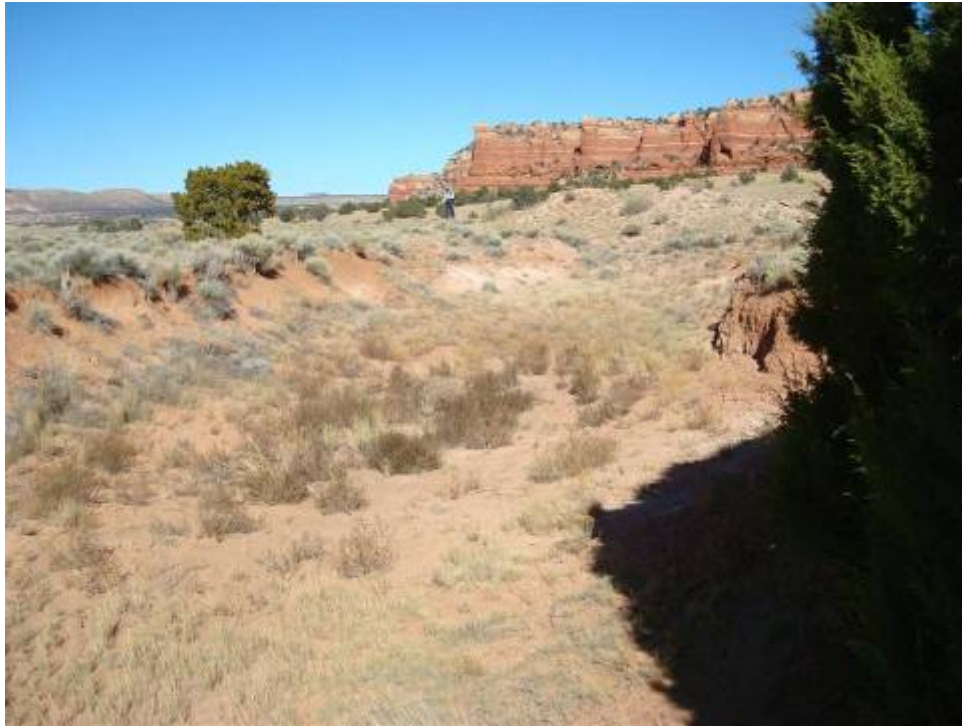
Photo 1. Red Top Mine site, towards the north

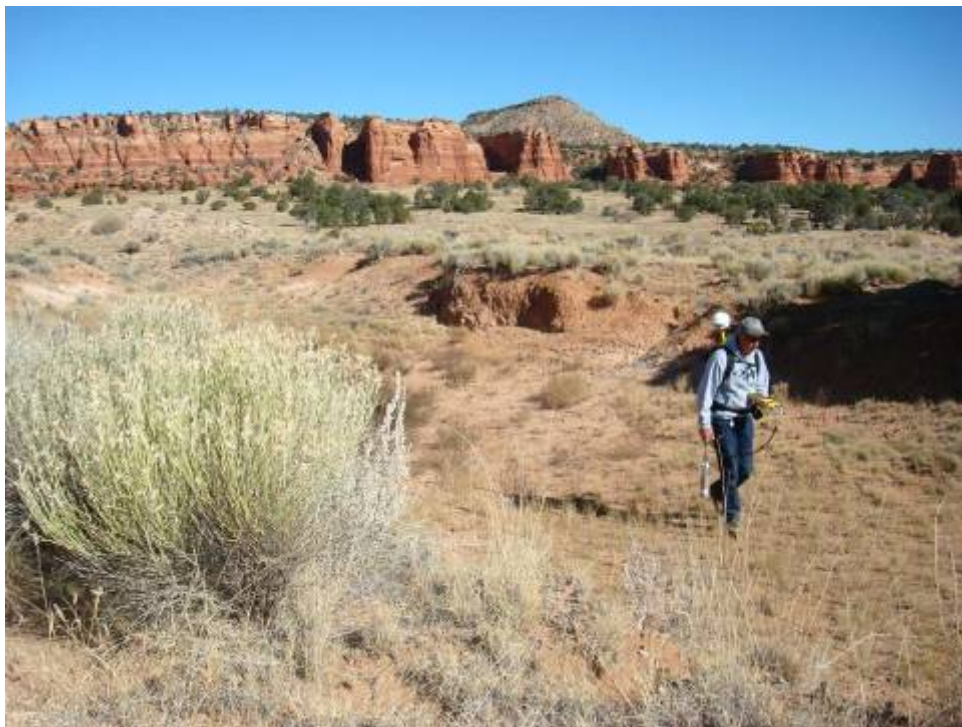
Photo 2. Red Top Mine site, towards the northeast

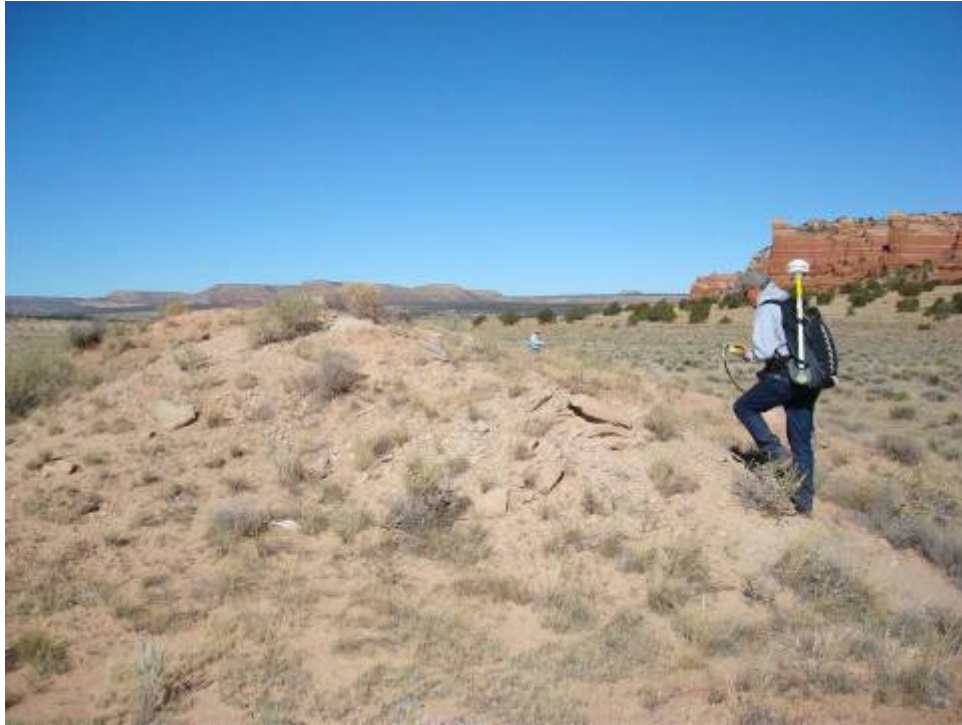
Reclamation status of the mine sites are currently unknown. No visible signs of reclamation were observed. A linear area appears to have experienced some subsidence. Waste Rock (soil) piles were observed. No adits or other mine features were observed during the site visit.

Photo 3. Red Top Mine site, waste rock pile

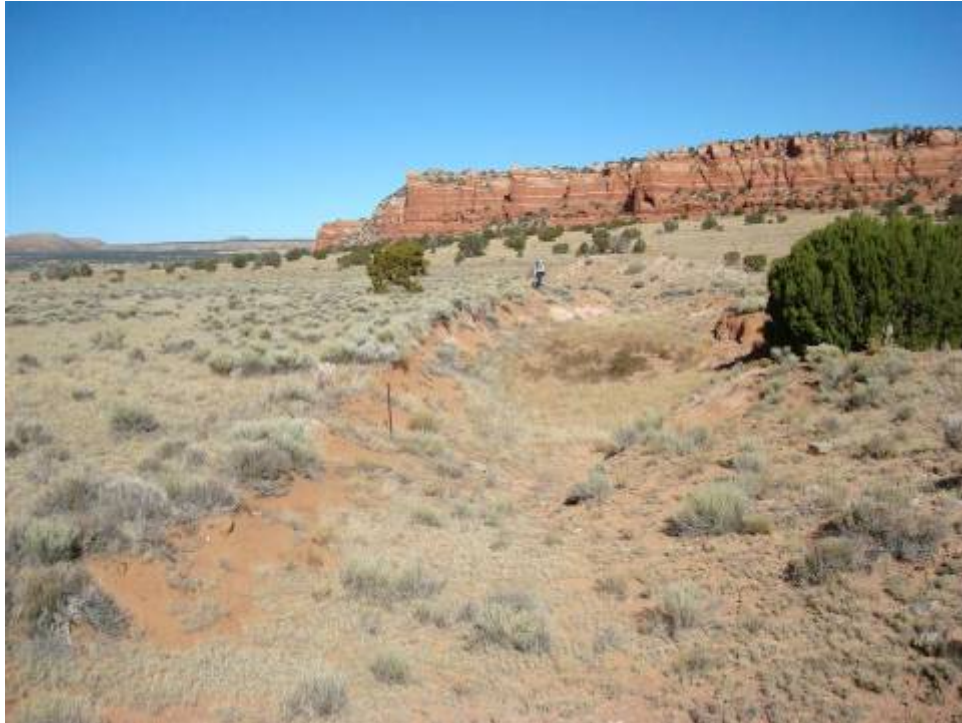
Photo 4. Red Top Mine site, towards the north

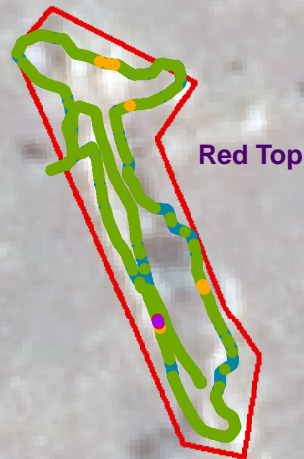
Gamma Radiation Measurements
Red Top
Baca/Haystack Chapter
Navajo Nation, New Mexico Figure 2

A total of 3,228 gamma radiation measurements were collected from mine sites, ranging from 6,197 cpm to 144,738 cpm. The measurements are represented in Figures 1 and 2.

Gamma survey conducted in October 2008
measured as counts per minute
