# Navajo Abandoned Uranium Mine Site Screen Report

## **Section 4 AUM Site**

### **Navajo AUM Eastern Region**

**May 2009**

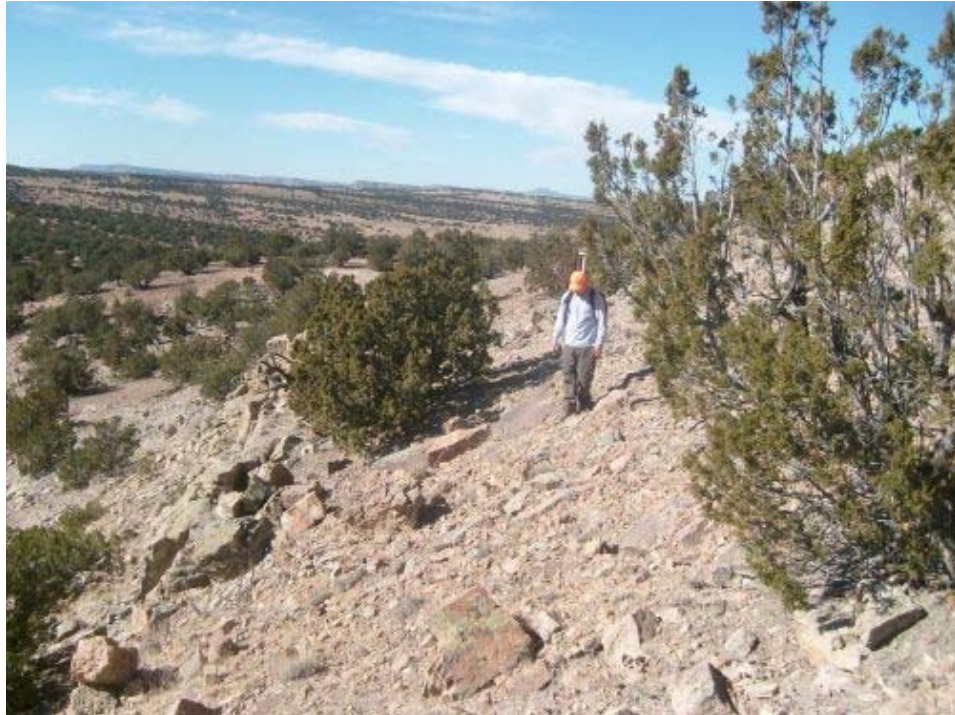
Reclamation status of the mine site is currently unknown. No waste piles, adits, pits, or other features were observed during the site visit.

Photo 1. Section 4 mine site, towards the north

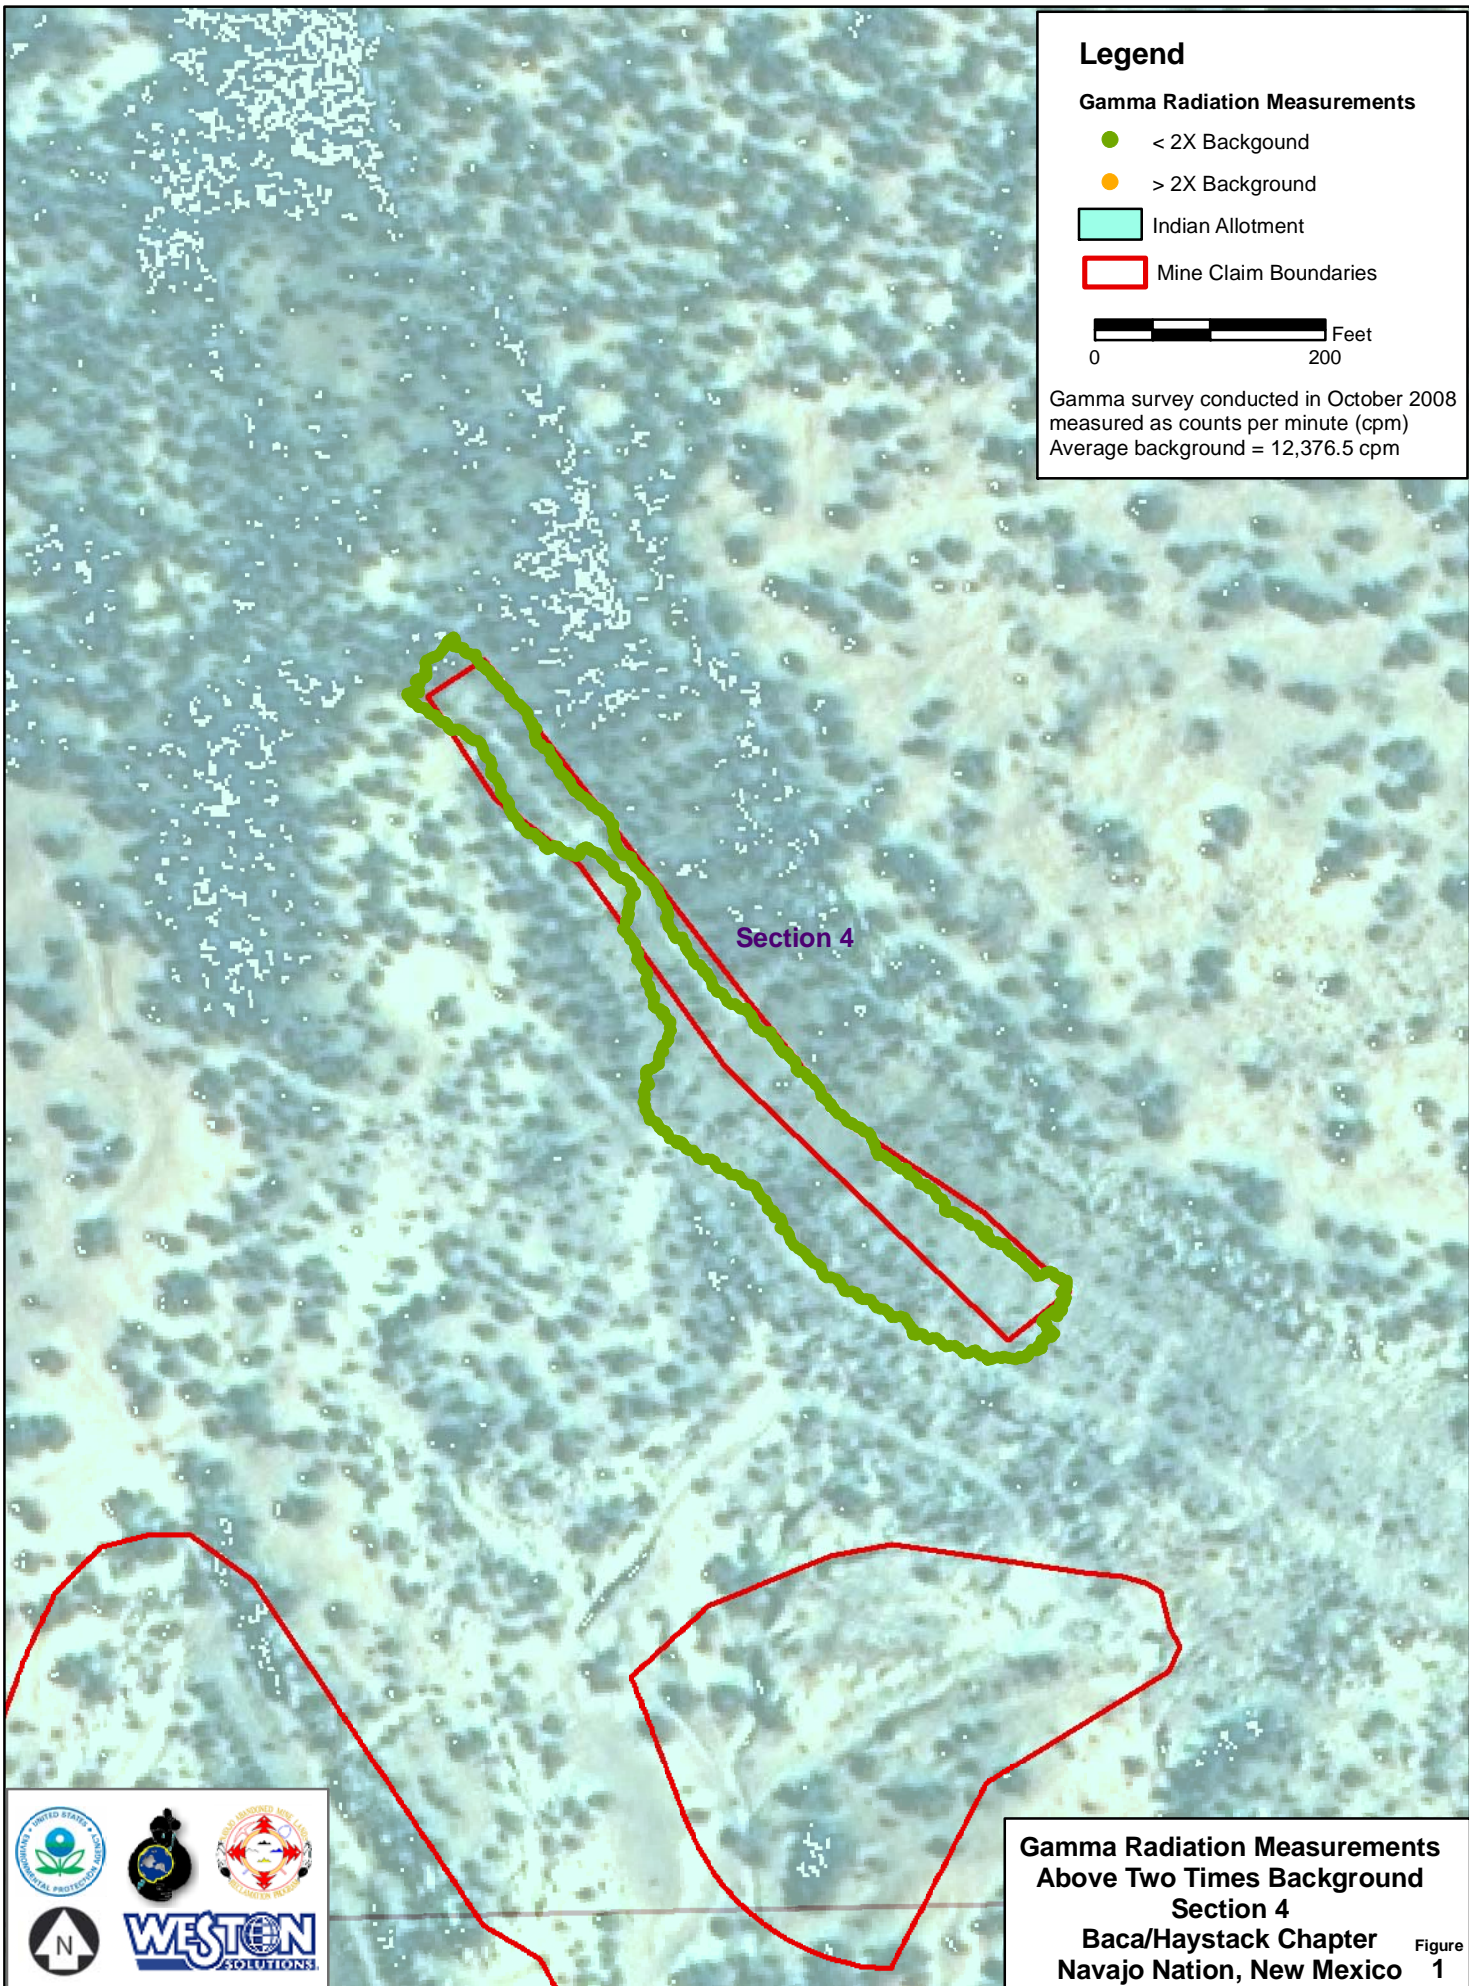
**Gamma Radiation Measurements  
Above Two Times Background  
Section 4  
Baca/Haystack Chapter  
Navajo Nation, New Mexico** Figure 1

A total of 912 gamma radiation measurements were collected from the mine site, ranging from 9,207 cpm to 20,788 cpm. The measurements are represented in Figures 1 and 2.

Gamma survey conducted in October 2008  
measured as counts per minute (cpm)  
Average background = 12,376.5 cpm

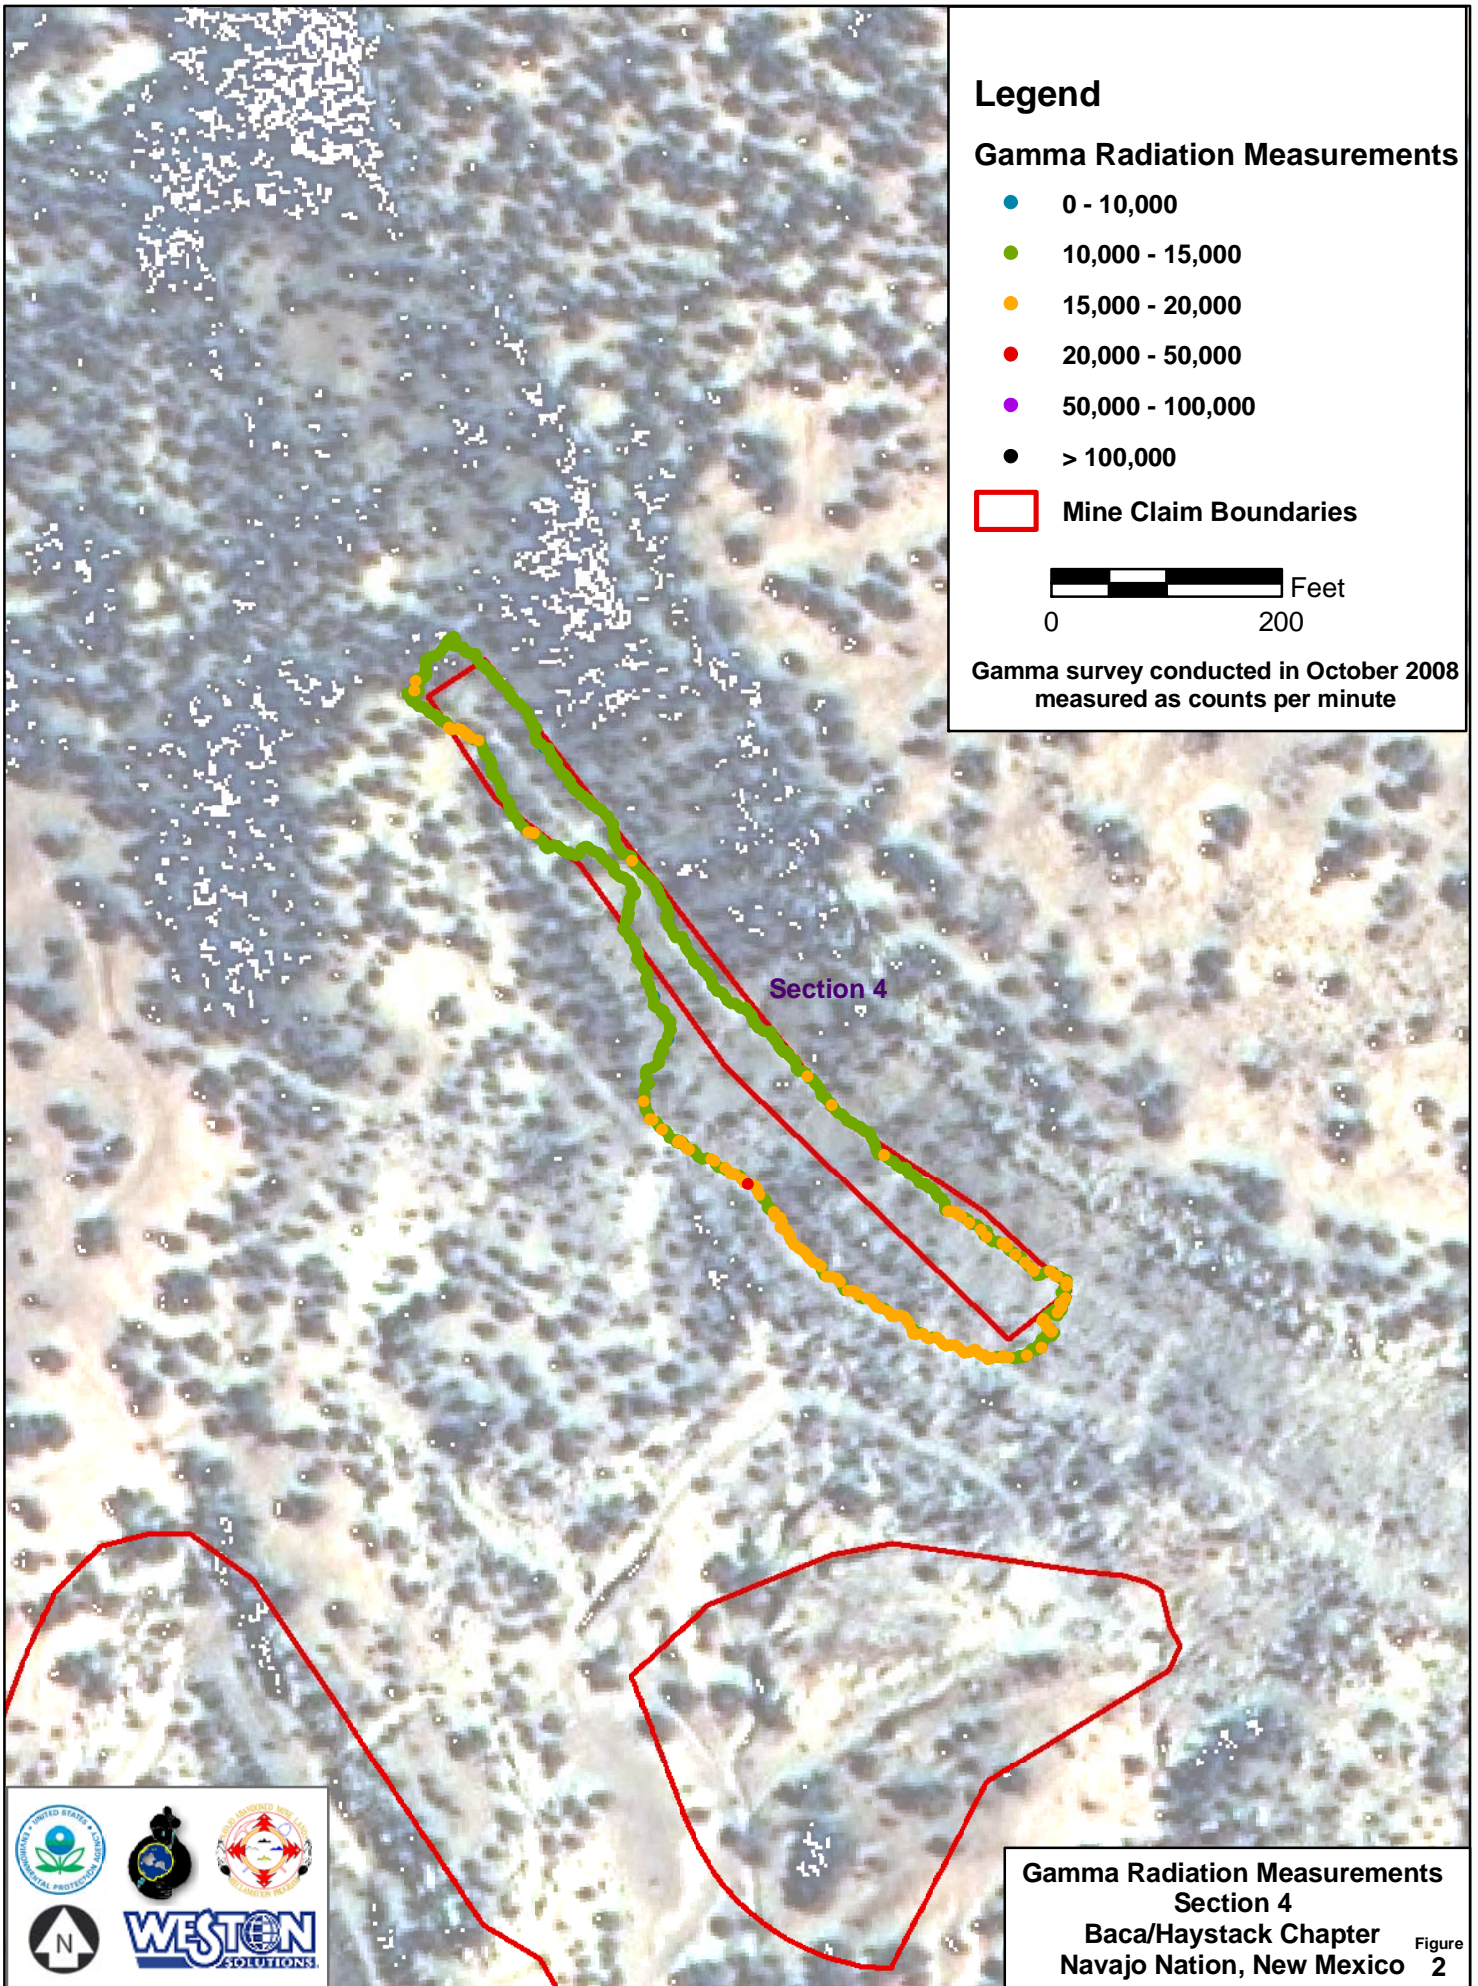
**Gamma Radiation Measurements  
Section 4  
Baca/Haystack Chapter  
Navajo Nation, New Mexico** Figure 2

Gamma survey conducted in October 2008  
measured as counts per minute
